## **RATHMULLAN PIER**

# **Condition Report**

**2021 CONDITION REPORT**

**Nicholas O'Dwyer Ltd  
Consulting Engineers  
Nutmog Office Park  
Nutmog Avenue  
Dublin 14**

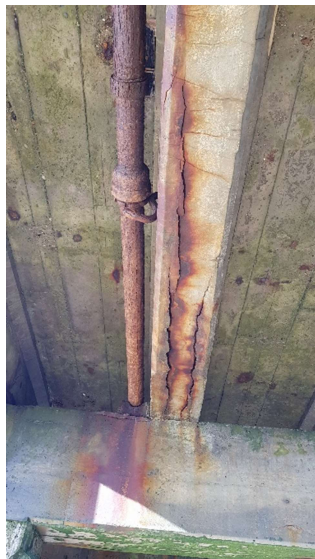
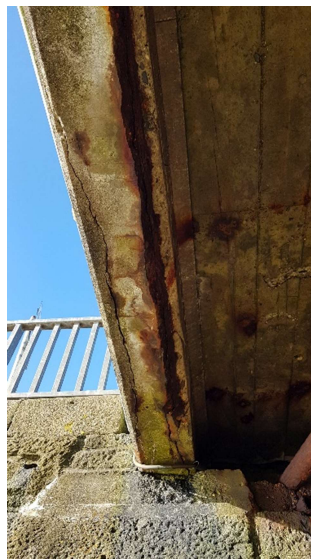
Almost all deck beams to the viaduct are severely cracked. Cracks in the soffits and on the sides of the beams run longitudinally and vary in width from hairline to 20mm. There is corrosion of reinforcement in all spans.

There are large areas of concrete spalling and in several the beams reinforcement is exposed. In some areas where the concrete has spalled away the reinforcement is severely corroded.

The cross beams at the top of the columns also show severe cracking and spalling of concrete with associated corrosion of the reinforcement. This is evident at all piers along the viaduct.

The level of deterioration for the beams under the decking shows significant increase from the 2008 inspection. There are areas where whole concrete beams have cracking along its full length.

We have attached a summary schedule in Section 4.3 indicating the previous and current levels of deterioration for the structural members. The beams supporting the deck are now at deterioration level 2 which shows significant progression of spalling and corrosion from the previous 2008 report.

We no longer consider that repair of the Viaduct slab or beams is possible due to their condition. The only current solution is the following.

*Viaduct:* Replace deck, replace cross beams and repair substructure.

The replacement of the existing decking and beams to the viaduct can be carried out using precast concrete T Beams and slabs supported on the existing repaired structure.

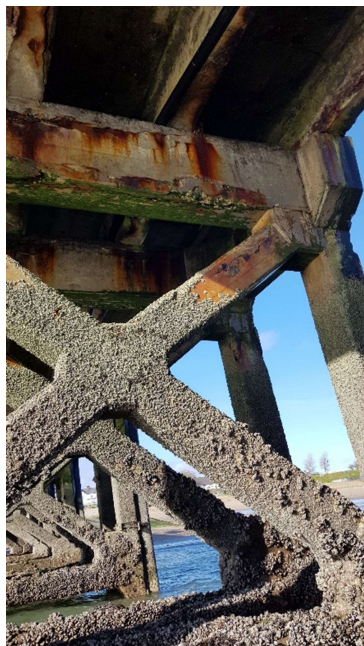
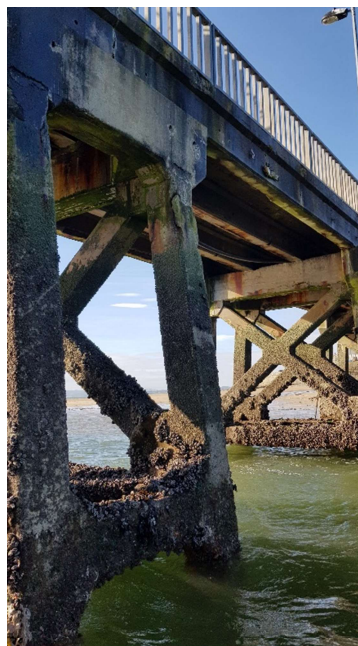
There are areas on all the columns where there is visible cracking and local deterioration of the reinforcement. The damage is normally at the corners of the columns in every column.

The diagonal bracing members in the vertical plane are cracked and concrete is spalling off these elements. Due to this there is visible corrosion of the reinforcement at all piers locations. The damage is severe on piers 8, 9, 11 and 12.

The support structures for the decking on both the viaduct and pier head will have repairs carried out on areas where there is cracking or spalling.

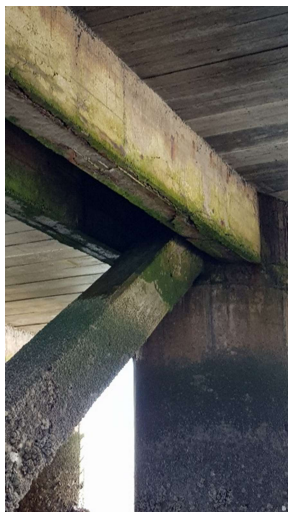
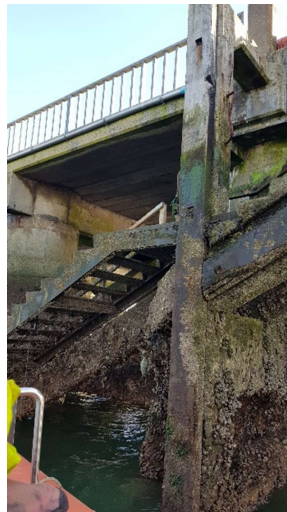
There is notable deterioration in the condition of the cross beams. since the previous inspection.

Like the viaduct beams, the pier beams have longitudinal cracks. These range in width from hairline to 15mm. The most sever cracking is visible on beams at gridlines 19,20,21,22 18/P-Q 17/P-Q.

The beams supporting the deck are in need of repair to varying degrees. Some beams will require patch repair over a limited area whilst other beams will require a full depth repair over the length of the soffit with additional patch repairs on the sides. The level of deterioration has increased but not as significantly as the Viaduct section since the 2008 report.

*Pier head:* Repair and strengthen superstructure.
