Underwater Inspection Report

Pier Condition Surveys – County Donegal

Rathmullan Pier

Project Title:	Pier Condition Surveys – County Donegal
Location:	Rathmullan Pier
Document No:	20-006/UI10

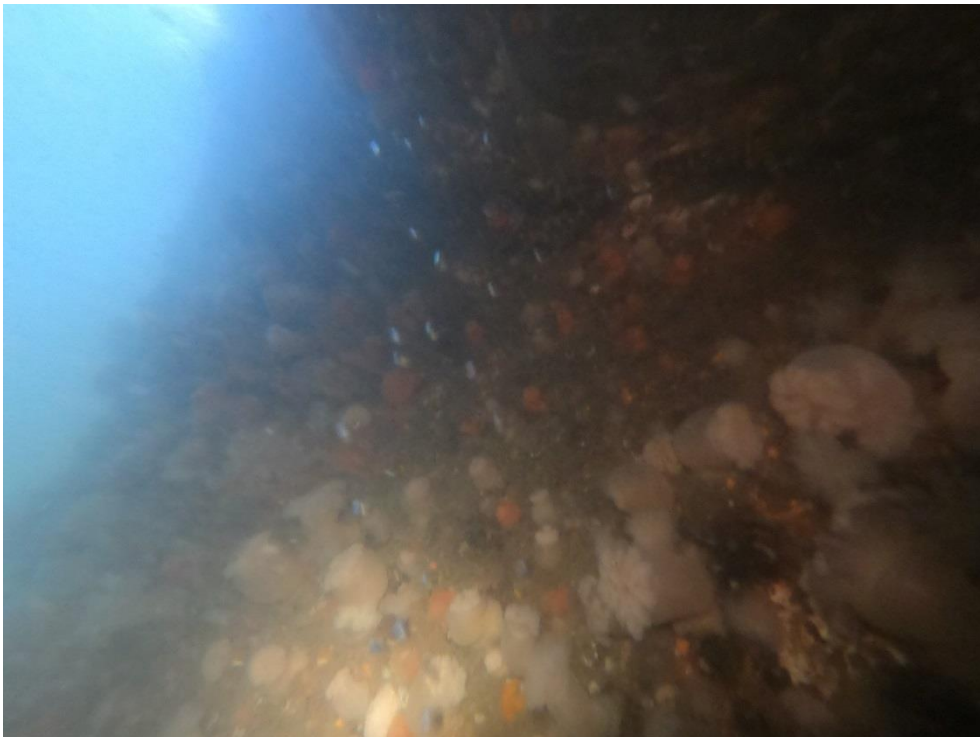
The submerged concrete elements are generally in good condition. The concrete is sound and notable defects are limited. (Pics B6 to B9)

Fig B6 - Typical Pier Head Column Condition

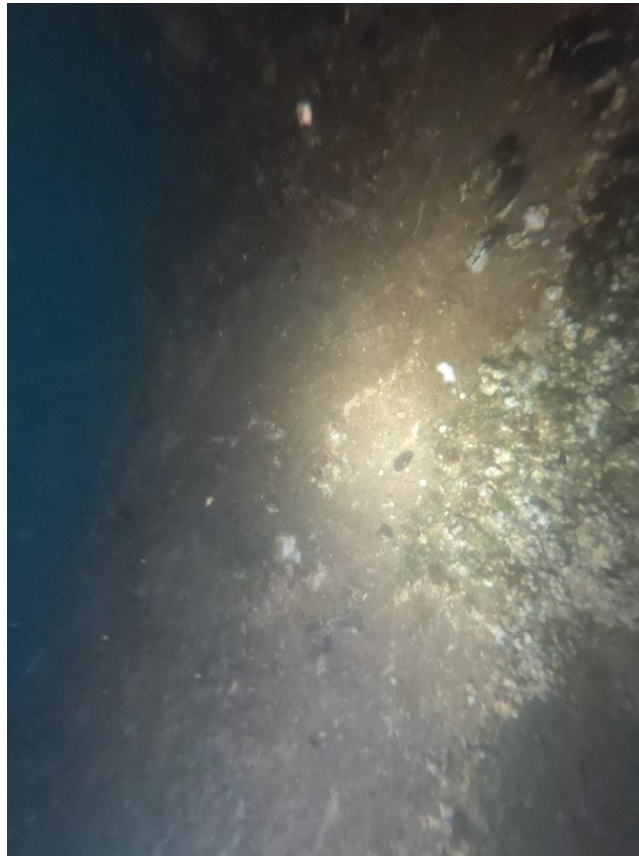
Fig B7 - Typical Concrete Condition

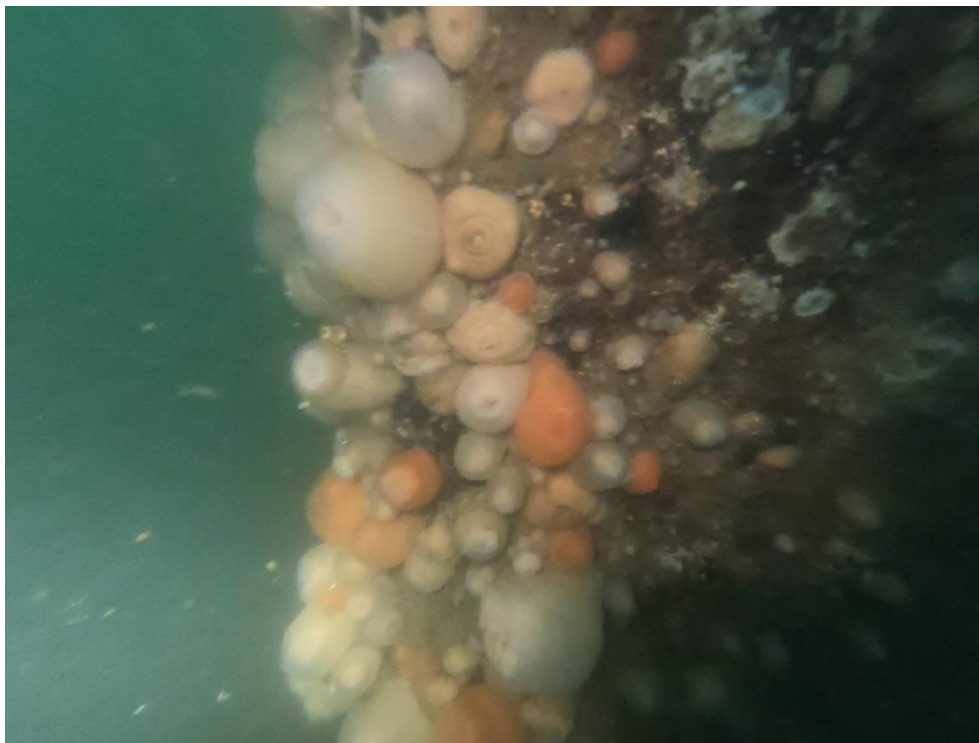
Fig B8 - Viaduct Column – Typical Condition

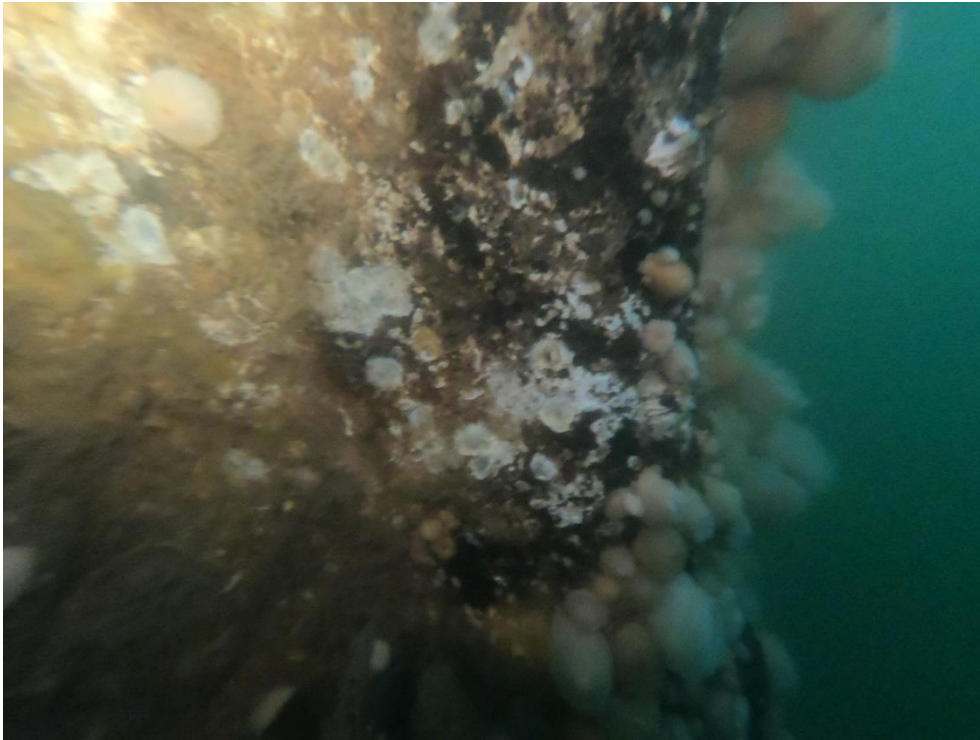
Fig B9 - Typical Concrete Condition

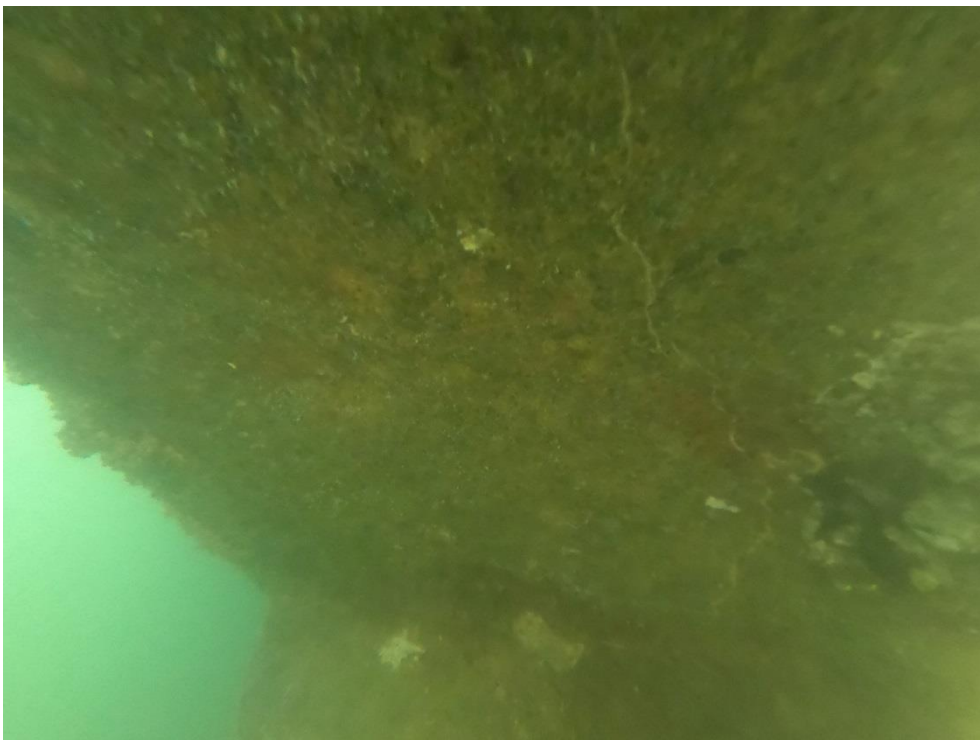
Frame No.	Element	Description	Pic Ref.
22	VDM Q22 – P22	Hairline crack to underside of member, 600mm above joint with P22	
22	VDM P22 – P21	Minor surface crack 1m long from joint with longitudinal beam at P21	B10
21	Lat Beam P21 – Q21	Delamination cracks along top corners of beam	B11
21	VDM Q21 – R21	Blown concrete on underside of VDM at R21 end. Full width of member, 1m long. Corrosion staining evident	B12
20	VDM R20 – Q20	Loss of concrete on underside of VDM near joint with beam at R20 end. 200 x 100 x 70mm deep. Corrosion staining evident.	B13

Fig B10 - Minor Hairline crack to underside of VDM

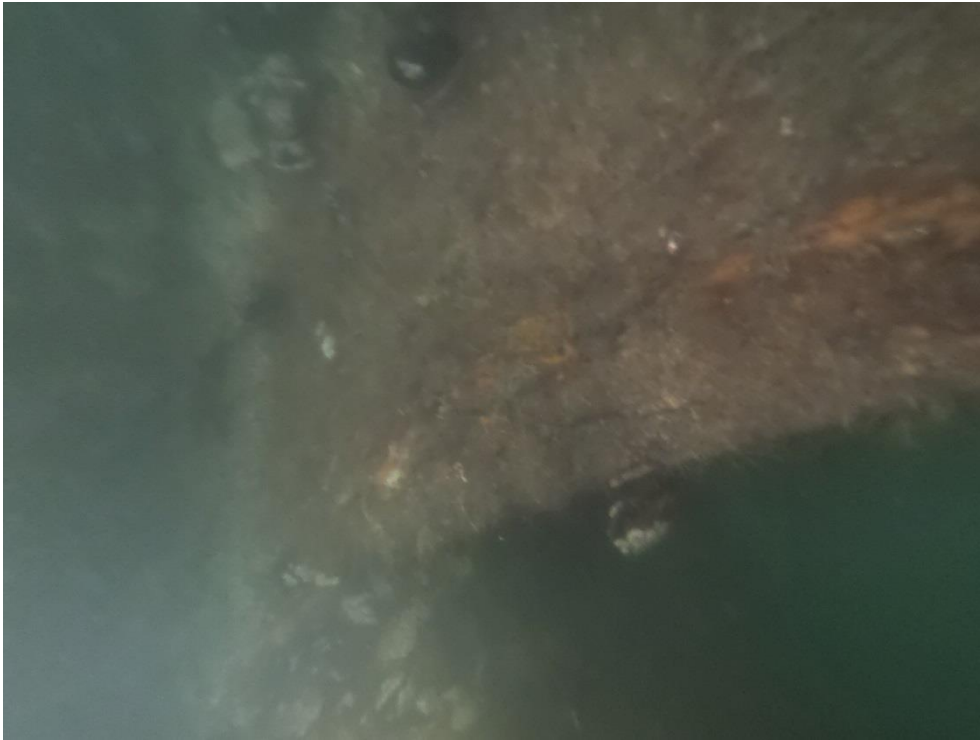
Fig B11 - Typical Delamination crack to bottom corners of VDM

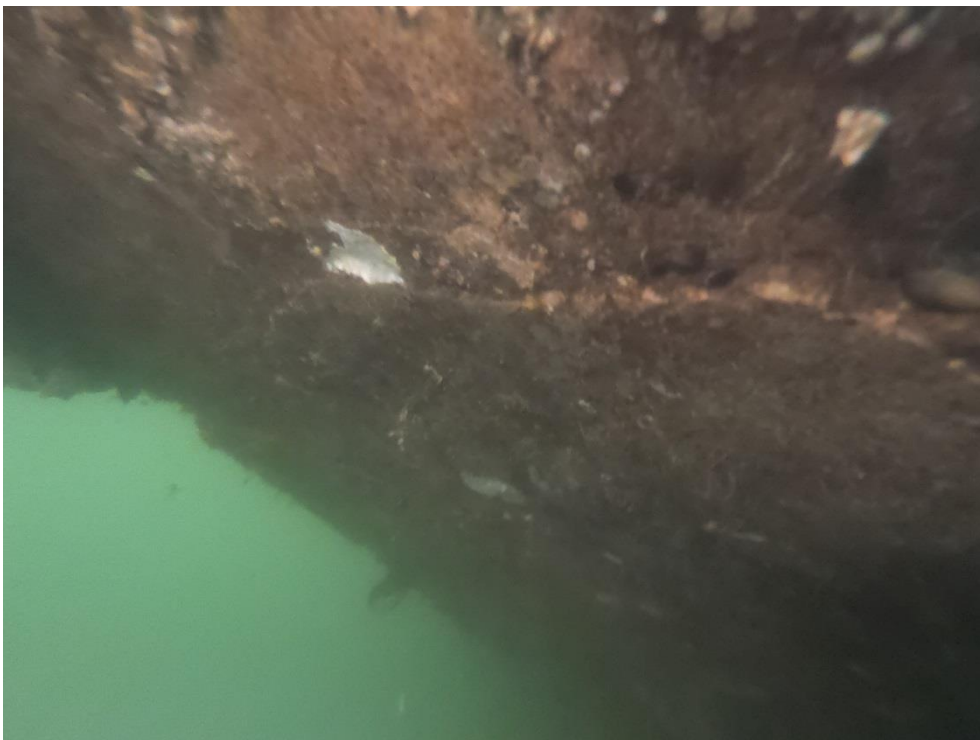
Fig B12 - Blown concrete to underside of VDM

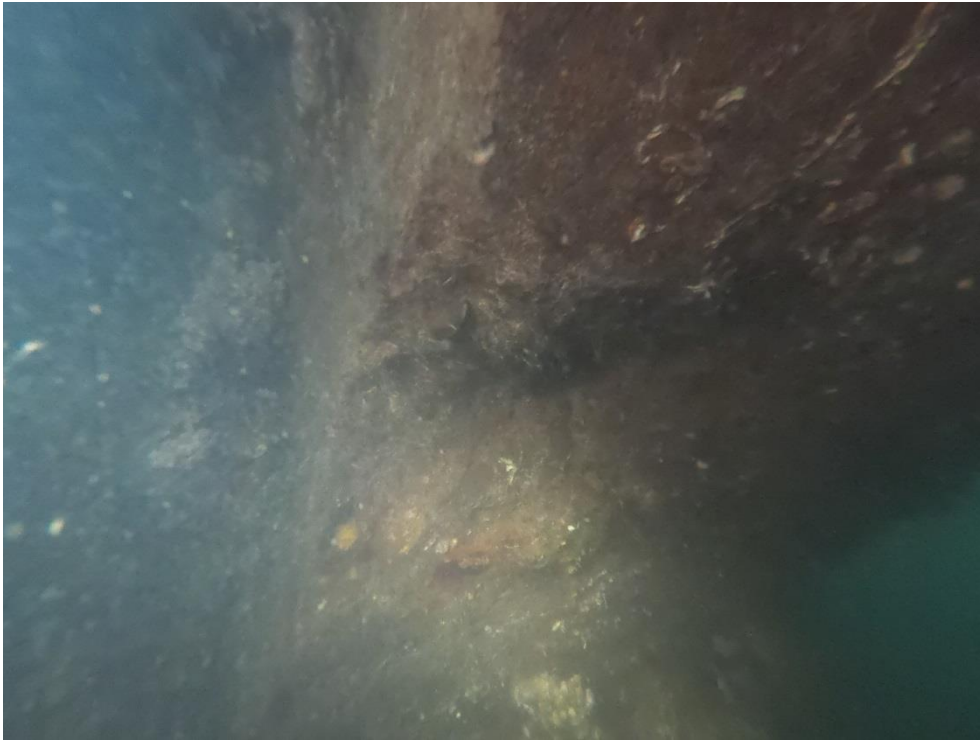
Fig B13 - Loss of concrete to underside of VDM (Frame 20)

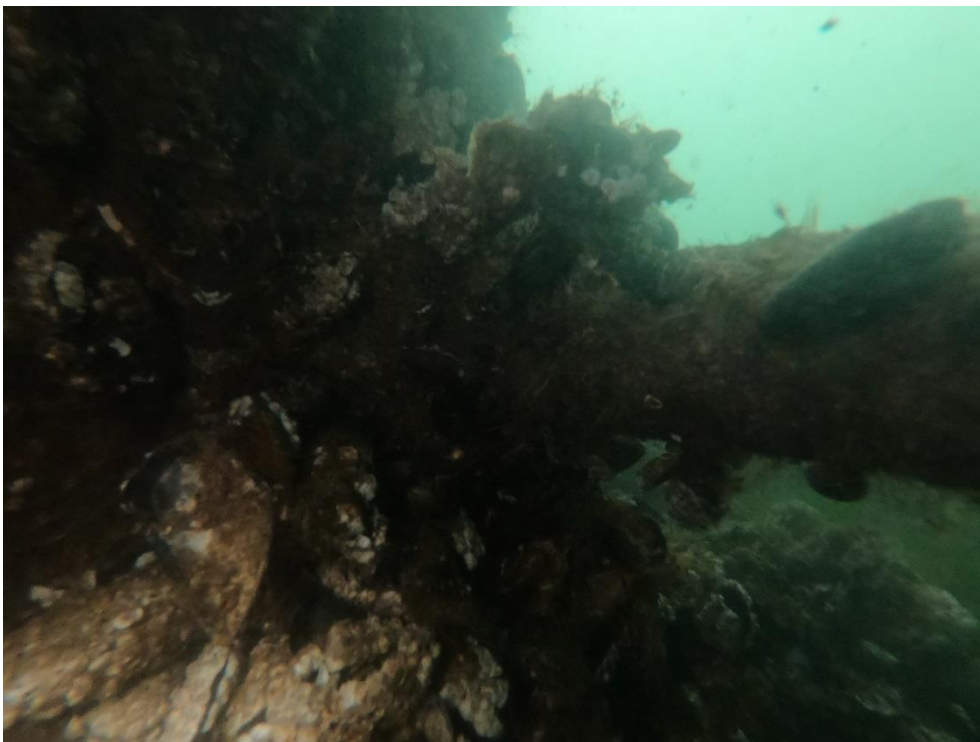
22	P22	Tie bar protruding from column opposite knuckle joint with horizontal beam.	B14
19	P19	Loss of concrete to column 1.5m below beam level, at joint between pours. Bottom of higher pour has eroded / washed out over a distance of 3m round the circumference x 400mm high x 200 max penetration depth.	B15
18	P18	There is a larger diameter concrete ring exposed at the base of the column, where there is 500mm of scour. Possibly a foundation or socket pour. No apparent defects to concrete.	B16
17	P17	Larger diameter ring exposed as at P18, for 1.5m round circumference x 100mm high. No visible defects.	B17
16	P16	Large volume of debris resting against base of column. 4 off Ø1m columns are protruding 1.5m from the bed in this area. Possibly previous piles or temporary works.	B18
16	Q16	Small horizontal gap at the underside of the longitudinal beam between Q16 and Q17. 250mm long x 20mm gap x 50mm penetration.

Fig B14 - Tie Bar protruding from column P22

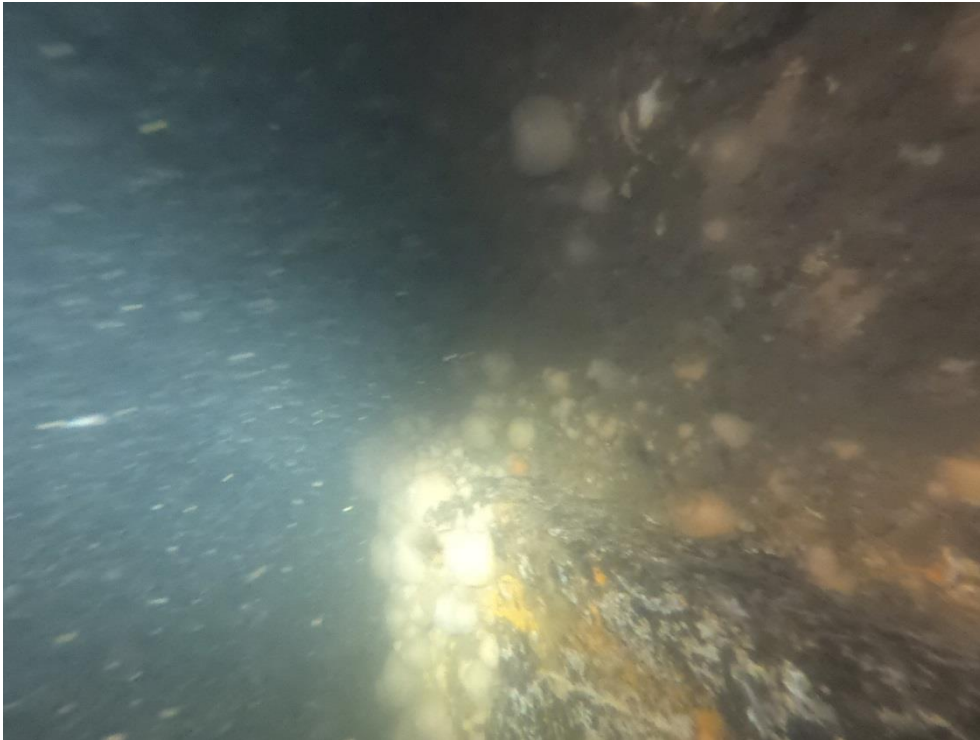
Fig B15 - Loss of section between pours – Column P19

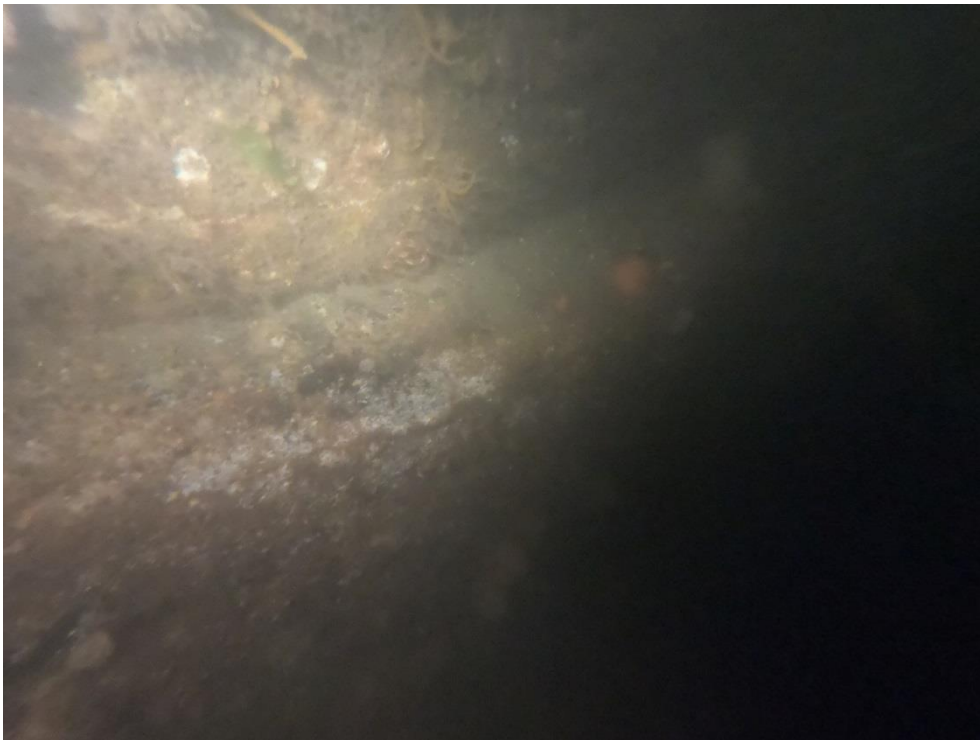
Fig B16 - Larger Diameter section exposed at base of column P18

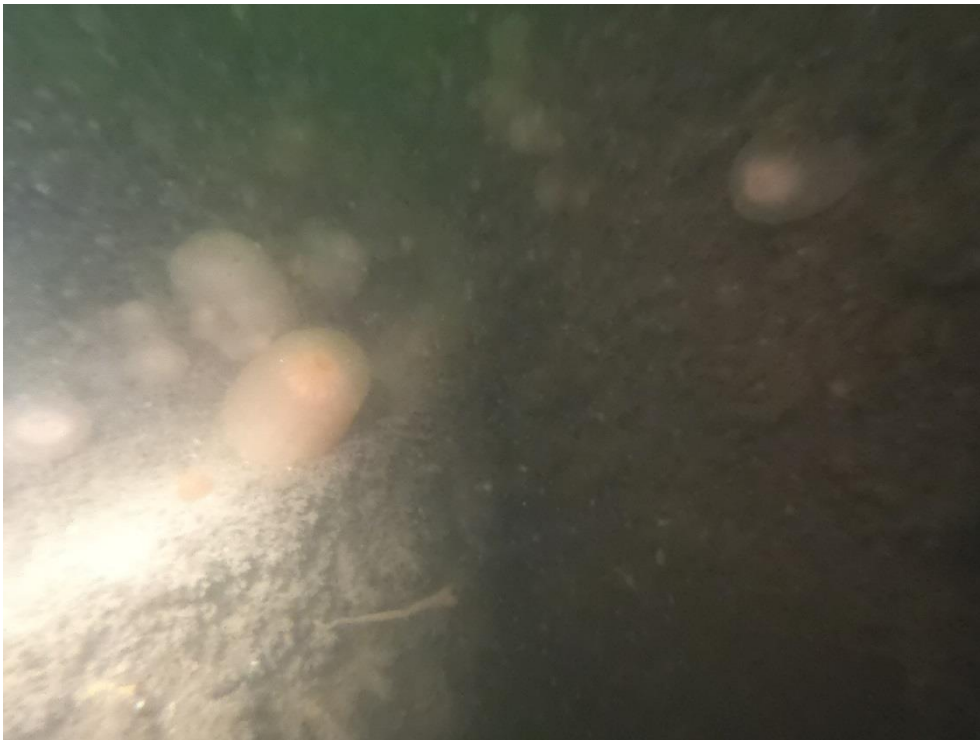
Fig B18 - Ø1m Column 1.5m high adjacent to Column P16

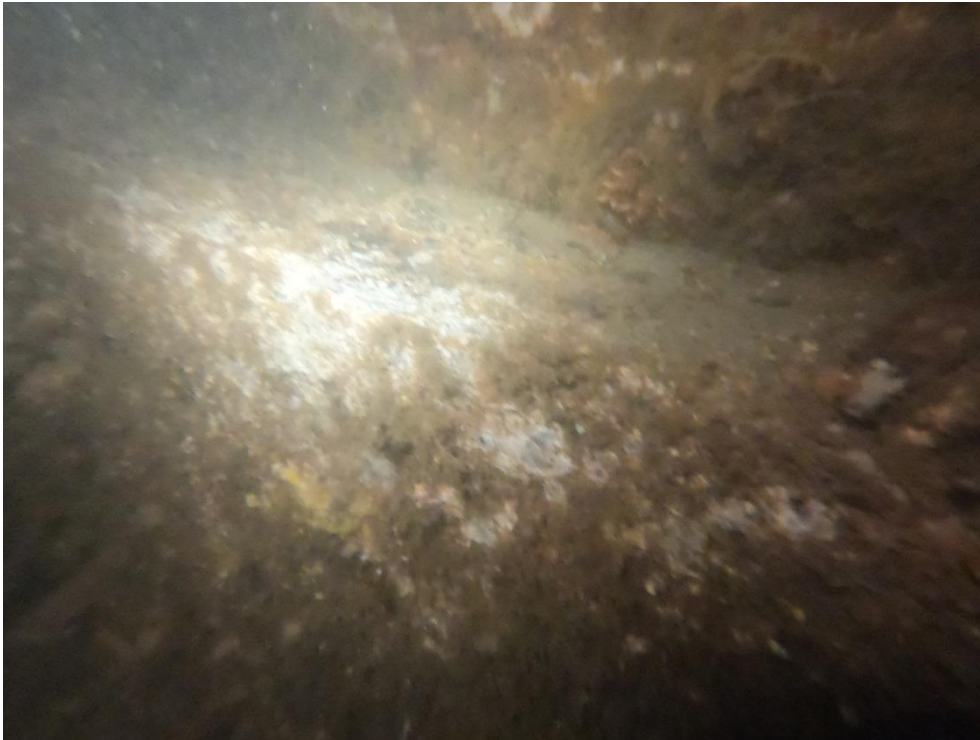
16	Q16	700mm scour at base of pile exposing larger diameter concrete ring as above. Larger section exposed 600mm high most of the way round column. There is a concrete apron that extends away from the ring to the surrounding seabed. Possible grout return from a socket pour.	B19

Fig B19 - Exposed ring at base of Column Q16

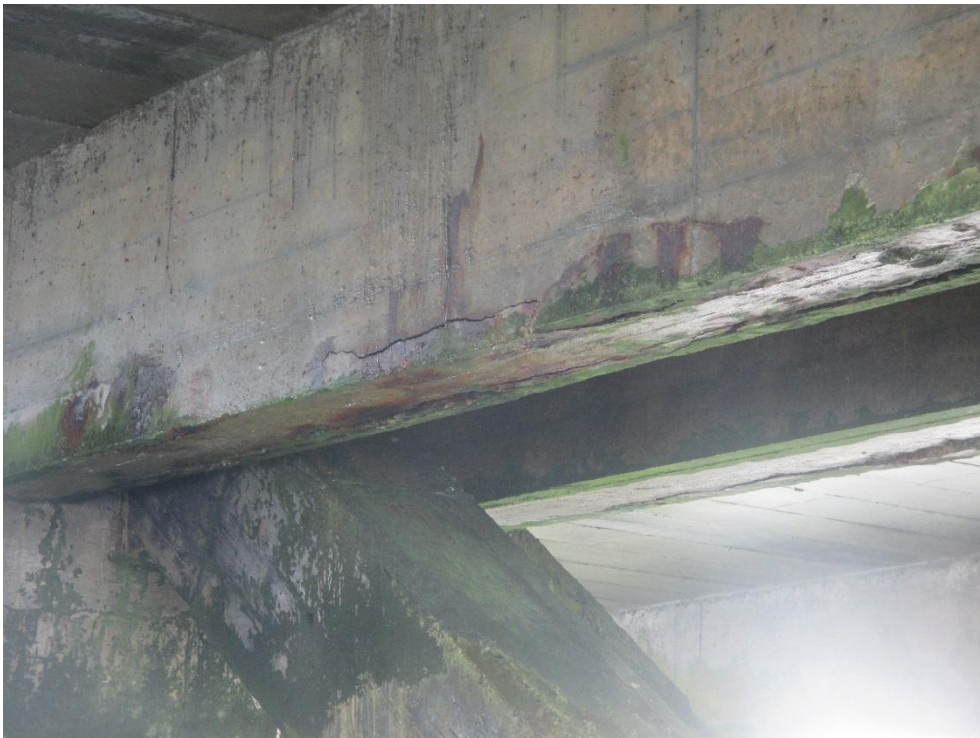
It was noted that defects to the concrete structure were evident at higher levels, particularly to both the soffit level longitudinal and lateral beams, within the splash zone. These show evidence of delamination, particularly at the corners where reinforcement bar has corroded and ‘blown’ the concrete off the corner. There is rust staining evident in these locations and surrounding areas. There are similar defects to lower level beams and diagonal members but at a reduced concentration. These defects were not accessible from the water during the inspection but were inspected as part of the principle inspection by Nicholas O’Dwyer.

Fig B20 - Typical high-level beam delamination crack.
