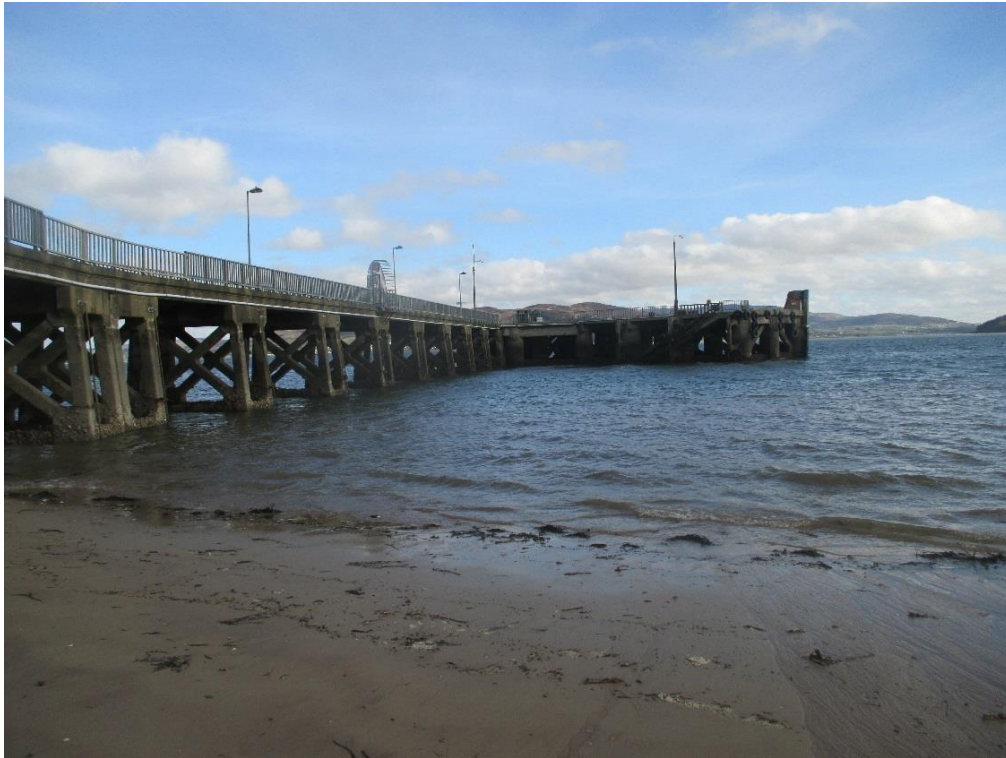
Photo 1 – General view of pier.

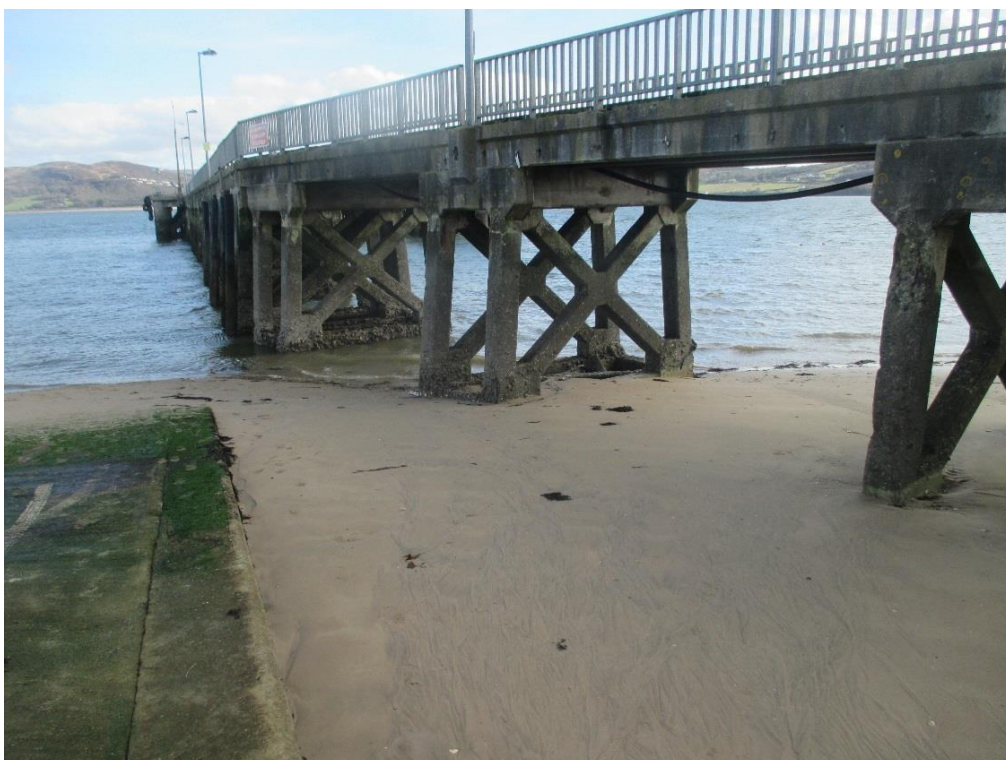
Photo 2 – View of viaduct from shore end.

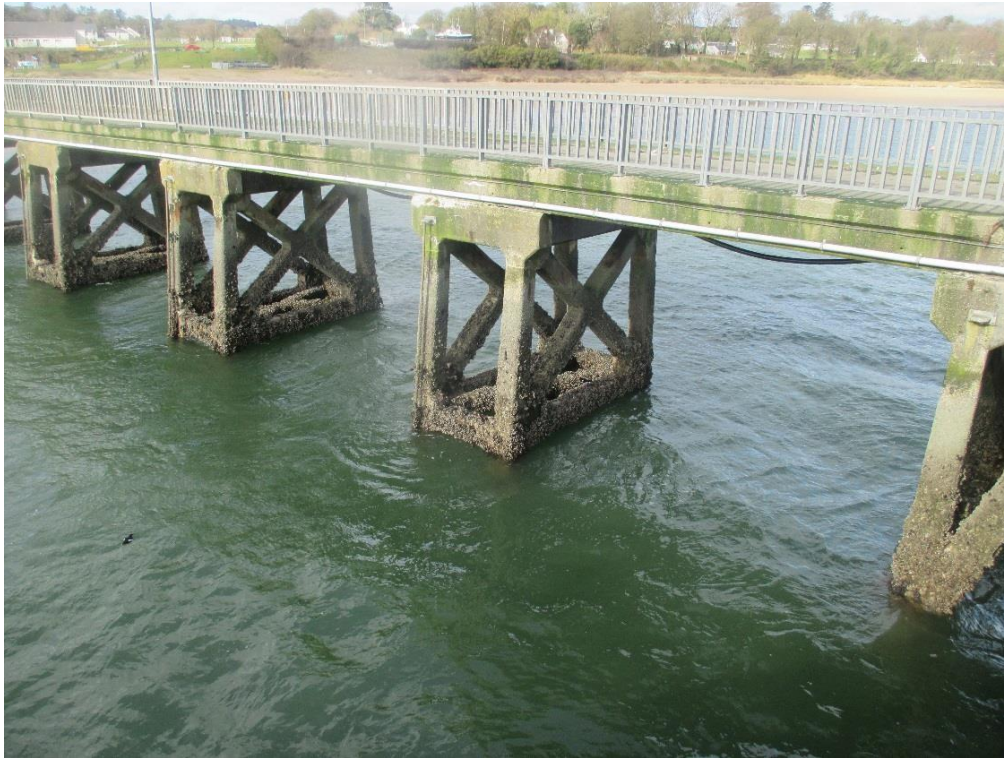
Photo 3 – View of viaduct from pier head.

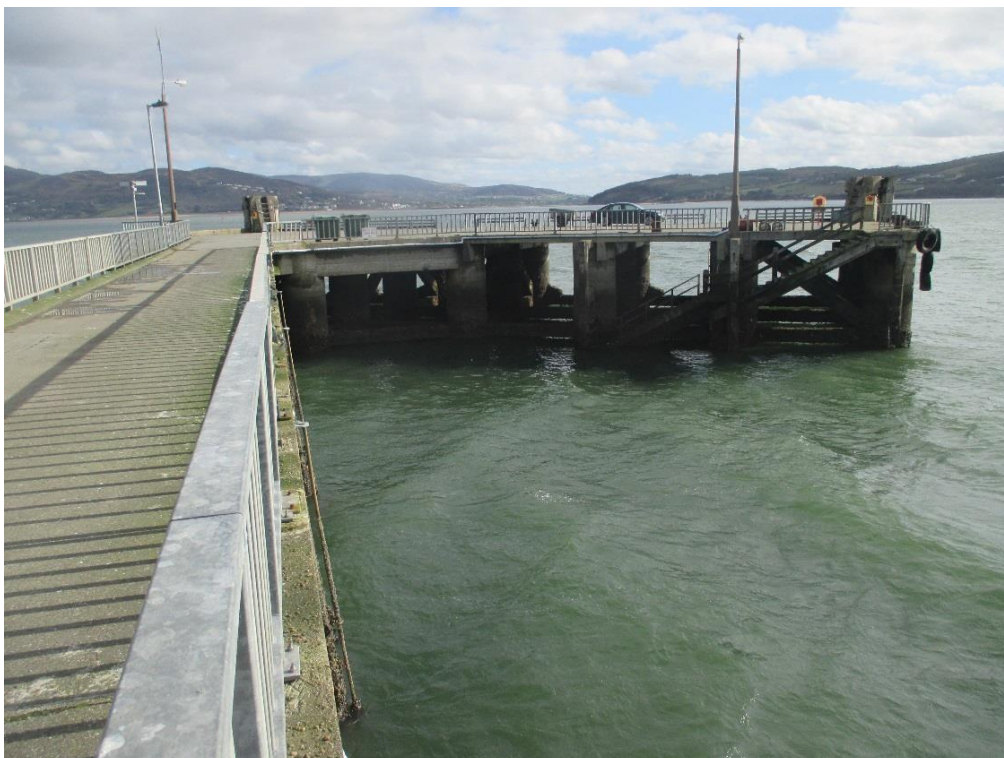
Photo 4 – View of pier head from viaduct.

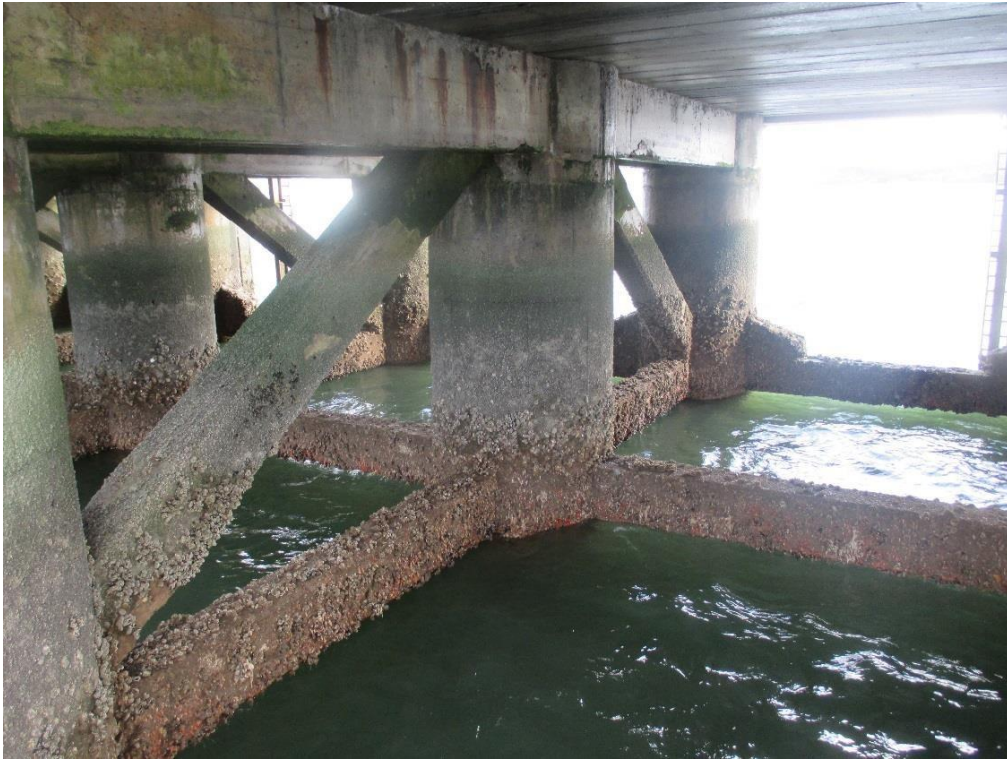
Photo 5 – Typical pier head frame arrangement.

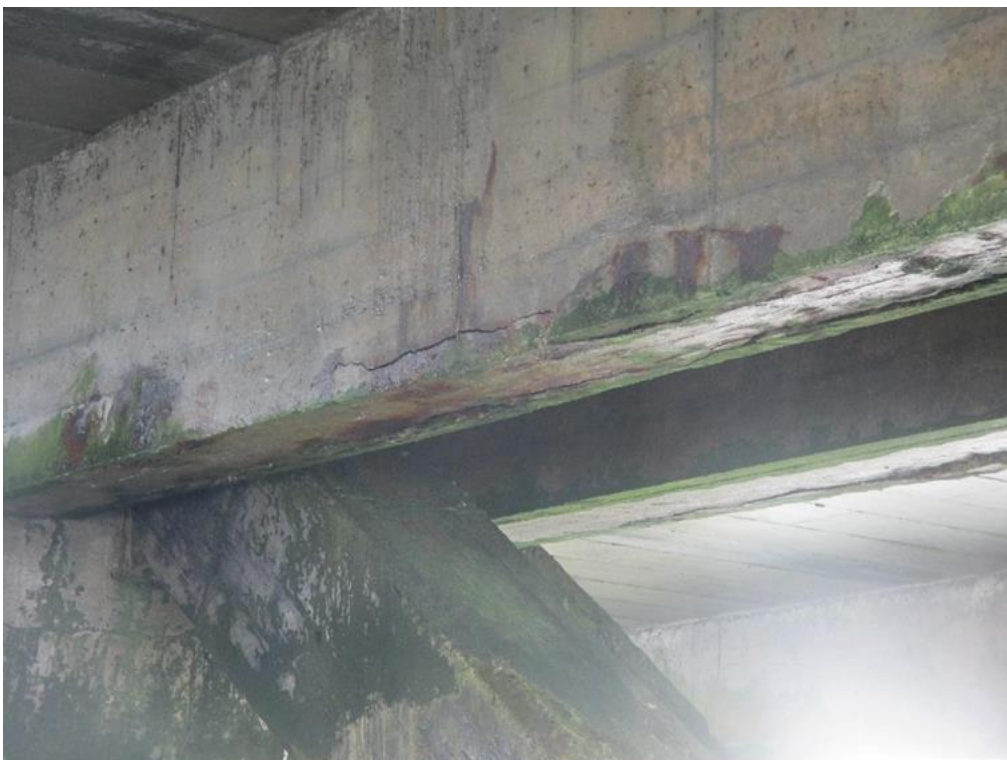
Photo 6 – Typical high-level beam delamination crack.
