**REPORT OF
THE EXPERT
PANEL ON
CONCRETE
BLOCKS**

June 2017

Report of Expert Panel on concrete blocks in counties Donegal and Mayo.

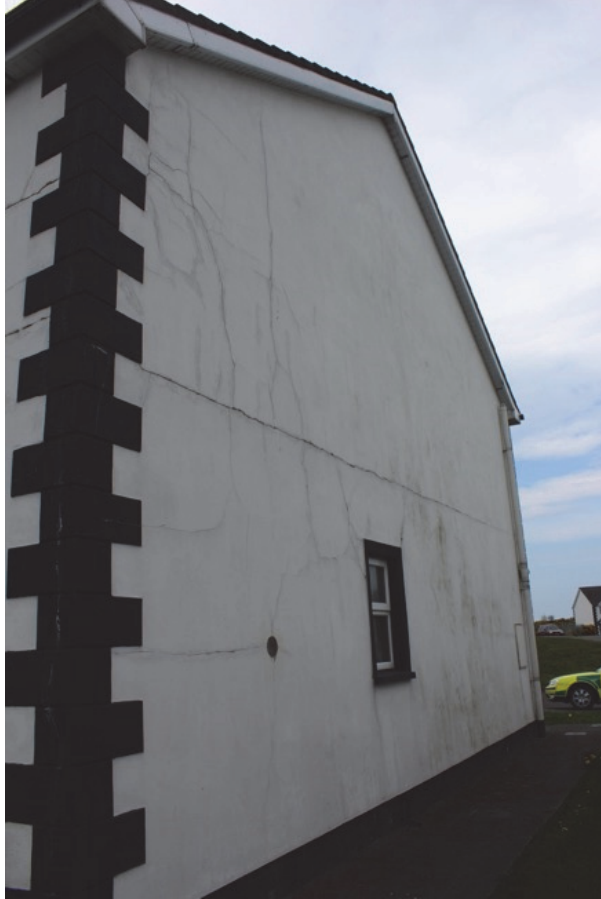
a) Typical horizontal and vertical cracking to gable

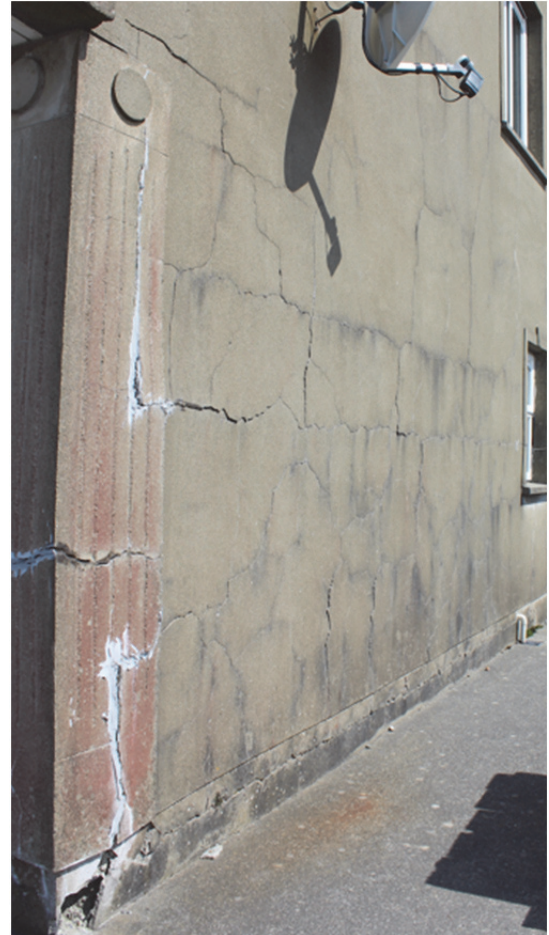
b) Characteristic horizontal and vertical cracks

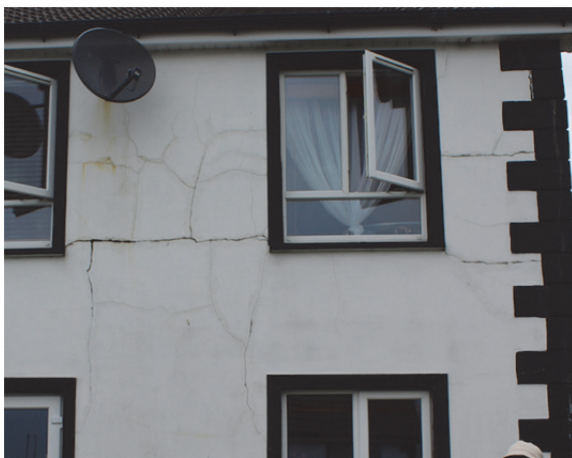
c) Rear wall cracking

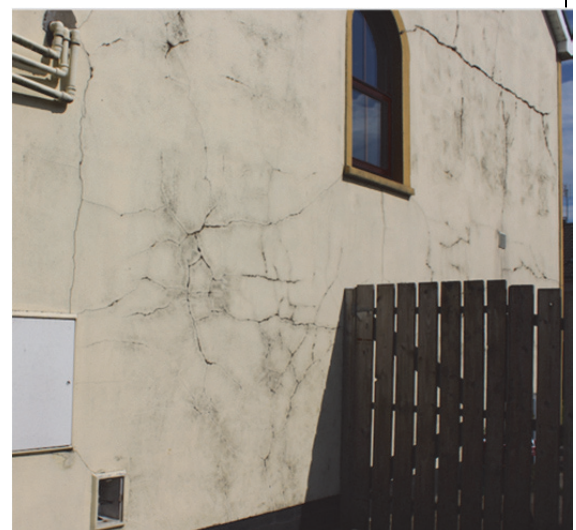
d) Gable cracking

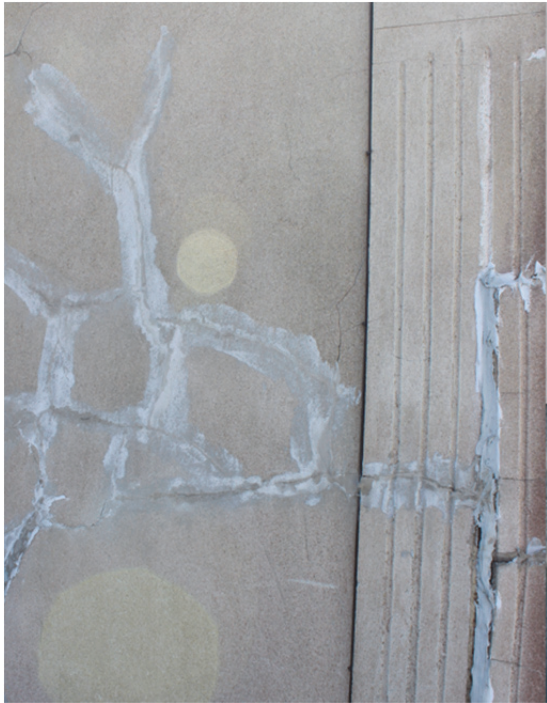
a) Filled cracks, characteristic corner crack

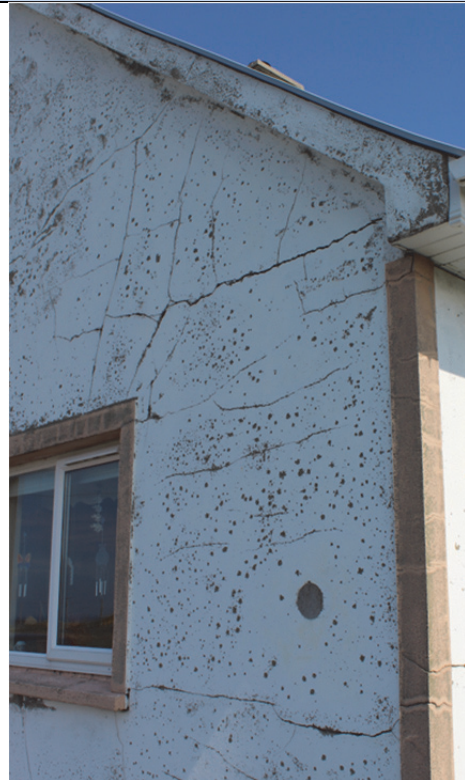
b) Cracking on exposed gable

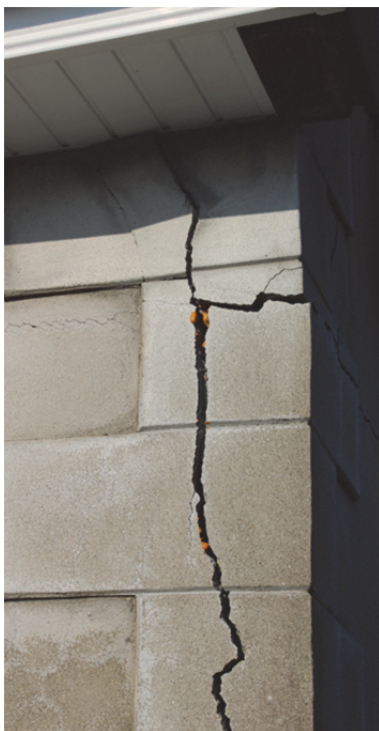
c) Corner crack

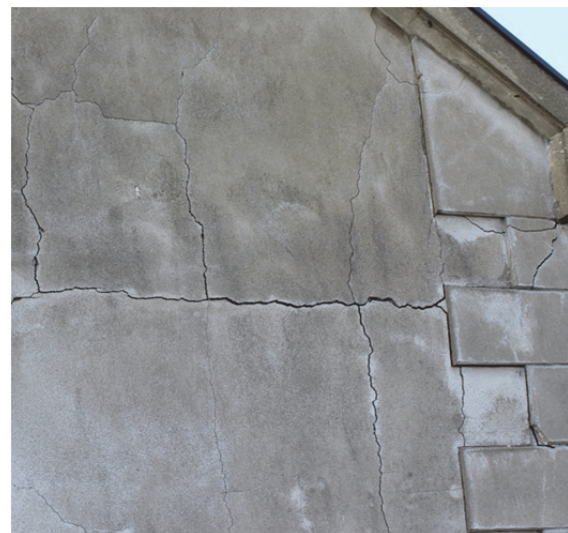
d) Pattern Cracking

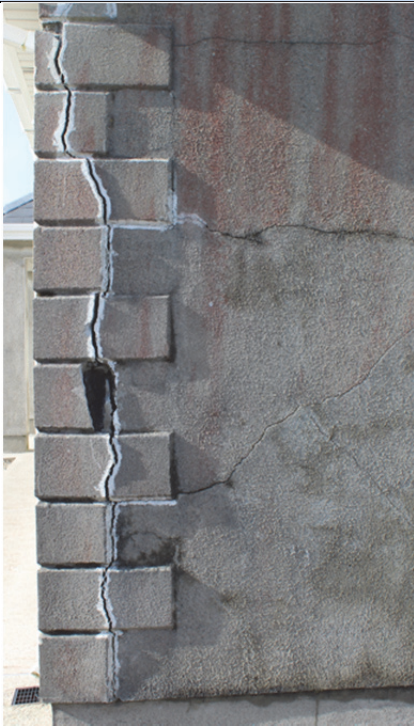
e) Typical vertical cracking at gable corner

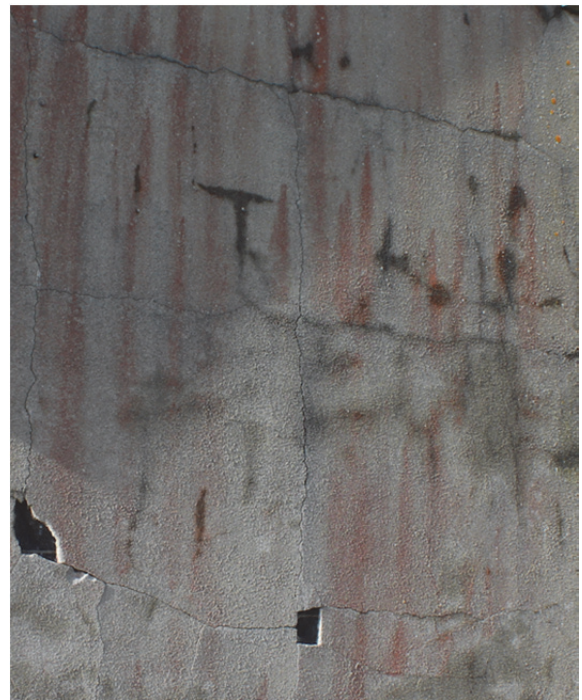
f) Typical pattern cracking

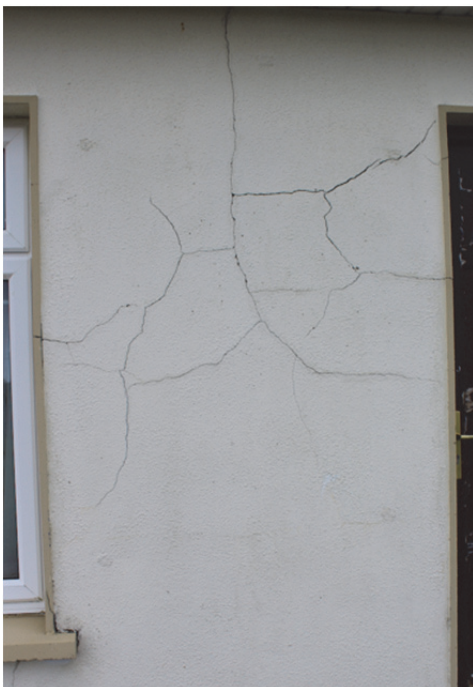
c) Cracking on sheltered wall

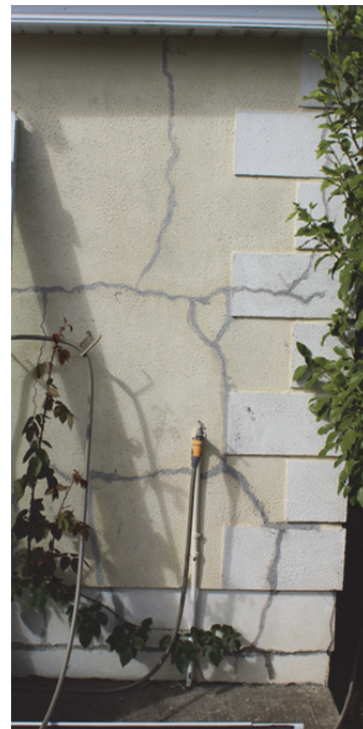
d) Pattern cracking, sealant filled

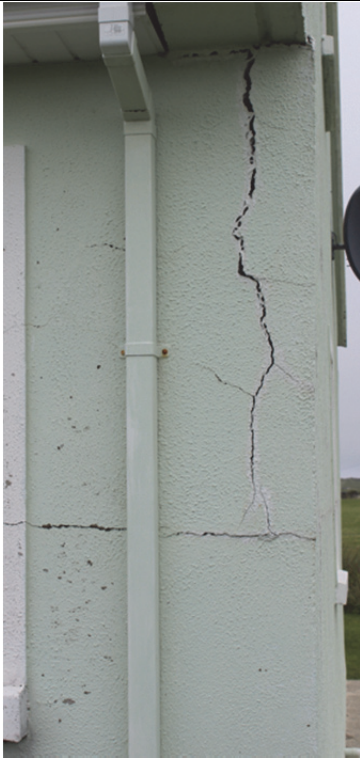
a) Front wall corner crack

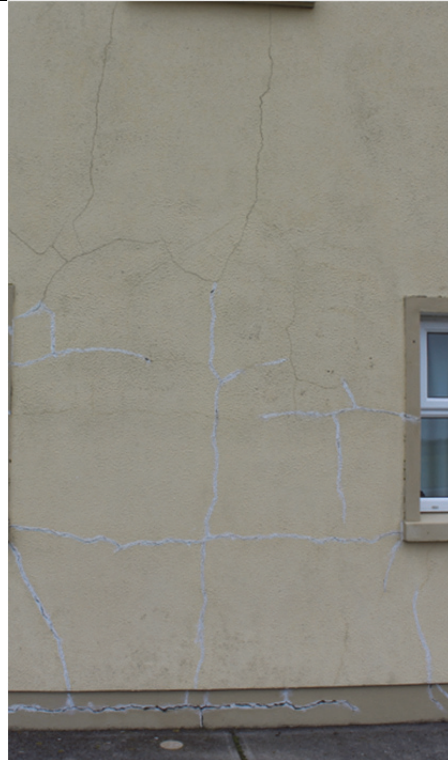
b) Horizontal and vertical cracking

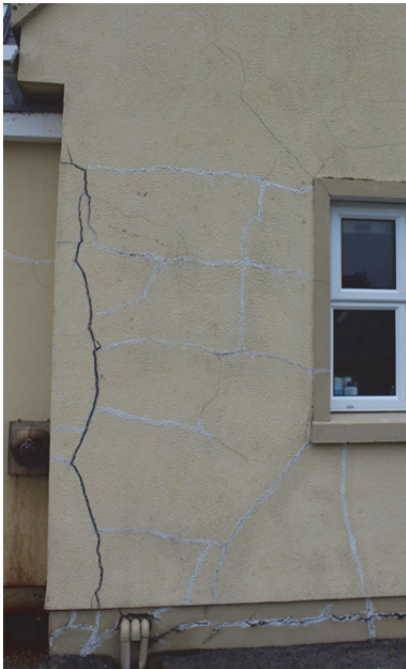
c) Corner and pattern cracks

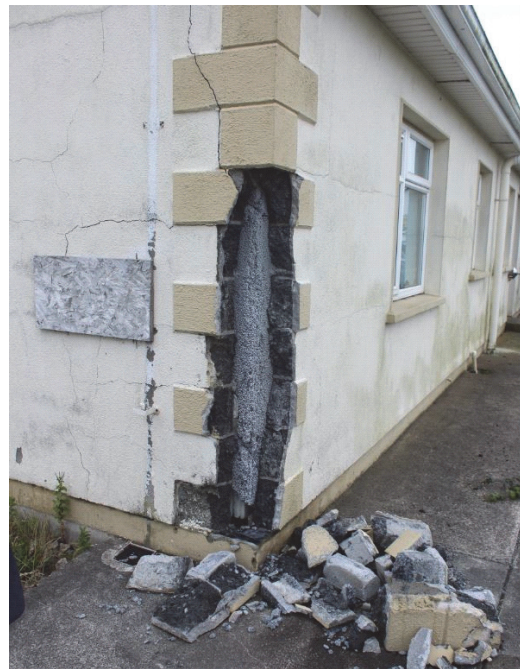
d) Corner of house fallen away.
