**Cultural Heritage Assessment  
Greenore Port, Berth 2  
Greenore, Co. Louth  
17D0032, 17R0051**

25 May 2017

Project Director  
**Beverley Studios, Church Terrace, Bray, Co. Wicklow**

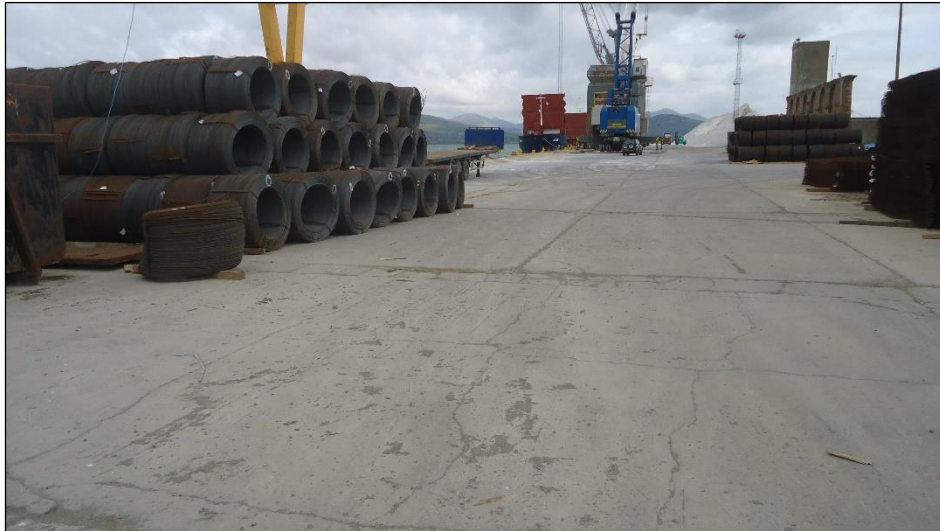
The Port is dominated by the current reinforced concrete deck of the quayside (Plate 4). Upstanding structural elements are largely present to service the modern port. The north side of the quay, Berth 1, services vessels as the principal active berth. The area to its south, which includes Berth 2, has noticeably shallower water. Proceeding south again, the port has been extended by reclamation, and a series of concrete caissons line the foreshore (Plate 5). At Low Water, a shingle beach is evident, with the shallower water of the Lough exposing a wide area of intertidal sands on which oyster beds are set (Plate 6).

**Plate 4:** View looking North along deck of current quayside.

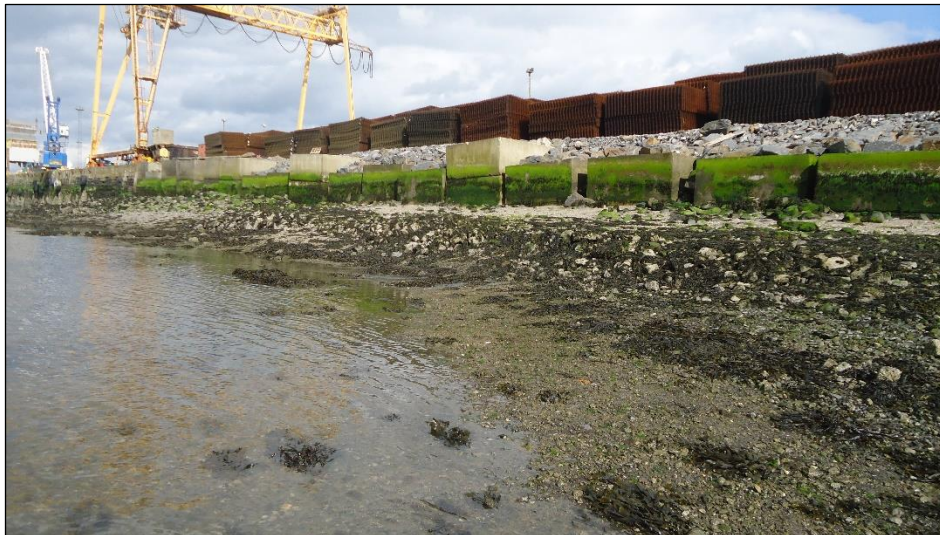
**Plate 5:** View looking East across intertidal foreshore at south end of the Port, showing the concrete caissons placed along the former beach area to facilitate reclamation for the Port.

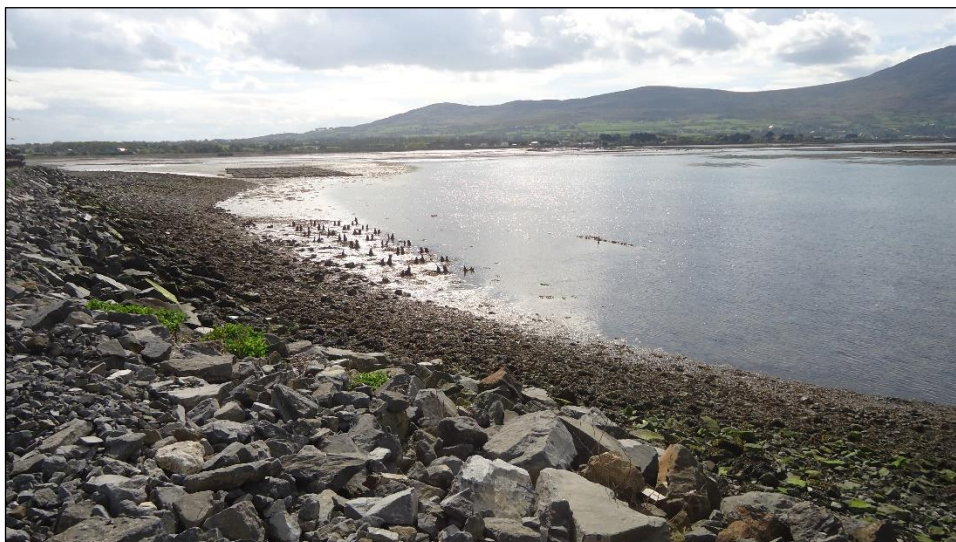
**Plate 6:** View looking southwest from the south end of the Port, looking towards the oyster beds at Low Water. The oyster bed in the near-ground appears to be disused and abandoned.

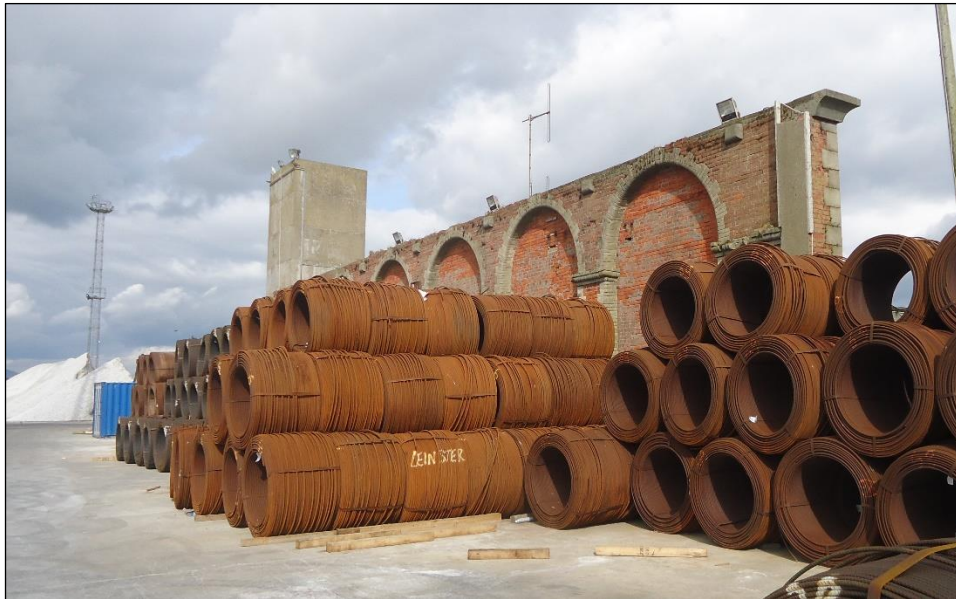
The hotel does not survive above ground today, and the railhead is largely disappeared. There is little of the nineteenth-century fabric visible across the port area, but there is a length of standing wall at a remove from the current quayside (Plate 7). The wall is built using red brick for the most part, and retains elegant granite arches. It is a surviving element of the former railway station that is shown on the early twentieth-century Ordnance Survey maps.

The wall runs along the very eastern boundary of the development area. There is no indication that the wall will be impacted by the development, and it should be left intact as it is the only surviving element above ground of this early history of the Port. Precautionary measures may be required to ensure that it is not damaged during the development.

**Plate 7:** View looking northeast over stacks of steel to the standing remnant of the railway building.

- The standing wall remains of the former railway station lies just outside the site boundary. It should be protected from the danger of accidental impact during construction works.
- Subject to impact proposals, archaeological observation and recording is recommended of the construction of the old quay wall. Such inspection work should be conducted by an experienced maritime archaeologist.
- Archaeological monitoring of the dredge works is recommended, with the proviso to resolve fully any material of archaeological interest recovered at that point.

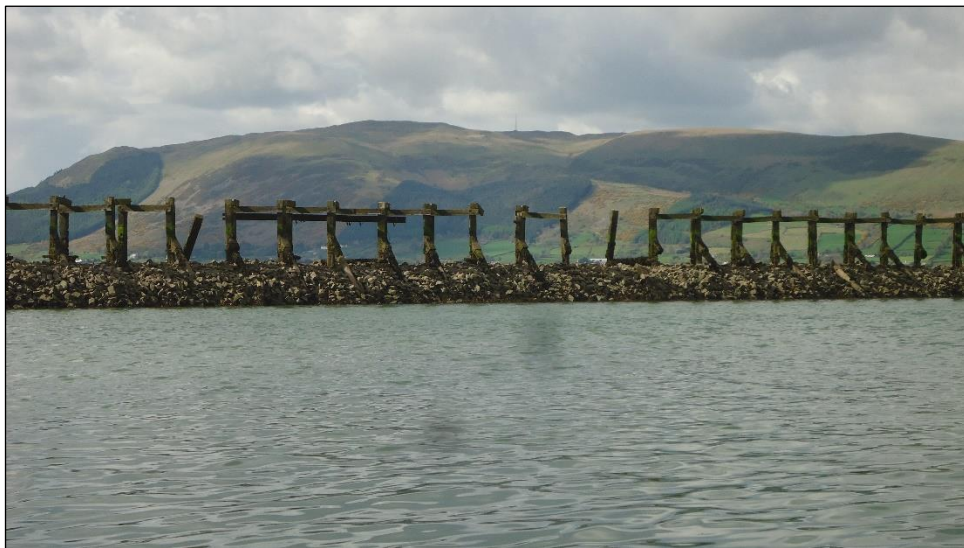
The feature referred to as a 'Breakwater' appears to serve less as a breakwater and more as a tidal aid. The structure has a solid rock armour base that is exposed at Low Water but above this the structure is an openwork array of concrete members (Plate 8). While these may have supported a deck in the past, today the elements are upstanding and do not offer protection from northerly or easterly airflows. It is apparent, however, that the feature helps the ebb tide to scour the seabed in front of the quayside, and this scouring activity creates a very dynamic rip tide that runs in front of Berths 1 and 2.

The breakwater lies outside the development area and will not be impacted by the works.

**Plate 8:** View looking north-northwest across central portion of the Breakwater feature to the west of the quayside, at Low Water. The solid rock-armoured base supports an open-work lattice of concrete members that are exposed at High Water, and may have held a deck in former times.

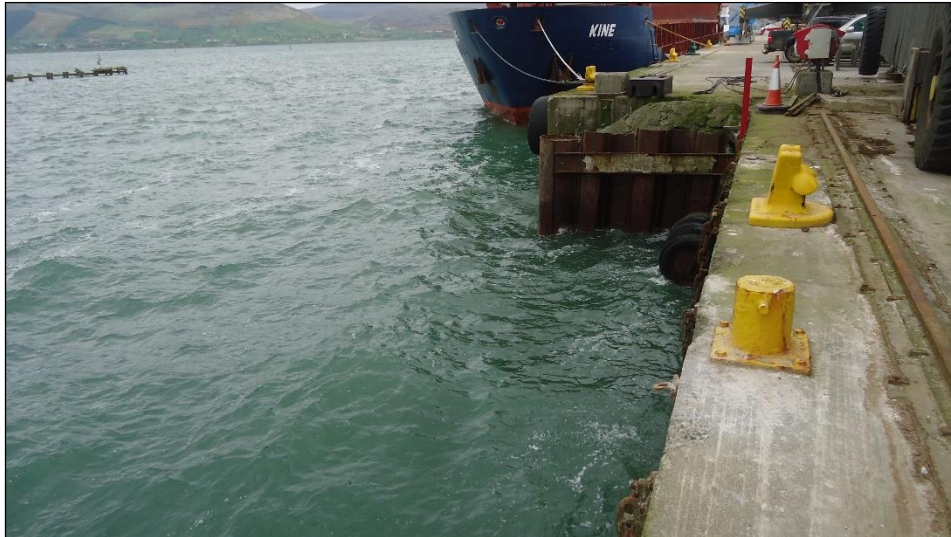
The principal focus of interest is the existing quayside of Berth 2 and the seabed beneath. Berth 2 is currently recessed back from the façade of Berth 1 (Plate 9). The deck area of Berth 2 is a modern reinforced concrete surface that has been placed directly on top of an older stone-built quay, which survives underneath and whose façade is exposed fully as the working quayside (Plates 10-11).

**Plate 9:** View looking towards the north end of Berth 2, showing it is recessed from the façade of Berth 1. In the proposed development, the new façade of Berth 2 will be flush with that of Berth 1, offering a continuous quay wall.

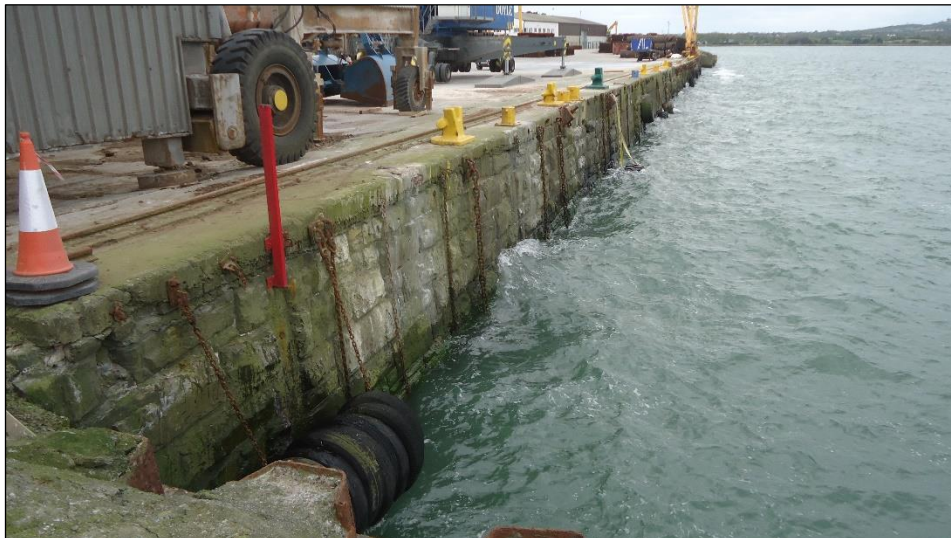
**Plate 10:** View from Berth 1 looking south along the façade of Berth 2.

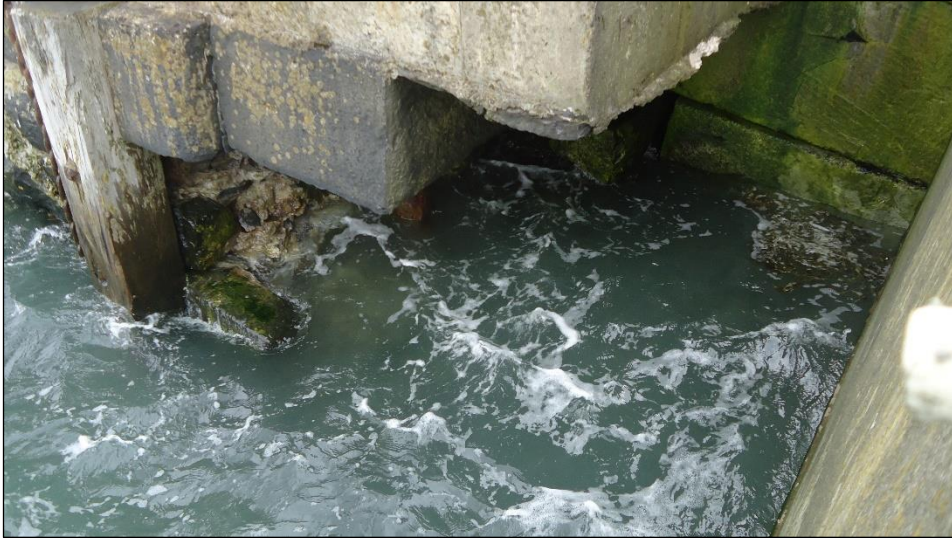
**Plate 11:** View at the south end of Berth 2, showing the base of the concrete deck than is placed on top of the stone-built quay. The picture also shows the scour that has developed at this junction, producing a large cavity.

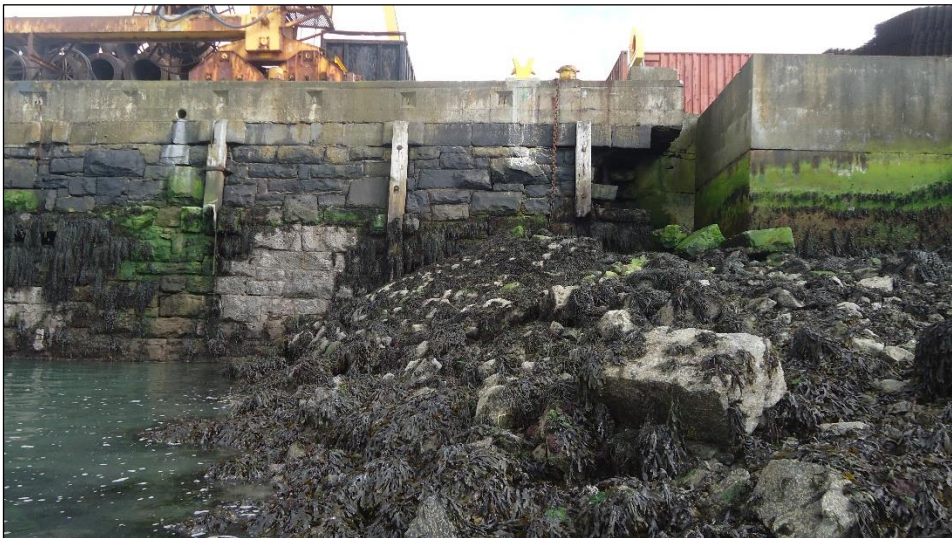
The stone-built quay is a well-constructed feature (Plates 12-13). It is made up of cut stone blocks, laid in courses where the stones mask the formal courses by being of different sizes. At regular intervals, there are pairs of projecting jamb stones to capture and secure in place vertical timber fenders.

**Plate 12:** View at south end of Berth 2, showing the façade of the stone-built quay.

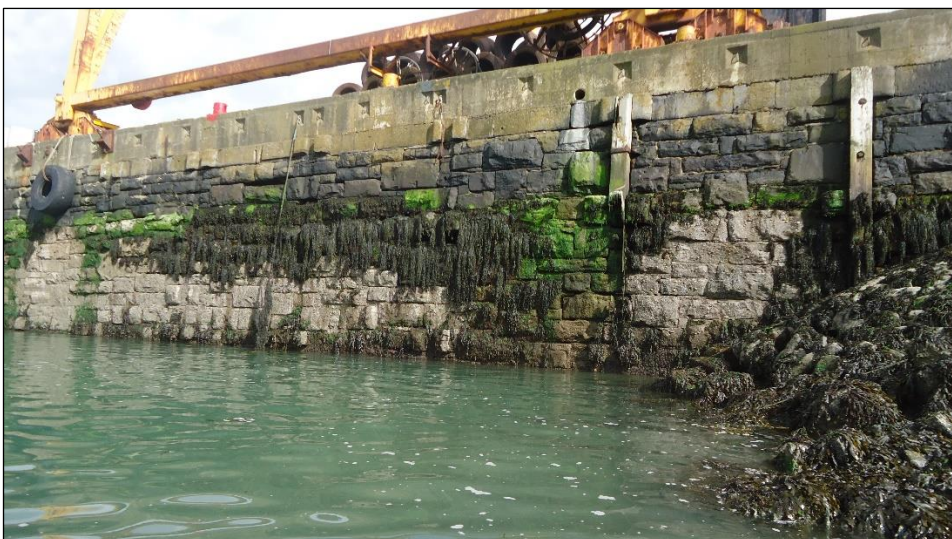
**Plate 13:** View along the façade of the stone-built quay, showing the cut stone blocks and the projecting jamb stones in the upper level spaced at regular intervals to secure the vertically-set timbers used as fenders.

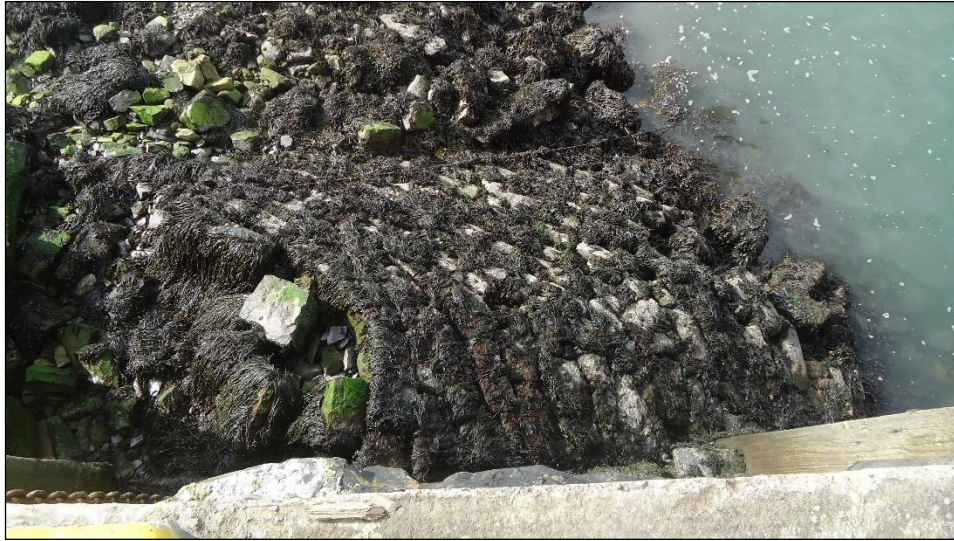
The base of the quay wall is covered in silt and cobble for the most part, but the most southerly section features a glacis embrasure built at its base to act as a rock armoured defence against erosion (Plates 12, 14). The feature is curved in plan view and serves to deflect scour from the base of the quay wall.

**Plate 14:** View looking down from quayside at the embrasure feature built in front of the stone quay at its southern end, to act as an armoured protection.

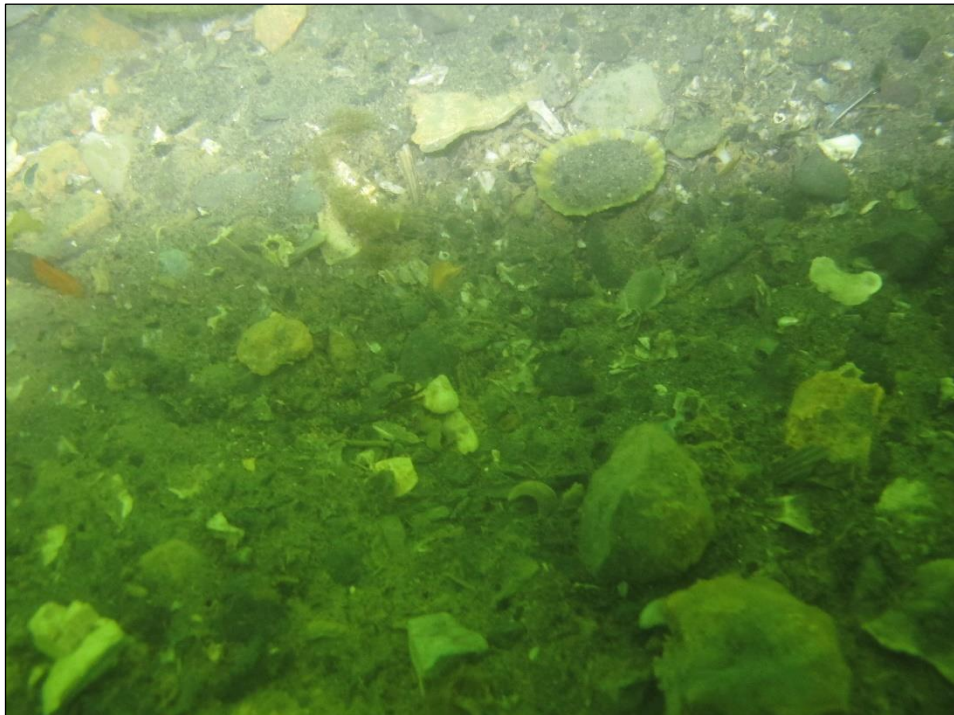
The sub-tidal element is covered for the most part in a loose shingle and cobble (Plate 15). There is frequent modern debris lying on its surface (including fenders and metallic debris), and there are some patches of silt. The only feature observed is a line of vertically-set timber uprights that form a line of shuttering located some 10m out from the quay wall (Plate 16). The feature is first apparent approximately 30m north of the southern limit of Berth 2, and it continues to where the stone-built rock armour toe buries the timberwork. It is understood that the timberwork would have served as part of the quay's construction. The timbers are set edge-to-edge and many feature eroded tops, where the top surface is sheared off at an acute angle, perhaps from previous cutting action.

**Plate 15:** Underwater image showing the nature of the seabed within the dredge footprint.

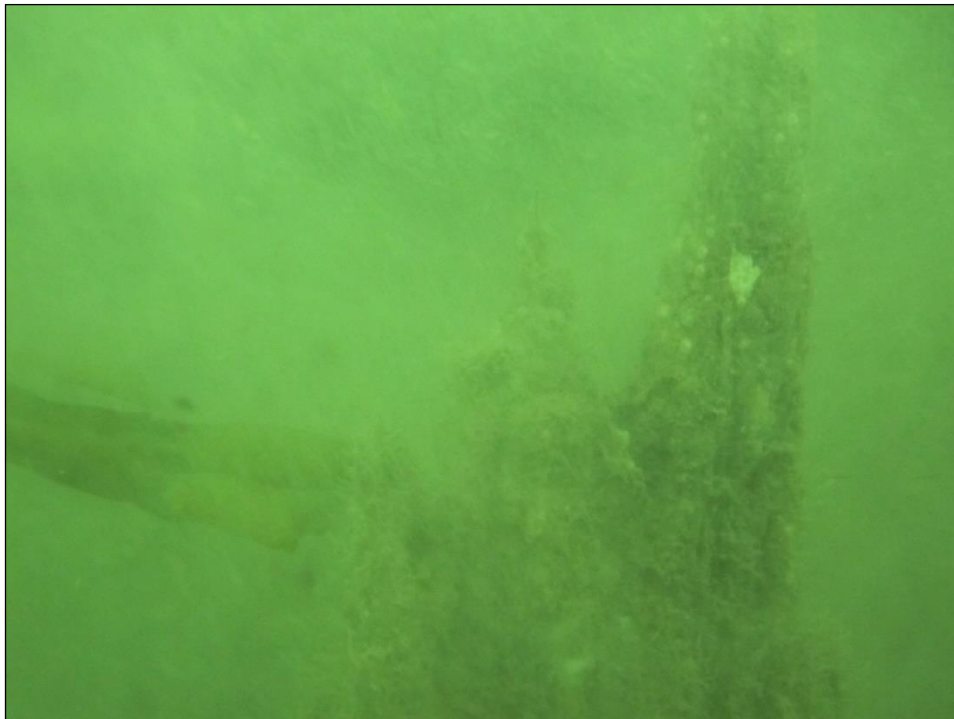
**Plate 16:** View showing example of the eroded tips of timbers associated with the timber shuttering observed at the south end of Berth 2.

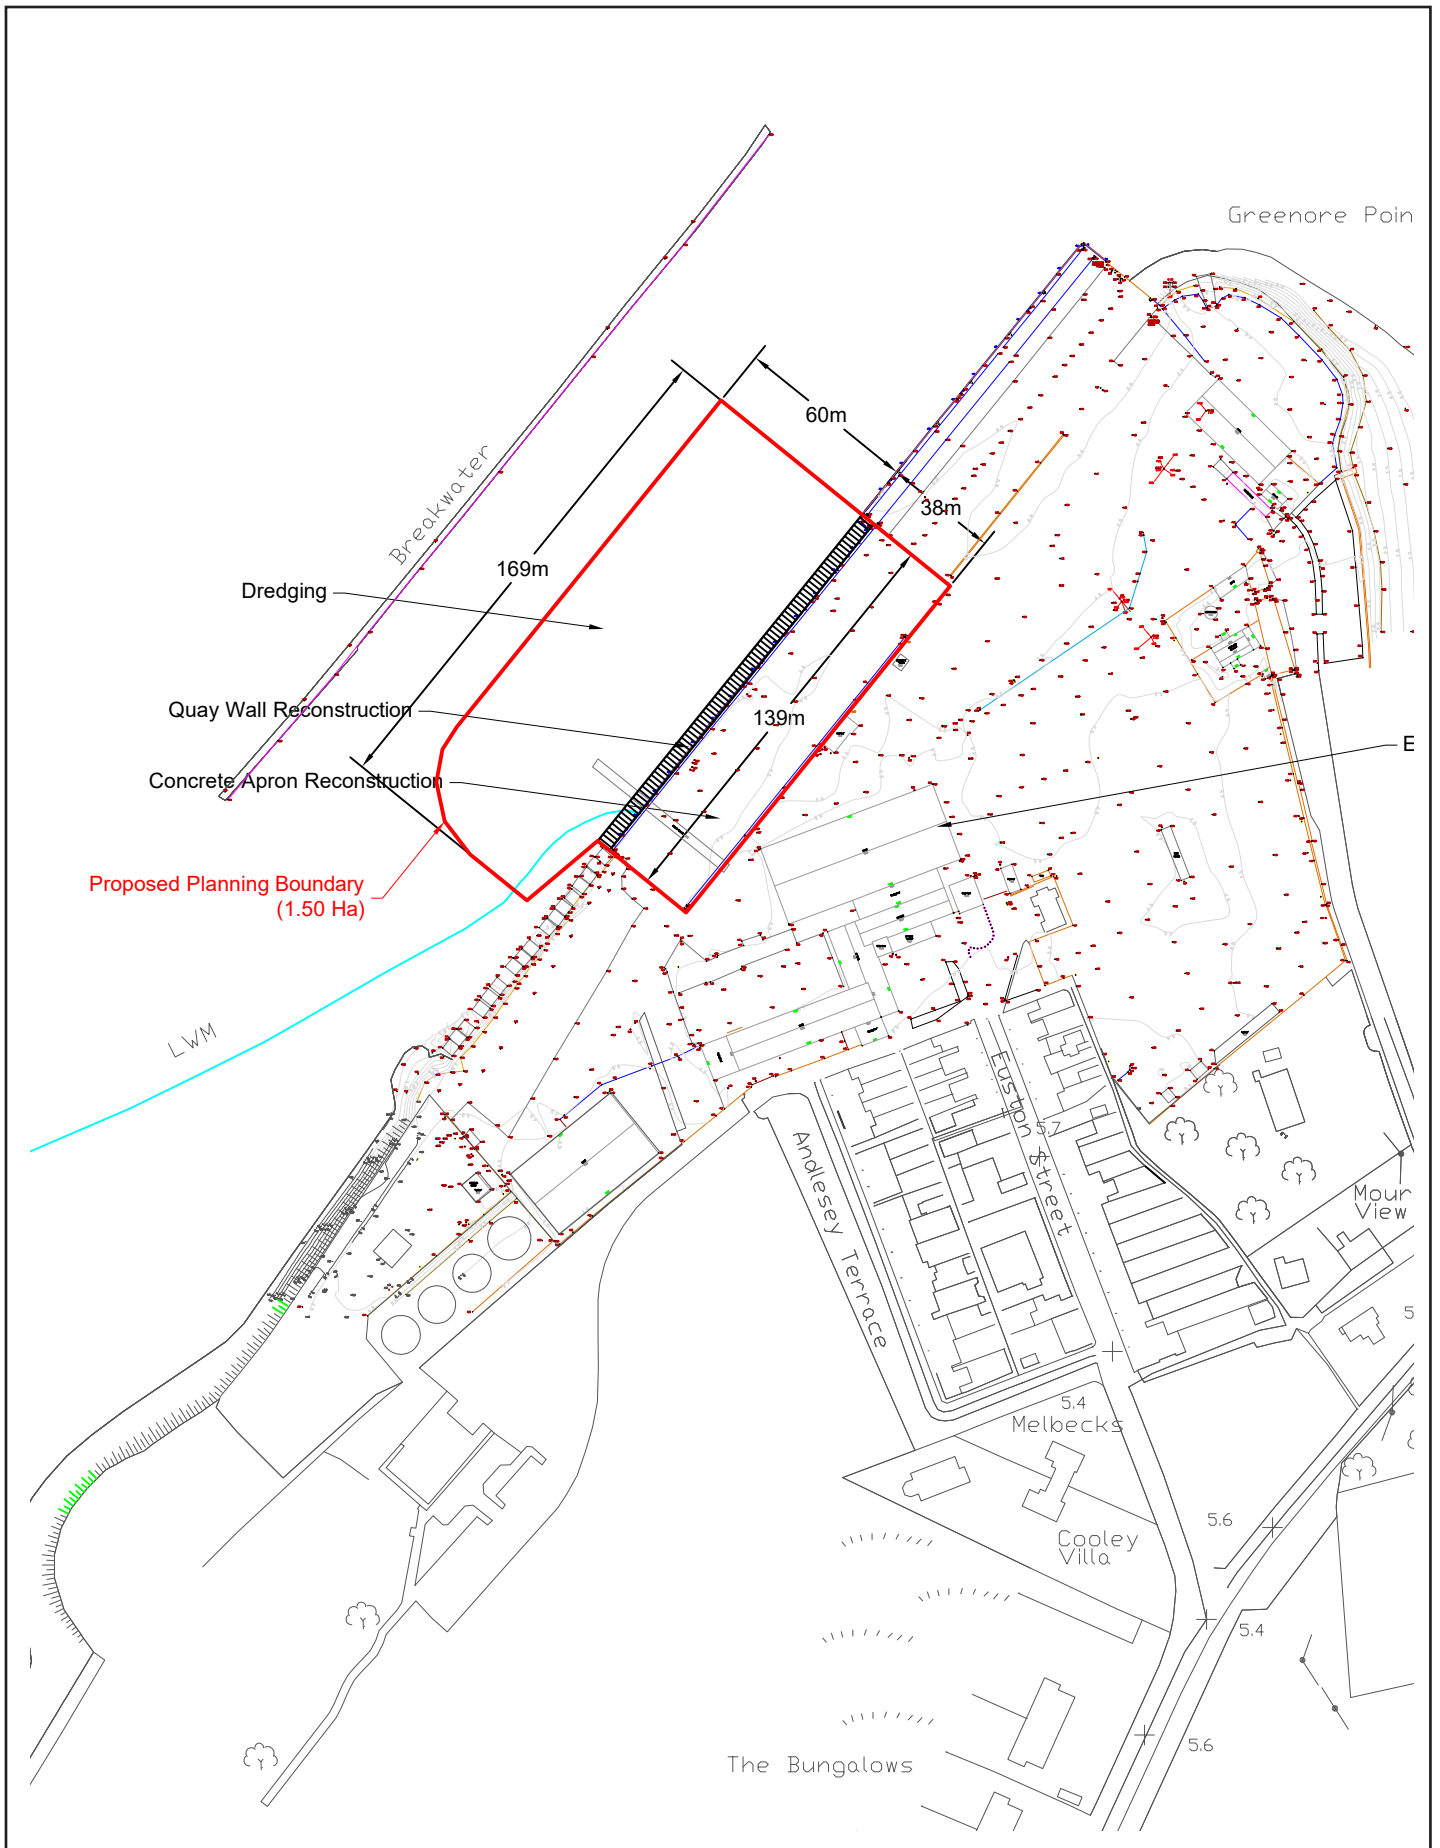
The reclamation works proposed are located within the existing port area and aim to rehabilitate an existing berth to improve health and safety on site (Figure 2). The works include the addition of a new quay wall and deck over an existing quay. The works will dredge the adjacent seabed to a depth of  $-7.5\text{m}$  Chart Datum (CD), to facilitate access to the upgraded berth and to align it with the existing Berth No. 1. Current bed levels vary between  $0\text{m}$  and  $-7.5\text{m}$  CD. The dredged spoil, if suitable, will be re-used between the existing and proposed combi-wall.

Figure 2: Detail from Project Drawing C983/PP/1 Layout Plan, showing proposed development.
