Dun Laoghaire Baths

Investigation Works

Dr Jason Bolton

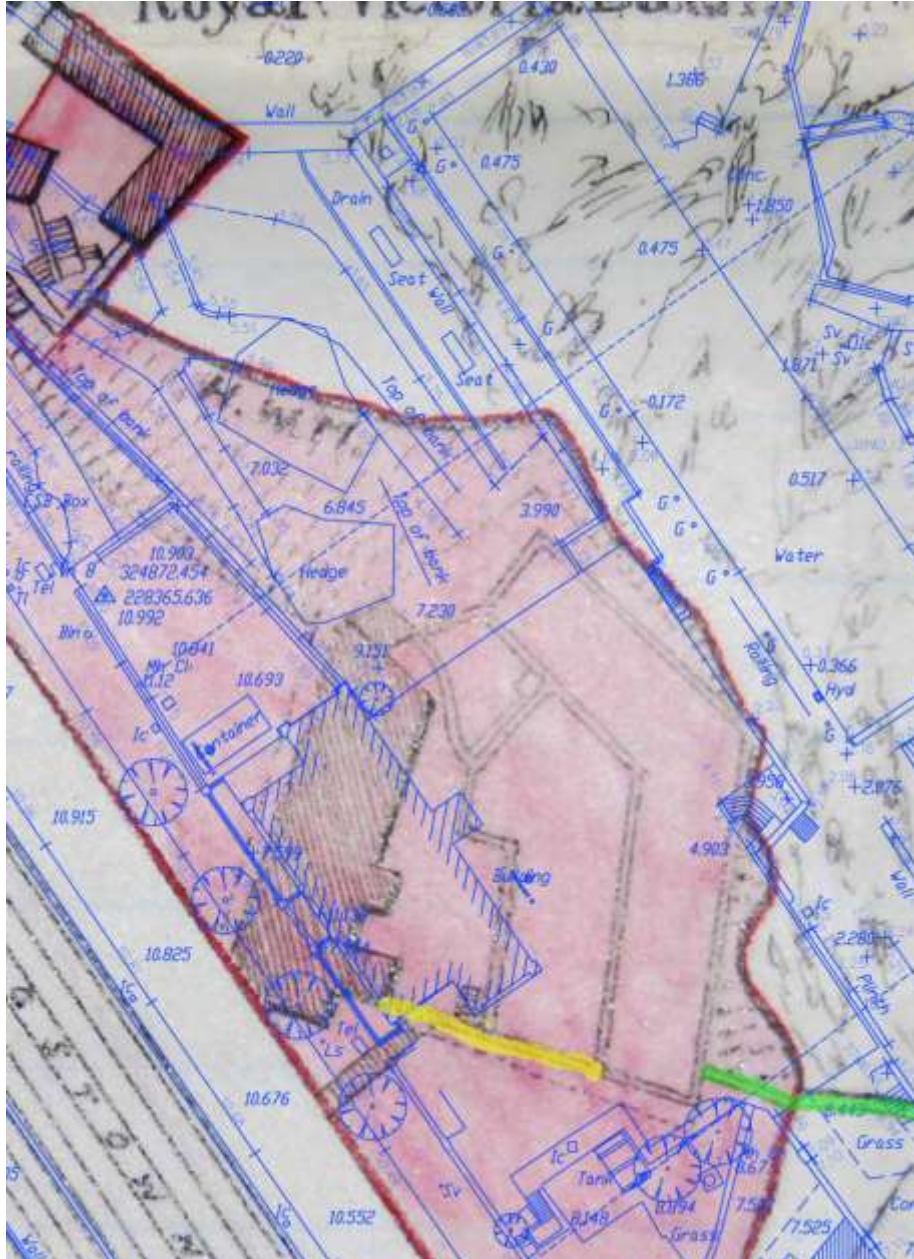
Fig 10: Overlay of the title deed map with modern mapping of the Dun Laoghaire Baths (courtesy of Noelle Sweeney, Architect, Dun Laoghaire-Rathdown County Council) showing the surviving wall *in situ* coloured green, and the probable extent of wall and entrance taken down and re-built on a new alignment (coloured yellow) surviving within the baths complex.

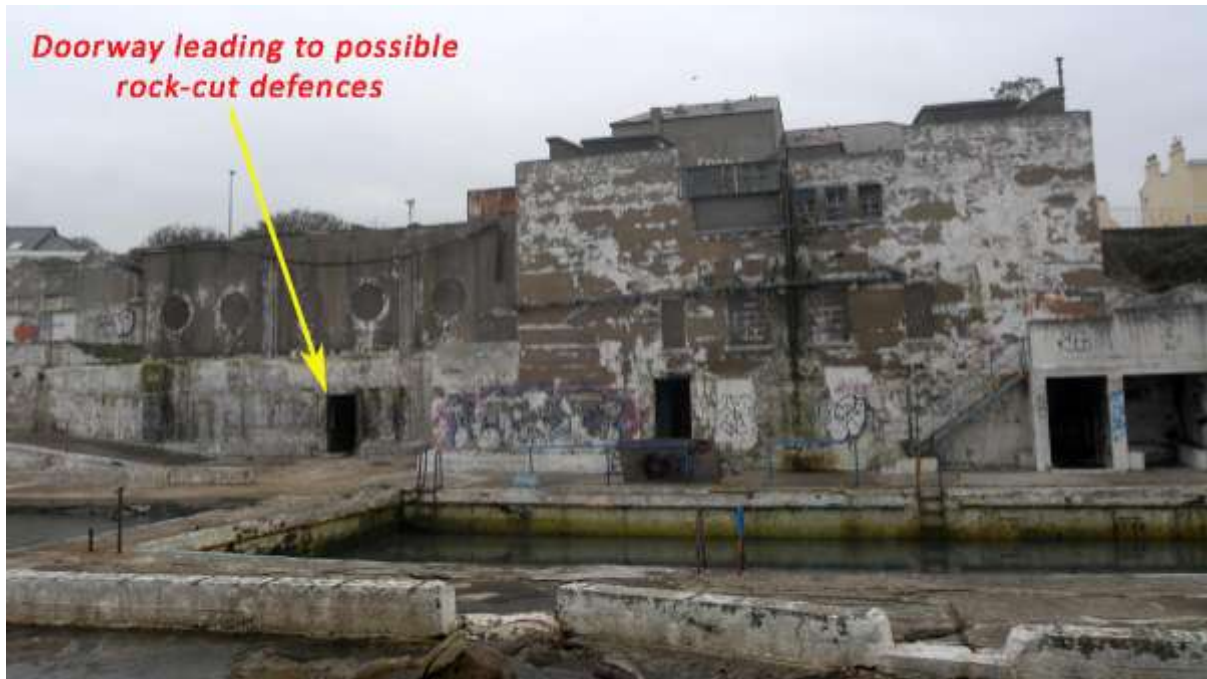
Fig 11: General view of the bath complex (November 2011) showing the two doorways opened up at basement level. The rock-cut defences and re-used granite masonry are found within the eastern door (arrowed) with a substantial amount of 20th century concrete construction overburden.

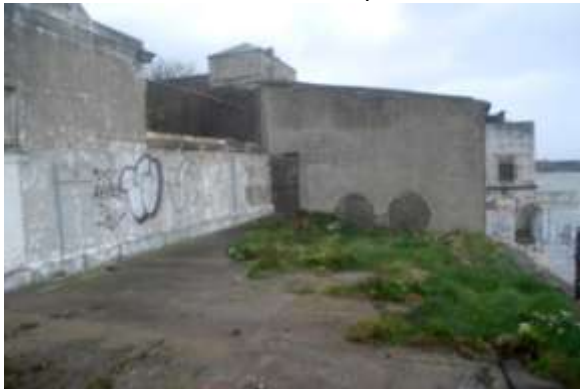
Fig 12: Side view of the 20th century bath complex showing a concrete buildings and surface throughout.

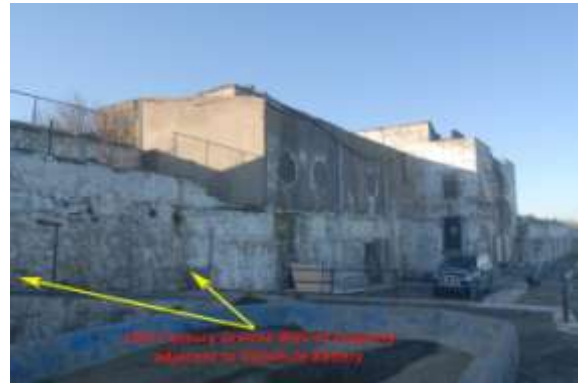
Fig 13: The 20th century concrete bath complex enveloped 19th century granite boundary walls.

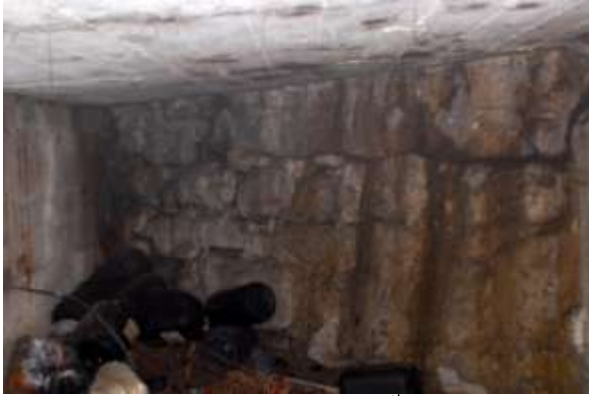
Fig 14: View of continuation of 19th century granite masonry wall (see in Fig 13) showing the concrete roof above and concrete walls adjacent.

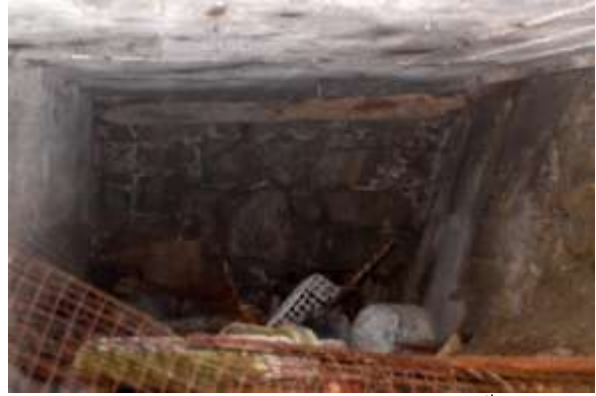
Fig 15: View on further continuation of 19th century granite masonry wall to meet granite bedrock which has been cut back to form a beveled slope.

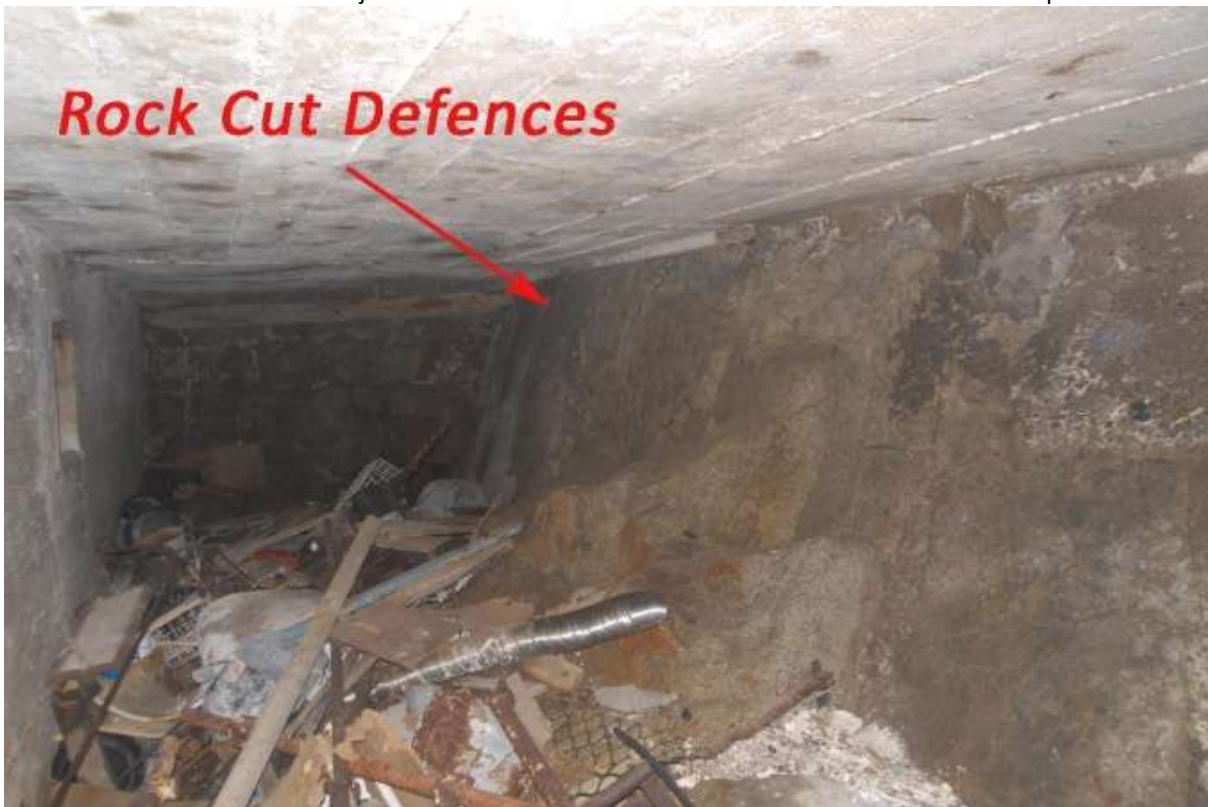
5.1 Possible Rock-cut defences: At basement level, the granite bedrock has been cut (i.e. quarried) to form a battered near-vertical rock face. This type of feature is also found at No.11 Sandycove battery and No. 10 Bartra tower, and is also a feature of earlier fortifications where it forms part of the external defences. This vertical rock face is found below a poured concrete flooring structure within the bathing complex. A passage has been cut through the vertical rock face in this area to form a passageway leading to the boiler room and the rear of the complex.

Fig 16: General view of the eastern end of the bath complex at basement level showing the 19th century granite masonry wall (seen in Fig 15) meeting the cut granite bedrock. This rock surface has been quarried back and is likely to have formed the lowermost part of the defences of Glasthule Battery.

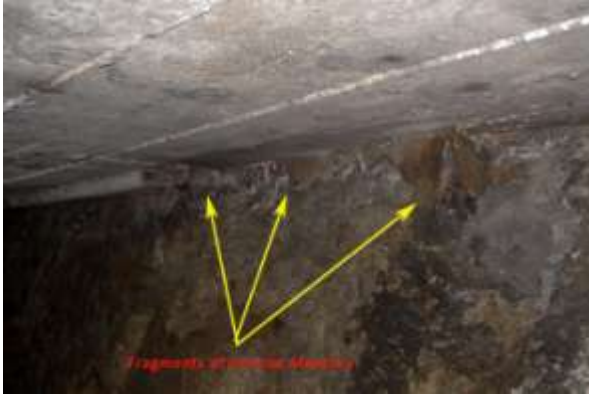
Fig 18: The masonry above the rock-cut defences appears to have been removed, though some granite masonry fragments remain. It should be noted that these granite blocks are not ashlar masonry and so cannot be definitively attributed to the battery structure. It appears that the ashlar masonry of the battery was taken down/demolished, though fragments of the masonry may survive incorporated as coarse aggregate or masonry artifacts within the 20th century bath structures.

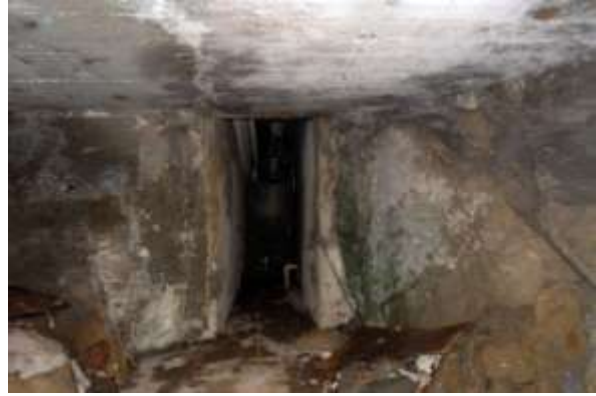
Fig 19: The bedrock has been cut to allow access into the boiler room and the rear of the complex. The current opening is lined with concrete retaining walls and is considered to be 20th century work. However, there is a reference in the 1830s for a rock-cut drain running from Glasthule Quarry (now the site of the People's Park) through the grounds of the shoreline^{vii}.

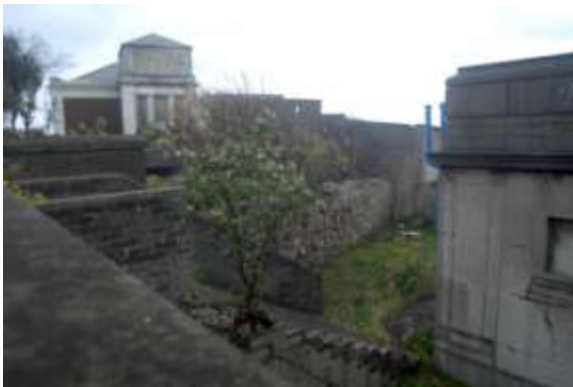
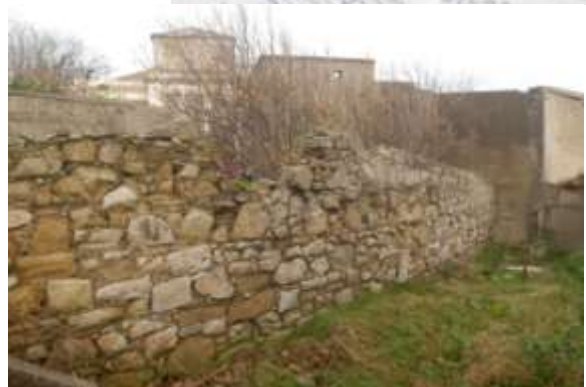
5.2 Traces of Battery and Original Structures: There are no standing structures or masonry walls which can be confidently said to form part of Glasthule battery, though stretches of boundary walls from properties built east of the battery during the nineteenth century have survived.

Figs 21 & 22: Granite masonry wall found at higher level within the Baths complex which retains salt-weathered granite, slate pinnings and sea-sand rich mortar aggregate.

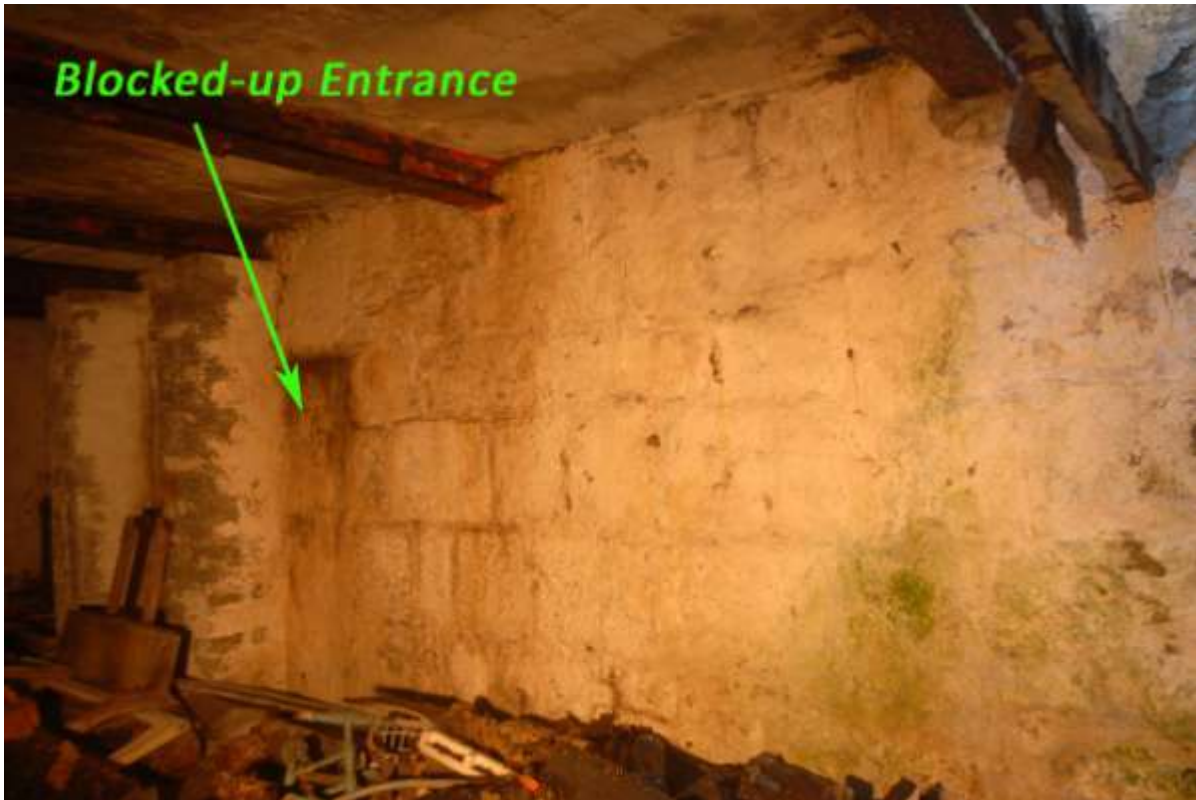
Fig 26: A short stretch of over-painted coursed and rough hewn-squared granite masonry survives at basement level^{viii}. The doorway is most probably the entrance to the entrance shown in the 1821 engraving (see Fig 23) with similar doorway and masonry surviving at Dalkey battery (see Fig 25). However, this granite wall does not follow the known alignment^{ix} of Glasthule battery, but follows that of the Edwardian baths. A likely scenario is that the landward battery wall (coloured yellow in Fig 10) was taken down and re-used once the property began to be developed for municipal bathing.

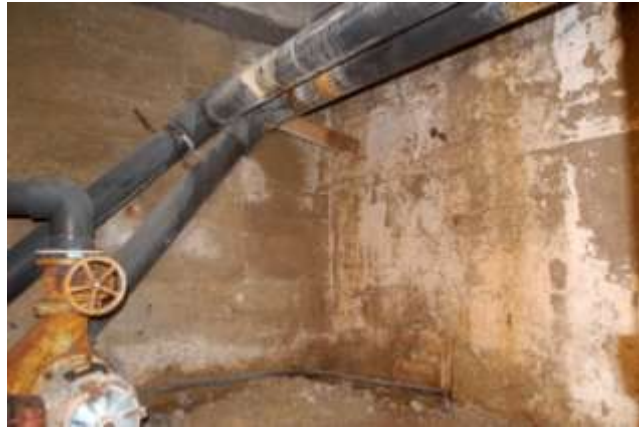
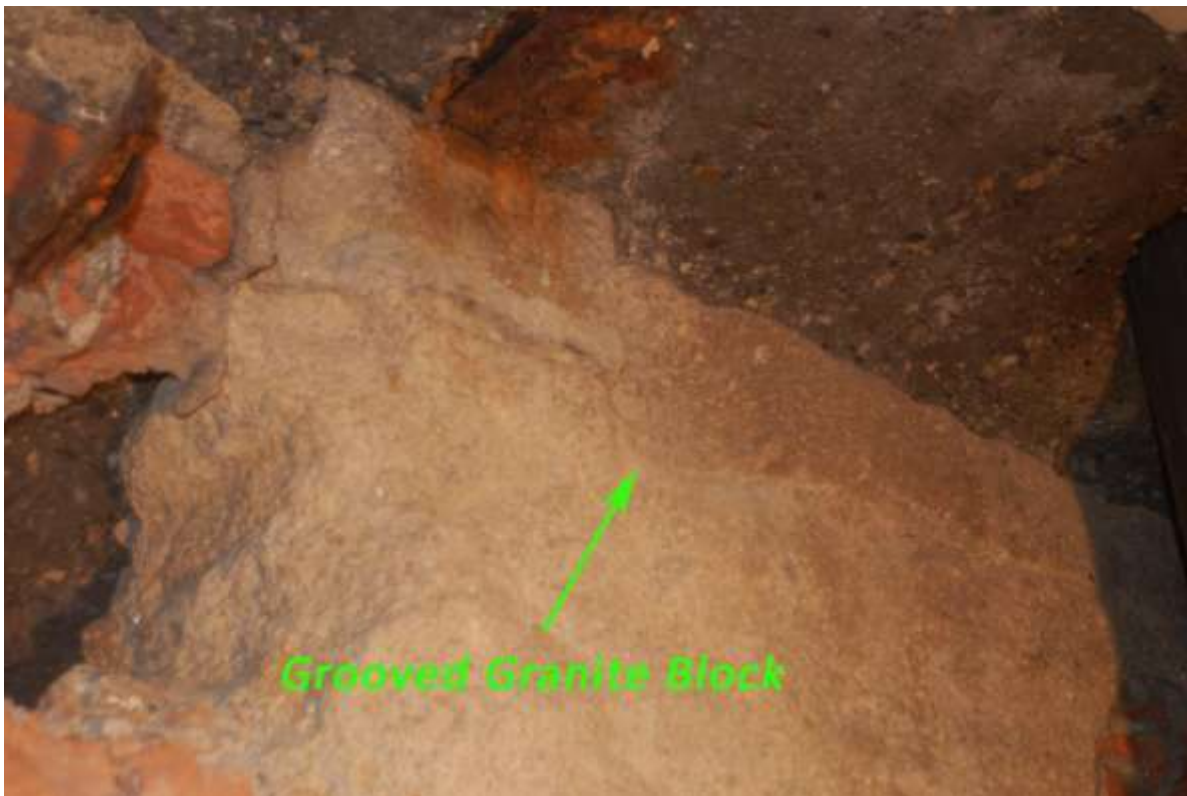
Fig 29: There are a small number of granite masonry blocks visible at basement level which have been incorporated in the Edwardian municipal baths. This stone, re-used as a support for an iron 'I' beam has a groove. Similar grooves are found to house the iron racers on which the guns were moved to direct fire on enemy shipping (see Fig 30 below for *in situ* examples).

5.5 Recommendations for further work: Further investigative work is unlikely to uncover any new significant findings, and it appears that substantial remains of the battery do not survive. The surviving fragments of re-used granite masonry salvaged during the removal of Glasthule battery and now found at basement level only of the existing bath complex could be considered as Edwardian *spolia*, however it is difficult to argue that they have any significant archaeological value. However, it would be prudent to undertake archaeological monitoring of the demolition of any of twentieth century structures, especially where concrete flooring surfaces are to be disturbed, as there remains a slight possibility of some original features surviving behind current retaining walls^{xv}.
