REPORT on
18 MOORE STREET, DUBLIN 1
On behalf of
THE RELATIVES OF THE SIGNATORIES
TO THE 1916 PROCLAMATION

Date: March 2014

ISSUE – REV. (A)

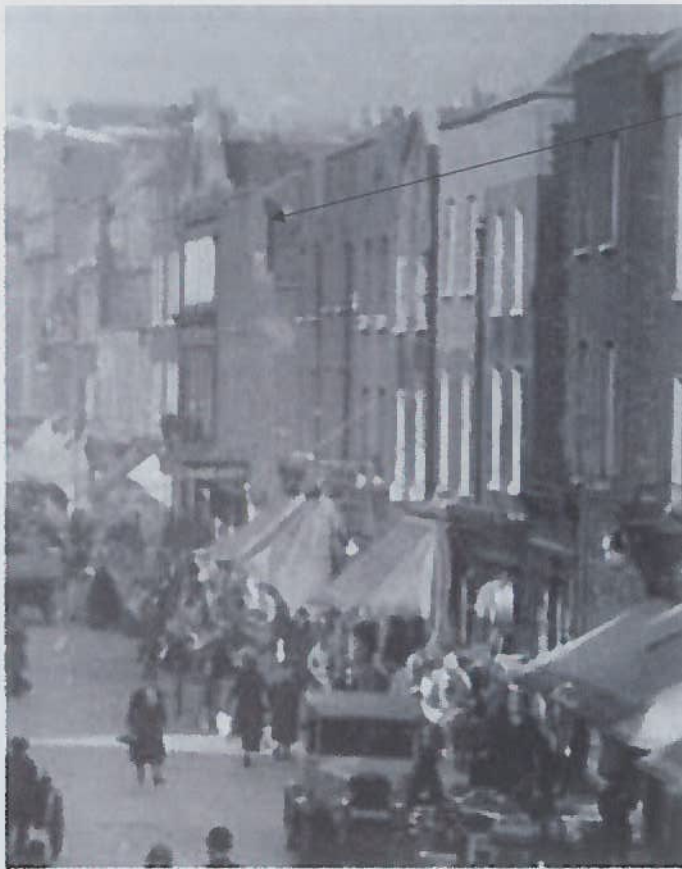
Photo 02.

Moore St. c.1930

Damage to no.18

The point at which the height of the building was reduced can be established as happening sometime between 1930 and 1950. Photographic evidence from a picture taken in 1930 shows damage and a collapsed wall at second floor level to no. 18 Moore Street.

The extent of this damage eventually led to partially demolishing the front elevation, and roof, and reducing the building height of the building to two stories over basement. An early 1950's photograph of Moore Street clearly shows the buildings as they are today, i.e. 2 stories over basement.

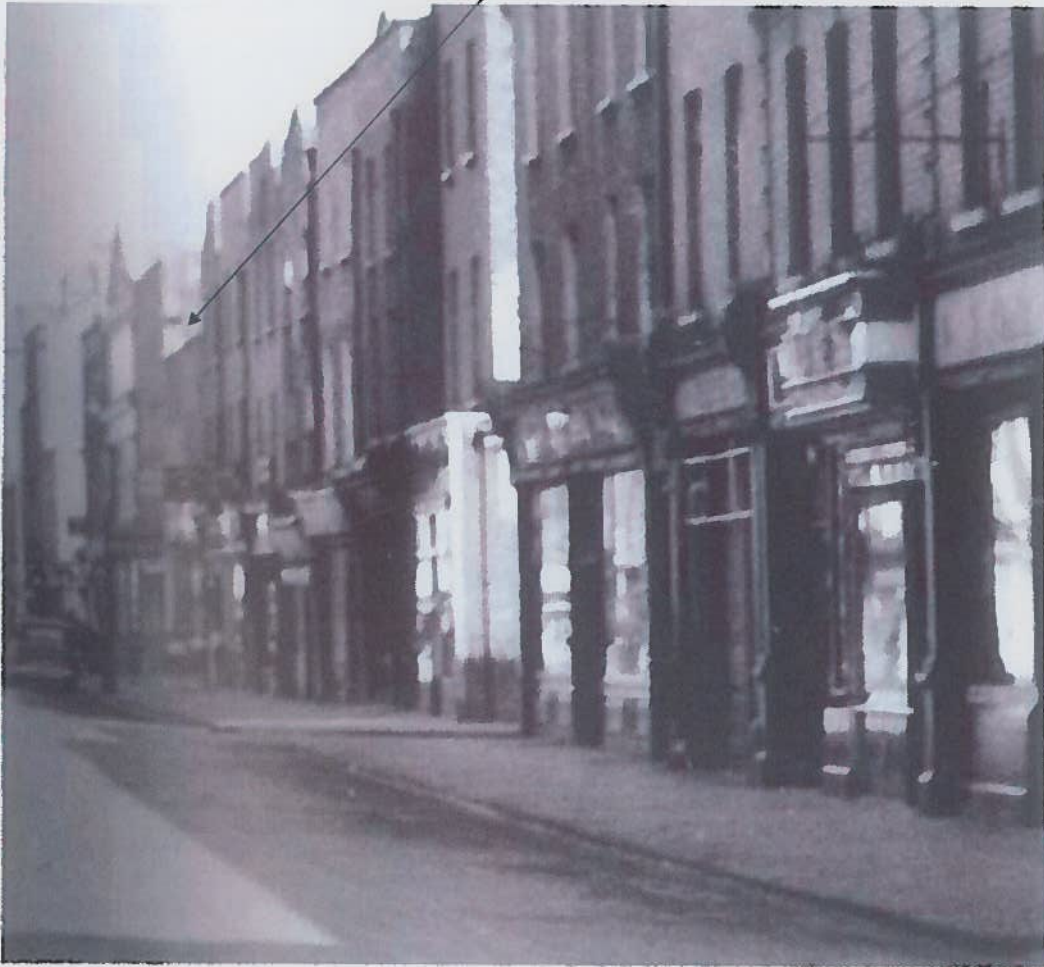
Moore St. c.1952

No.18 & 19

Photo 03 – Moore Street circa. 1950

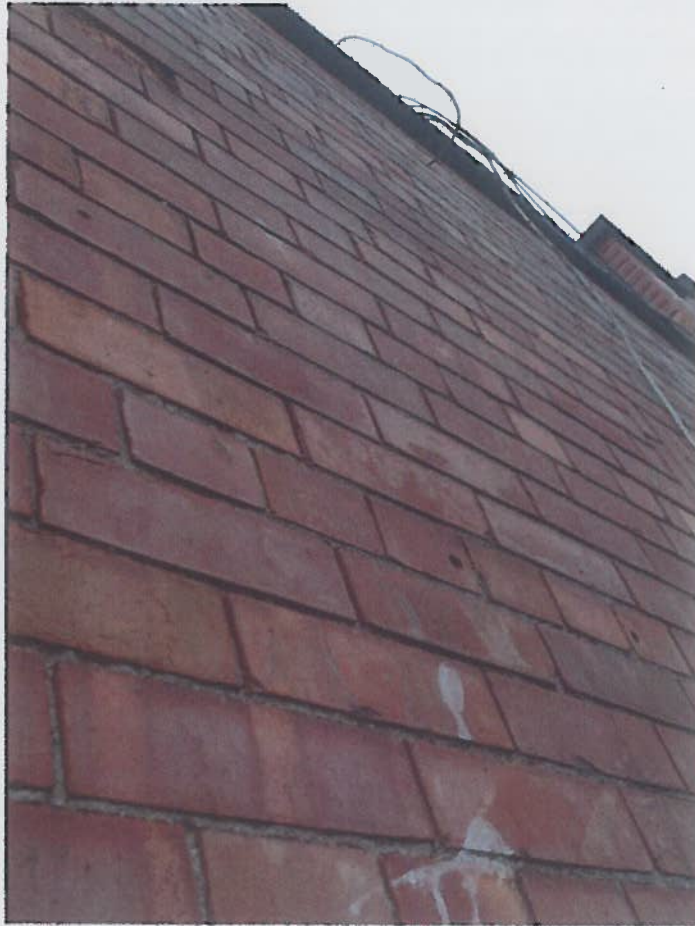
Photo. 03 – Brick detail to front elevation.

The brick soldier courses over the windows, and the pointing match with the design of the buildings comprising the National Monument and would have been typical of the construction circa. mid-late 19th century. There is some impact damage on the brickwork, possible bullet strikes, the cause of which should be investigated. Otherwise the bricks are in reasonable condition.

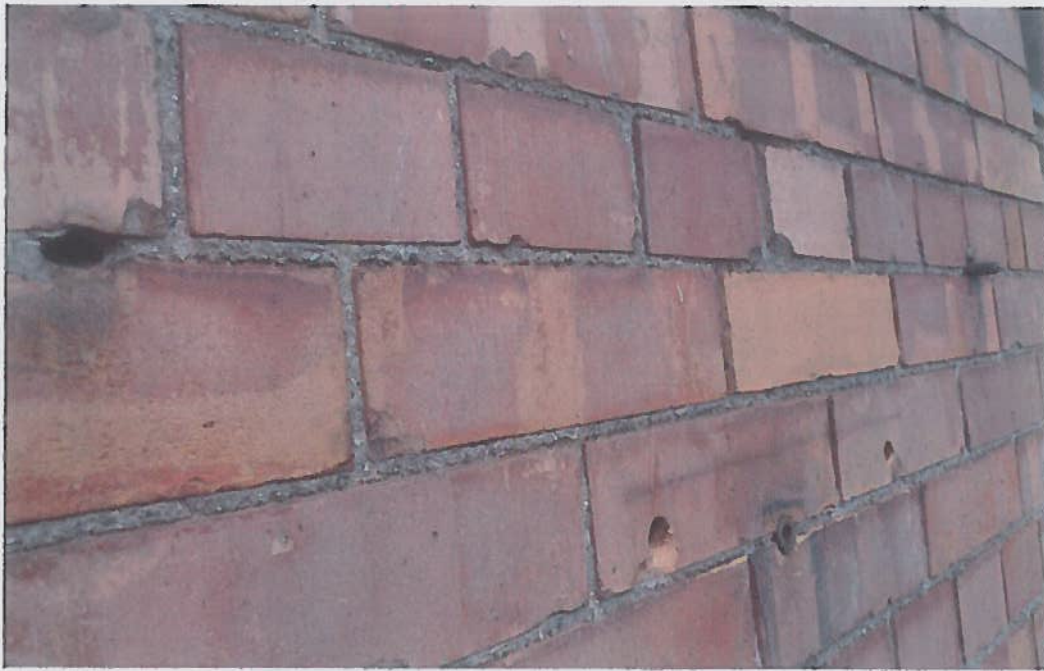
Photo 04 – Impact damage (possible bullet strikes) to bricks

1. The brickwork on the front elevation should be tested and examined.
2. The front elevation should be opened locally to examine the build-up of the walls.
3. The party wall at first floor level between no. 18 and no. 19 should be opened up and examined.
4. The rear wall at first floor level should be opened up and examined.
5. Investigations should take place to see if a basement is present.
6. The roof and chimney should be investigated further.

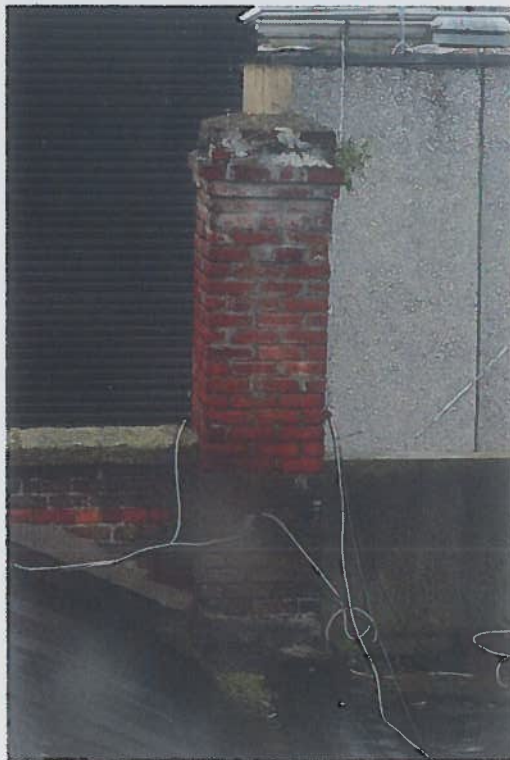
Photo 05 – View of chimney

On inspection there was no evidence of a basement which would have been typical to a building of this age. Presumably the basement access has been blocked. A notable feature visible on ground floor level is a front (Moore Street wall) corner chimney. The chimney on the front elevation is an unusual feature for this type of building. In my opinion, the chimney was located here when the building was refurbished. The reason for its location and indeed the design of the roof was presumably to maximize the floor area of the building. Alternatively, the chimney may have been in use to smoke fish for the retail element, this fact needs to be established by investigating the basement.

It can be noted that the builder refurbishing the chimney used the original salvaged brick to form the chimney, and stock brick below the parapet where the brick cannot be seen.

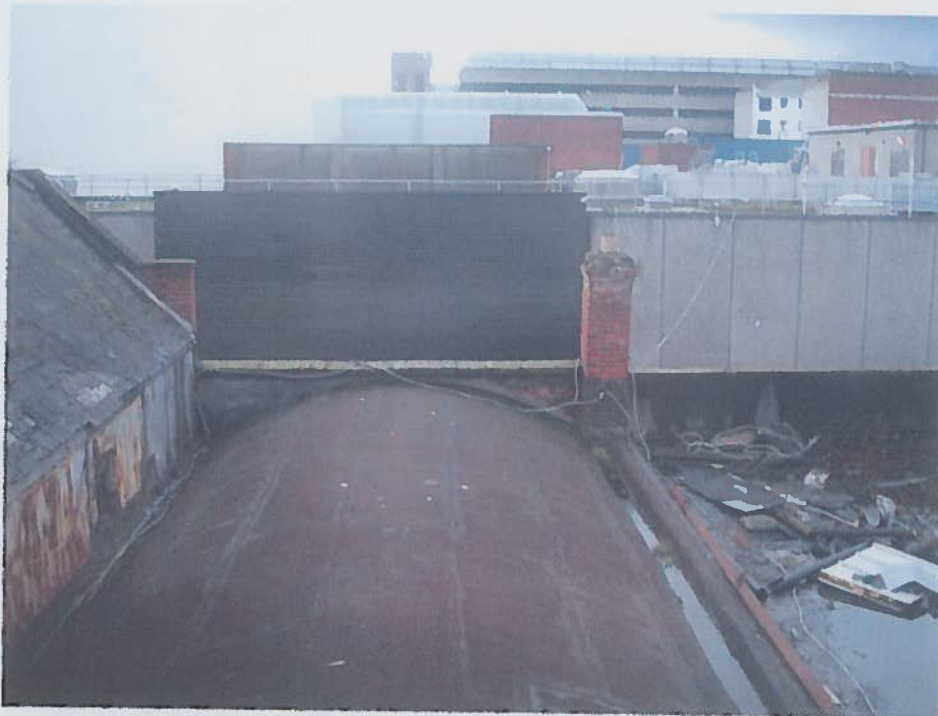
The trusses are boarded and a torch on felt lining has been fitted externally, which covers the roof and its original roof light, etc. A more detailed inspection/survey of the roof should be undertaken.

Photo 06 – External view of roof

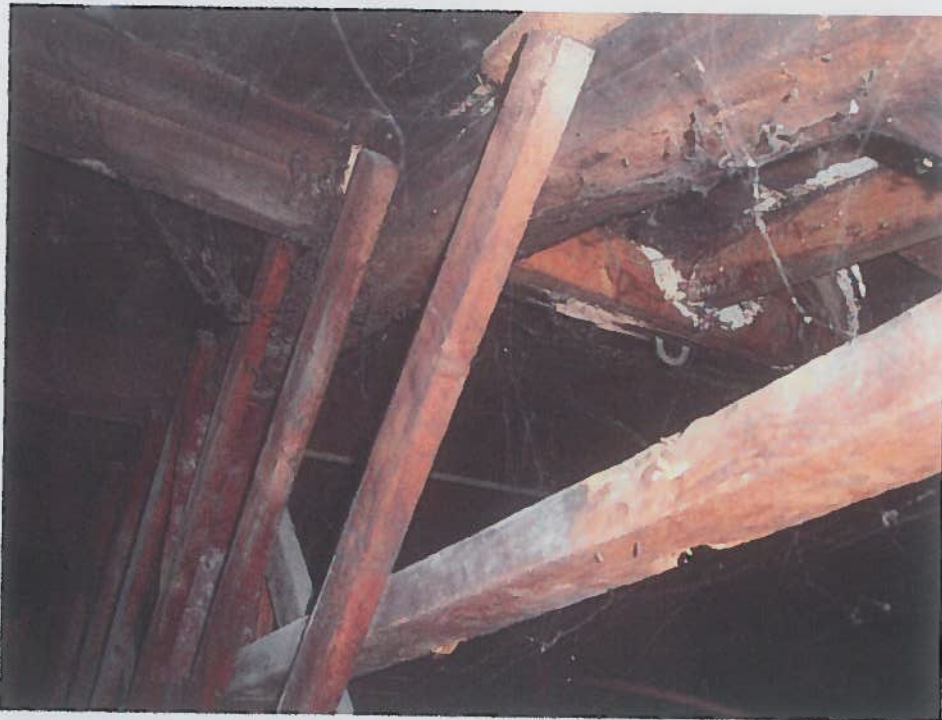
The roof over the original house at no. 18 is curved, comprising of 'Belfast' or 'Bowstring' trusses, where the top member of the truss is curved and formed by sandwiching together timbers and then bent under stress. The 'Belfast' truss was introduced circa 1860 to meet the demand for efficient wide span industrial buildings, although not commonly used until the early 1900's. The reason for this type of truss and roof in this situation would be light weight retro-fit with a very low profile, which would have suited this building once the top floor was removed.

Photo 07 – Internal view of curved truss.

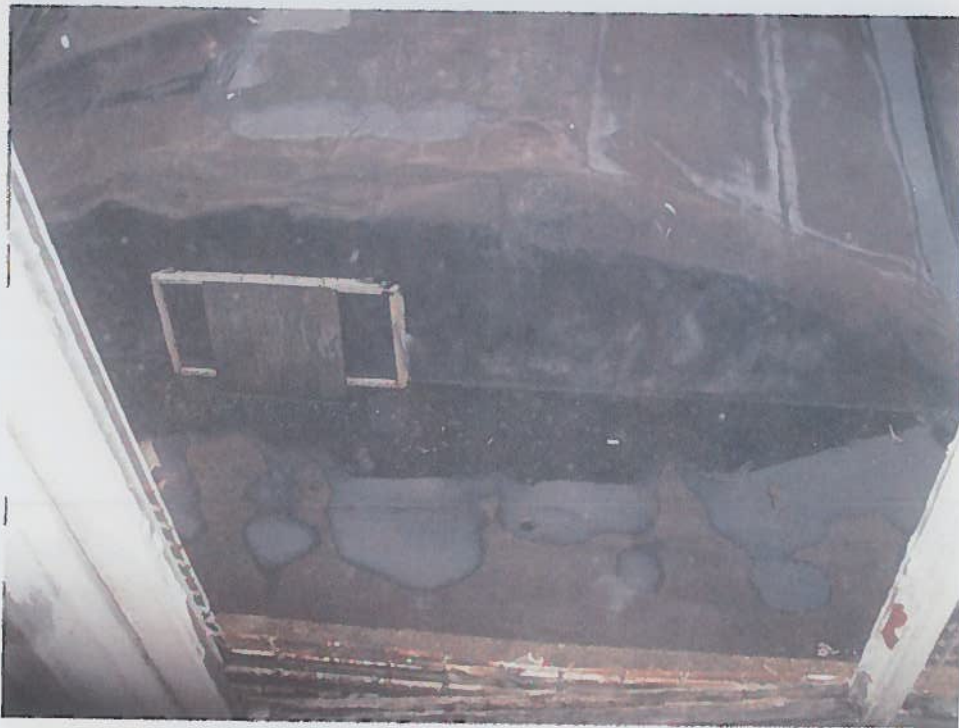
Photo 08 – External rear view of roof.
