Environmental River Enhancement Programme

Annual Report 2021

IFI/2022/1-4586

Inland Fisheries Ireland & the Office of Public Works

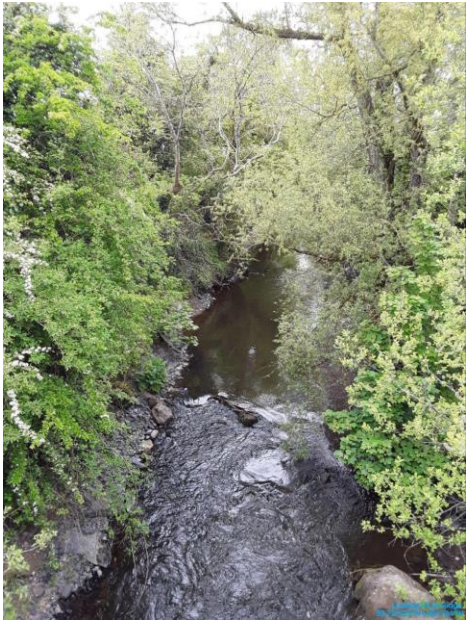
Figure 2.3 Example of an entrenched site on the Moynalty River (C1/8/10).

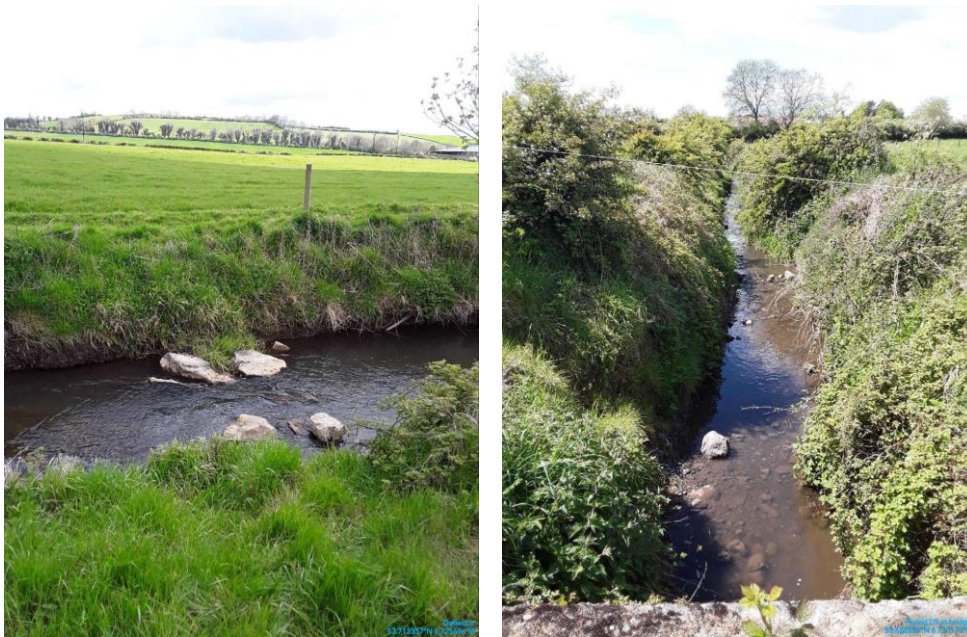
The next site is on another straightened tributary (C1/8/1) discharging into the main Blackwater (Figure 2.17, right). The site has been extensively over-deepened, resulting in minimal variation in channel velocities and depths. The substrate is good in places for the river type but there is excessive silt on it. The banks are now re-naturalising, and simple native vegetation is in succession. There is no floodplain connectivity due to the re-sectioning. Overall the site was classified as Poor.

Figure 2.17 Artificial deflectors (left) creating good flows in a straightened part of the river channel C1/8/5 (Good status). Picture shows excessive silt on substrate (right), extensive over-deepening of the channel and simple native bank vegetation colonising the banks in channel C1/8/1 (Poor status).

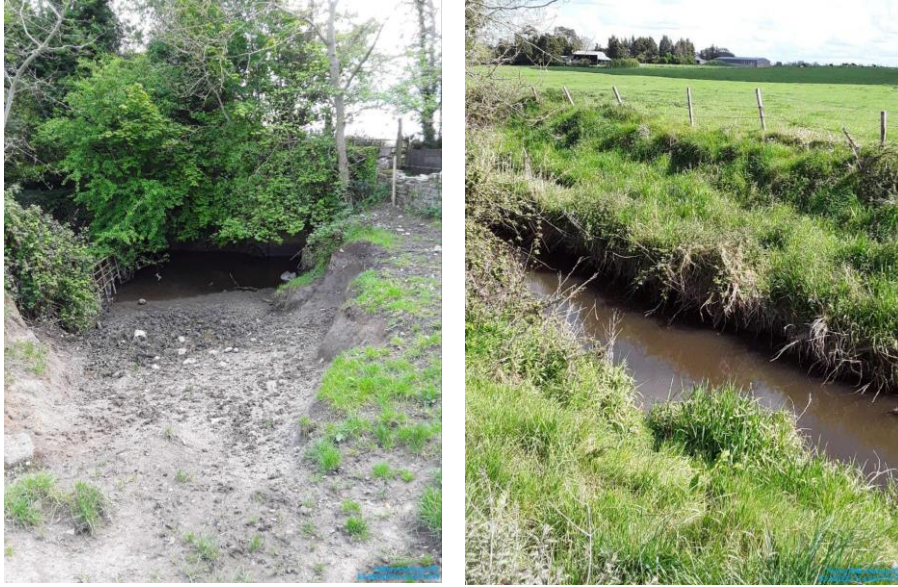
Another site which displayed issues with hydromorphology was on a larger tributary within the scheme (C1/8/9) which fared Poor. The banks have been excessively over-deepened at this location resulting in a lack of connectivity between the channel and floodplain. There was poaching at various points along the reach, and the scale of these cattle drinkers was quite extensive (Figure 2.18). The flows in this channel were not perceptible, and the substrate not visible due to the high levels of turbidity in the water. Overall, there was a good range of riparian cover, although this is not immediately visible in the photos below.

Figure 2.18 Cattle poaching and high turbidity within the channel C1/8/9 (Poor status).

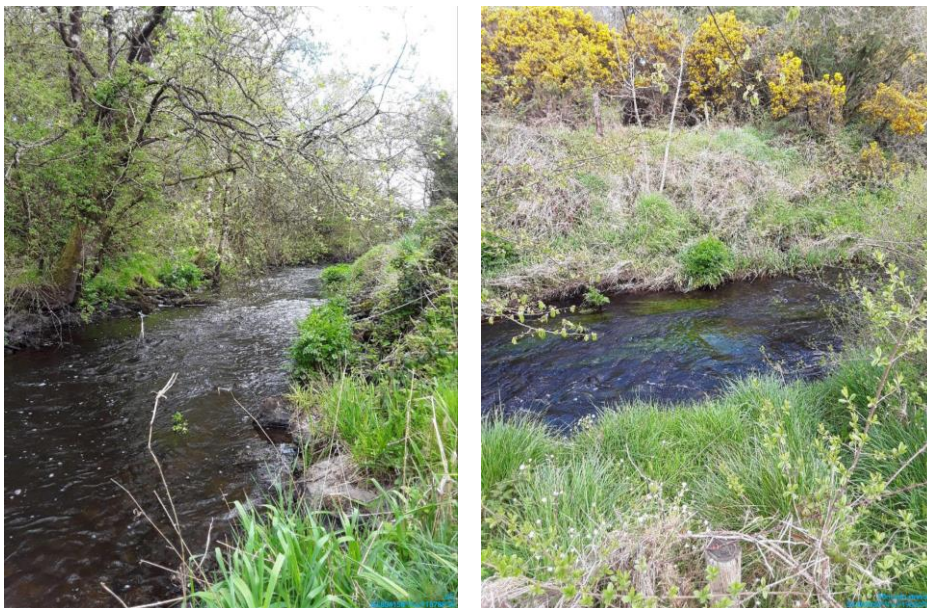
On the main stem of the Barora River (C1/8/10), just upstream of the Moynalty confluence, the site was surveyed and yielded an overall Good result despite the extensive over-deepening and over-widening (Figure 2.19). The historic re-sectioning has renaturalised along the bank profiles and the site has good riparian habitat and cover. There was diversity in velocities and depths, with a variety of instream vegetation and woody habitat present. The substrate is also free from siltation and favourable for fish. This is supported by the electrofishing results at the site, with a wide variety of species recorded, of various age classes.

Figure 2.19 Riffle habitat and riparian cover, instream vegetation on channel C1/8/10 (Good status).

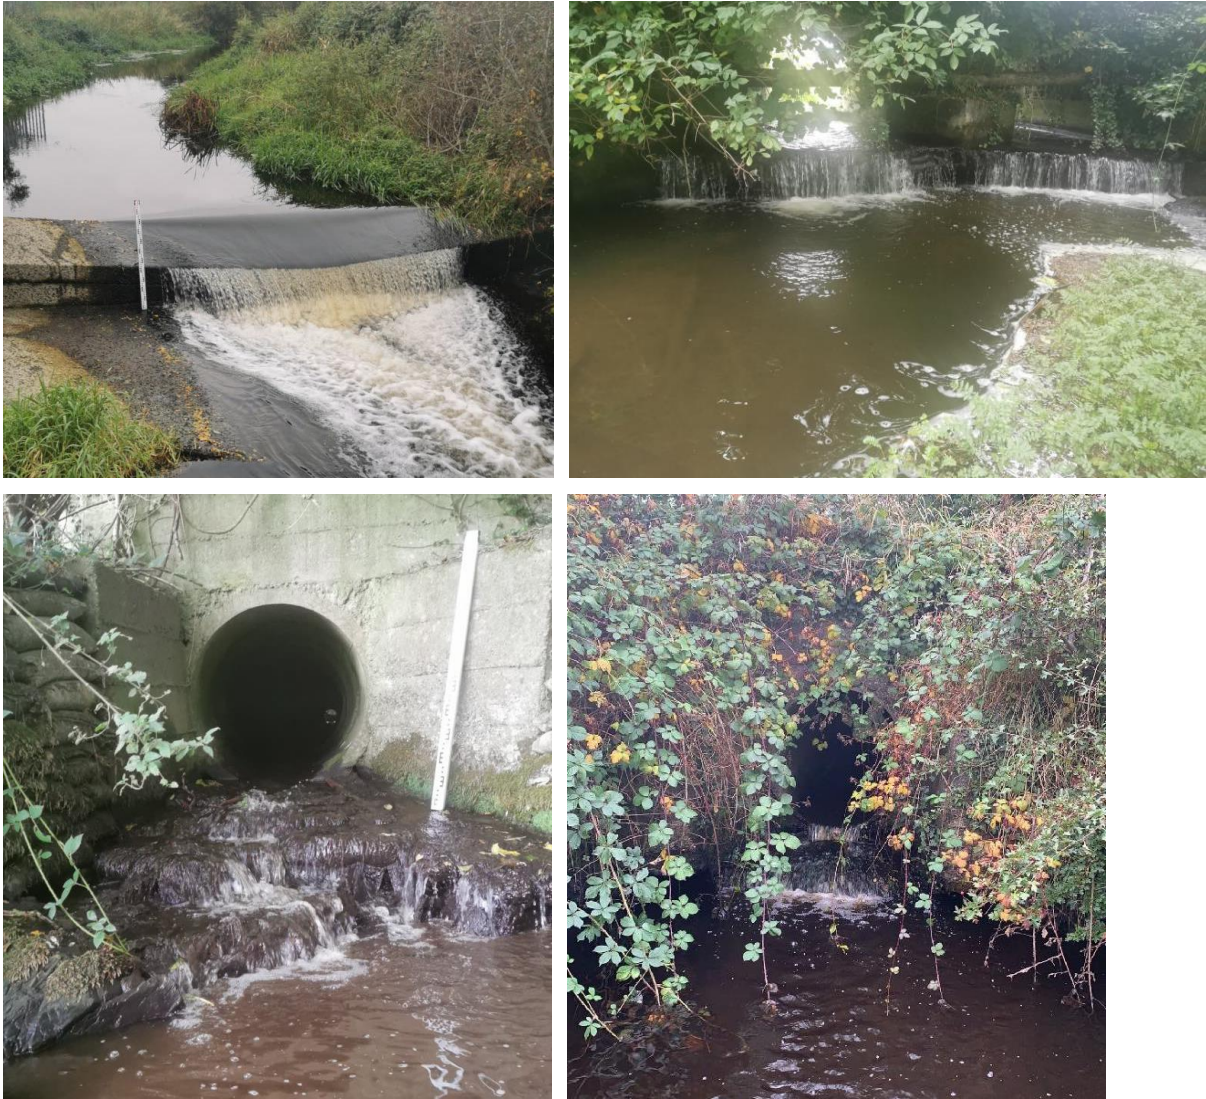
Figure 2.21 Small gauging weir (top left, C1/8/10); two-eye bridge with drop (top right, C1/8/15); culvert with apron and drop (bottom left, C1/8/16); perched culvert (bottom right, C1/8/19).

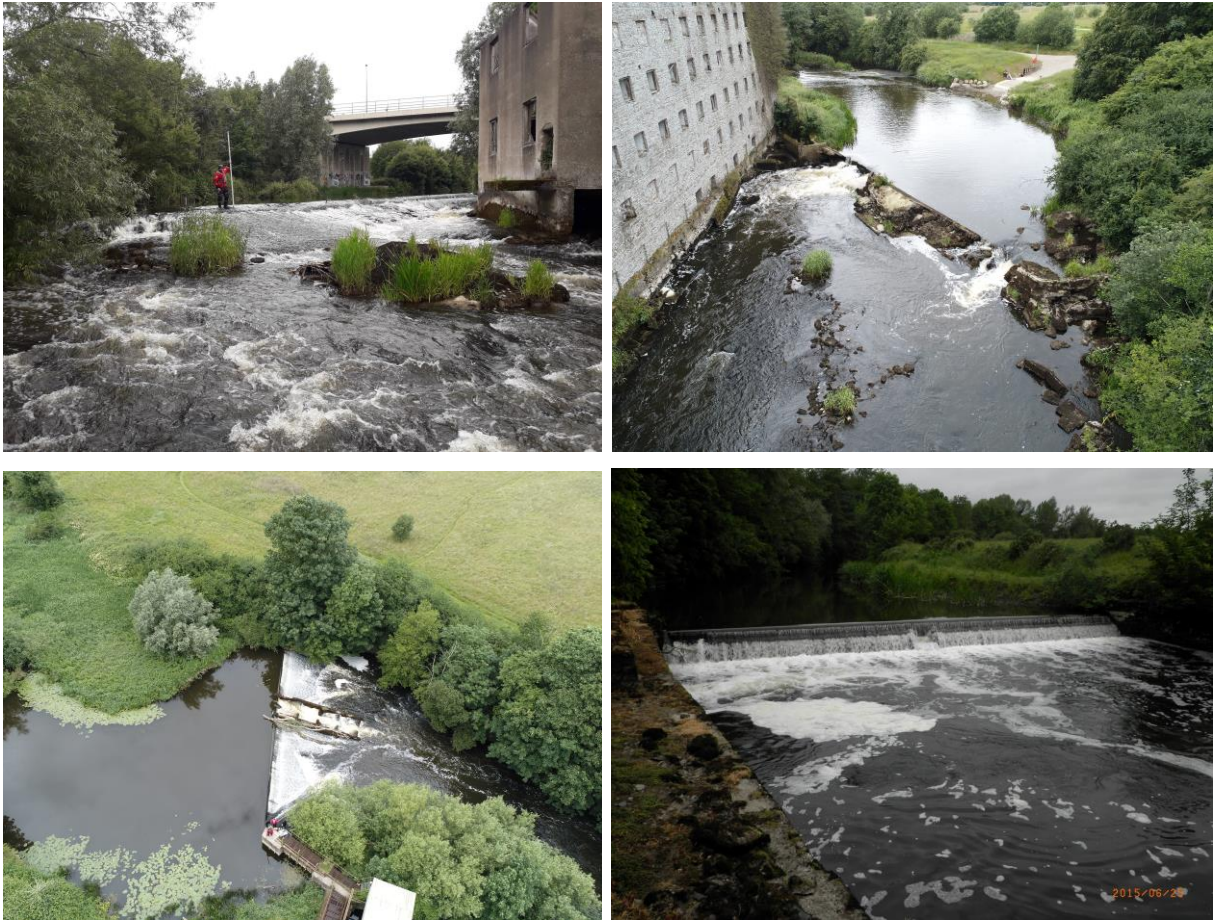
Figure 2.23 The four lowest weirs on the Blackwater: Eliot’s Saw Mill (top left); Spicer’s Mill (top right); Balmoral weir (bottom left); and Martry weir (bottom right).

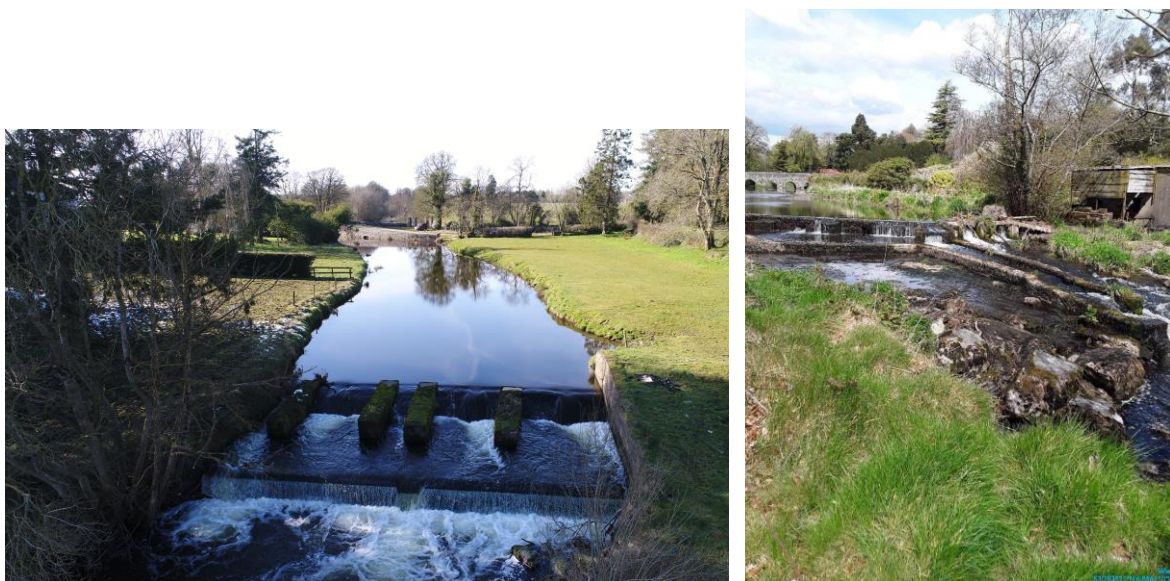
Figure 2.27 The stepped weirs at Mahonstown (left) and Moynalty (right).

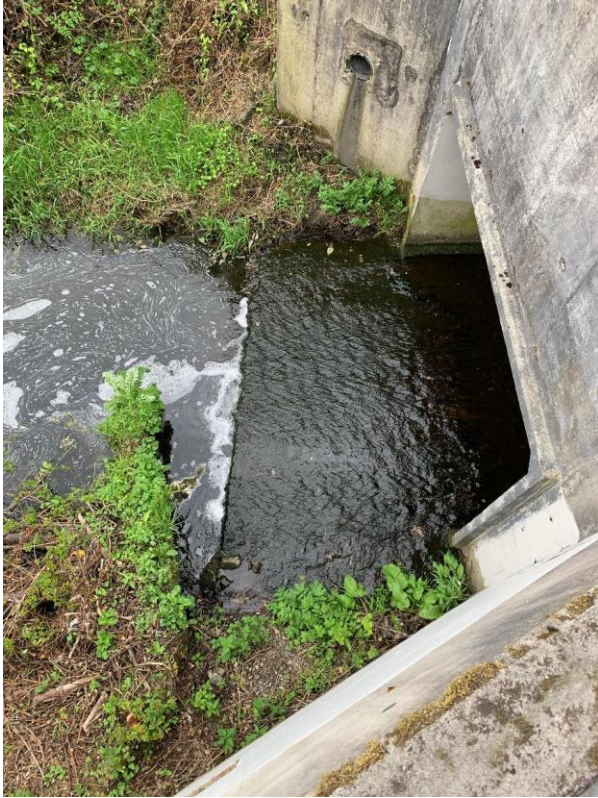
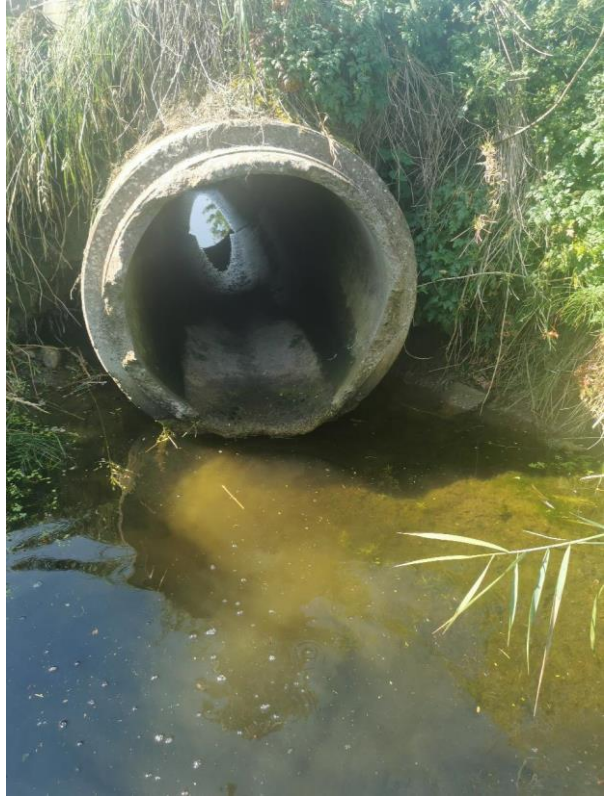
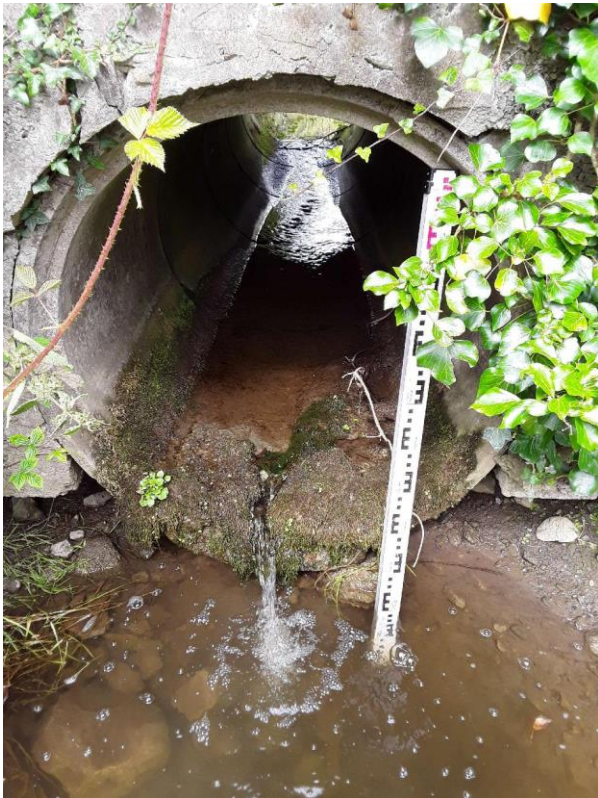
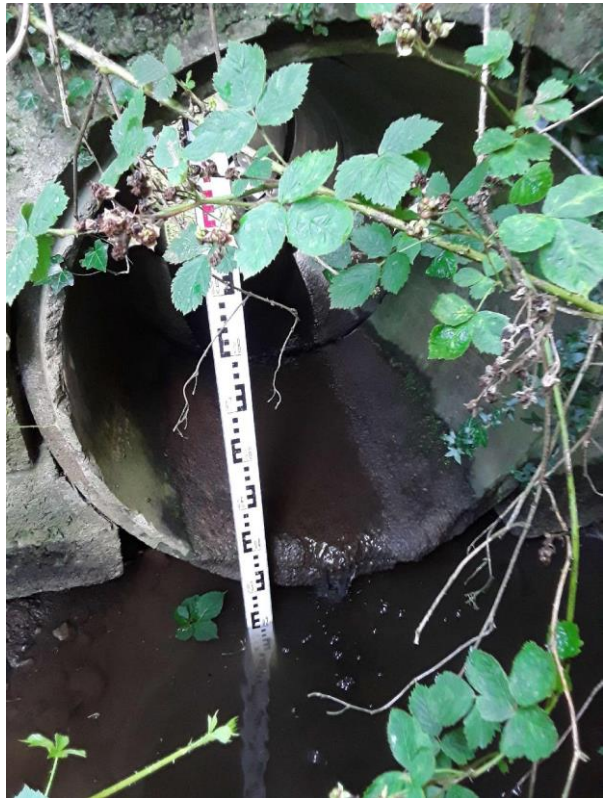
Figure 3.2 Examples of barriers on the Broadmeadow & Ward scheme. Bridge apron with drop, and perched culvert (top, C1/6). Two perched culverts (bottom, C2/10).

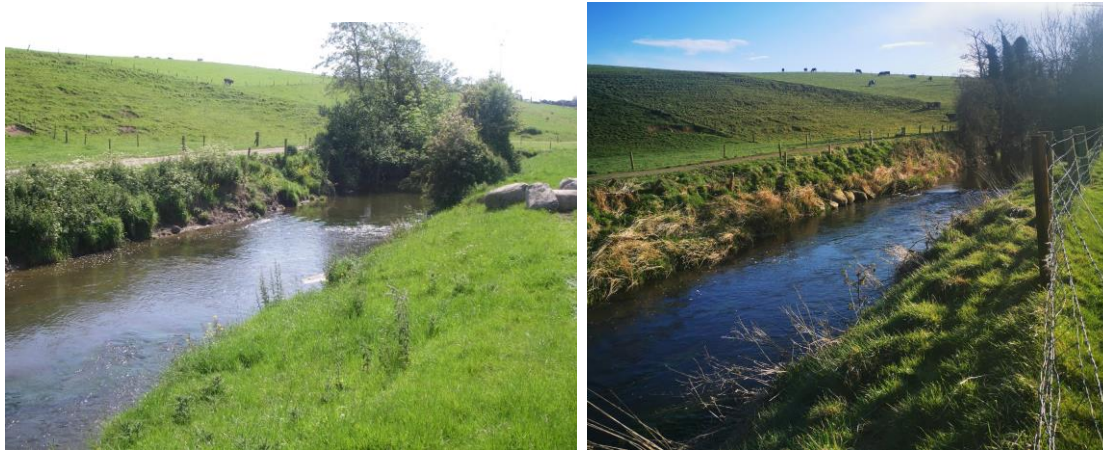
Figure 4.3 Photograph taken on the left-hand bank looking from T0 upstream to T30 (left, 2009 and right, 2022) where the vortex weir was constructed.

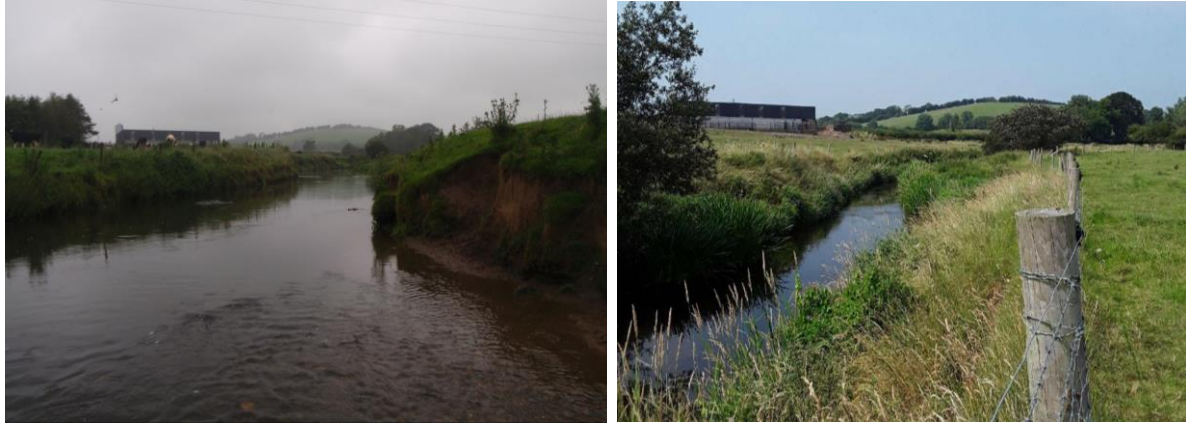
Figure 4.8 Photo taken in the channel in 2009 (left). Photo taken from left bank top of the same stretch of channel in 2021 (right). Both images are facing upstream.

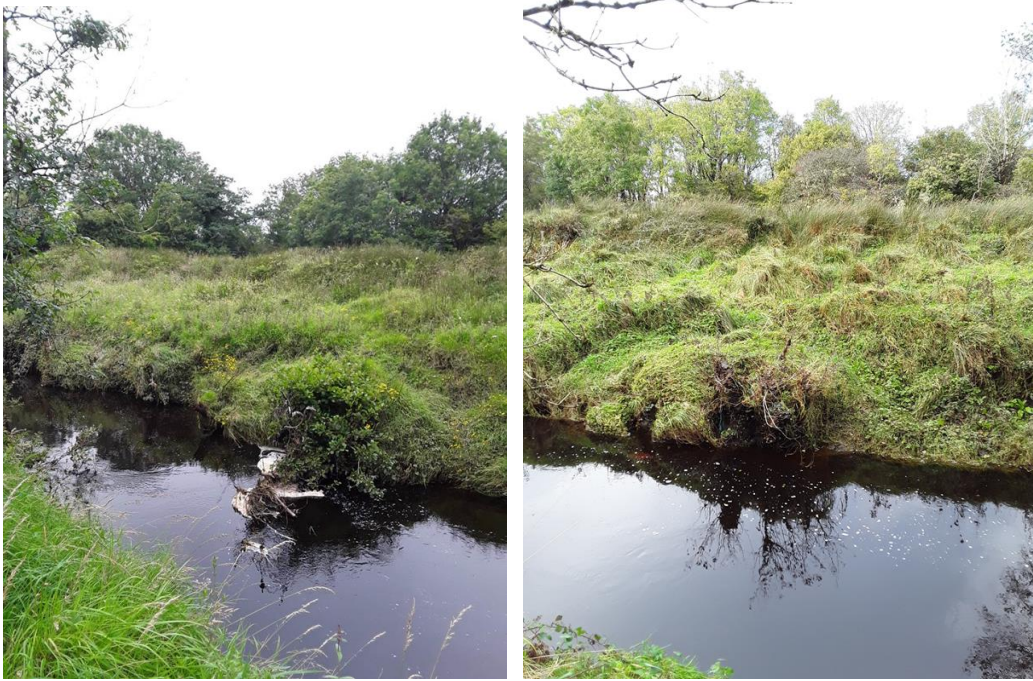
Figure 5.2 Example of an obstruction removed from the channel (left, 2020 & right, 2021).

During the follow up walkover in 2021, identified work sites from 2020 were photographed post works to show the extent of works undertaken. Blockage / tree removal from the instream sections of the river was recommended if currently impeding on flood conveyance, and if items had the potential to impact flows before the next maintenance cycle. In Figure 5.2, it can be seen that low impact methods were used to remove this obstruction from the left-hand bank (LHB). This tree stump remains intact and continues to stabilise the bank. Similar work at a larger scale is evident in Figure 5.3 below.

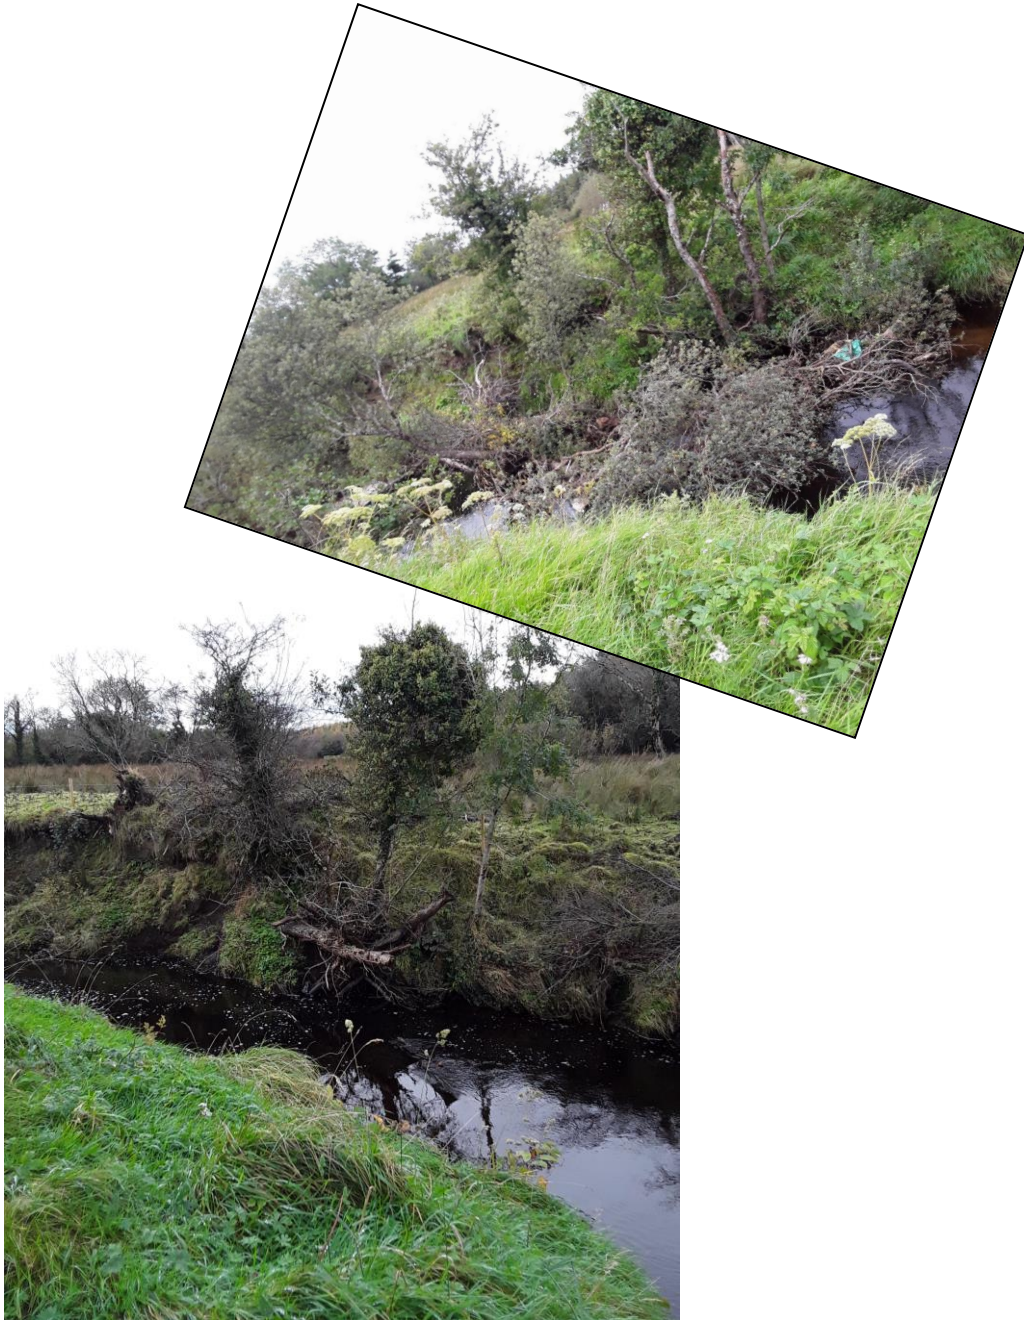
Figure 5.3 Example of effective but not destructive debris dam removal (top, 2020 & bottom, 2021).

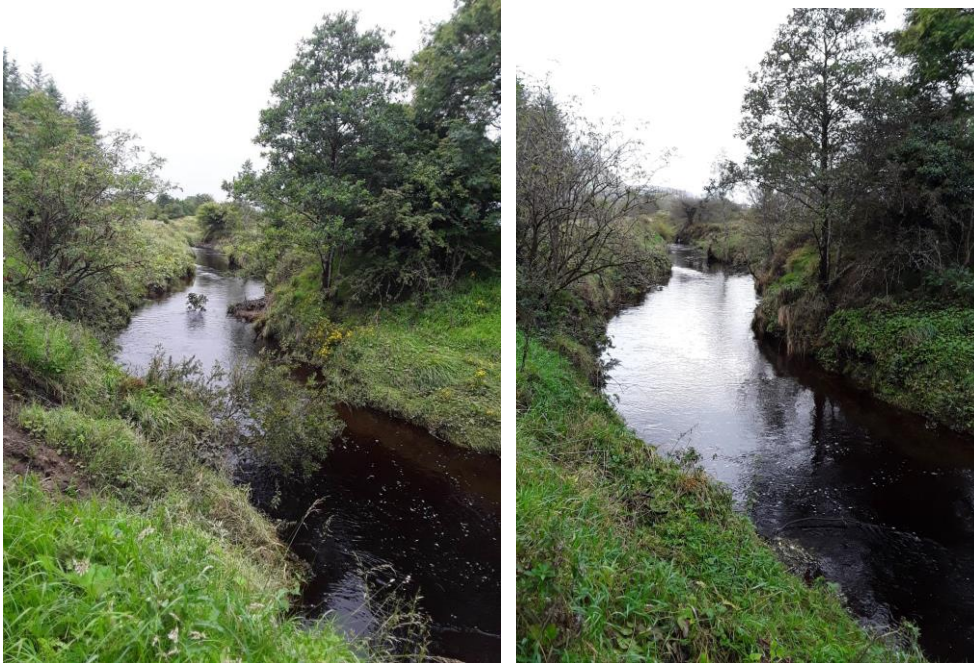
Figure 5.4 Example of the removal of minor and potential blockages (left, 2020 & right, 2021).

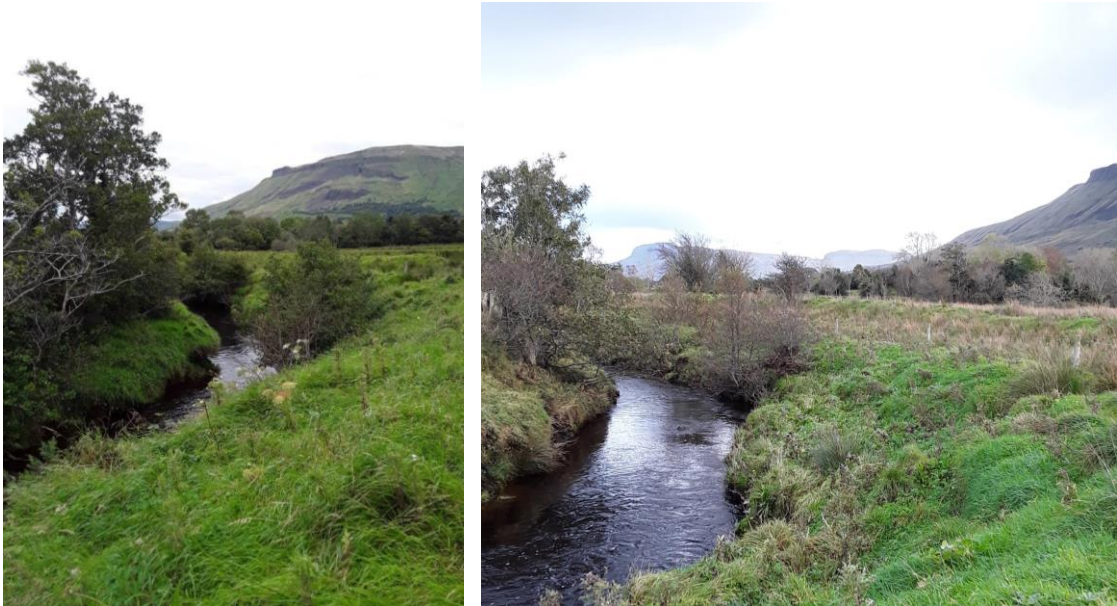
Figure 5.5 Example of a site where guidance was given to leave this section untouched (left, 2020 & right 2021).

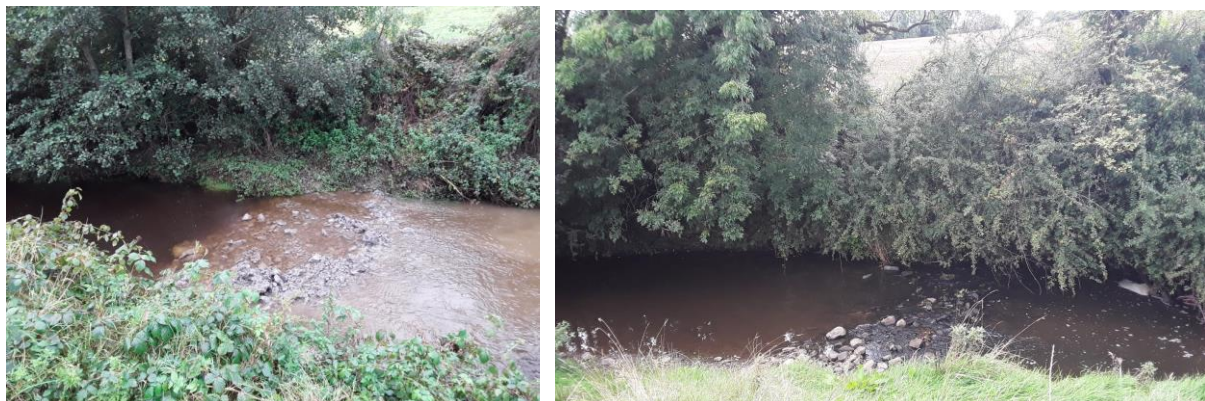
Figure 5.10 Left photo was taken post-works in 2019, and right photo was taken during a follow up walkover in 2021. It is evident that the pool and riffle remained intact.

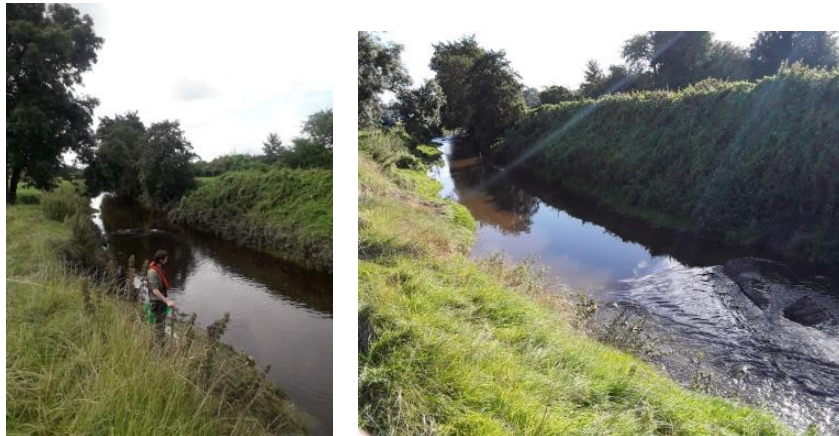
Figure 5.11 Left photo was taken pre-works showing a uniform glide and the photo on the right taken post-works. Changes in flows are evident following the introduction of paired deflectors which were created using the material from within the channel.

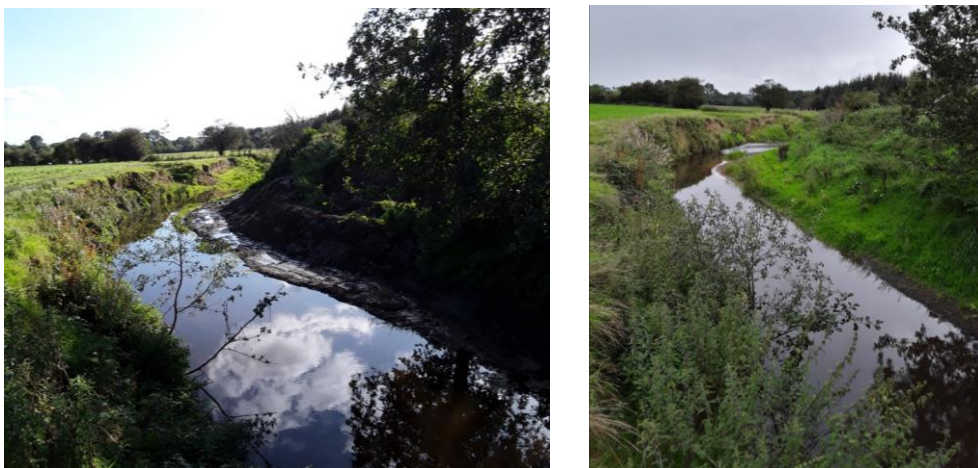
Figure 5.12 Left photo was taken post works of a berm topped during the works and the follow up photo on the right was taken in 2021.
