Havhingsten

Appendix I1 - Marine Survey Report - BU Port Erin to BMH Loughshinny

Havhingsten Subsea Cable Network

Volume - Segment 1-1 BU Port Erin to BMH Loughshinny

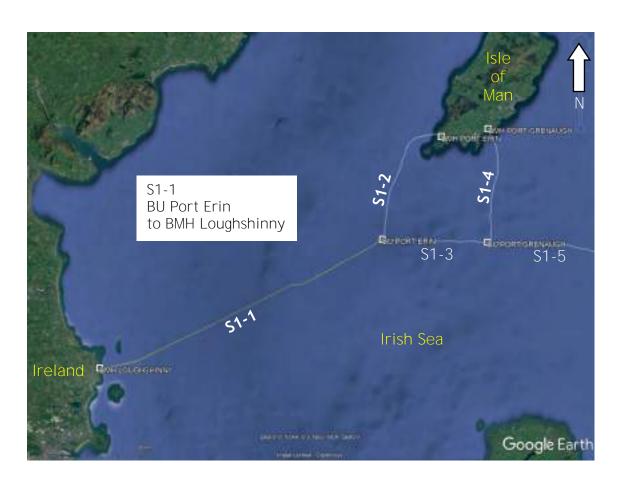
Figure 1.1: Havhingsten Subsea, Segment S1-1, BU Port Erin to BMH Loughshinny

This report presents the results obtained during the inshore and shallow water survey for Segment S1-1 of the Havhingsten Cable Route survey from BU Port Erin to BMH Loughshinny (Figure 1.1). There are no deep water parts along this segment.

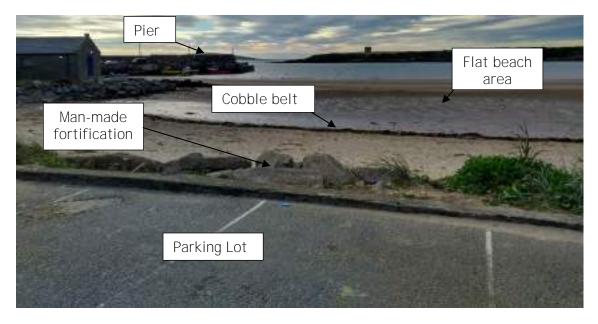
Figure 4.36: View from parking lot towards the south onto the shoreline depicting the flat beach area mostly covered by SAND and the COBBLE belt formed during high tides as well as man-made structures (Pier and man-made fortification).

The BMH is located at 53° 32.8293'N, 006° 04.8724'W (KP80.626) in the southeastern corner of the parking lot. The parking lot is easily accessible by following the Loughshinny Park Drive to the east until reaching the pier in the small harbor area (Figure 4.36 and Figure 4.37).

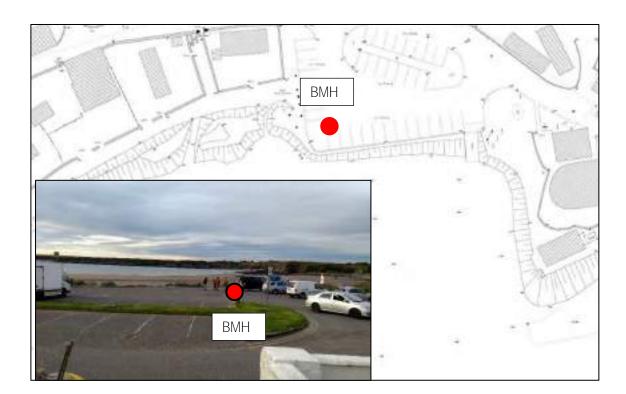
Figure 4.37: Land survey chart- illustrating the BMH position at the southwestern corner of the parking lot.

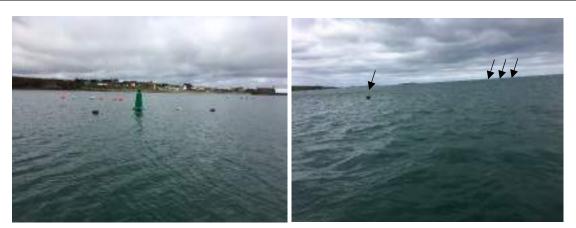
Figure 6.2: Fishing buoys off Loughshinny

The shelter offered by the pier in Loughshinny, hosts a small fleet of fishing boat (Figure 6.1). Visual observation of fishing buoys (Figure 6.2), gears and vessels have been reported during the inshore survey (Figure 6.3). Numerous trawl scars are evident at the seafloor in the MBES and SSS records (Chapter 4.2.5).

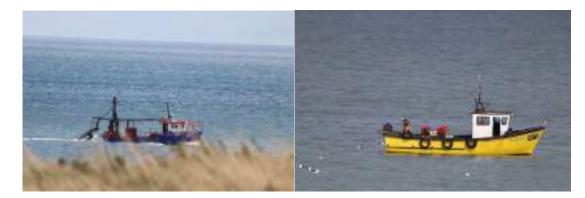
Figure 6.3: Fishing gears and boats (registration number DA116, left, and DK72, right,) in operation off Loughshinny

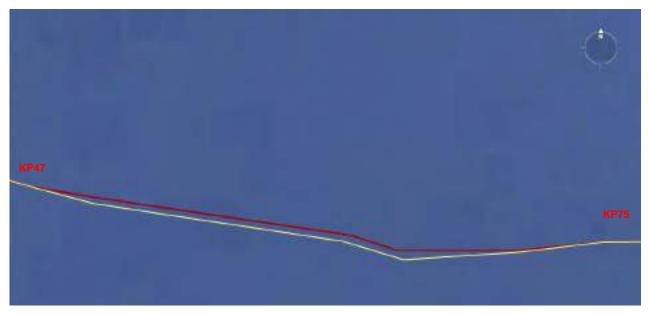
This document refers to the changes required along the approach to Blackpool in the UK EEZ between approximately KP47 and KP75.

Figure 1: Segment 1-5 route development proposal along BU Port Grenaugh to BMH Squires Gate Lane in red

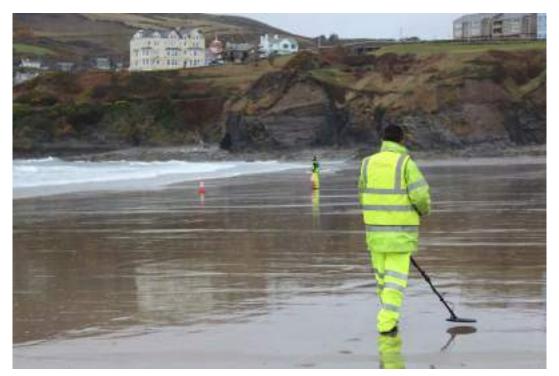
2.4. Hand-held metal detector and walkover surveys were conducted following 5m wide traverses to match those used for the geophysical survey. The metal detector was set to detect all metal, but the sensitivity was adjusted to compensate for the high salt content of the beach sand. All identified features and detected finds spots were recorded photographically with a brief description, if deemed necessary. Locations were recorded using a hand-held Garmin GPS and plotted into an AutoCAD base plan. As this survey was non-intrusive, no finds spots were excavated. A Minelab X-Terra 705 metal detector was used to conduct the surveys (Fig. 3).

Figure 3 Metal detecting on Port Erin beach

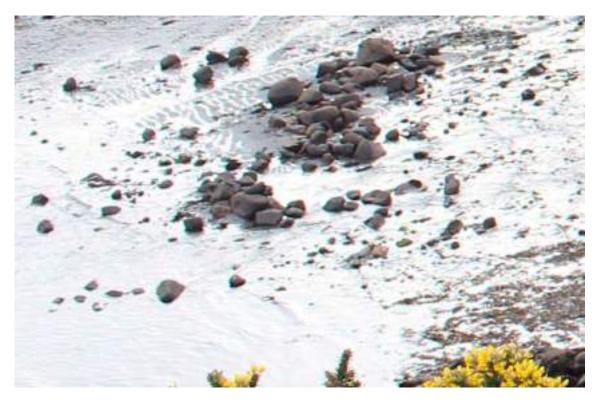
Figure 11 Boulders located in the lower intertidal zone at Port Grenaugh interpreted as a possible fishtrap or barrier to small vessels

- 3.5. One of the sites mentioned in the DBA (Cotswold Archaeology 2019), *Cronk ny Merriu*, a presumed Iron Age defended promontory, which was later built over by a Viking longhouse, was visited during the walkover (Fig. 10) and was confirmed to be well away from the study area. The possible remains of a fish trap, or a rudimentary barrier against small vessels was also inspected at low tide but the surviving remains (Fig. 11) are difficult to interpret with any certainty.

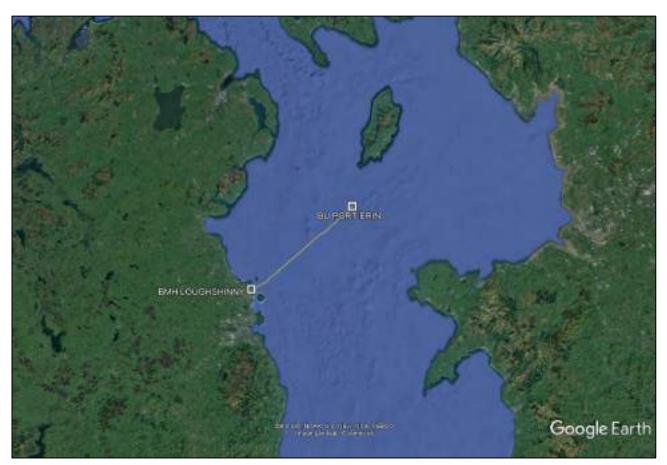
Figure 1-1: Location Map for the Havhingsten Segment S1-1

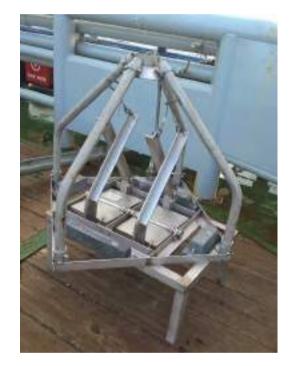
Seabed samples were acquired using a 0.1 m² dual van Veen grab (Figure 3.1).

Figure 3.1: Dual Van Veen grab (0.1 m²)

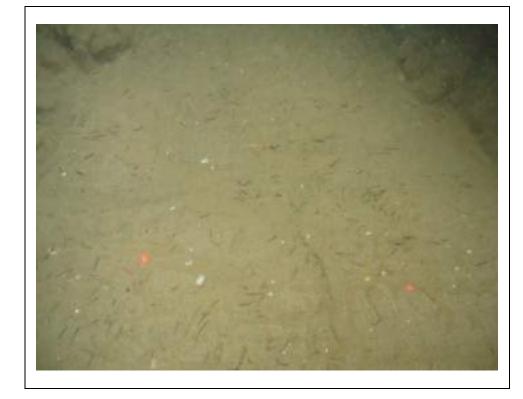
Photograph: CC05_TR01A_09

Easting: 347 121.7 mE Northing: 5 957 124.6 mN Depth: 83.0 m BSL

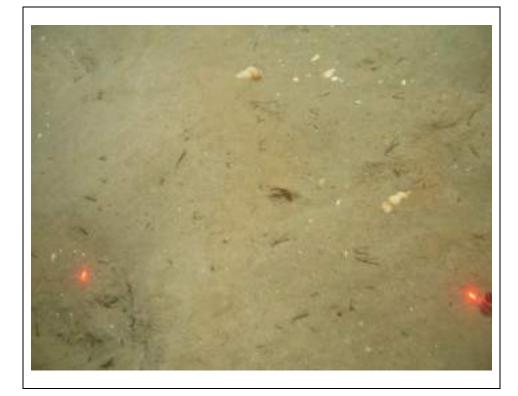
Photograph: CC05_ST01_07

Easting: 346 274.3 mE Northing: 5 957 560.0 mN Depth: 82.0 m BSL

Sediment Type: Mud with shell fragments

Fauna: Faunal turf and faunal tubes (Sabellidae)

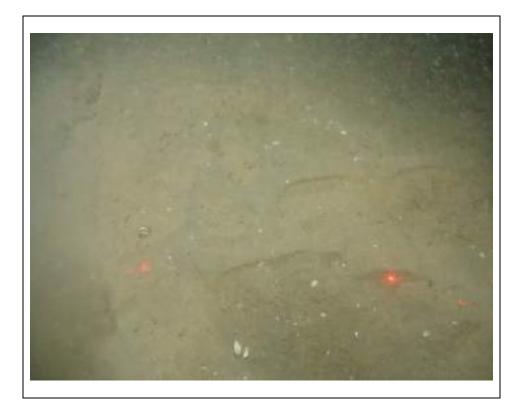
Photograph: CC05_ST01_19

Easting: 346 342.1 mE Northing: 5 957 552.1 mN Depth: 82.0 m BSL

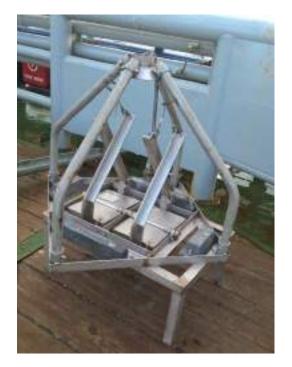
Seabed samples were acquired using a 0.1 m² dual van Veen grab (Figure B.1).

Figure B.1: Dual Van Veen grab (0.1 m²)

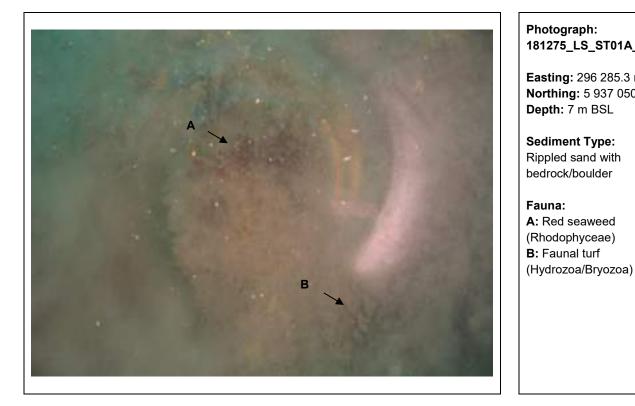
Photograph: 181275_LS_ST01A_04

Easting: 296 285.3 mE Northing: 5 937 050.9 mN Depth: 7 m BSL

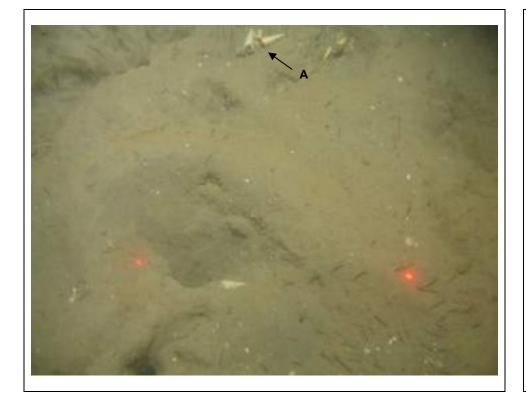
Photograph: CC05_TR02_22

Easting: 346 550.0 mE Northing: 5 957 509.7 mN Depth: 82.0 m BSL

A. Hermit crab (Paguridae) Faunal turf and faunal burrow

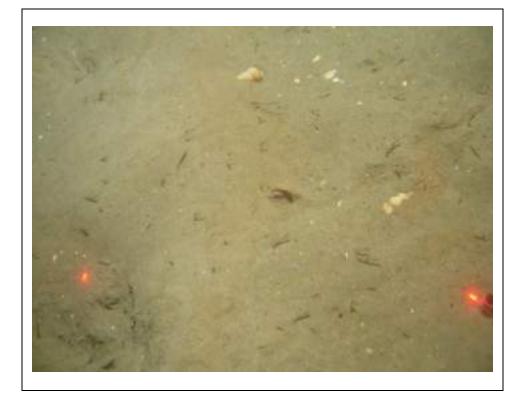
Photograph: CC05_ST01_07

Easting: 346 274.3 mE Northing: 5 957 560.0 mN Depth: 82.0 m BSL

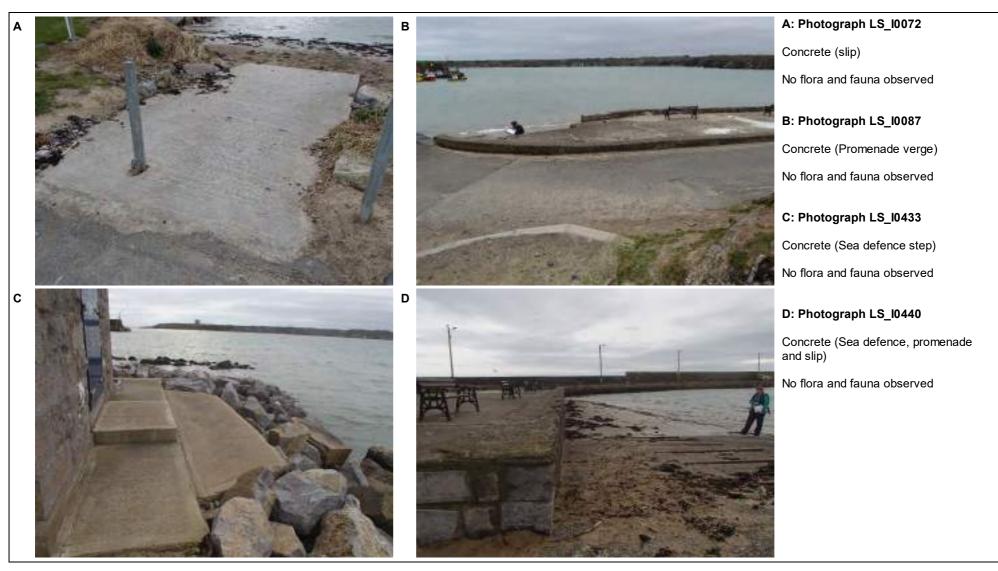
Figure 3.2: Example photographs of 'littoral rock (and other hard substrata)' (A1/LR), Havingsten cable route, Loughshinny

Figure 3.2 presents example photographs of this habitat, within the Loughshinny survey area.

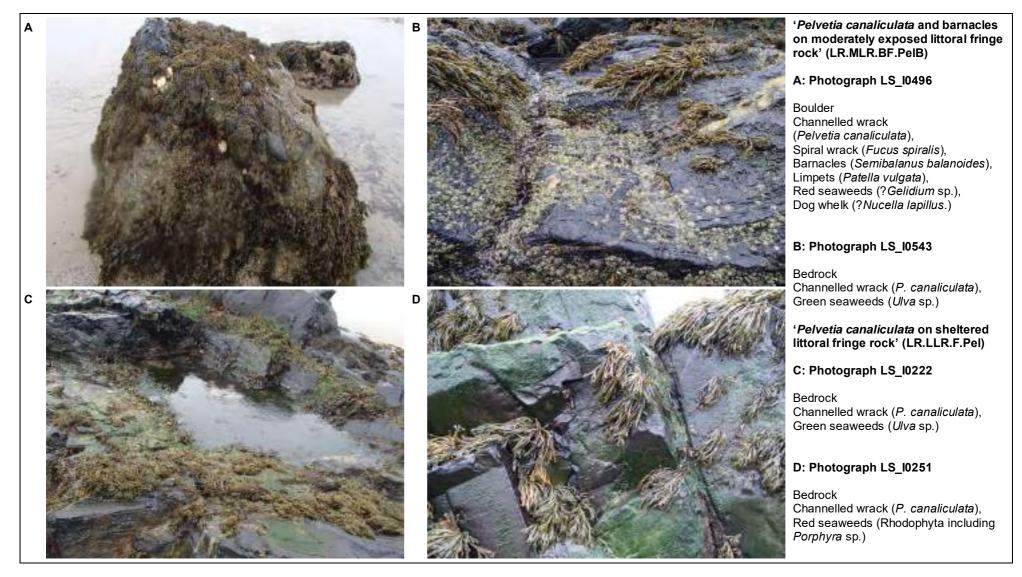
Figure 3.3: Example photographs of '*Pelvetia canaliculata* and barnacles on moderately exposed littoral fringe rock' (A1.211/LR.MLR.BF.PelB) and '*Pelvetia canaliculata* on sheltered littoral fringe rock' (A1.311/LR.LLR.F.Pel), Havingsten cable route, Loughshinny

Figure 3.3 presents example photographs of this habitat, within the Loughshinny survey area.

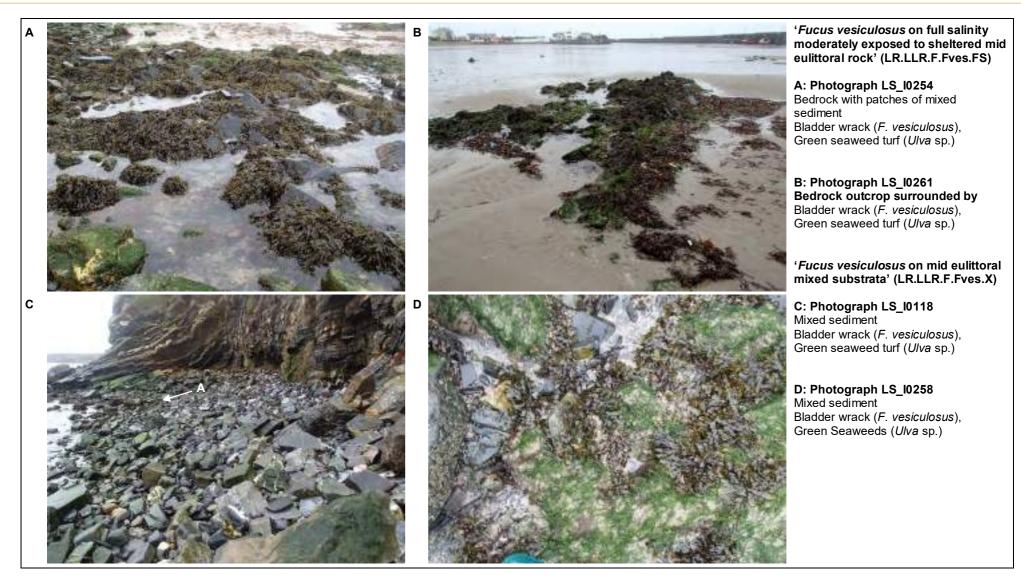
Figure 3.7: Example photographs of '*Fucus vesiculosus* on full salinity moderately exposed to sheltered mid eulittoral rock' (A1.3131/LR.LLR.F.Fves.FS) and '*Fucus vesiculosus* on mid eulittoral mixed substrata' (A.1.3132/LR.LLR.F.Fves.X), Havingsten cable route, Loughshinny

Within the Loughshinny survey area, this sub-biotope was observed on sheltered to mid eulittoral moderately exposed rock to the west of the survey area (Figure 3.1) and on the vertical surface of the pier. Some small areas (< 25 m^2) were recorded outwith the mapped area as target notes (Appendix B.2). This sub-biotope was dominated by the bladder wrack *F. vesiculosus*. The flora observed included the green seaweeds *Ulva* sp. and the red seaweeds *Porphyra* sp. The fauna observed included barnacles *S. balanoides*. Figure 3.7 presents example photographs of this habitat, within the Loughshinny survey area

Figure 3.7 presents example photographs of this habitat, within the Loughshinny survey area.

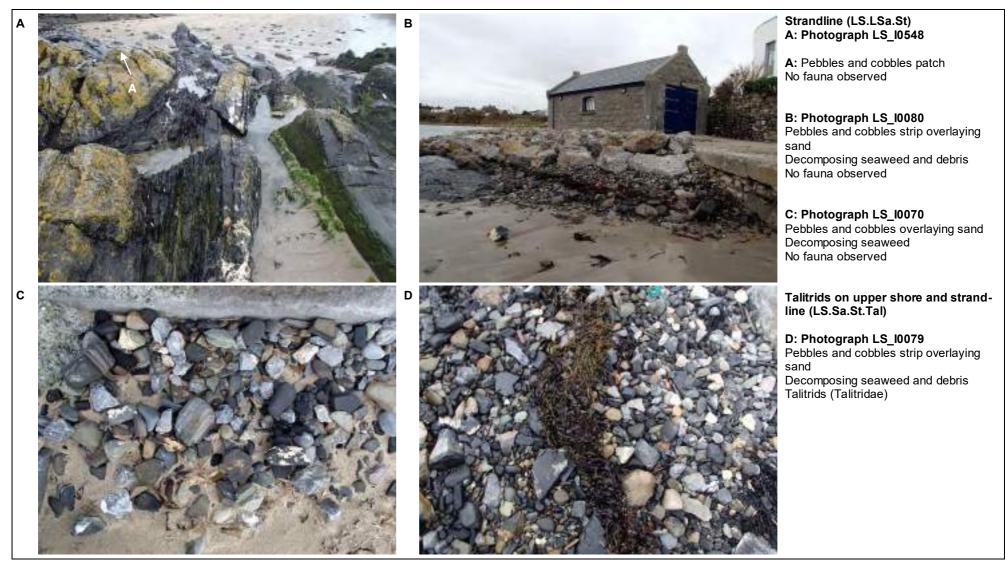
Figure 3.12: Example photographs of 'Strandline' (A2.21/LS.LSa.St) and 'Talitrids on upper shore and strand-line' (A2.211/LS.Sa.St.Tal), Havingsten cable route, Loughshinny

Figure 3.12a to 3.12c present example photographs of this habitat, within the Loughshinny survey area.

Figure 3.12d presents an example photograph of this habitat, within the Loughshinny survey area.

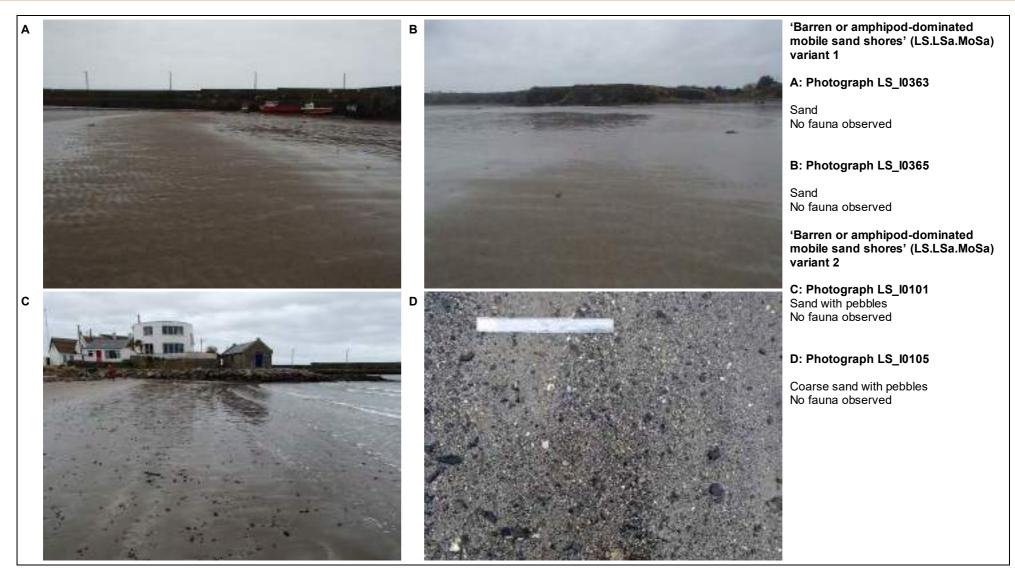
Figure 3.13: Example photographs of 'barren or amphipod-dominated mobile sand shores' (A.22/LS.LSa.MoSa), Havingsten cable route, Loughshinny

Figure 3.13 presents example photographs of both variants of this habitat, within the Loughshinny survey area.

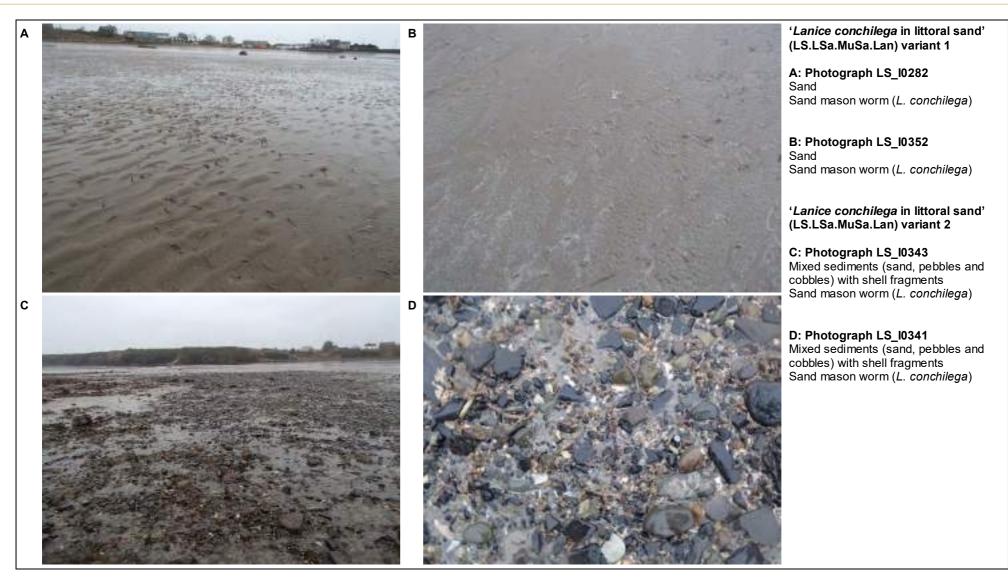
Figure 3.14: Example photographs of 'Lanice conchilega in littoral sand' (A2.245/LS.LSa.MuSa.Lan), Havingsten cable route, Loughshinny

Figure 3.14 presents example photographs of both variants of this habitat, within the Loughshinny survey area.

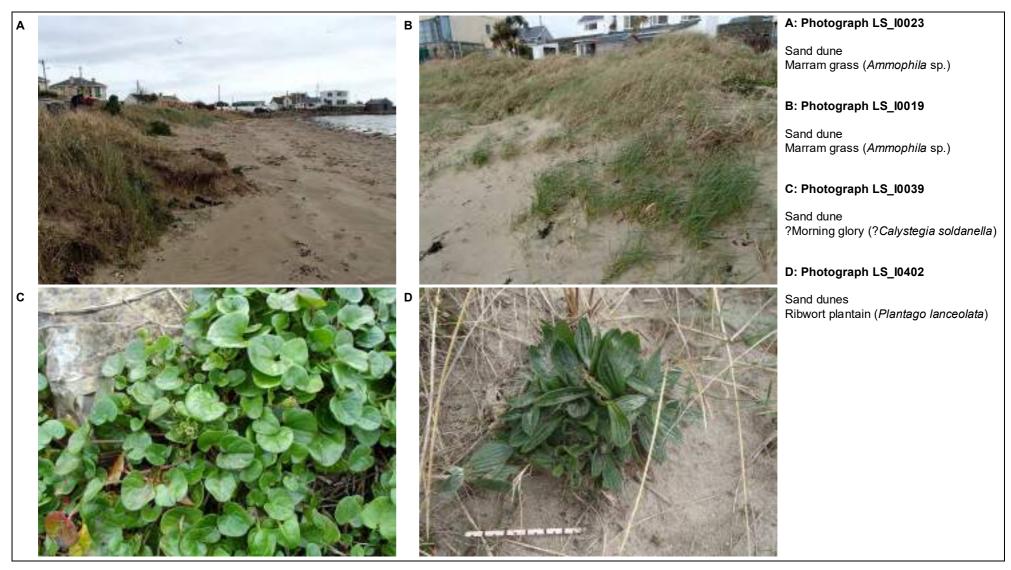
Figure 3.17: Example photographs of 'Atlantic white dunes' (B1.321), Havingsten cable route, Loughshinny

Figure 3.17 presents example photographs of this habitat, within the Loughshinny survey area.

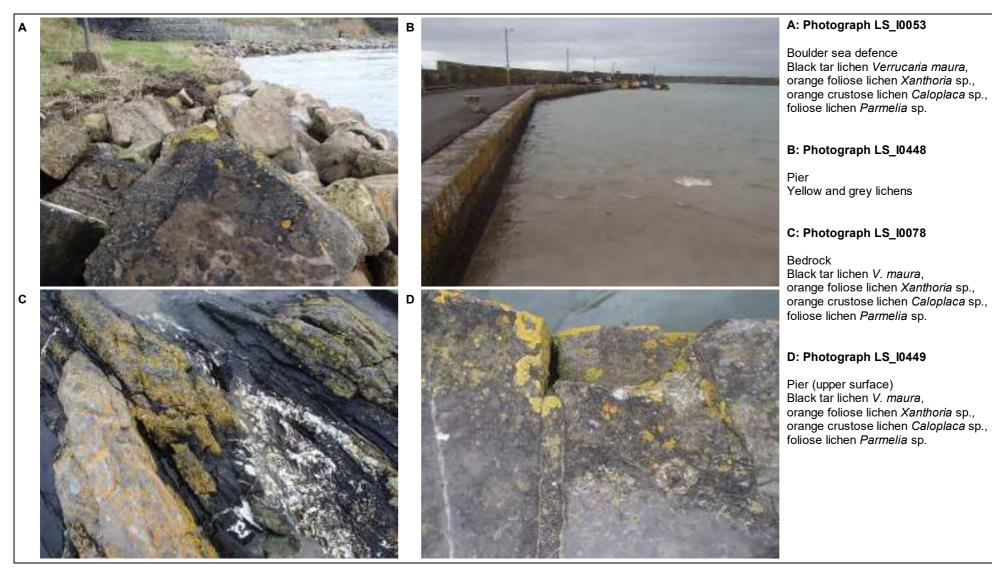
Figure 3.18: Example photographs of 'yellow and grey lichens on supralittoral rock' (B3.111/LR.FLR.Lic.YG), Havingsten cable route, Loughshinny

Figure 3.18 presents example photographs of this habitat, within the Loughshinny survey area.

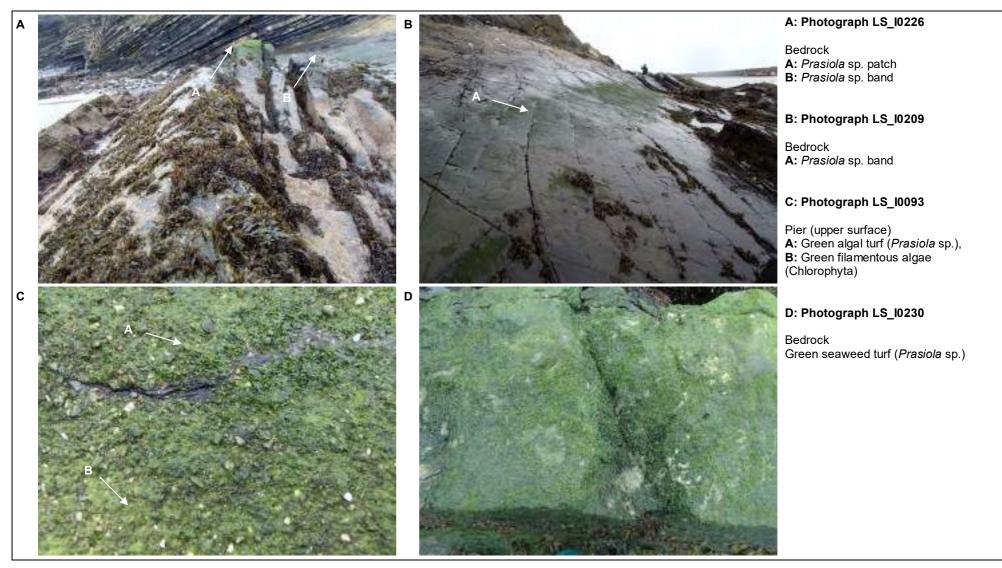
Figure 3.19: Example photographs of '*Prasiola stipitata* on nitrate-enriched supralittoral or littoral fringe rock' (B3.112/LR.FLR.Lic.Pra), Havingsten cable route, Loughshinny

Figure 3.19: presents example photographs of this habitat, within the Loughshinny survey area.
