GRIANÁN OF AILEACH
Co. DONEGAL

CONSERVATION MANAGEMENT PLAN

SEPTEMBER 2020

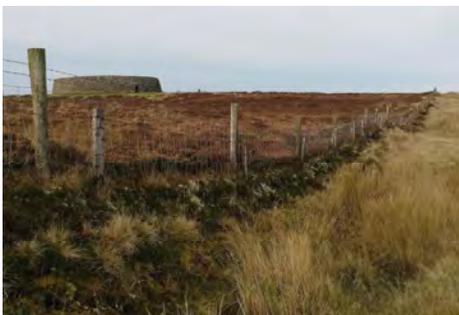
Figure 1.10 Eastern field boundary

Some remains of banks 3 and 4 may survive in the uneven ground beyond the eastern field boundary. This is particularly likely at northeast where a wire fence appears to run along the line of the banks. There are no visible traces of banks 3 and 4 in the reclaimed field beyond the western field boundary.

By the time the 25inch map was made in 1897-1913 (Figure 2.05) the Toulett / Carrowreagh boundary had been realigned. It now ran along the southern edge of the site, turned sharply north (Figure 1.10) and then west again to run towards the cashel just north of the doorway. The line of the boundary continues into the interior but the latter section – from a point outside the door – may never have been fenced. The field boundary currently defining the western perimeter of the site seems to be a relatively late addition – this is unfortunate as it truncates part of the hillfort. (Figures 1.11, 3.5). Traces of some of the removed boundaries can be identified on aerial photographs. (Figure 1.13). Interruptions in the earthen defenses may also mark their line.

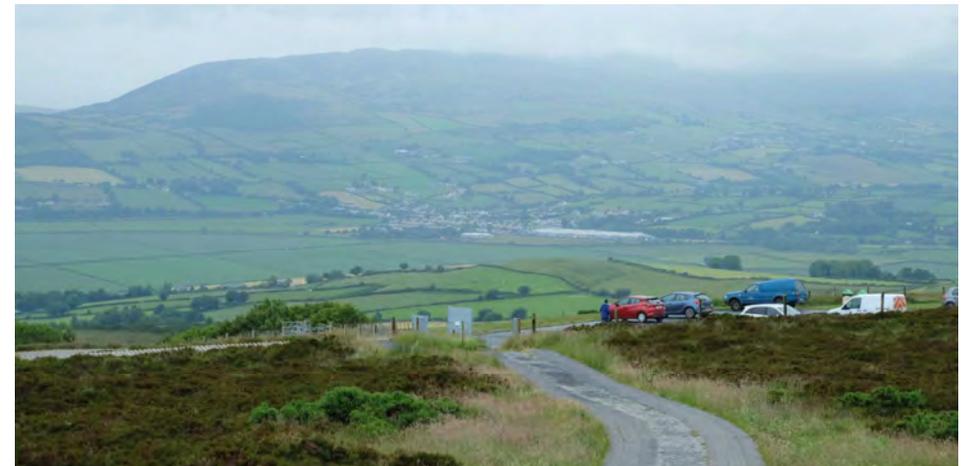
Figure I.15 Car park (to right) access path and universal access steps and ramp (to left)

The current surfaces of the path date from 2005. The path passes through the line of the outer and inner ramparts, but there is no indication of where this occurs. A timber ramped and stepped structure provides universal access up the steeper part of the route to the cashel. This feature was added in 2016.

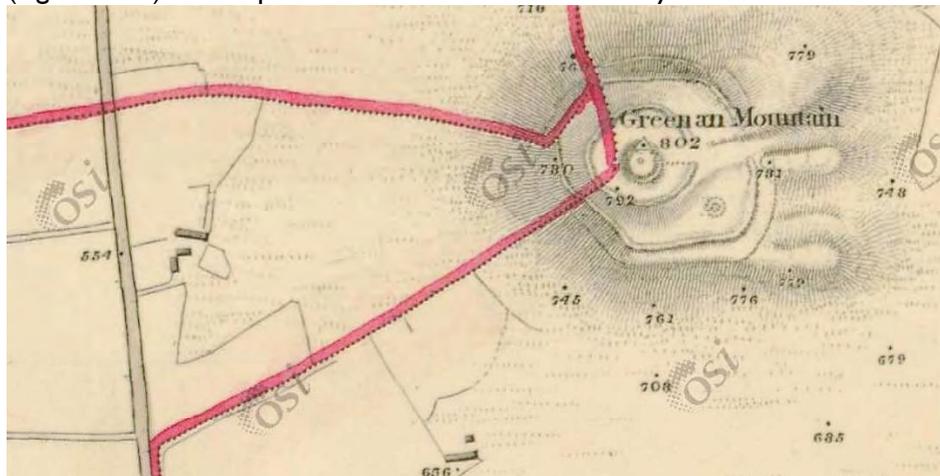
Figure 2.04 6" OS Map (1835)

The Ordnance Survey memoirs make no mention of any field boundaries abutting the monument but three are shown on the first edition OS six-inch map (1835). (Figure 2.04). All three are townland boundaries and are confined to the northwestern quadrant of the site. Two traverse the middle and outer defences and abut the western wall of the cashel; between them at the northwest a short stretch of the Toulett/ Speenogue boundary runs along the line of the outer rampart.

Grassland is also present on the lower slopes of the site and within the boundaries of the old field system (as shown on 6" maps from c.1840; see Figure 2.04). These old field boundaries are still present and while semi – improved grassland habitat dominates, scrub (VSI) has developed in places.

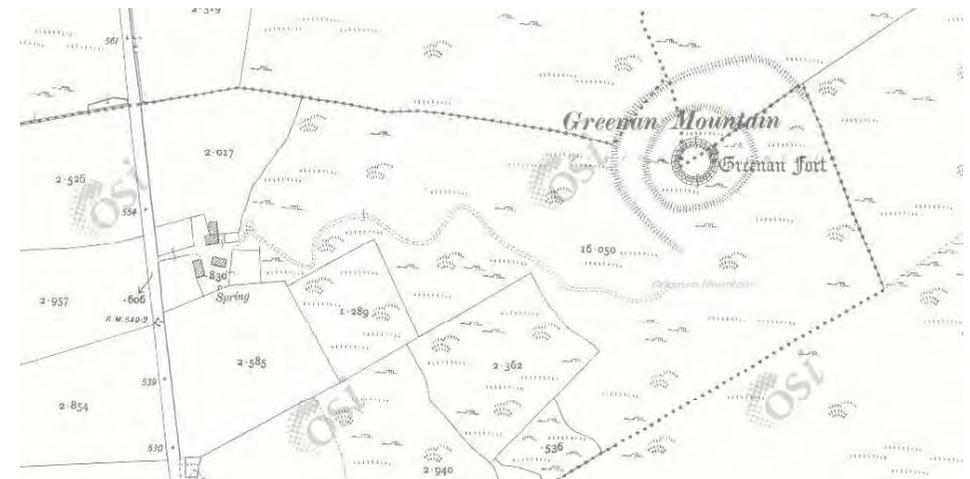
Figure 2.05 25" OS Map (1897-1913)

A curving track approaching the fort from the west may have been used by people coming from other directions. The track is shown on the OS 25-inch map (Figure 2.05) and on the second edition OS six-inch map. It ran uphill to within 50m of the holy well – the interval seems to have been open ground.

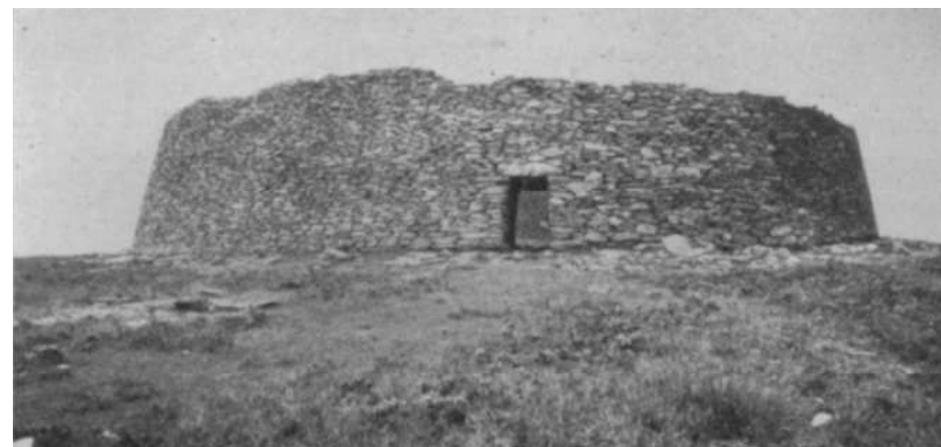
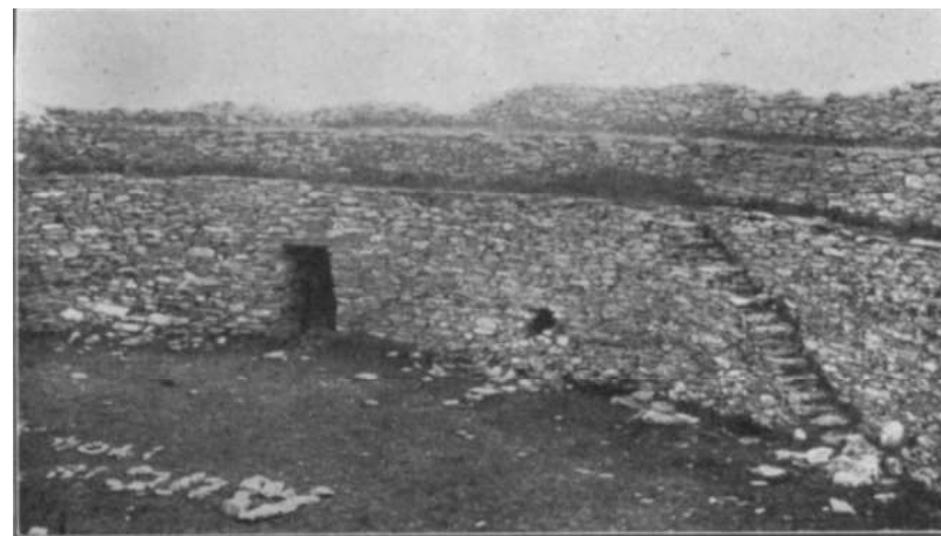
Figure 2.06 Photographs by Henry Crawford illustrating an account of an outing by the Royal Society of Antiquaries in 1915, but possibly taken around 1904. The pictures highlight the poor condition of the parapet.

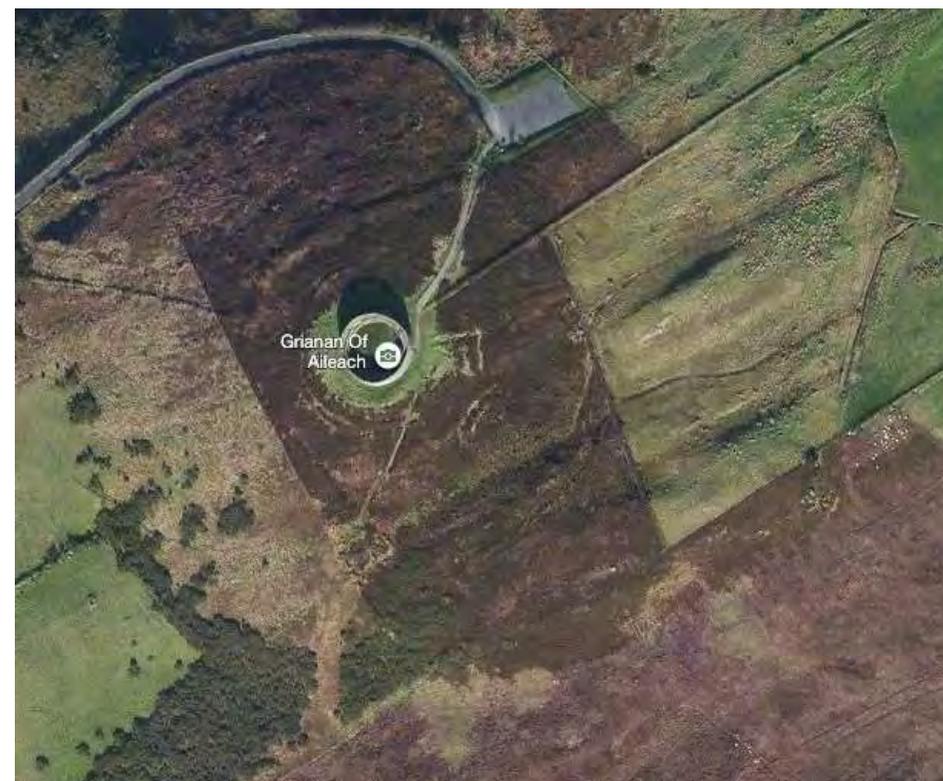
Figure 3.01 Aerial photograph with archaeological features highlighted (source Bing aerial)

Cashel	DG047-012001
Tumulus / Mound	DG047-012002
Holy well	DG047-012003
Ancient road	DG047-012004
Enclosure	DG047-012005
Penal mass station	DG047-012006

The line of the ancient road is generally assumed to follow the linear hollow defined by two natural rock ridges that run east-west close to the hill summit. The ridges are clearly visible in the cleared field to the east of the monument (Figure 3.01). They become less clear in the vicinity of the cashel and may have more or less petered out east of the cashel entrance. Bernard (1879) noted that the 'bare rock' in the interior of the cashel ran in a north-westerly direction.

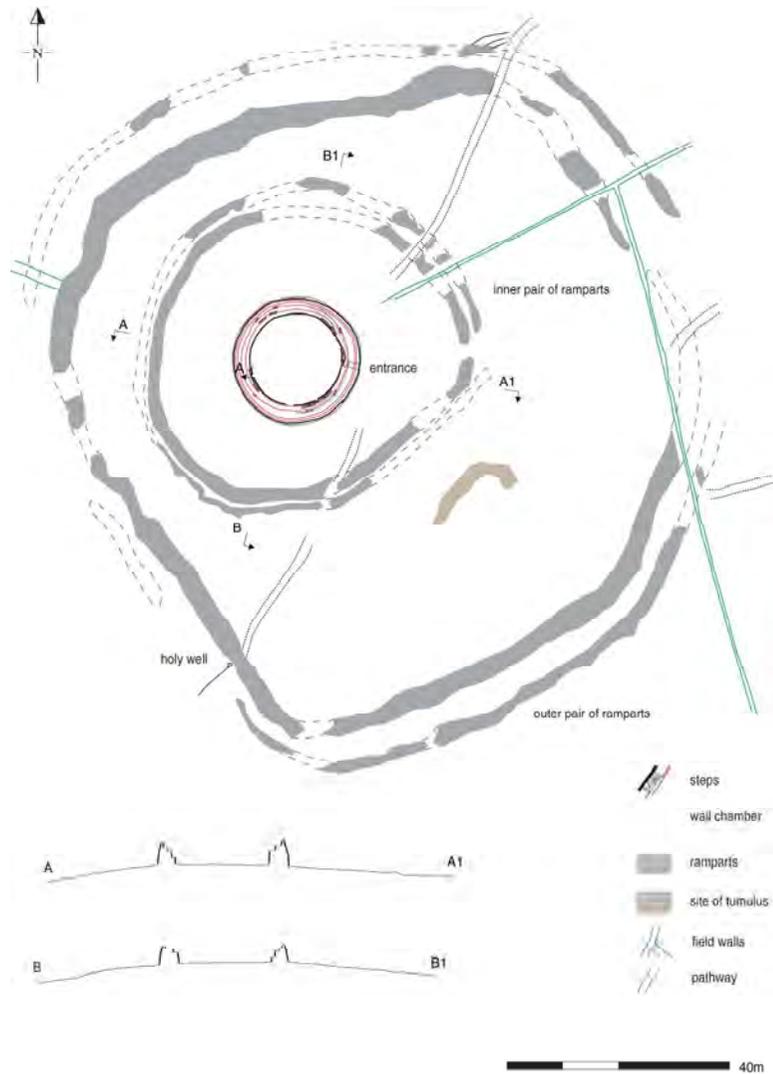
Figure 3.03 Topographical survey of the site 1996 carried out as part of The Discovery Programme's *Western Stone Forts Project*.

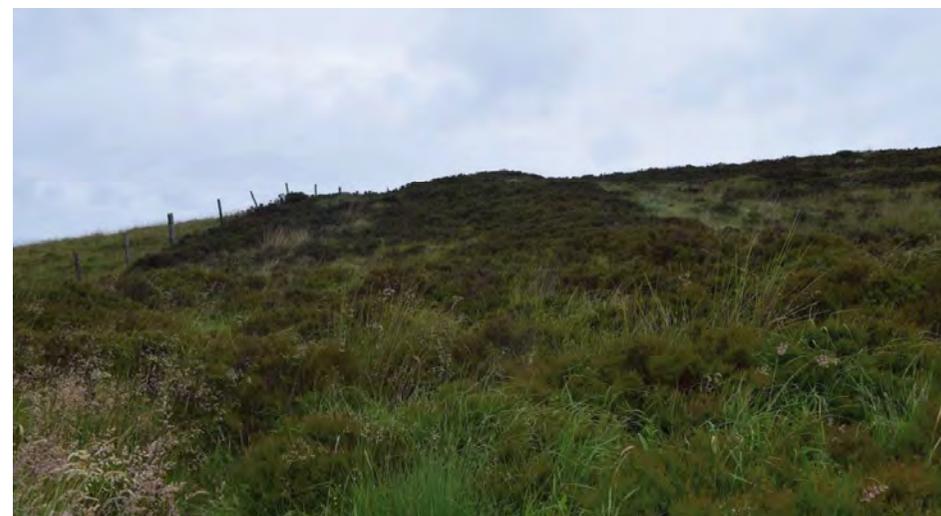
Figure 3.05 Western flanks of banks 3 and 4, looking northwest

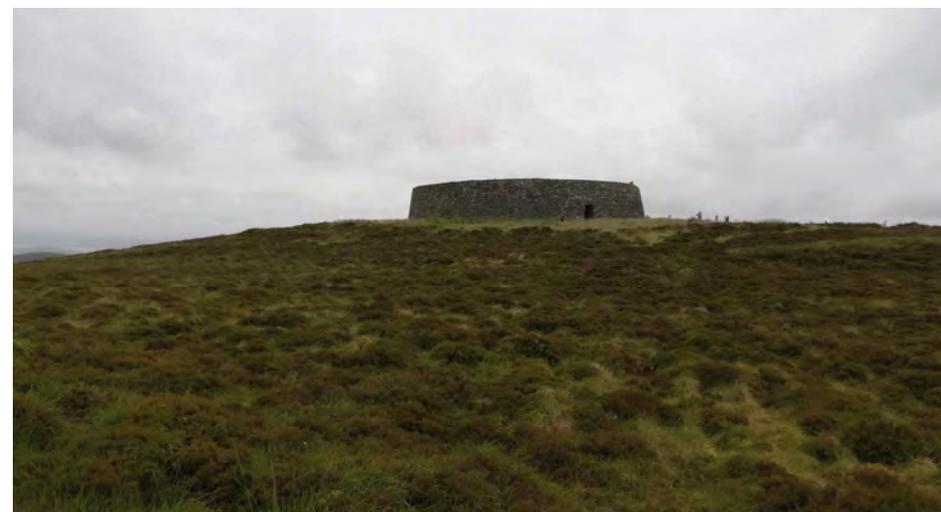
Figure 3.06 Viewed from the southeast, banks 1 & 2 are just discernible, on the skyline, enclosing the greensward that surrounds the cashel

Both sets of enclosing banks are now heather-covered and rarely survive above 0.60m in height. They are made up of stony clays and appear to be very eroded. Although some loose stone is visible on the summit of the outer banks at the southeast there is no definite evidence to suggest that any of the banks was ever stone-revetted.

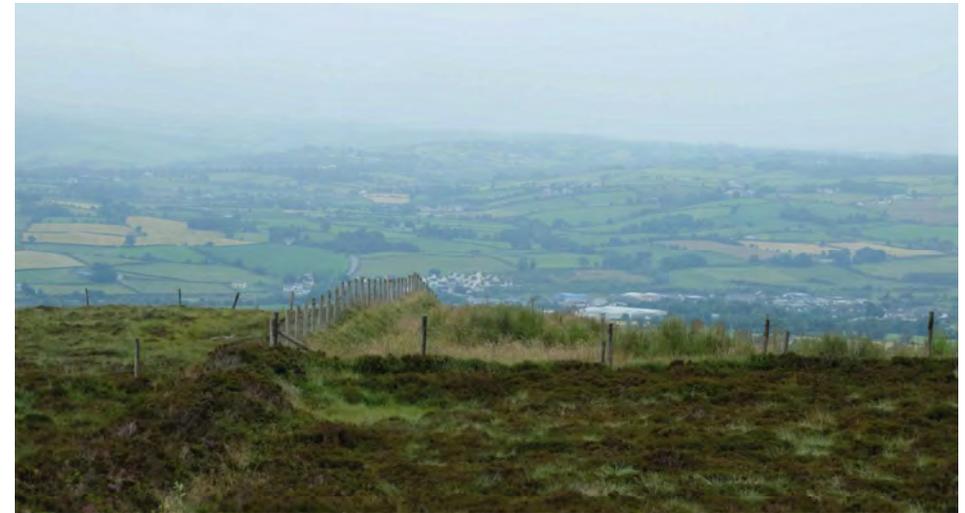
Figure 3.07 Field banks to the northwest cut directly into the outer banks

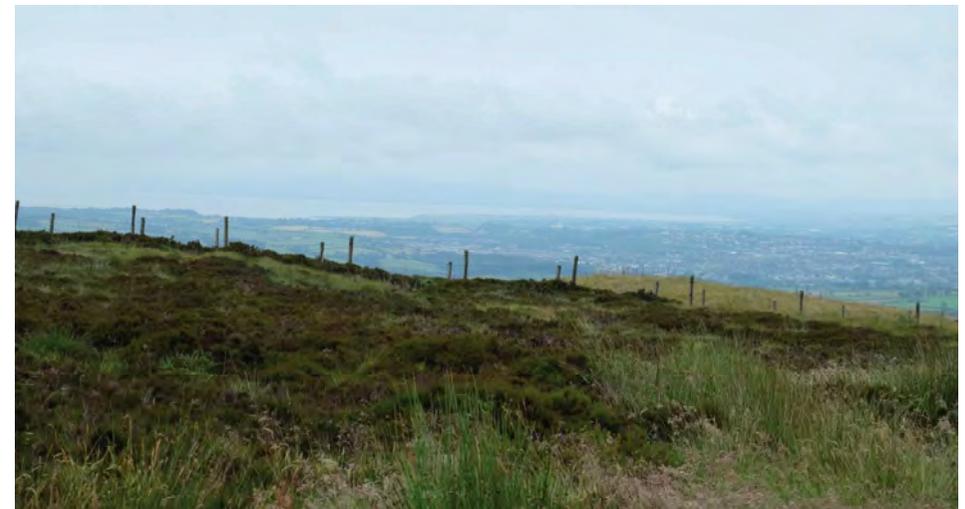
Figure 3.08 Field boundaries to the east cut off the outer flank of bank 4

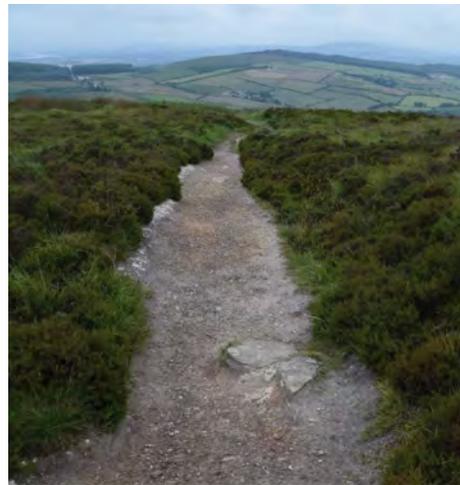
Figure 3.10 Eroded path leading from the cashel to the well in the interior of the hillfort

The northeast field boundary (a very prominent feature on the ground) cuts across the outer and middle defences. (Figure 3.08). On the south, the path to the holy well has truncated banks 1, 2 and 3. (Figure 3.10). Long sections of bank 2 are untraceable. Bank 1 is well-preserved along much of its circuit, the main exception being at north where there is now a large gap in the rampart.

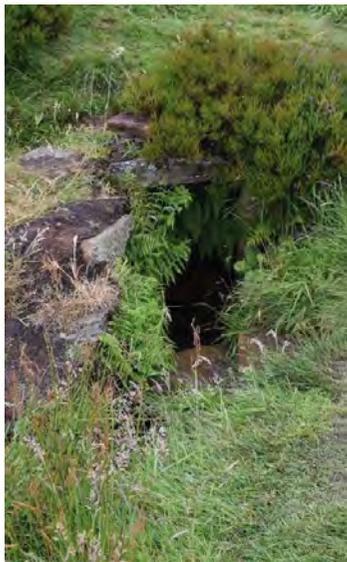
Figure 3.14 Holy Well

The spring well is located between banks 3 and 4 at the foot of a steep slope on the S face of the hill. It is traditionally known as St. Patrick's well. The well presents as a small pool, lintelled on the upslope side and with some flat slabs at ground level on the southern end (Figure 3.14); traces of collapsed stonework (probably of no great antiquity) are evident on the western edge. The well is accessed by an eroded pathway leading downslope from the cashel.

The spring well is an authentic feature, although most of the stonework visible there presently is of doubtful antiquity. The feature is marked 'well' on the OS plan of the site. The OS described it as a spring well 'which when discovered a few years back was covered with a large slab' (Colby 1837, 221). It is unclear how long the well was venerated as a holy well. Neither Col. Blacker, the OS or Walter Bernard referred to it as a holy well. O Muirgheasa (1936) recorded the tradition that Tobar Phadraig or St. Patrick's well had been neglected and forgotten until the nineteenth century, when it was discovered and opened with much religious ceremony by clergy from Derry. While the history of the holy well is somewhat obscure, it has certainly been a place of pilgrimage since the later nineteenth century and now forms an integral part of the monument complex.

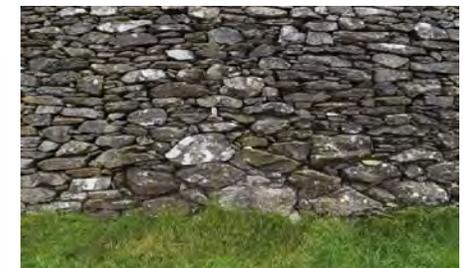
Figure 3.18b Dovetail jointing in the original masonry (lower 40cms) of the external wall face.

At most, only the lower 1- 1.50m or so of the cashel wall was upstanding when the OS recorded the site in the 1830s. Much of it had fallen to little more than 0.5m high when Bernard commenced his restoration work in the 1870s. Bernard marked the extent of the original masonry with a tar line. Apart from being noticeably more weathered and pressure-cracked, the original stonework is less regular than the repairwork (Figure 3.18). Flat-faced boulders (average size 0.55m long by 0.20m high but with examples up to 1.10m in length) were used and there was a marked preference for polyhedral shaped stones and dovetail jointing. The batter along the best-preserved original section appears to have been circa 1:10. The bottle-like profile of Bernard's reconstruction was either erroneously modelled on the slumped external face of the enclosing wall at Staigue fort, or it may be due to subsidence of the soft core that he used in the rebuild.

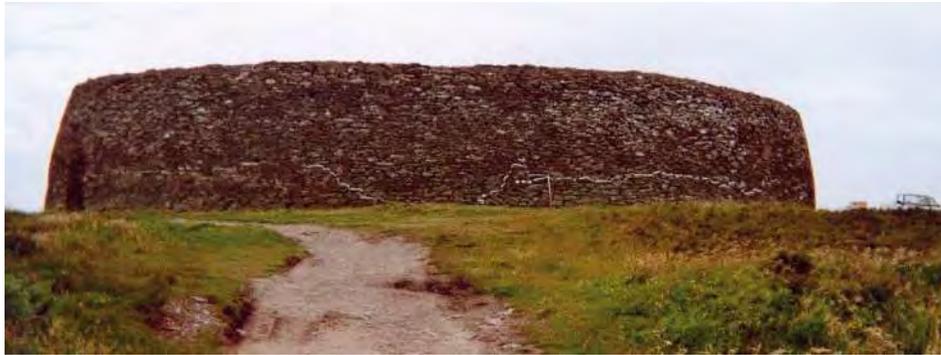
Figure 3.19 Photo of N elevation; the white line marks the surviving extent of the original stonework (Moore 2008, Plate 3). Walter Bernard used a tar line to record how much of the original was still standing in 1874.

A detailed survey of the stonework of the cashel was undertaken by Declan Moore (Moore 2007) in advance of the major programme of works carried out by the OPW between 2003 and 2007. The survey mapped the surviving traces of Bernard's tar line – on the exterior this was evident on the northern elevation only (Figure 3.19). The southern facade, or parts of it at any rate, may have been largely reduced to foundations by 1874 - later episodes of collapse and repair could also have removed traces of the tar line. In Moore's study, the presence of lichen, and contrasts in masonry styles, were also used to differentiate between old and new work. Large sections of the wall were dismantled and rebuilt between 2003 and 2007. Examination of the wall core material confirmed that very little of the original wall was upstanding when Bernard commenced his work. (Figure 3.20).

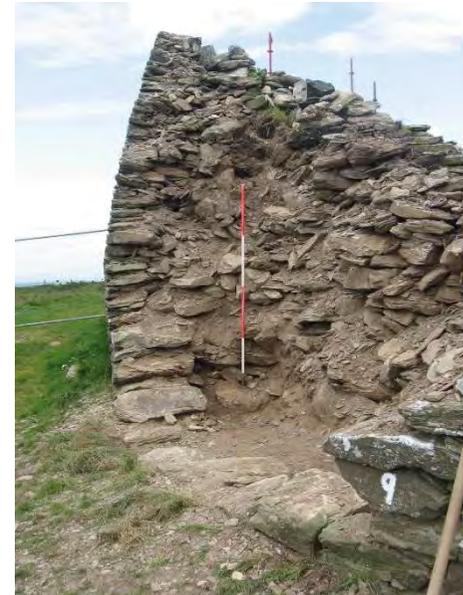
Figure 3.20 Dismantled section of north elevation of cashel wall showing loose core made up of small stones and clay (Moore 2008, Pl. 15)

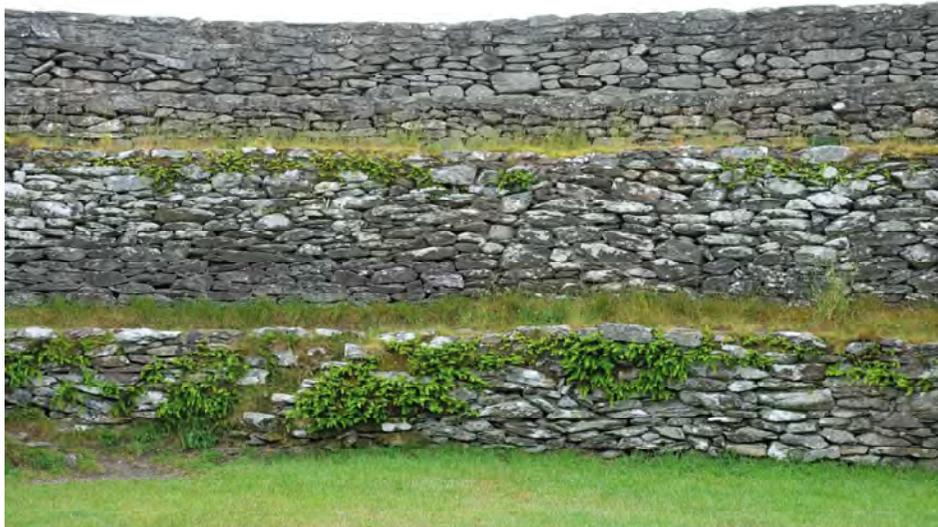
The reconstructed terraces and steps are in good condition

Figure 3.21 Steps and Terraces

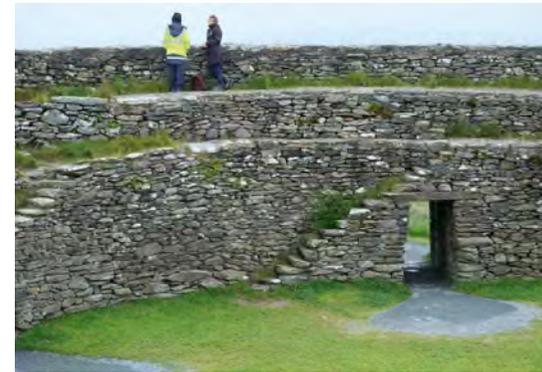
Figure 3.22 Unlikely steps over the doorway

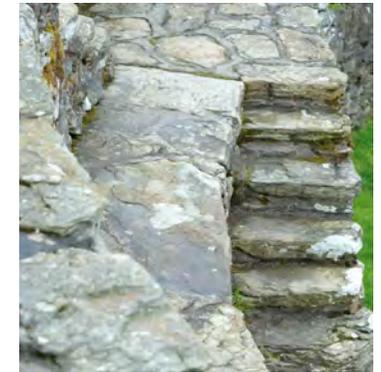
Figure 3.23 Cemented flags

OPW records show that the steps and terraces were rebuilt or repaired on many occasions in the twentieth and twenty-first century. Vandalism at the site in 1972 resulted in most of the steps being pulled down (OPW record 20191004143133). The flagstones surfacing the terraces were concreted in position in the late twentieth century. (Figure 3.22)

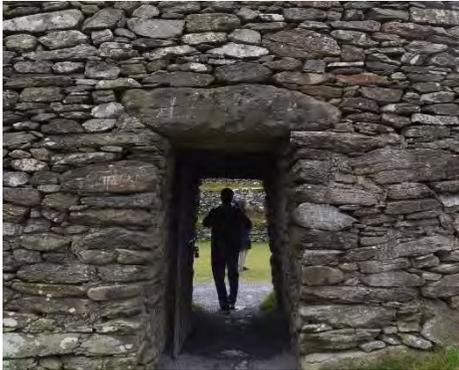
Figure 3.24 External view of cashel entrance

The present dimensions of the doorway tally with those of the 1870s reconstruction and with the restoration suggested in the OS memoir. The absence of a splay is unusual. Cashel entrances typically widen to the interior - this allowed more light to penetrate the passage and made operating the door easier.

The stonework surrounding the door (internally and externally) was entirely rebuilt by Bernard (Figure 3.26b) and was also dismantled and rebuilt during the 2003 – 2007 programme of repairs. The roof lintels have been replaced at least on one occasion in the twentieth century (OPW records); the ingoings of the doorway have also been extensively rebuilt. The innermost lintel also seems to have been replaced – an undated photo in the OPW records shows it graffitied with the name 'Jehovah Shannan'.

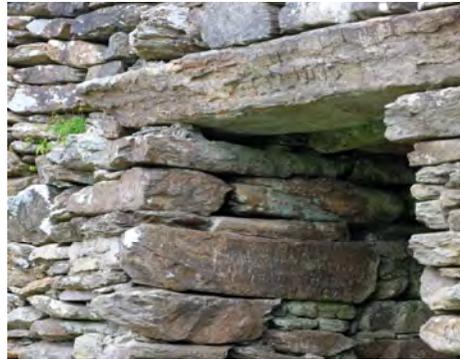
Figure 3.25 Graffiti on internal lintel

The repaired entrance is in good condition but marred by the prominent and unsightly graffiti on the lintels (Figure 3.25).

The most apparent graffiti is on the lintel over the entrance. (Figure 3.24). Carved, this can only have been created when there were no other visitors or supervisors present. There have also been instances of painted graffiti: easier to achieve in a brief, unobserved moment.

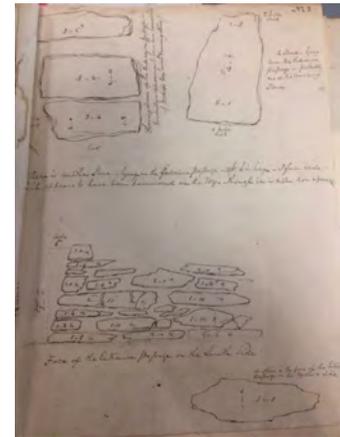
Figure 3.26a Lintel stones (top) and the S side of the entrance sketched by Du Noyer in the 1830s (OS archives).

The entrance to the cashel survived to a height of 4 foot (1.2m) in the 1830s; the lintelled roof had collapsed, but, at least one of the lintels lay on the ground where it had fallen (Figure 3.25a). Scale drawings, sketches of the masonry and a suggested reconstruction were all included in the OS memoir (Colby 1837). The condition of the door had deteriorated significantly by the 1870s. No details were given by Bernard but the tar line he used to demarcate the original stonework suggests the ingoings of the doorway stood to a height of around 0.4m (Moore 2007, Pl. 2).

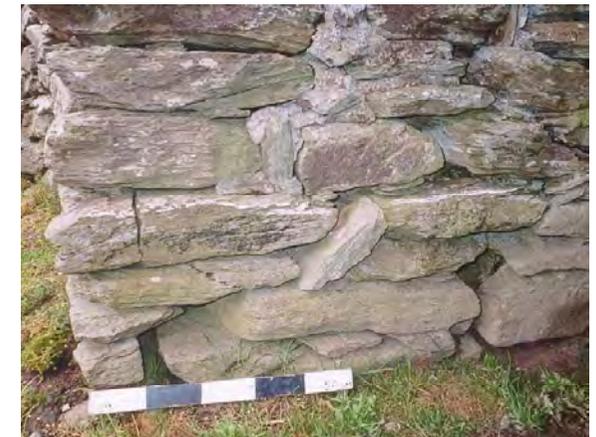
Figure 3.26b Surviving traces of Bernard's tar line on the northern ingoing (Moore 2008, plate 2).

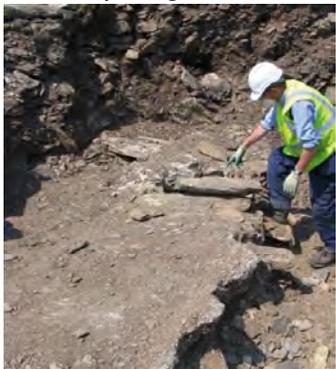
Figure 3.27 Cement slab overlying the N intramural passageway; photo taken in 2006 during a major programme of repairwork by the OPW (Moore 2008, pl. 7)

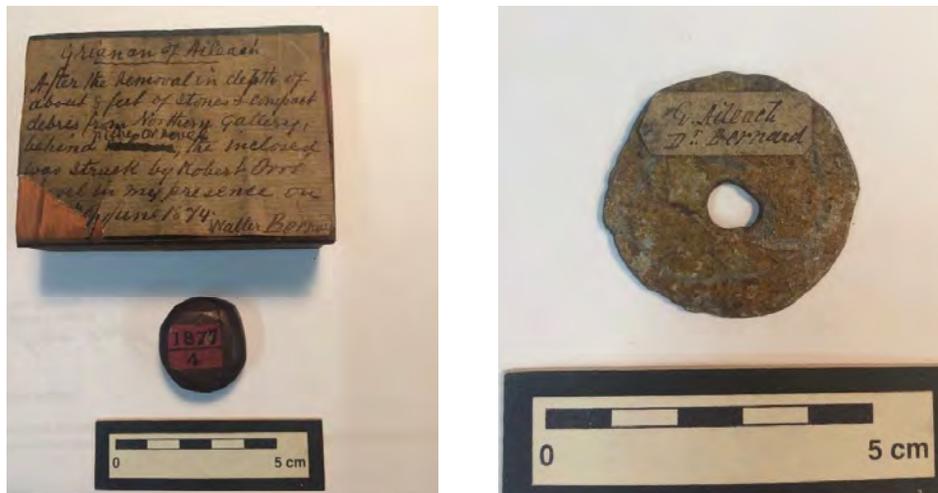
Figure 3.28 Left, polished stone gaming counter (1877:4.1) and (left) small perforated disc, possibly also a gaming piece or token (1877:4.2), from Grianán Aileach. Collection of the National Museum of Ireland.

Ten lithic items from Grianán have been identified in the National Museum of Ireland collection. Most are stone discs probably used either as gaming pieces and tokens (Figure 3.28) or pot covers. Two heavier disc-like stones may be weights. Most of the items are roughly made – it is easy to imagine them being fashioned and used by a garrison guarding the fort.

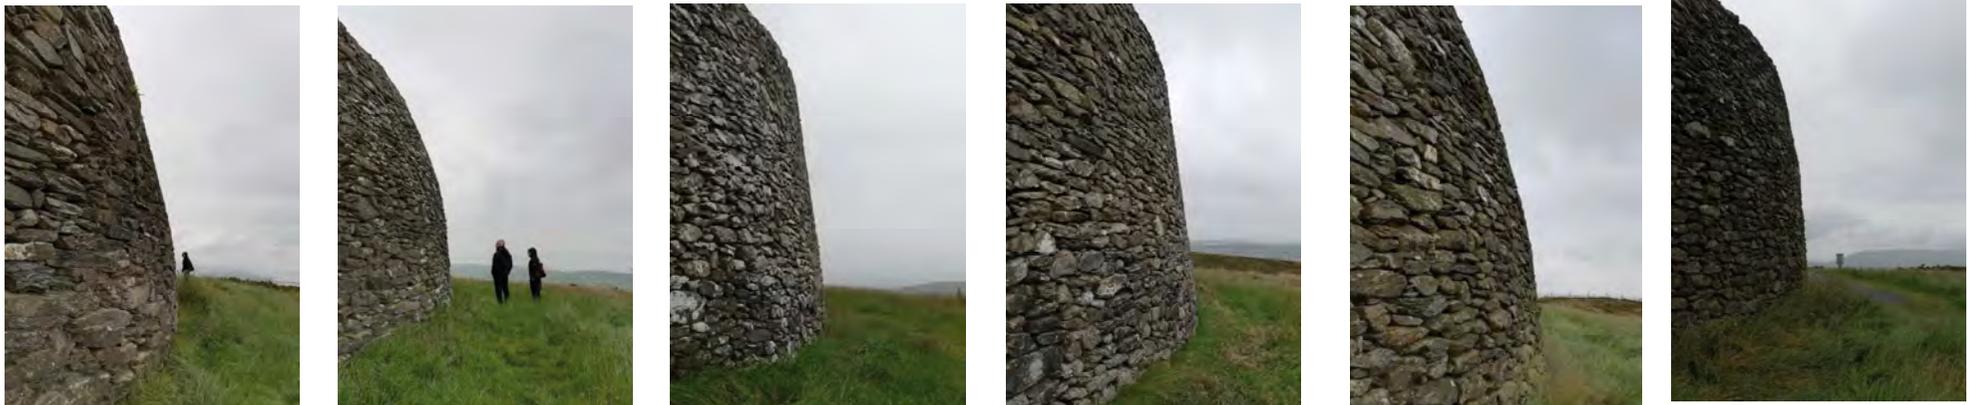
Figure 3.29 Photographs showing the variation in the batter of the cashel wall. This may result from both settlement of the wall core and varying interpretations of the original form of the wall.

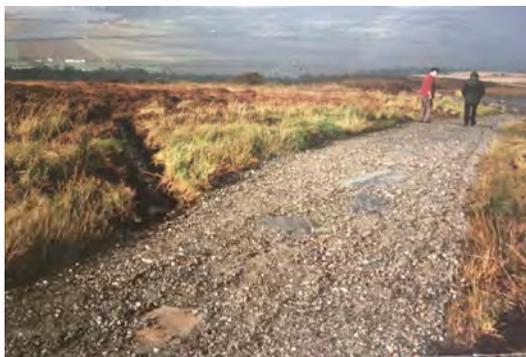
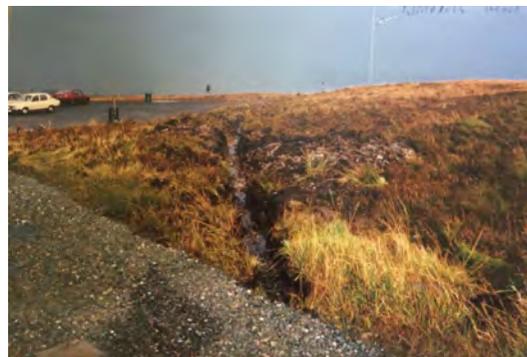
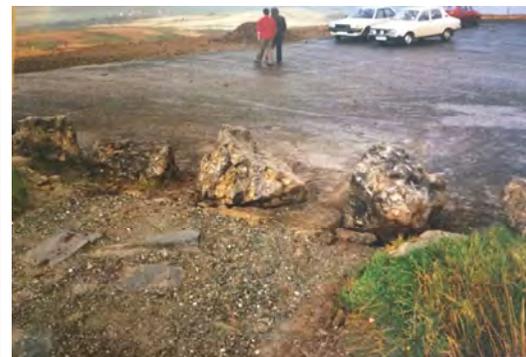
Figures 3.30-3.32

Photos from National Monuments File (DG047-) showing work on the access road from the car park to the cashel in the late 1980s. From L-R drain running NW from road; drain running NE; the junction of access road and car park. The drain cut through the outer pair of ramparts and 'minor damage' was noted on file.

The best-preserved section of the outer defences is at southeast, where banks 3 northeast (in the rough land adjoining the south side of the car park). Further north, they have been truncated by the entrance pathway and an associated drain (Figures 3.30, 3.31) – the entrance path also cuts through banks 1 and 2. (Figure 3.03).

The entrance path has been modified on a few occasions. In the late 1980s the original path was widened / extended, and an associated drain cut through the outer pair of ramparts; 'minor damage' was noted on photos included in SMR file. (Figures 3.31 - 3.33).

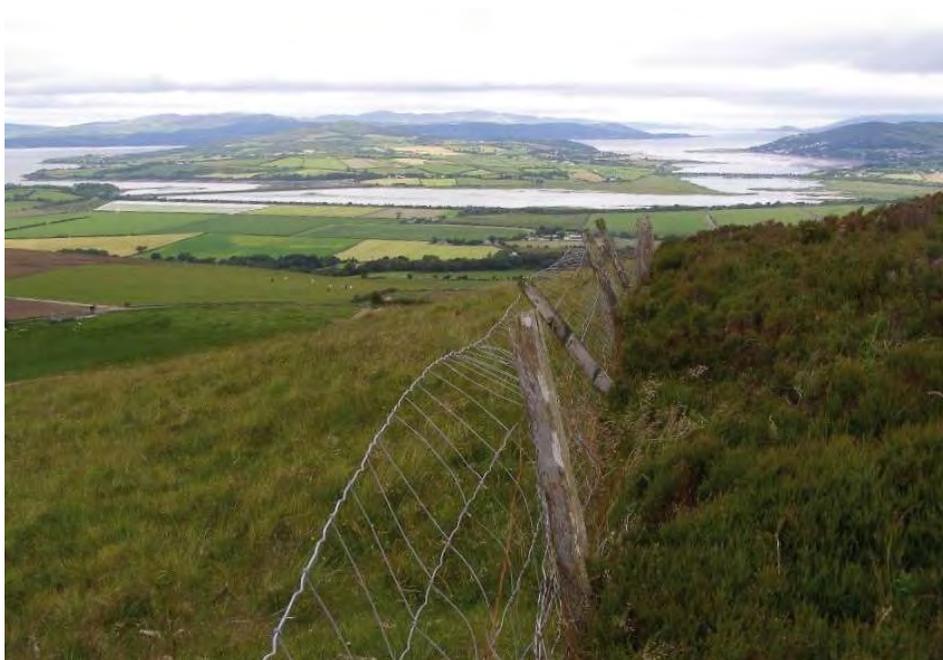
4.06 Habitat change evident on the land surrounding the An Grianan site (grazing replacing heath habitat with grassland).

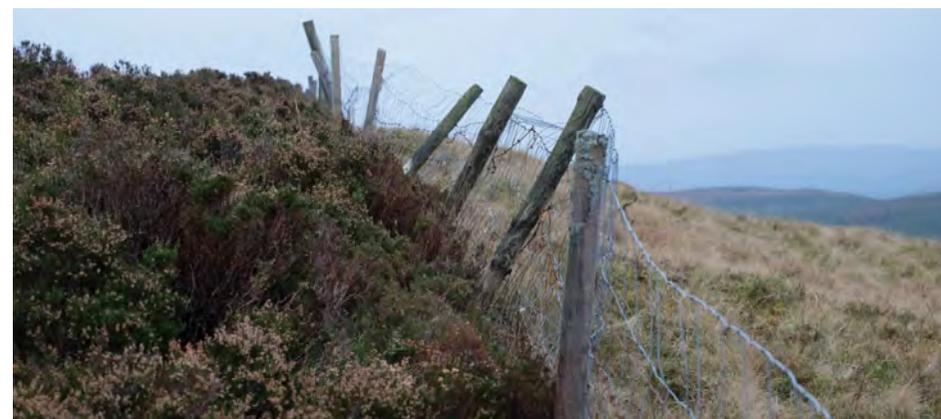
6.03 Field fence enclosing the site to the west. This relatively recent boundary is defined by the change in vegetation, more stringly than by the fence enclosure. There is no fieldbank here

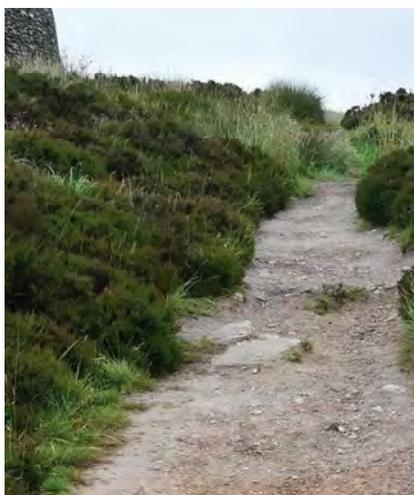
7.02 Path to the well: impact on habitats and presentation

The only constructed paths, at the Grianán of Aileach, are the timber and gravel path that leads from the car park directly to the cashel, (Figure 7.03) and the ramped timber boardwalk / step structure, installed to provide universal access. A further eroded path leads, from the greensward that surrounds the cashel, through the heath and ramparts, to the well. (Figure 7.02). There is nothing to prevent people wandering elsewhere in the site, but the rough going, arising from the wet heath habitat, makes this difficult, and unattractive to all but the more fit, inquisitive or adventurous.

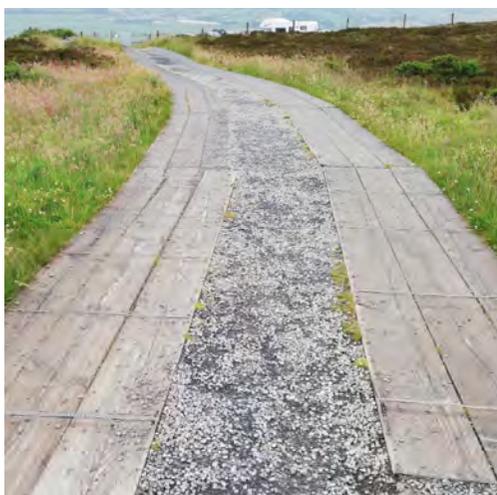
7.03 Main access path: impact on habitats and visual presentation

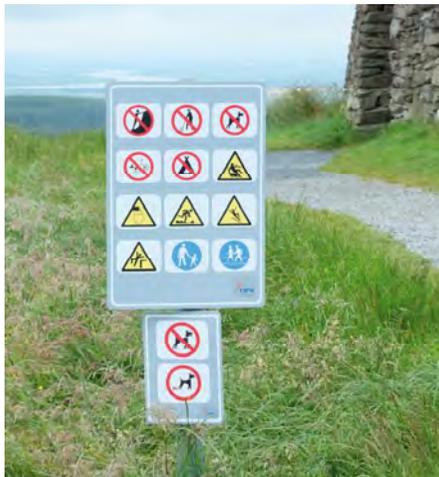
7.06 Warning signage outside the cashel

Visitors enter the site, and explore the cashel, at their own risk. The hazards that visitors are to be aware of are summarised in pictogram signs, located both at the entrance to the site from the car park, and adjacent to the entrance to the cashel. Access for security vehicles to the site is through the gate at the bottom of the path, and is controlled by the OPW / Emergency services. There is no control over the number of people entering the site, except for that arising from the limited capacity of the car park.

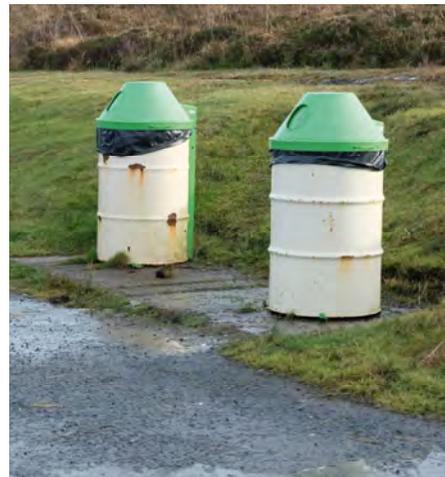
7.07 Litter Bins

The only visitor facilities provided at the site are litter bins. These are emptied by Donegal County Council. The waste bins have lids which are important in order to prevent waste blowing around the site and to avoid attracting vermin and corvids. However, if the bins fill up, people may leave additional waste beside the bins. While on site for the habitat survey, a group of hooded crows were observed, that had raided a nest (most likely meadow pipit) and were fighting over the remains of a young bird. Given the limited amount of wet heath habitat on the mountain it would be good to protect what is left and not encourage any predators which may be attracted by waste.

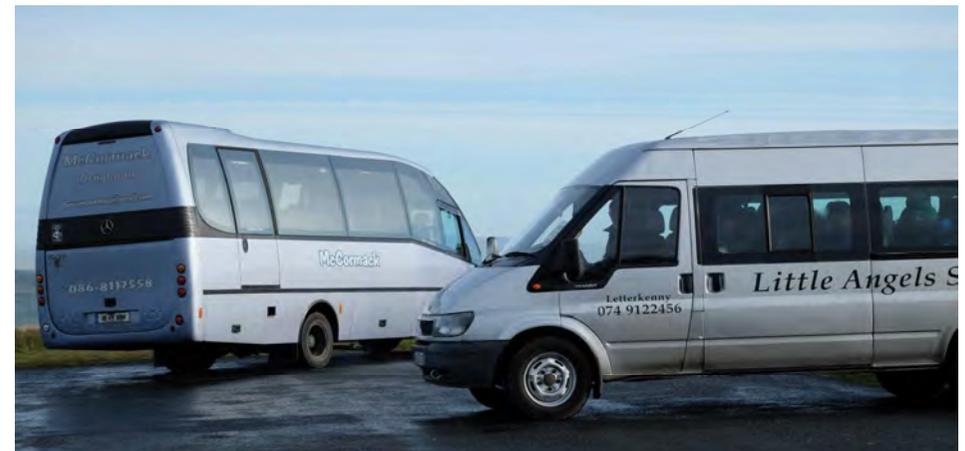
7.14 The car park is suitable for mini-buses but not coaches

The current car park provides space for around 20 cars. When it was constructed a degree of levelling was carried out, subtly changing the profile of the hillside. It is not recommended that this car park be expanded, as this would detract further from the presentation of the monument and destroy further areas of heath habitat.

There are no passing places on the steep access road, but sufficient width for two ordinary cars to pass with ease. The steepness of the road requires slow speeds, which reduces any risk to walkers. The road remains closed at times of frost and snow, as to access it then would be hazardous.
