Environmental River Enhancement Programme

Annual Report 2019

IFI/2020/1-4515

**Inland Fisheries Ireland & the Office of Public Works
Environmental River Enhancement Programme**

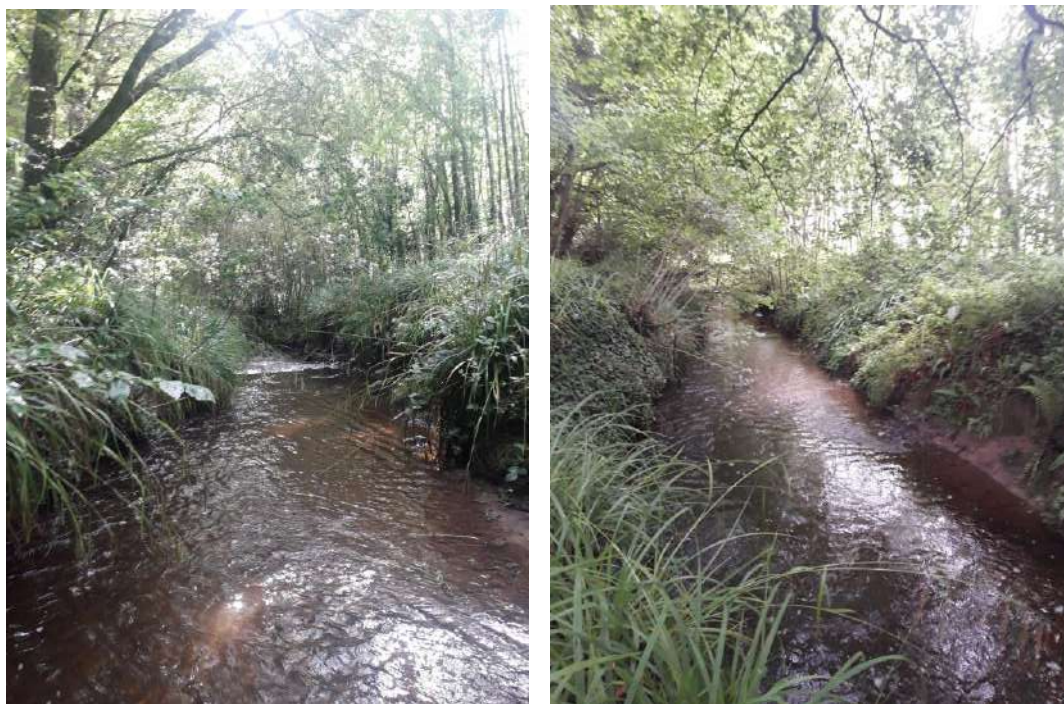
Figure 2.10 Example of a RHAT site achieving 'Good' status on the River Arra.

The overall RHAT score is developed from the individual scores given to 8 attributes, each of which is scored independently when on site (Figure 2.11). Each component is scored from 0-4, with 4 being the highest possible score given per element and all 8 are weighted equally.

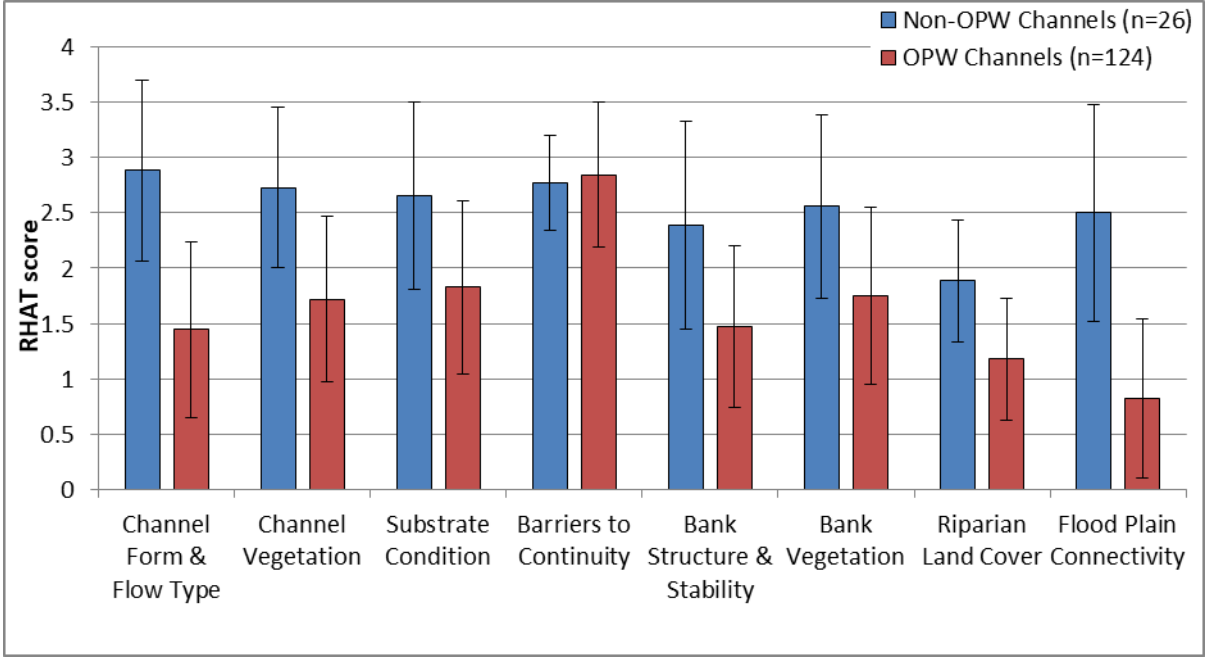
Figure 2.14 Mean and standard deviations for the 8 scoring components of the RHAT survey, separated into undrained channels (n=26) and OPW-drained channels (n=124) in the Dee, Bonet, Inny, Blackwater and Deel catchments.

When the individual components of the RHAT scores from the four catchments are separated and averaged (Figure 2.14) there are clear differences in the mean scores between OPW (n=124) and non-OPW channels (n=26). The only similarity is the close result in the Barriers to Continuity component. The largest difference is in the Flood Plain Connectivity component, followed by Channel Form & Flow type.

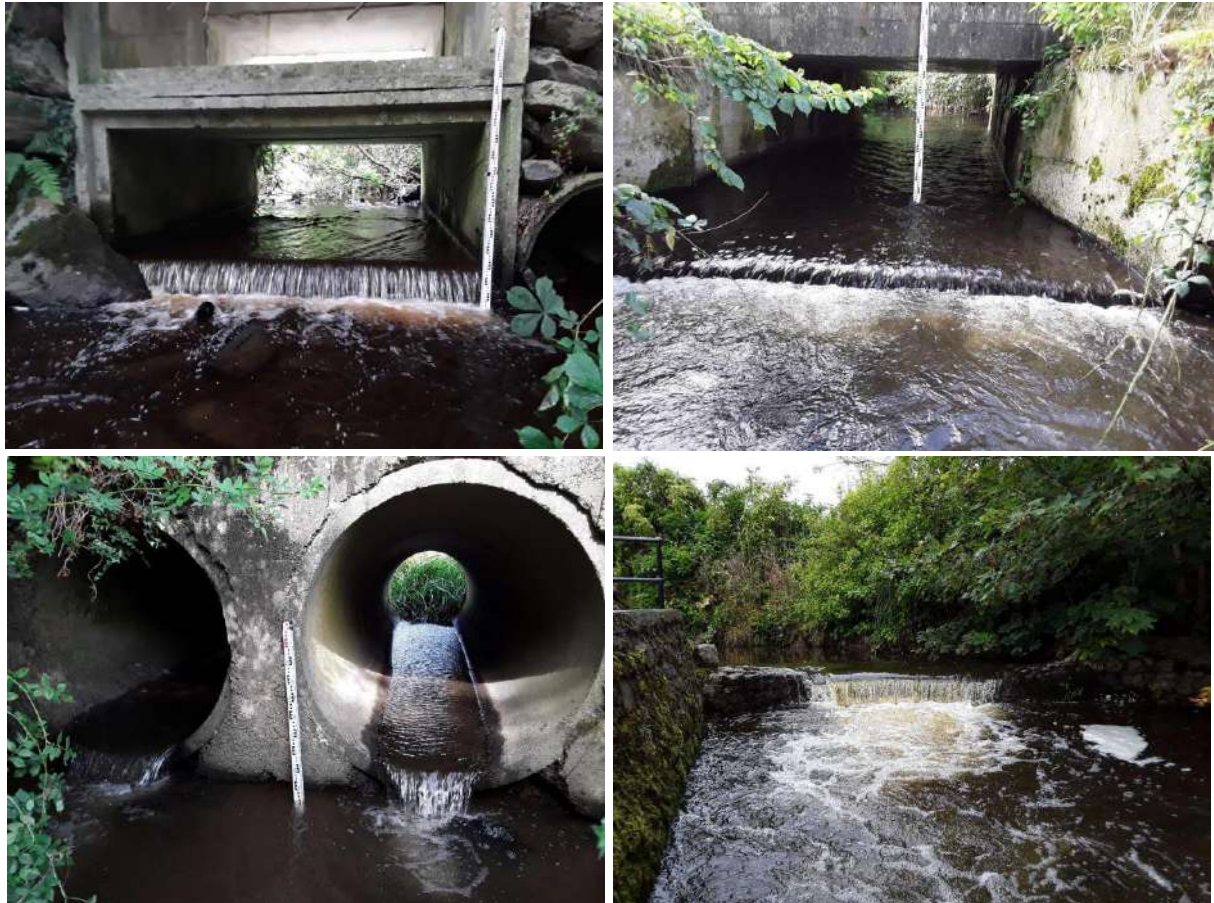
Figure 2.19 Examples of barriers identified during the Deel survey, including a box culvert, bridge apron, pipe culvert and small weir.

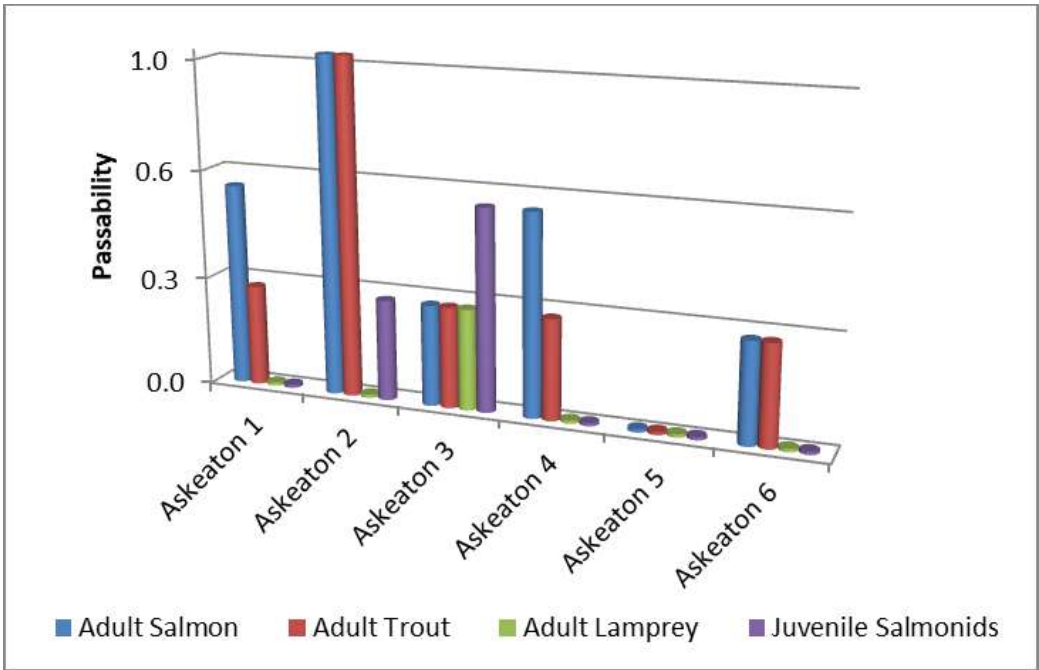
Figure 2.20 Passability assessment for the six structures in Askeaton on the River Deel. The 0-1 range is a passability scale. 0-Complete Barrier; 0.3-Partial high impact barrier; 0.6-Partial low impact barrier; 1-Passable Barrier.

This series of structures represents a significant hydromorphological pressure in the Deel catchment, preventing the free migration of keystone fish species. The free passage of migratory species - salmon, sea trout, eel and lamprey is fundamental in achieving 'Good' ecological status for the Water Framework Directive as their absence represents a deviation from reference conditions.

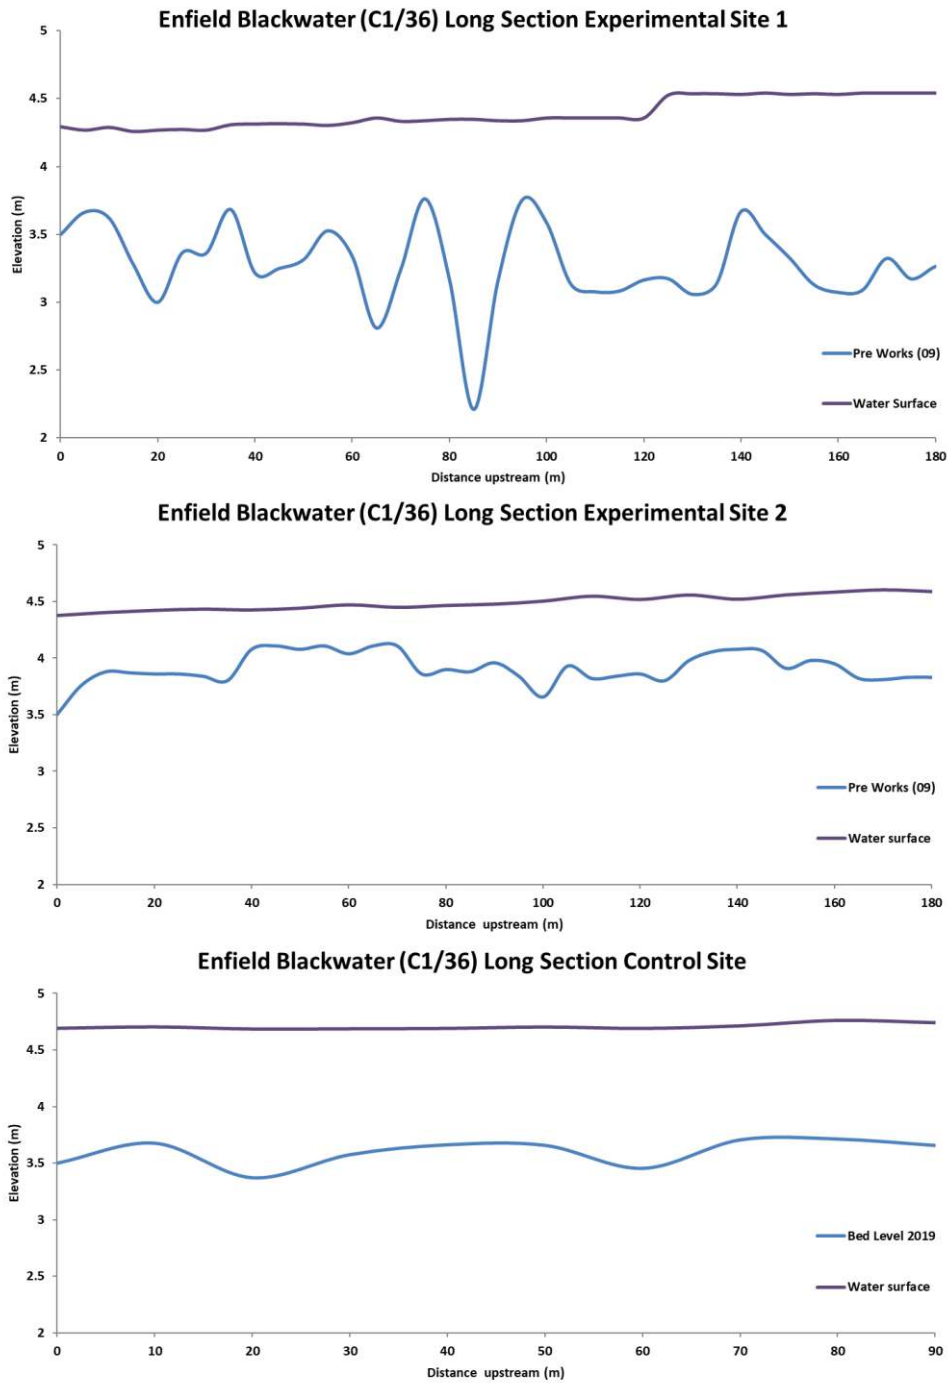
Figure 3.4 Longitudinal profile for Experimental site 1 (top); Experimental site 2 (middle) in 2009, prior to works completed. Longitudinal profile for the site selected as a control (bottom) in 2019.

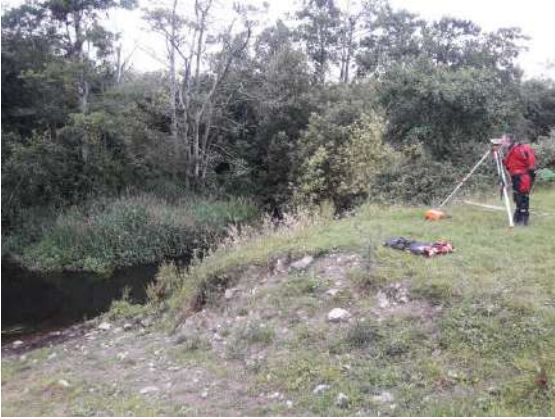
T120: At Exp.1, T120 a single deflector was introduced on RHS in 2010 as part of the Capital Works plans. The structure, located on the left hand side of the channel and now growing a stand of the tall emergent grass *Phalaris*, is evident from both the cross-sectional profile and the photo (Figure 3.9). This deflector constructed in 2010 has since been incorporated into the instream channel form and is densely covered with marginal vegetation. There was also evidence in 2019 of the channel beginning to cut in behind the stone of the deflector.

Figure 3.9 Cross-section taken at T120 (left). Photo looking d/s at single deflector on LHB located at T120 in Experimental site 1 (right).

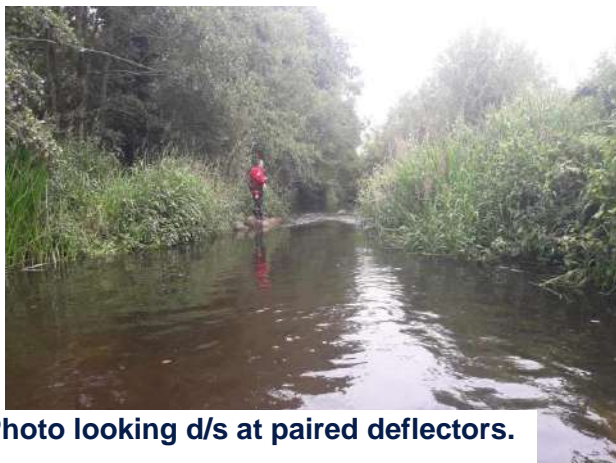
Figure 3.12 Photo looking d/s at paired deflectors.

At the inlet to the structure, the channel flows over a uniform stretch with an average 1.02m water depth and a steady velocity of 0.13m/s (Figure 3.11). At the midpoint of the paired deflectors, the water velocity speeds up to 0.4m/s through the narrowing (3m) of the structures. The depth of water through the paired deflectors reduces to almost half the depth at inlet (average of 0.49m).

At the outlet or exit of the structure, velocity in the middle of the outlet peaks at 1m/s, and the river scours deeper sections of the channel as a result (Figure 3.11). The graph shows an increase of depths at the outlet compared to mid deflectors.

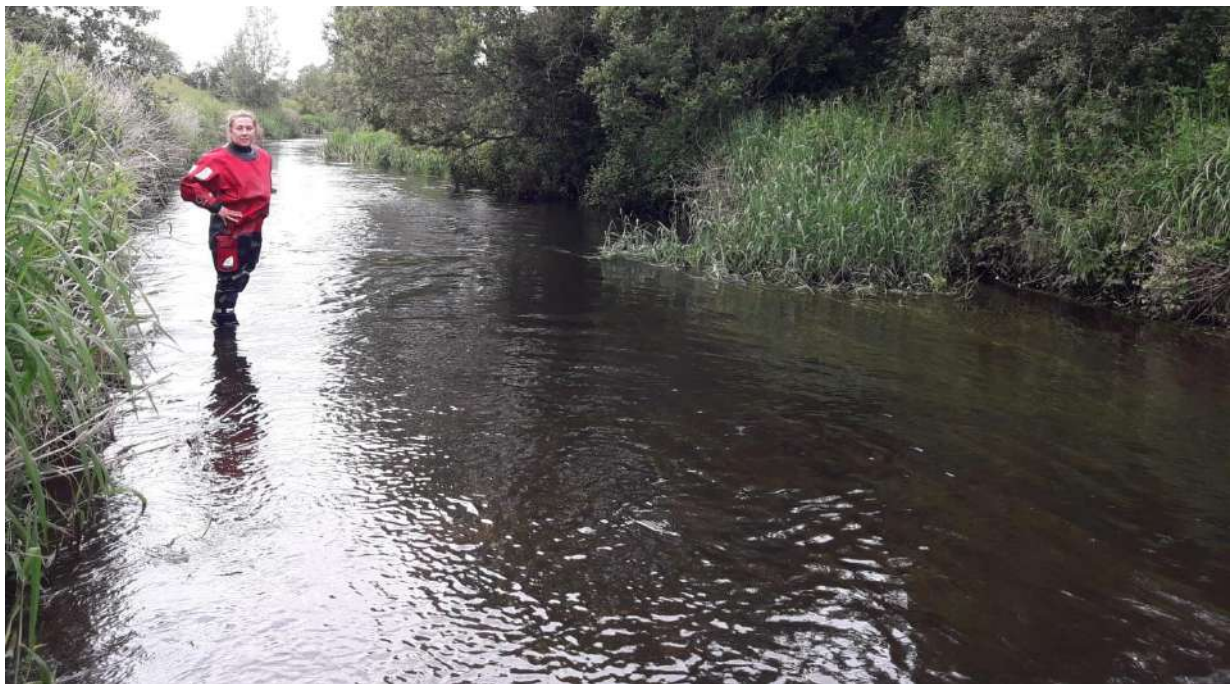
Figure 3.15 Photo looking downstream at rubble mat located at T120 in Experimental site 2.

Velocities at the inlet and outlet of structure were similar while velocities over the midpoint of the structure increased greatly, peaking at 0.77m/s mid channel (Figure 3.14). The river is slower at the edges of the river channel due to friction with the banks (average velocity 0.11m/s). The depth profile shows the extent of shallowing caused by the rubble mat, reducing depths from an average of 0.72m at the inlet to 0.33m through the structure. The shallowness of the rubble mat is evident in the photo (Figure 3.15).

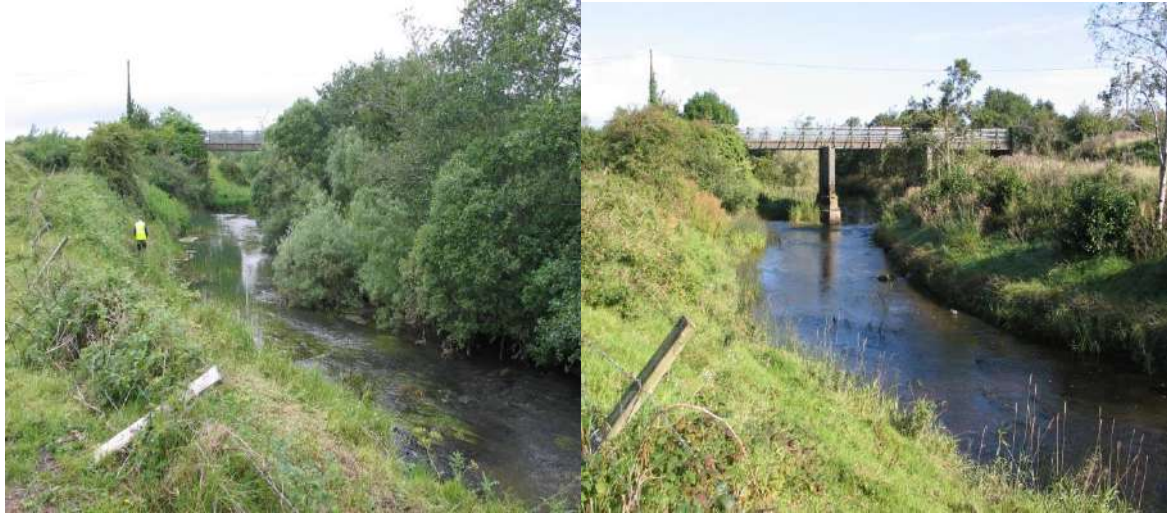
Channel maintenance, which consisted primarily of tree management, was completed on the Eignagh in the winter 2005 - 06 period. Tree management works consisted of removal and trimming (Figure 4.5).

Figure 4.5 Photos upstream of Cloongoonagh Bridge pre works (left) in 2004 and one year post works (right) 2006.

Tree management works completed in winter 2005-06 reduced the percentage of canopy cover recorded in 2006 to less than half of what was recorded before maintenance commenced. Sites 1 & 3 were excluded from the physical surveys in all years of the survey as tree management had already been completed at these sites. Site 2 acted as a control from 2005-2007 as this site had little tree coverage and remained untouched for the 3 year period (Figure 4.6). Site 4 did show a reduction in percentage canopy cover between surveys in 2006 and 2007. Factors other than maintenance, which influence canopy cover in these sites include the natural cycle of trees, particularly alder trees, and this may have impacted this result in site 4. Trees dying off and falling into the channel or lying on the bank slope reduce measured canopy cover. The fallen tree is then not providing any cover for the water body, but now has the ability to create habitat within the riverine corridor and this may have occurred in Site 4 between 2006 and 2007.

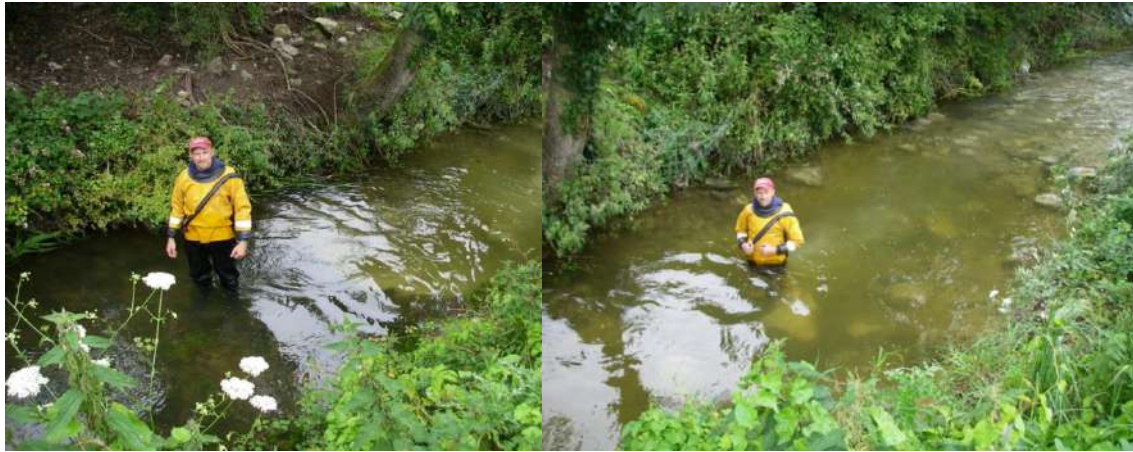
The enhancement works consisted of a total of 5 pools being excavated within a 200m stretch of channel. Pools were dug where tree cover would shade the channel and be beneficial to fish utilising the pools. The material excavated was placed in the channel directly downstream of the pools to create riffle habitat (Figure 5.2).

Figure 5.2 The Clonshire study site showing the pre-digging situation (left) and changes following bed excavation and formation of pool and riffle (right).

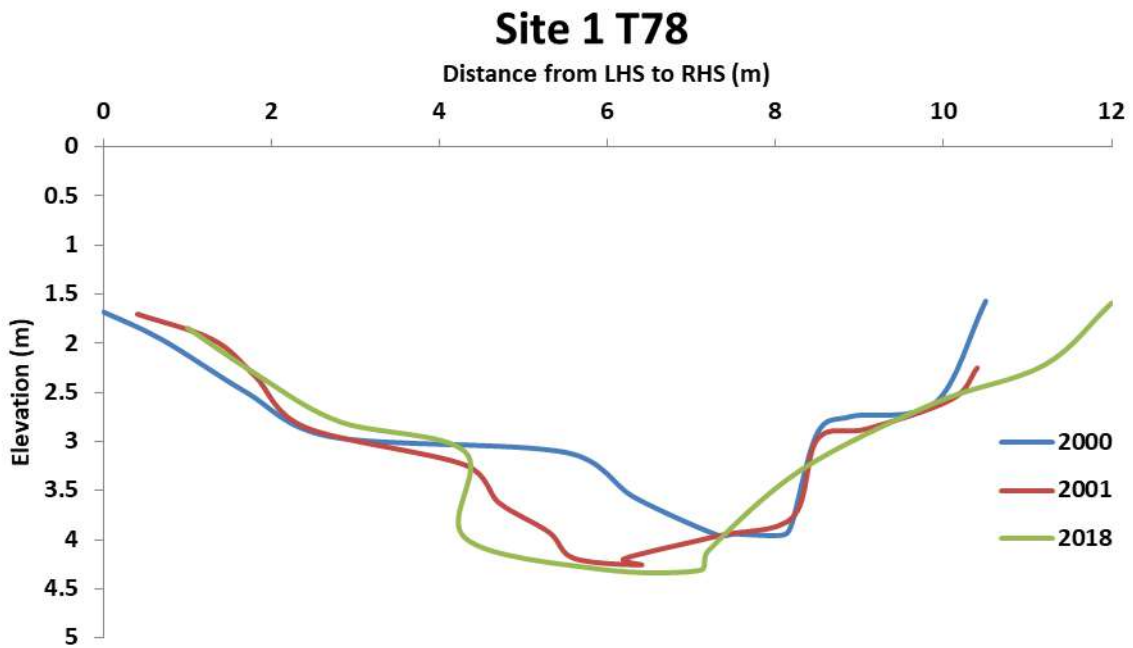
Figure 5.6 Changes to cross-sectional form at representative location in Site 1 pre- and post-maintenance and in longer term.

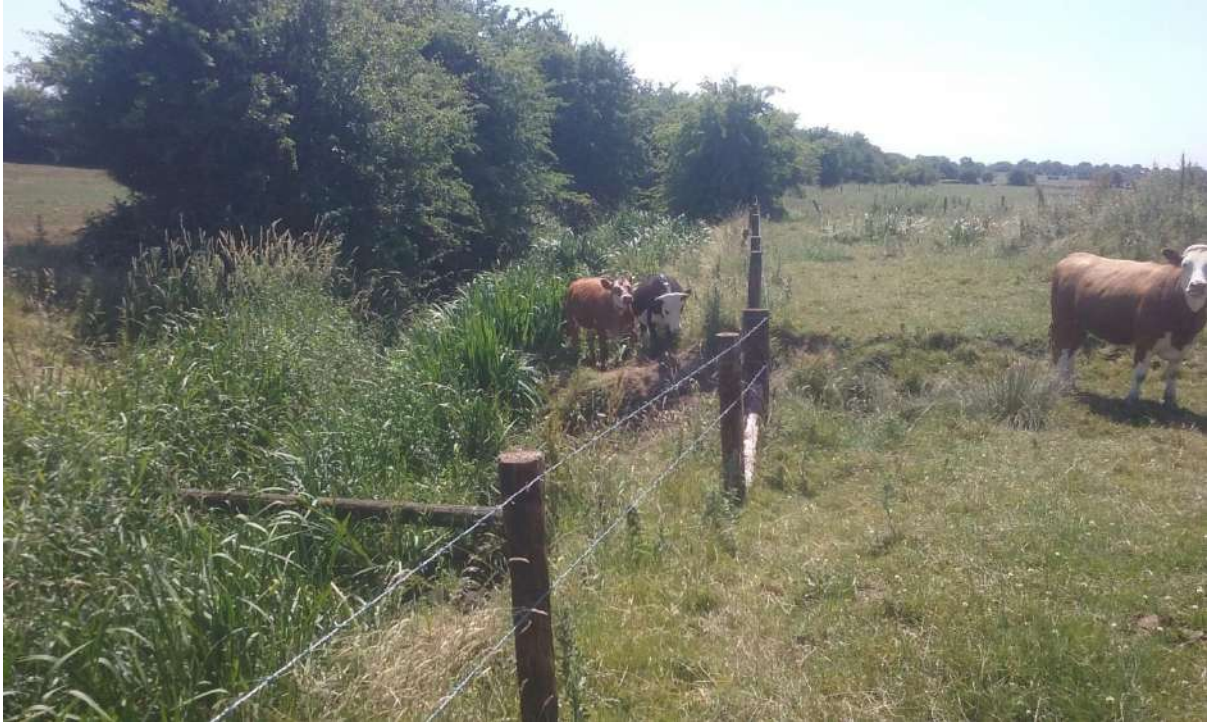
Figure 5.11 Dungolman Site 4 (2018) showing cattle ingress into the cross section despite robust fencing.

The mean values, with standard deviation, for each site showed a degree of fluctuation in values that might not be expected. It is surprising that the control (Site 5) showed an increase in cross-sectional area in 2001 following maintenance. This indicates that some degree of maintenance may actually have taken place at this time. Mean values for all the variables measured showed an increase in 2001, following maintenance, over the 1996 pre-maintenance data and mean values reduced by 2017/18 to levels similar to the 1996 pre-works figures. This overview impression points to a degree of removal of materials by the 2001 survey, with some bed desilting, berm manipulation and bank slope re-profiling. The reversal of this trend by 2017/18 points to a degree of dynamic process having occurred, with some berm re-formation. Fencing on the left bank at the various sites, including Sites 1 and 2 would have served to eliminate livestock, for the most part. It is likely that poaching by livestock (Figure 5.11) would have contributed to berm instability over a period of years. Evidence of this was clear in Site 4 (Standard Maintenance) in 2018, where cattle still had access and where the channel had been heavily encroached by trampling and collapse of the berm (Figure

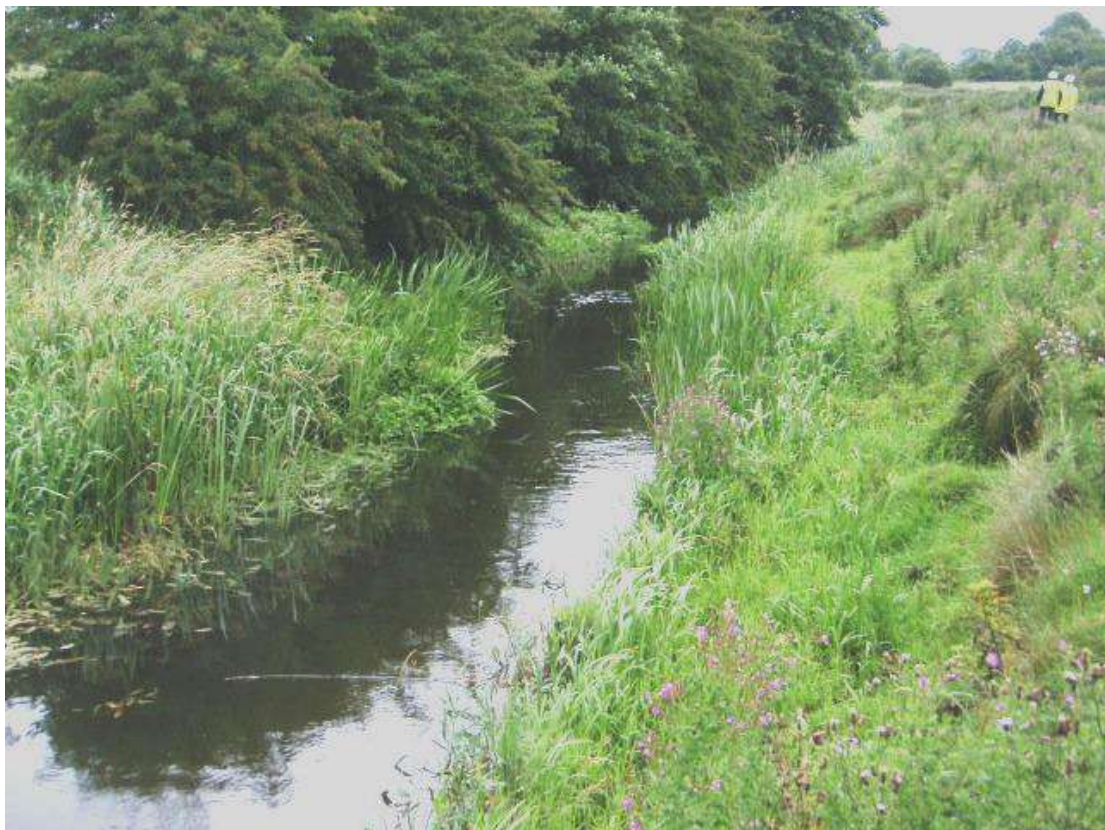
Figure 5.13 Tullamore Silver approx. 2007, showing open channel flow through a wedge-shaped cross section excavated in maintenance.

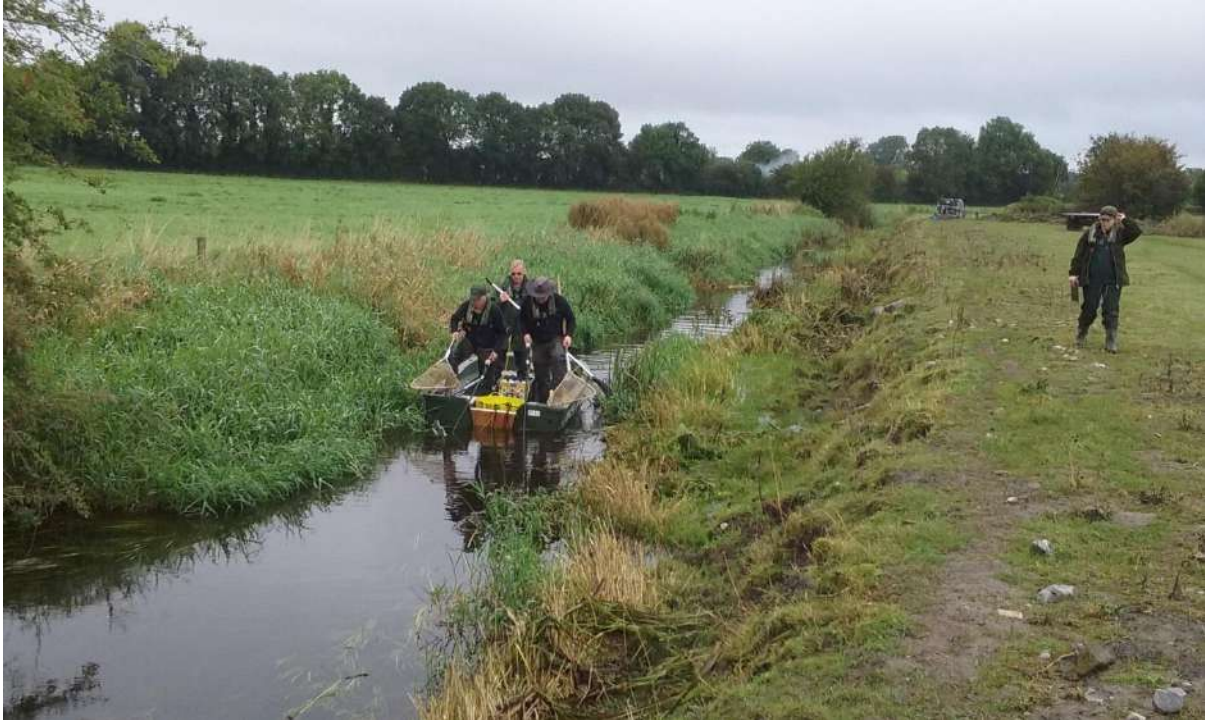
Figure 5.15 Electro-fishing following the removal of instream flaggers at site 9 in 2016. Note prevalence of berm on left bank (OPW machine working bank).

The levelling survey in 1997 indicated that the trapezoidal form continued to remain modified from the drainage scheme design, particularly in Transect 10 and 30 (Figure 5.16). The bed material in the study areas in the Tullamore Silver is cohesive grey clay that can retain its shape when modified. However, some degree of loss of 'definition' may be inevitable with time. The 2019 survey indicated a broad similarity of form with a shelving or low berm area evident on the left bank at T85 and a gradual sloping of the left bank from the channel bed compared to a more steep slope on the right bank (Figure 5.16). Berm re-development is also evident at other sites in this section of the Tullamore Silver (Figure 5.15).

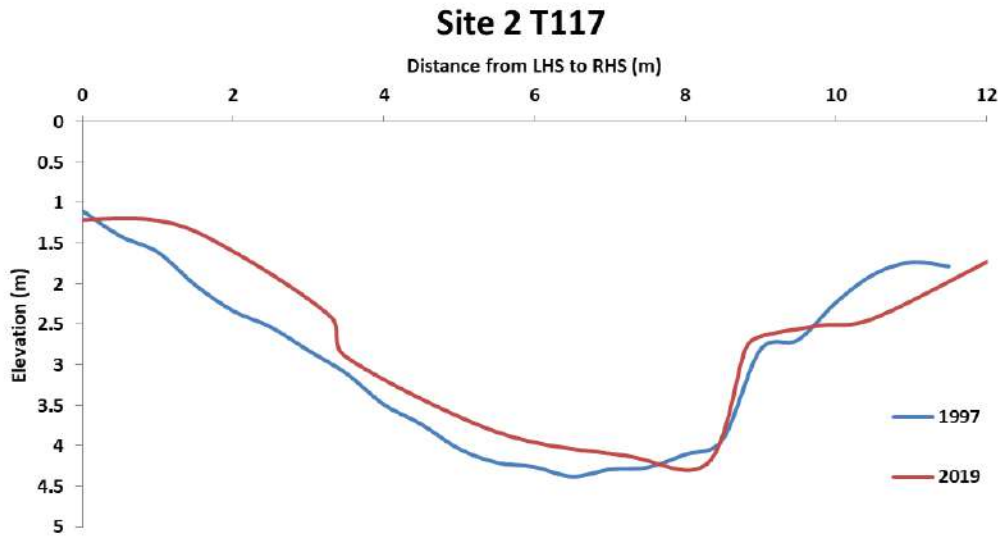
The levelling survey in 1997 indicated that the trapezoidal form continued to remain modified (Figure 5.17). Even allowing for the misalignment of the graphics there is limited evidence in change of form over the 22-year period at Site 2. The small degree of berm formation on the right bank and the general sloping of the left bank are similar between years indicating a degree of more 'robust' machine intervention on the right side and a lesser level of intervention on the left side.

The two transects from Site 4 both showed a degree of contraction, due to deposition at the right side of the channel at a low level, between the 1997 and the 2019 surveys. The relatively uniform slope on the left side of the channel, as seen in Site 2, was also apparent in the two transects from Site 4.

Figure 5.17 Cross-sectional form at one transect from Site 2 (original standard maintenance site of 1990) and two transects from Site 4 (also given standard maintenance) levelled in 1997 and 2019.

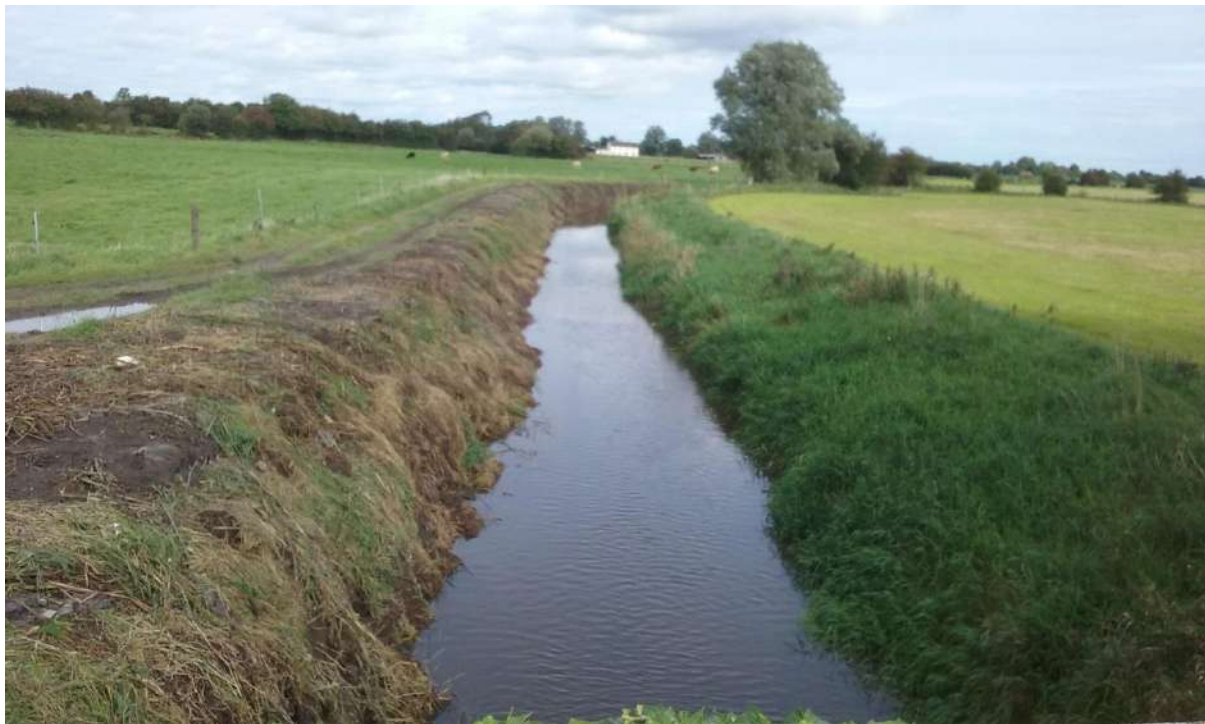
This site was located in a straight section of channel upstream of Newbridge. It was highly photogenic as a consistent photo record could be compiled from the bridge using a dwelling house in the background as a reference (Figure 5.18). The channel cross-section presented an entrenched aspect with a reduced level of instream growth of tall emergent flaggers due to the narrow open-water flow path.

Figure 5.18 Site 10 – upstream view from Newbridge following maintenance in 2016. Evidence of low berm on left bank

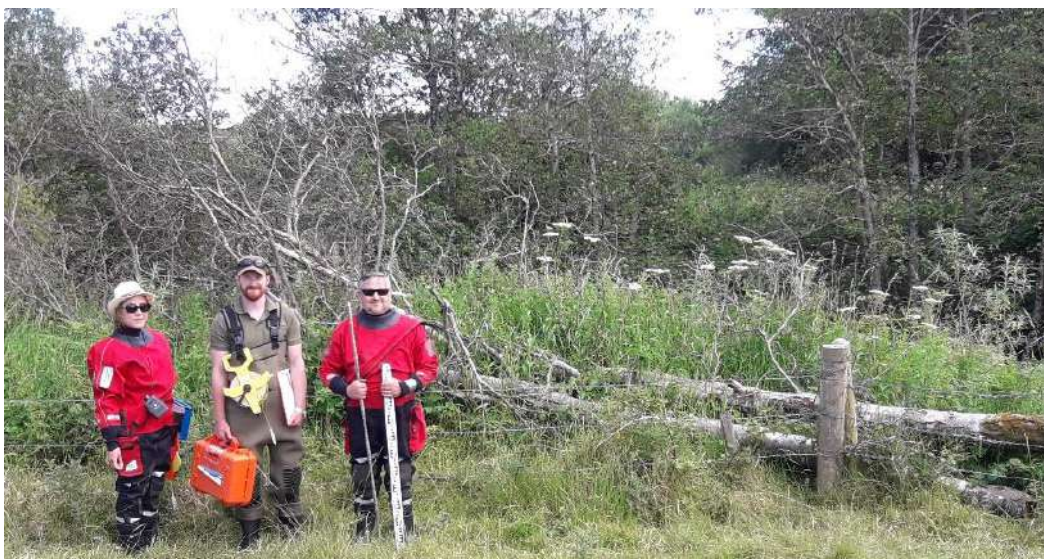
Following the IFI fish and habitat survey in June 2019, the OPW machines moved on-site to undertake the tree placement works. Paired timbers – suitably cut-down lengths of trees (Figure 6.2) – were drilled to permit pinning into the river (Figure 6.3).

Figure 6.2 EREP Team in 2019 standing beside timber pieces on the bank top, indicating the size of these timber structures.

The timbers were positioned by machine at a relatively shallow angle of approximately 30° from the bank facing downstream. Using heavy tracked machinery, the trees were pinned securely in place with 2 x 2m rebar welded to form a T-shape top suitable for pushing into the channel bed with the bucket of the digger (Figure 6.3).

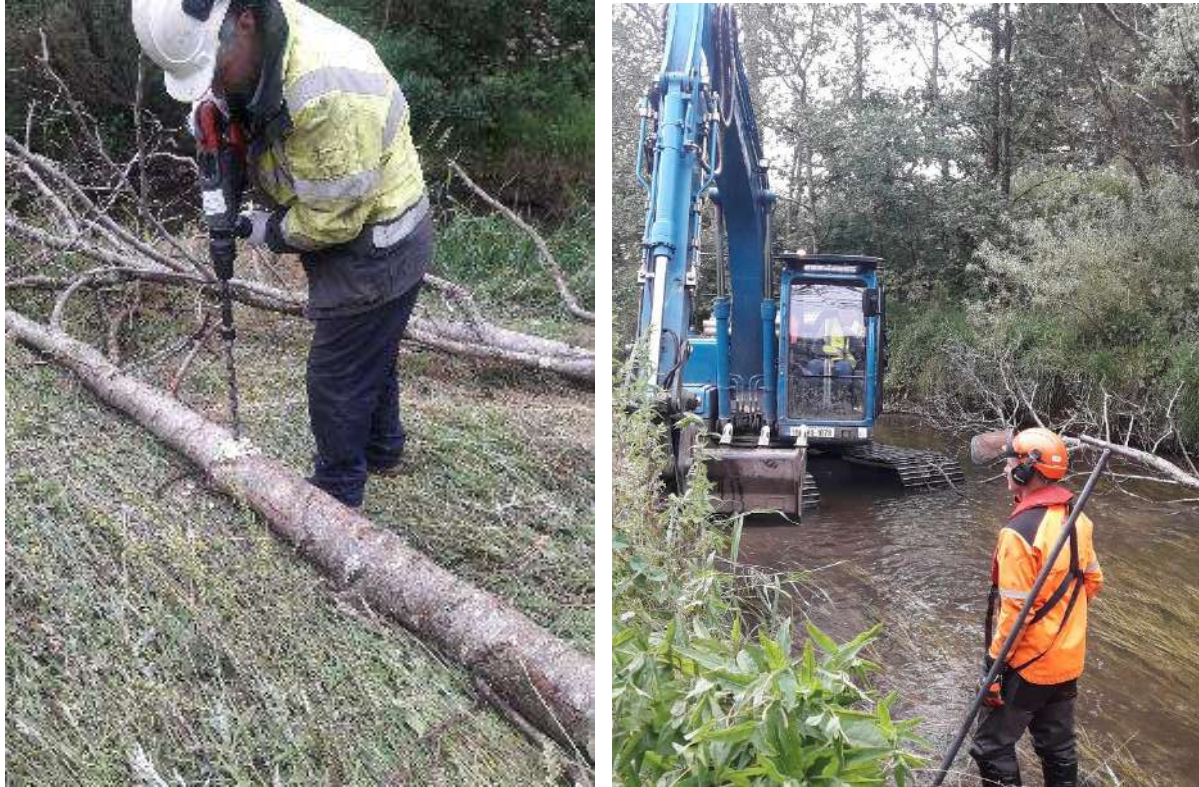
Figure 6.3 Photos of the various steps required to install the timbers.

These features were installed to aid the generation of scour pools for fish. Deflectors function by concentrating flow vertically or horizontally, increasing the speed of flow locally and creating areas of differential scour and deposition. It was important that the timbers were placed securely enough into streambed substrate to make sure they were stable and be at an appropriate height so that they are visible during low flow but overtopped during high flow conditions. This positioning is vital for the structures to work, contributing to new riverine processes within the channel (Figure 6.4).

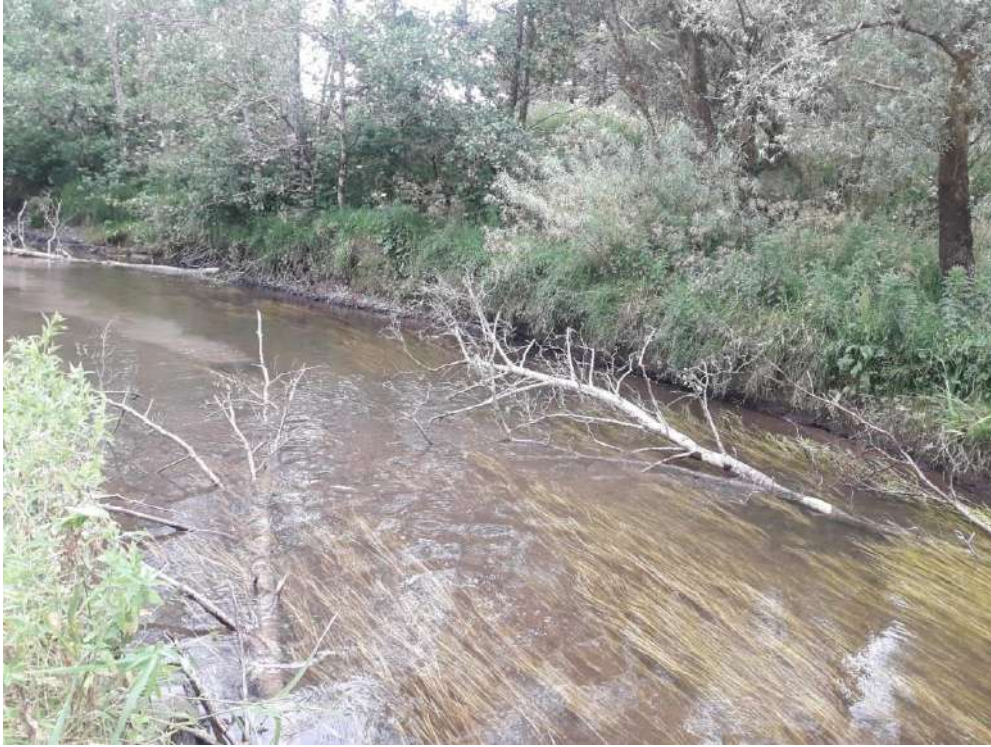
Figure 6.4 Completed pair of deflectors in the Eignagh River, Co. Mayo, July 2019 during low water levels.

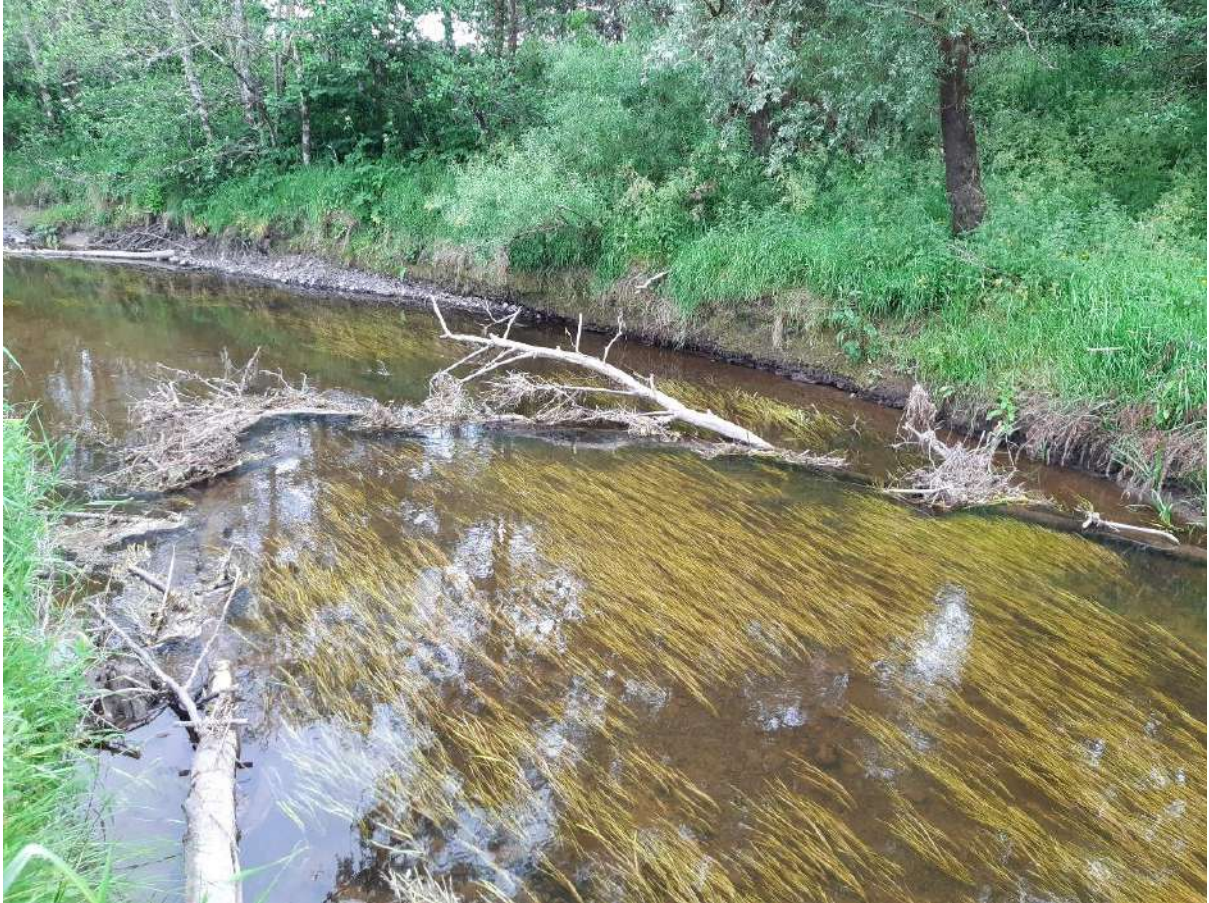
Figure 6.5 Photo of the deflectors taken in June 2020 during very low water levels.

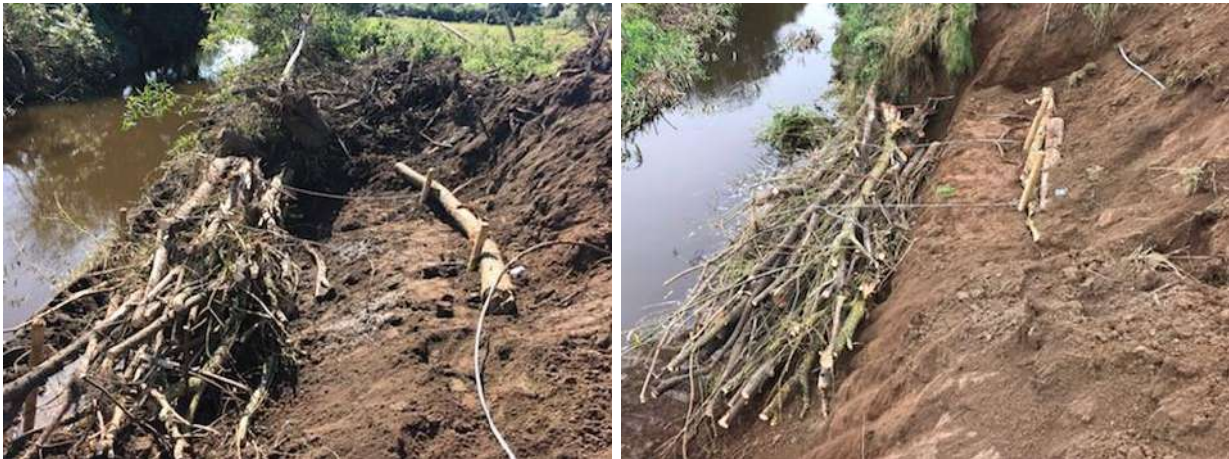
Soft engineering methods were piloted in this stretch of the Cor which offer an alternative to hard engineering bank protection measures. An example of works completed on the Cor is shown in Figure 6.7. It shows how trimmings of trees, primarily willows, collected during tree management can be used to form bundles which are secured into the bank. This worked well in this channel form and type. Using soft materials complies with WFD and has been used successfully in the past by IFI. The branches catch silt and sediment as its passes during heavy flows, which aid stabilisation of the bank.

Figure 6.7 Soft engineering: willow bundles pinned to bank for reinforcement, which were then covered with a clay sod to incorporate the structure back into the bank.

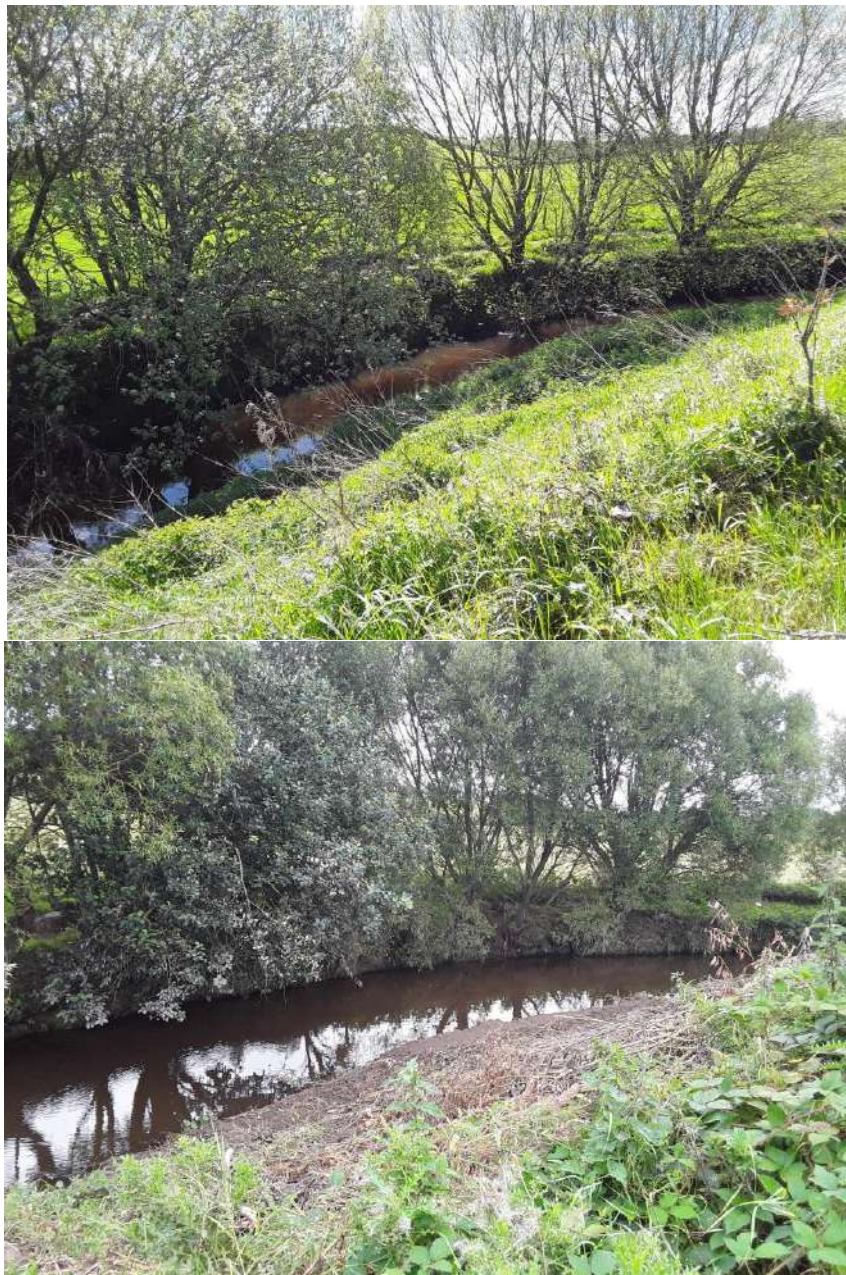
Figure 6.8 Example of berm management with retention of mature tree cover on the non-working bank.

Topping of berms allows for a greater area for overflow during higher water levels. An example with before and after pictures on this stretch of the Cor is shown. In this case there was evidence of minor erosion on the right-hand bank, so topping the berm on the left-hand bank increases the cross-sectional area creating a larger area for flows, therefore alleviating the pressure/impact on the right-hand bank. Moreover, allowing the channel to be narrow in low-flow conditions in this small section may create more diversity in flow types and lead to habitat creation. The roots of vegetation in the berm may stay *in situ* stabilising this feature within the river channel.

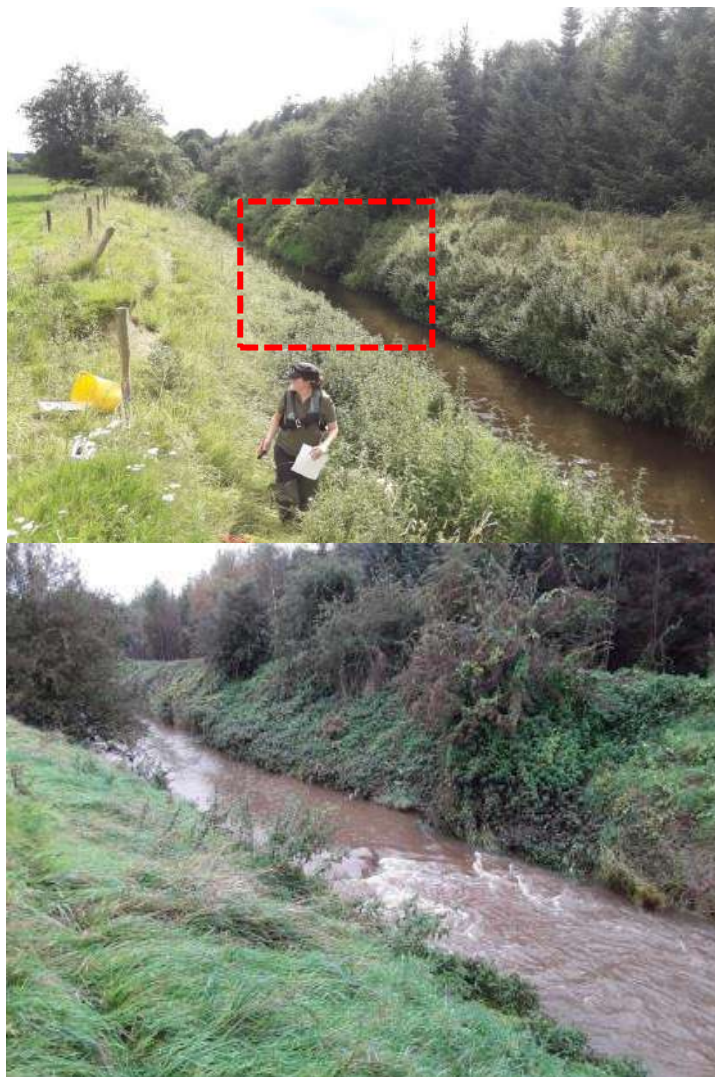
Figure 6.9 Example of pool excavation and riffle creation – before and after experimental digging.

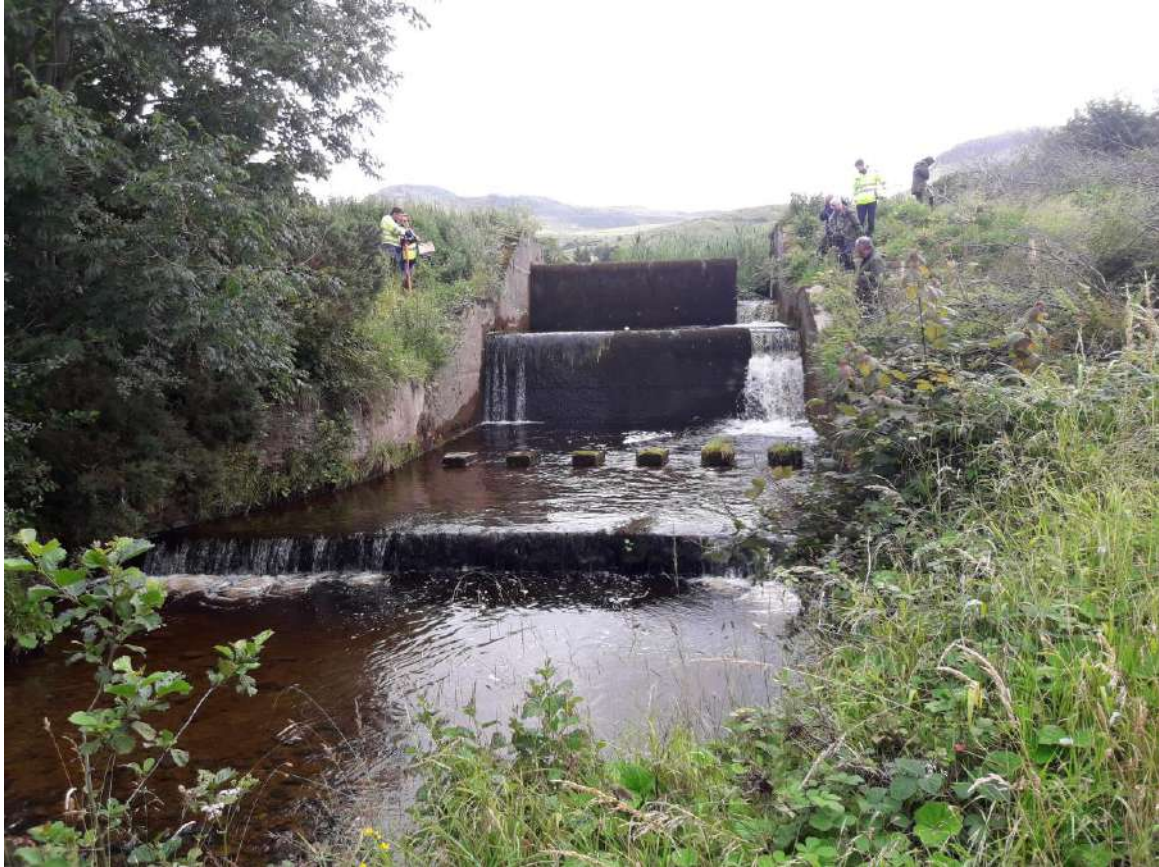
Figure 7.2 Gravel trap on the Largydonnell Stream, Duff catchment (ST8).
