Environmental River Enhancement Programme

Annual Report 2019

IFI/2020/1-4515

**Inland Fisheries Ireland & the Office of Public Works
Environmental River Enhancement Programme**

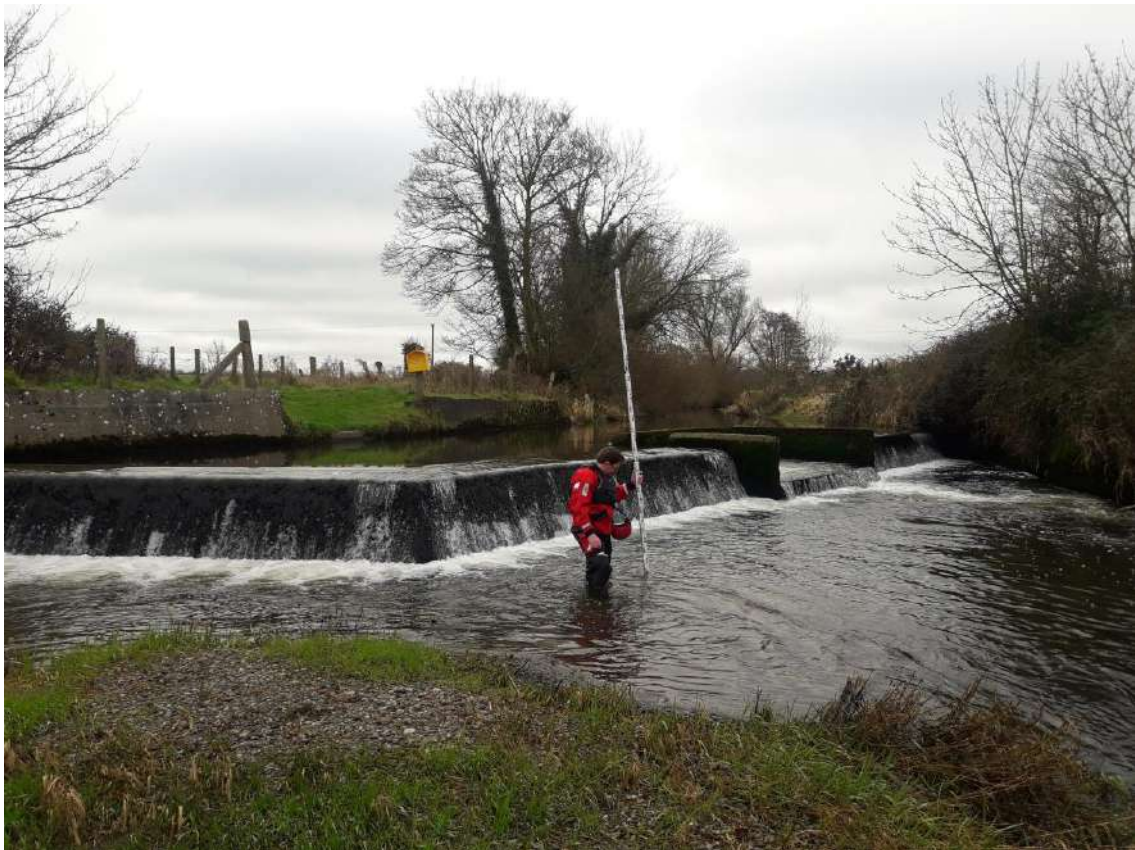
Figure 7.3 Gravel trap on the River Loobagh, Maigue Catchment (ST12).

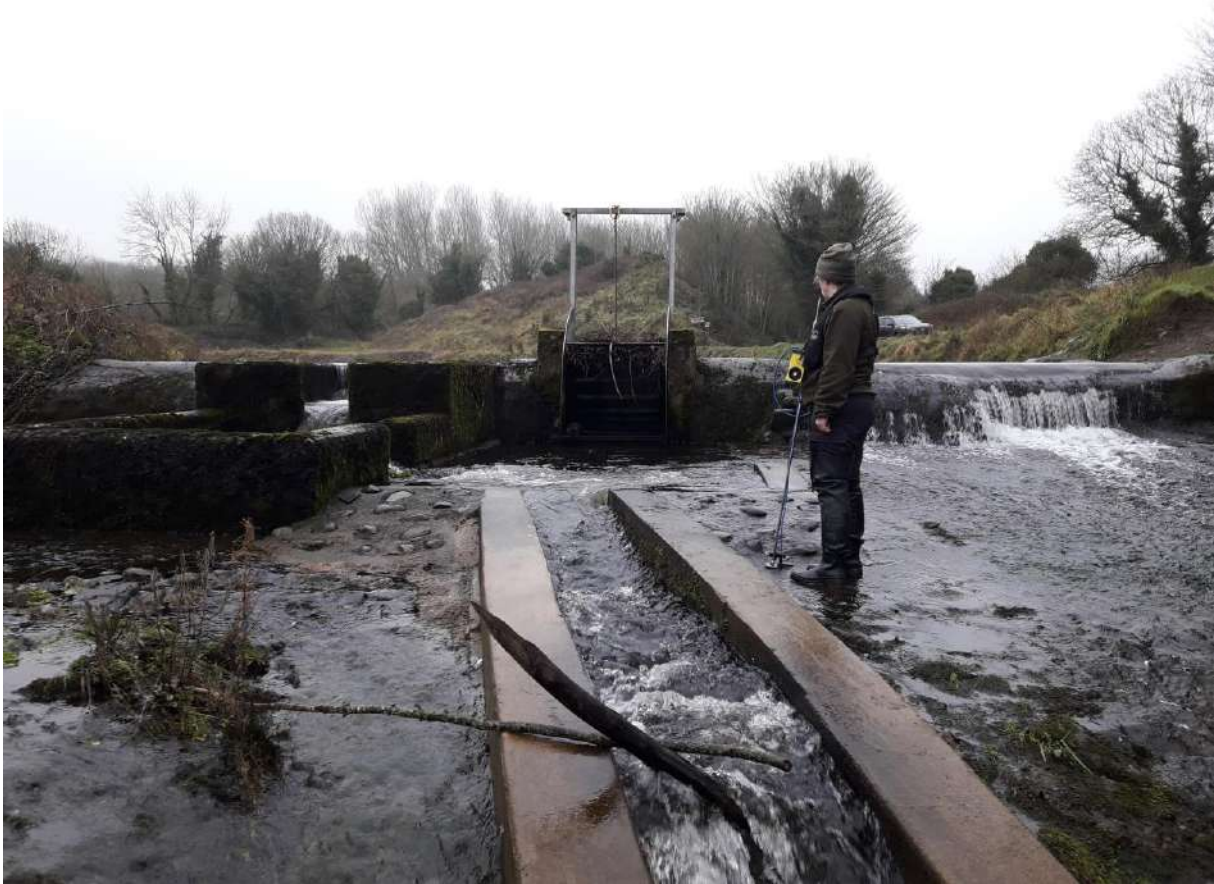
Figure 7.4 Gravel trap on the Kilcormac Silver, Brosna catchment (ST6).

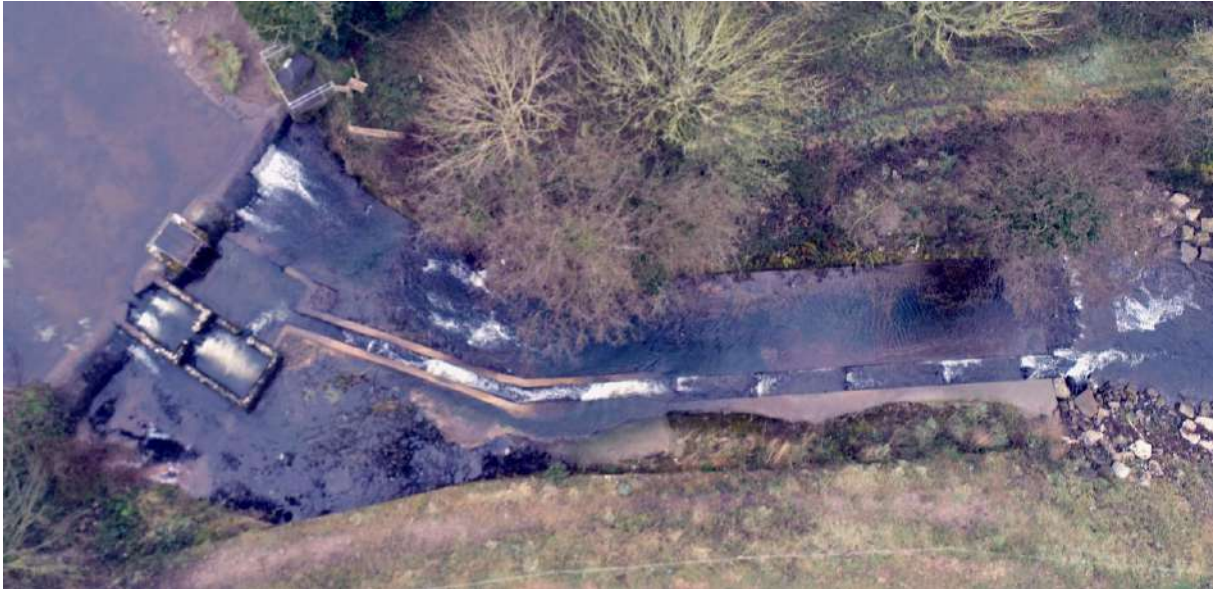
Figure 7.5 Drone image of the gravel trap on the Kilcormac Silver, Brosna catchment (ST6).

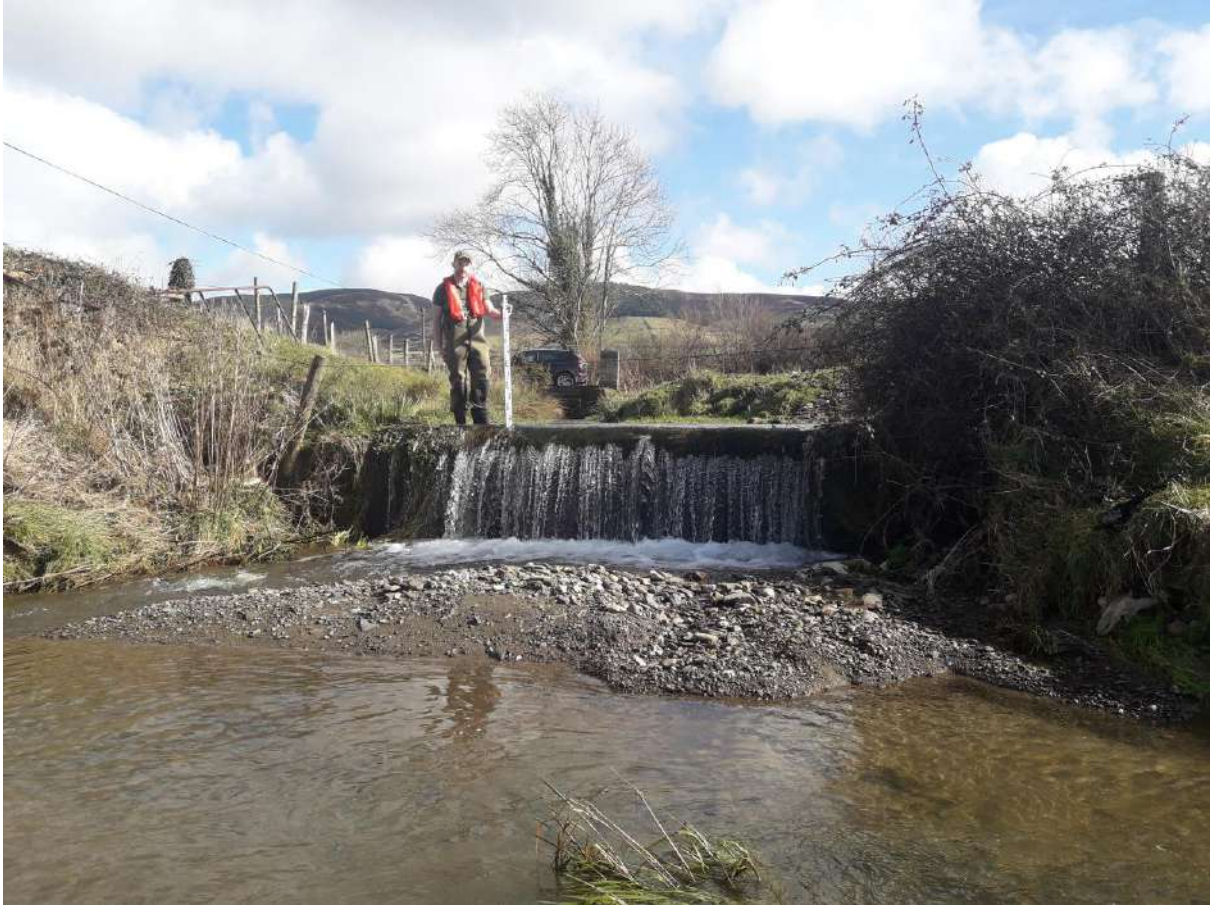
Figure 7.6 Gravel trap on the Ollatrim River, Nenagh Catchment (ST13).
