Archaeological Impact Assessment (AIA) and Marine Geophysical Data Review

Emerging Preferred Route Cross Shannon 400kV Cable Project

**River Shannon Estuary
Carrowdotia South Td, Co. Clare
Coolnagoonagh and Kilpaddoge Tds, Co. Kerry**

24 January 2020

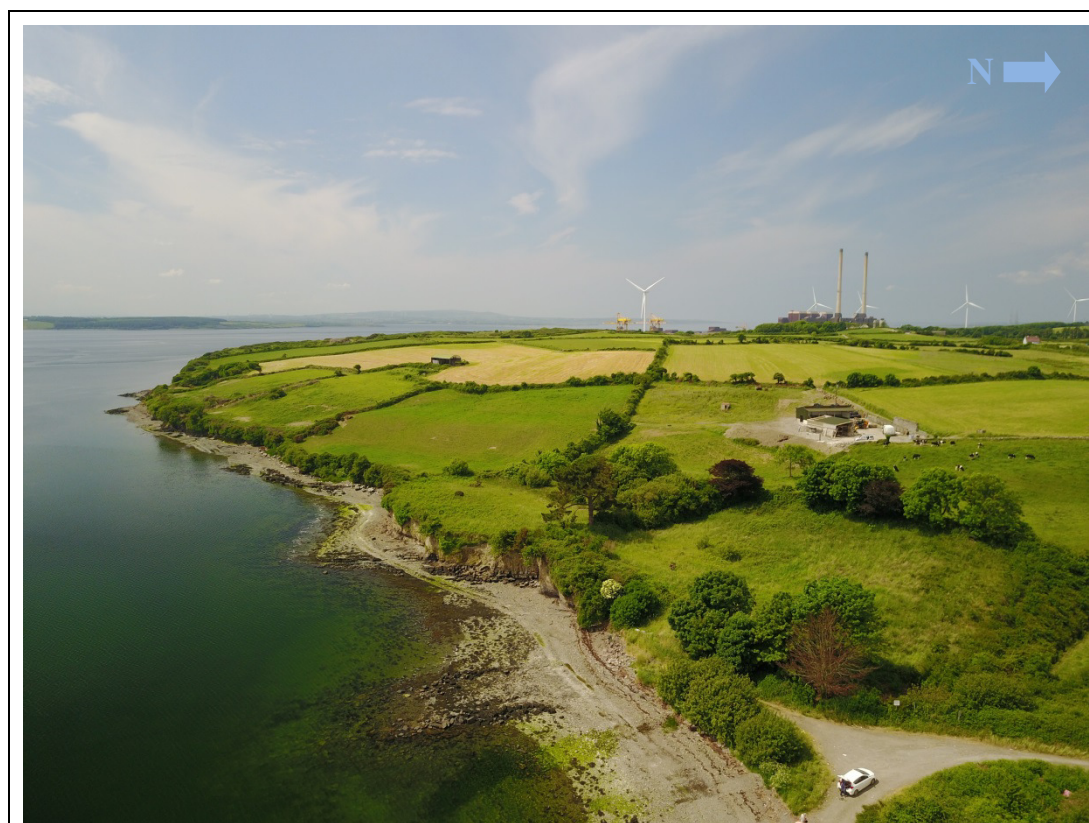
4.5 Landfall Survey Area N3 (foreshore east of Money Point)

Name	Landfall Survey Area N3
Townland	Carrowdotia South, Poulnadaree
ITM	505407E, 651449E - 505880E, 651921N
Extent	731m of intertidal foreshore
Feature(s)	F01-F04
Figure(s)	1-2, 8, 11, 14
Plate(s)	31-47
Status	Area de-selected as potential landfall location

A number of nineteenth-century features were encountered on the east side of the foreshore survey area and Landfall N3. The remains of a boat quay/slip (F01) were observed, as indicated on the OS historic mapping (Figure 8; Map Item 18); a curvilinear structure (F02) of rough-cut limestone is buried within the foreshore deposit; and a line of wall foundation stones (F03) delineate the upper foreshore. A natural feature (F04) was also recorded, that is a submerged peat horizon with a series of tree bowls (submerged woodland) and is of significant palaeoenvironmental interest.

Feature F01 (boat quay/slip) extends in a southeast direction from the HWM to a point several metres below the LWM; ITM 50680E, 651877N - 505706E, 651850N (Plate 41). The feature is partially preserved, only the lowest, foundation elements of the structure being retained (Plate 42). The visible remains of Feature F01 measure 32m in length (northwest-southeast) x 16m in width (northeast-southwest). A short section (c. 5.6m) of drystone walling is located adjacent to Feature F01, positioned along the upper foreshore between ITM 50670E, 651882N and ITM 505674E, 651888N (Plate 43). This walling is thought to be a later addition to the foreshore and is probably late nineteenth or early twentieth century date.

Feature F03 is comprises a series of twenty-two (22) limestone blocks that are thought to have once formed the foundations of a retaining wall that delineate the upper foreshore at this location (Plate 46). The feature measures c. 58m in length and extends between ITM 505738E, 651919N and ITM 505794E, 651931N. The structure is contemporary to the adjacent boat quay/slip (Feature F01).

Feature F04 is a section of submerged peat (saltmarsh) and woodland that extends across a 142m-long section of the foreshore, as indicated in Figure 10; ITM 505718E, 651895N, 505855E, 651906N (Plate 47). The area extends across the full extent of the foreshore and a series of water-eroded tree bowls are visible at locations along the HWM, mid water mark, and the LWM (see Plates 37-39).

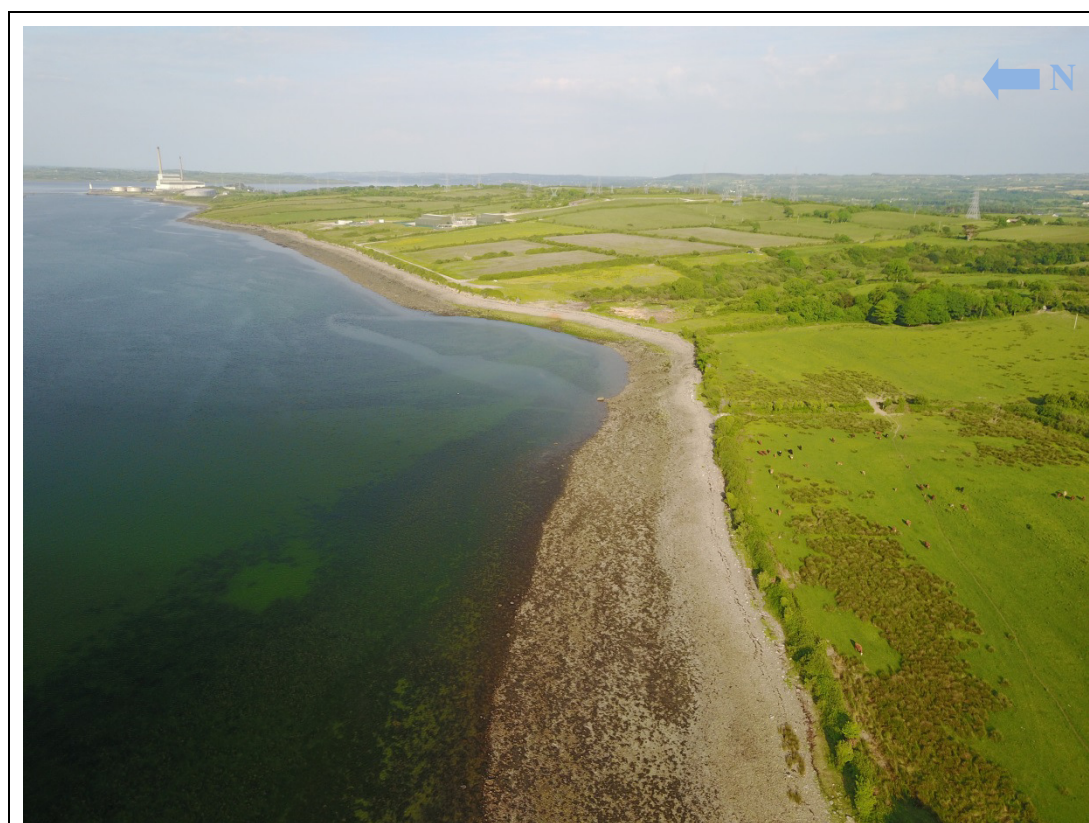
4.6 Landfall Survey Area S1 (foreshore Glencloosagh Bay)

Name	Landfall Survey Area S1
Townland	Coolnagoonagh, Kilpaddoge
ITM	504174E, 648602N - 505733E, 648998N
Extent	1.7km of intertidal foreshore
Feature(s)	F05-F08
Figure(s)	1-2, 9, 10, 12,14

Plate(s)	48-66
Status	Emerging preferred route selected within this area; Landfall S2

Feature F05 is located at ITM 504291E, 648552N (centre-point) and represents the remains of a building depicted on the OS 25-inch map of 1890 (Figure 10; Map Item 28). The structure is a single-story rectangular dwelling with an arched boat house to one side (Plates 55-56). The building has been constructed using rubble stone, with cut-stone masonry adorning its corners. A single rectangular profile window is present on its northern façade (Plate 57). The opening has a concrete repair and timber surround, indicating use of the building in the twentieth century. The adjoining boat house appears to be integral to the structure and retains

Feature F07 is the partially upstanding remains of a nineteenth-century lime kiln, situated on the upper foreshore at ITM 504788E, 648544N (Plates 63-64). The feature corresponds to a cartographic feature on the OS25-inch map of 1890 (Map Item 29). The south, east and west façades stand to a height of c. 2.2m (max.), while the northern side of the structure is missing; presumably collapsed due to erosion of the shoreline at this location.

Feature F08 was observed when inspecting an animal burrow (350mm opening) on the northwest face of a boulder-clay cliff face that delineates the upper foreshore at this location (Plate 65). A neatly constructed wall, comprising six (6) visible courses, forms the south side of the burrow, curving in an easterly direction (Plate 66). This structure is thought to be the partial remains of a buried *souterrain* or similar passageway structure and is likely to date to the Early Medieval Period.

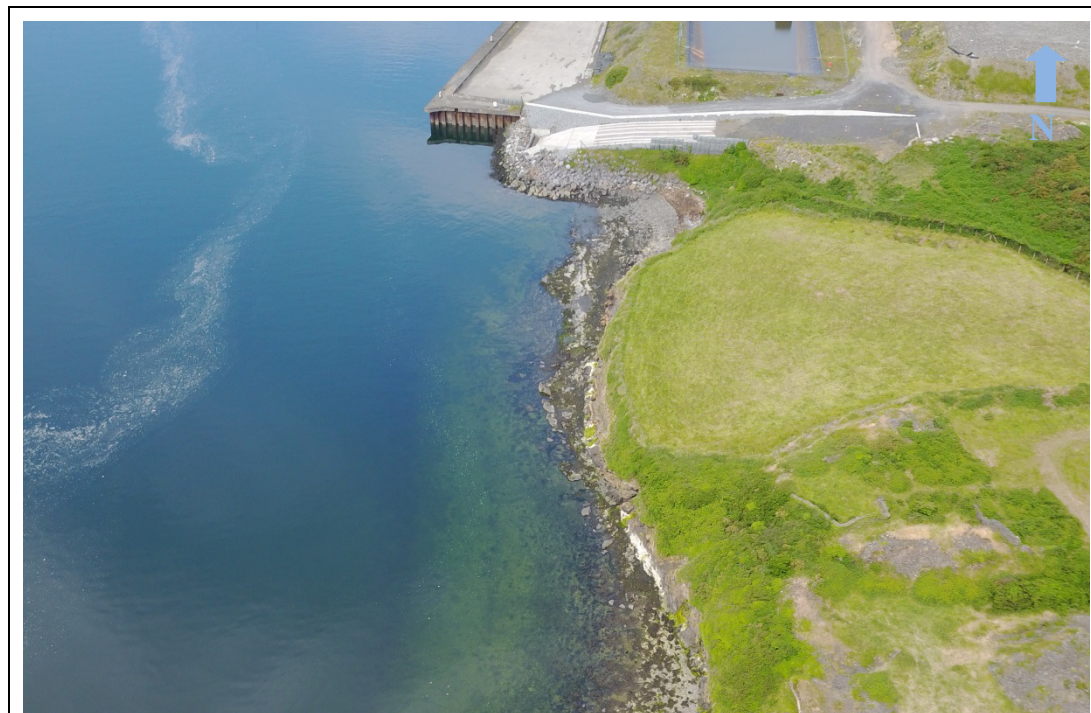
5.1 Northern Landfall (N2)

Name	Northern Landfall N2 (Route Option 2)
Townland	Carrowdotia South (Money Point)
ITM	504266E, 651251E - 504743E, 651194N
Extent	485m section of upper foreshore/ adjacent land area inspected
Feature(s)	F09-F011, Area of Potential AP1; cartographic feature
Figure(s)	1-4, 13-15
Plate(s)	67-81
Status	Proposed Landfall Site for emerging preferred route

part of the previous assessment in 2018. The remains of three (3) agriculture structures (F09-F11), identified a part of the more recent assessment and thought to date from the early-mid twentieth century, are also located outside the development footprint. Moreover, a very poor archaeological holding content can be ascribed to the area under assessment, with shelving bedrock lying close to surface deposits along much of the shoreline. In addition, a sterile compact clay, most likely glacial till (boulder clay), is frequently visible beneath the cobbles, boulders, and flagstone off-cuts that form the upper deposit of the foreshore at this location; the glacial till occupying the large gaps and fissures in the underlying bedrock.

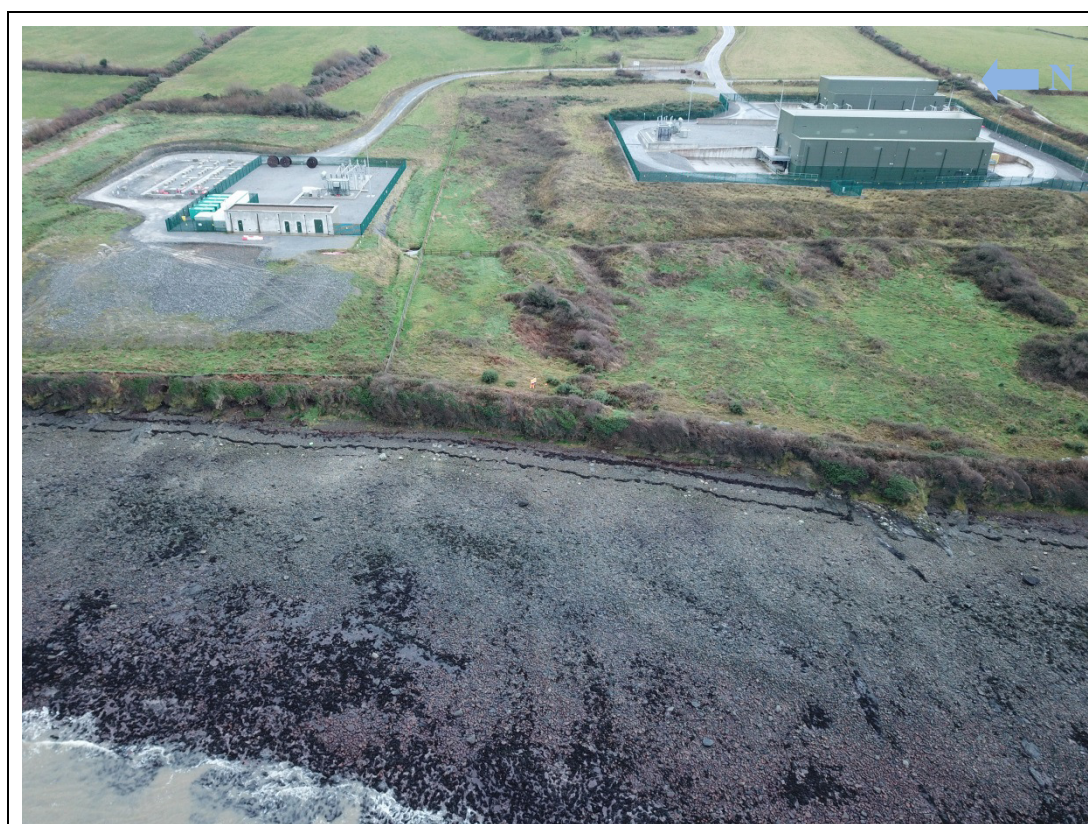
5.2 Southern Landfall (S2)

Name	Southern Landfall S2 (Route Option 2)
Townland	Kilpaddoge (Glencloosagh Bay)
ITM	505492E, 648717N - 505492E, 648841N
Survey Extent	330m section of upper foreshore/ adjacent pastureland inspected
Feature(s)	None
Figure(s)	1-3, 5, 13-14, 16
Plate(s)	82-92
Status	Proposed Landfall Site for emerging preferred route

The cables will make landfall on the southern side of the Shannon Estuary at ITM 505339E, 648758N (centrepoin). The intertidal zone at the proposed landfall extends c. 43m between the LWM and the HWM (Plate 82-84). The foreshore is composed of a high-density deposit of carboniferous limestone and shale cobbles/boulders (Plate 85); forming a shingle beach. Sub-angular cobbles are predominant (c. 60% of deposit) along the foreshore, measuring <200mm in size, and frequent sub-rounded boulders (<400mm) are also present (c. 30% of deposit). Occasional large boulders were also noted (>600mm), most situated above the HWM. Patches of finer material (c. 10% of deposit) were also noted above and below the HWM (Plate 86). These comprise pebbles (<50mm) and small cobbles (<80mm), interspersed with angular gravel (>4mm). The shingle deposit is of limited depth, with an average thickness of 150mm, that overlies a compact sub-stratum of glacial till (boulder clay) of light grey to orange colour. Bladderwrack (*Fucus vesiculosus*) seaweed is sporadically present across the intertidal zone, concentrated towards the LWM.
