Proposed dredging and beach nourishment at Magheraroarty pier and beach

Marine Intertidal Survey to inform Appropriate Assessment

Version: 7th September 2020 (FINAL)

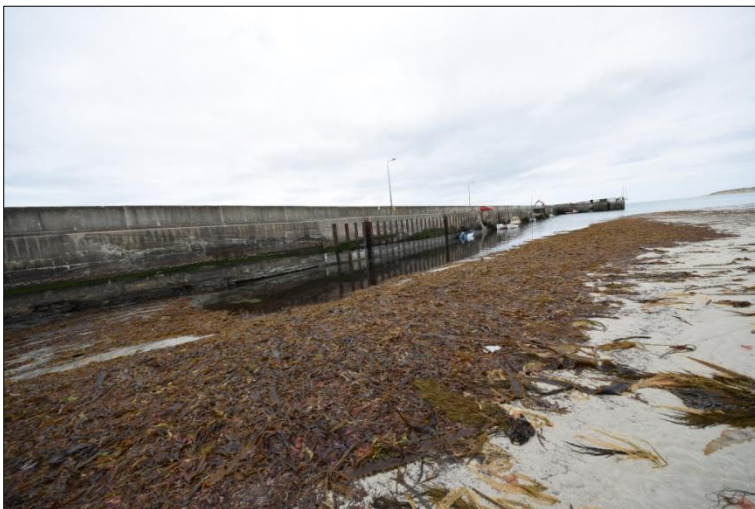
Plate 2 The subject pier area was dredged prior to the visit. This was not known at the time of the visit and there was no visual evidence that dredging had taken place.

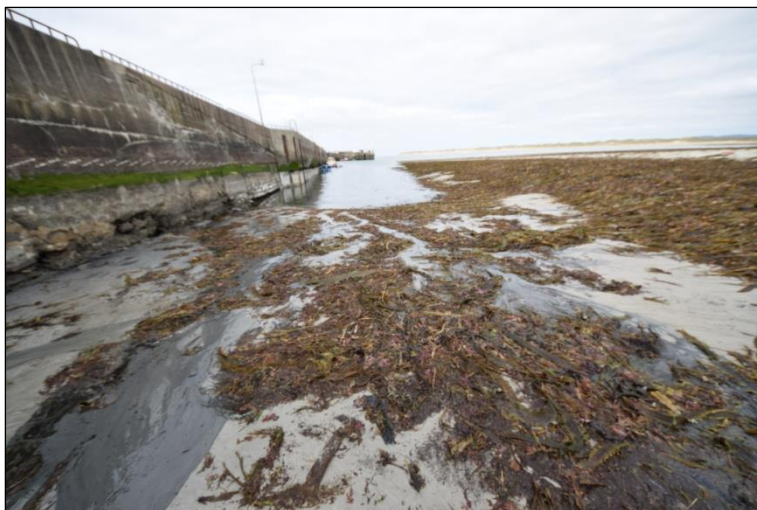
Plate 4 The subject pier. Water quality / visibility was poor and there was a large accumulation of rotting seaweeds. Sediments were anoxic.

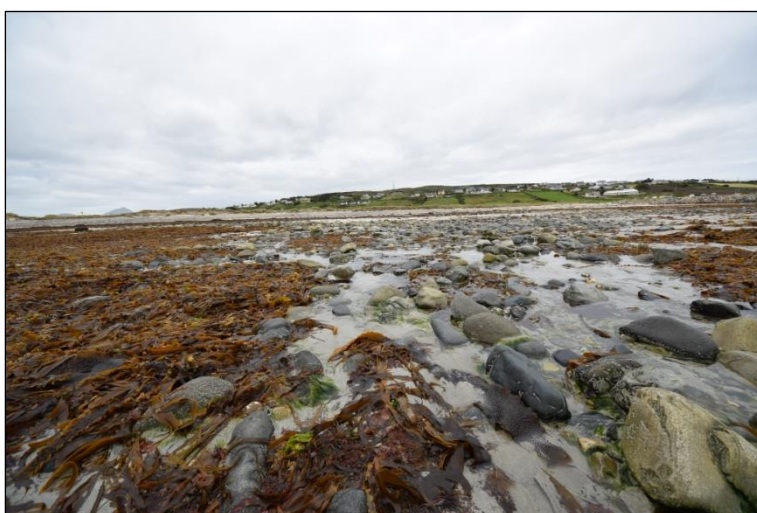
Plate 6 Some localised mixed substrate on the beach (not affected by the dredging) has higher biodiversity than the subject transect areas.

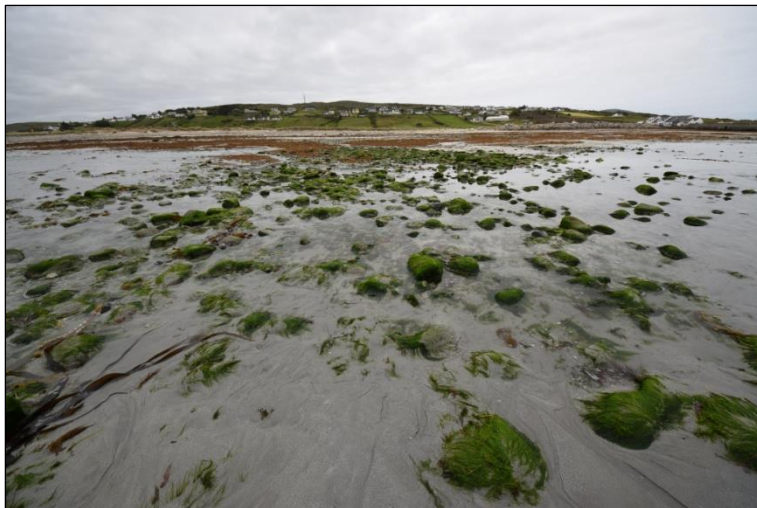
Plate 7 Other example of a localised mixed substrate area on the beach (not affected by the dredging).

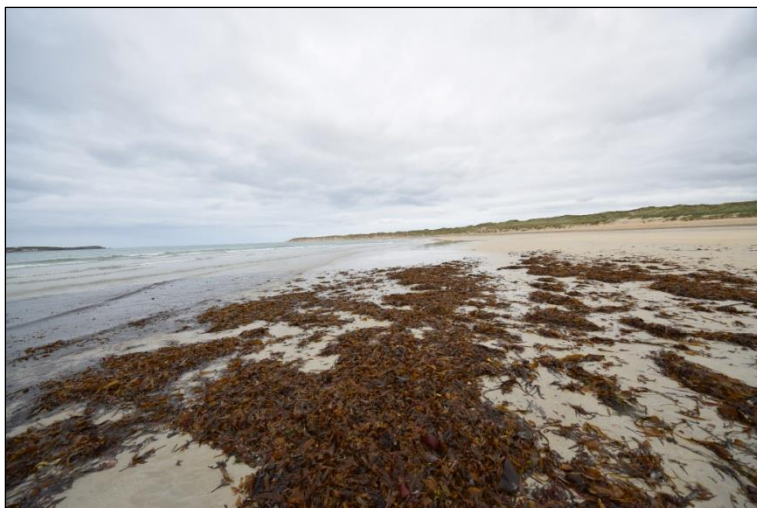
Plate 8 Looking east to the 'beach nourishment area'. Sand and dead seaweed and very impoverished fauna.

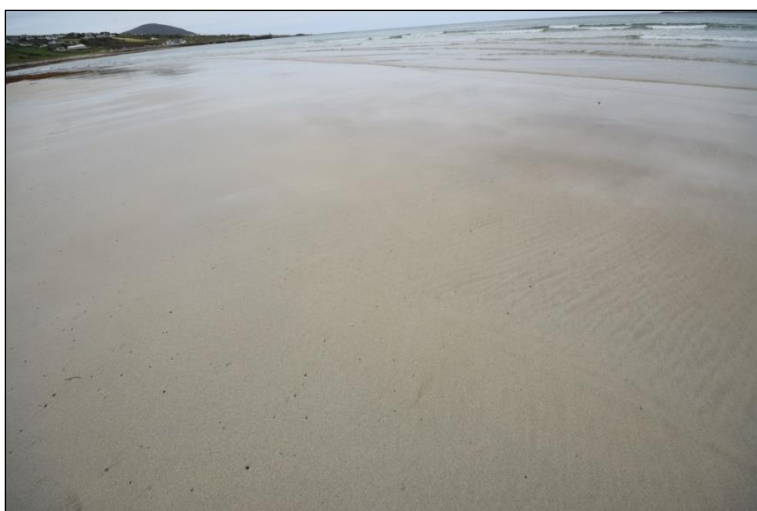
Plate 9 The 'beach nourishment area'. It is understood that sand had been placed here immediately prior to the survey. But most areas of the beach had a very impoverished fauna.

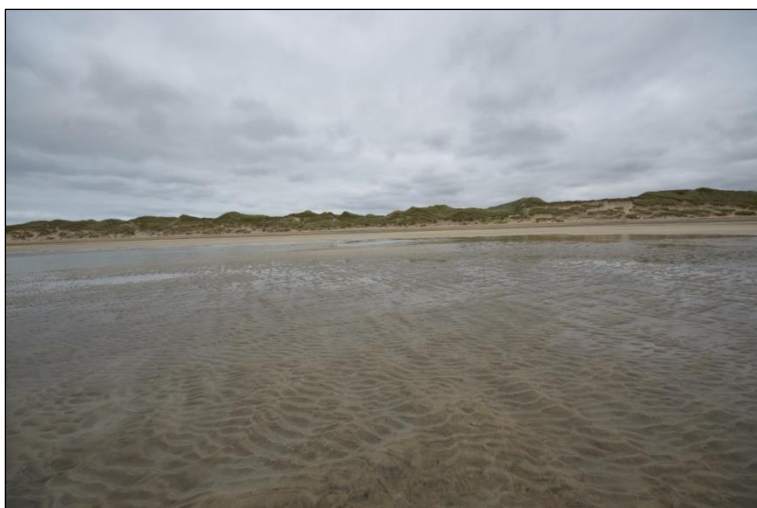
Plate 11 Reference survey area at low tide on the 8th June 2020. This area was not disturbed but also had a very impoverished faunal community.

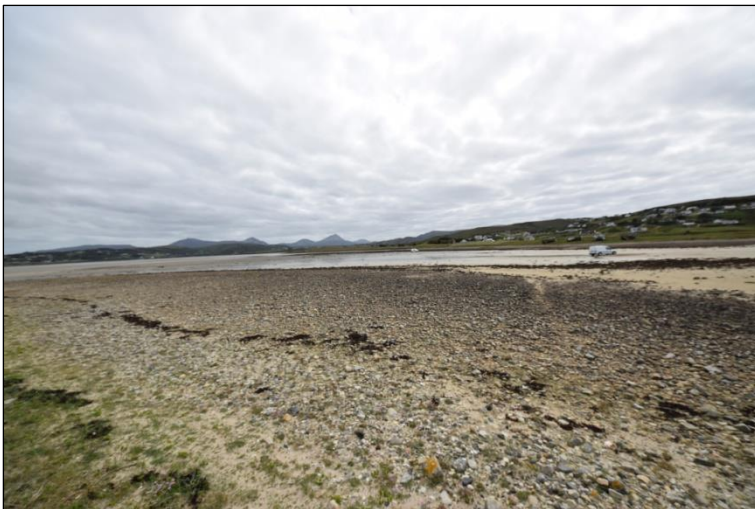
Plate 14 The Ballyness Bay area – vans had driven out on the shore during low tide with several people engaged in bait digging.

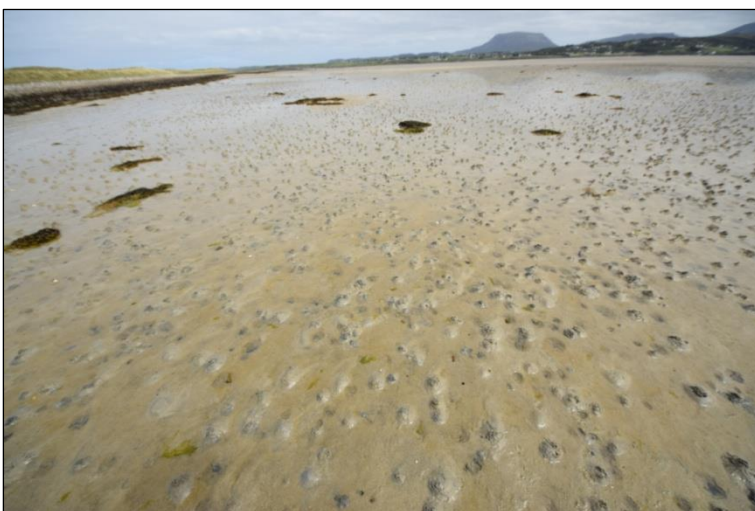
Plate 15 The Ballyness Bay area – this area is significantly more important for marine intertidal fauna than the Magheraroarty beach area. Very high densities of *Arenicola marina* were present.
