# Natura Impact Statement

Natura Impact Statement in relation to proposed Annual dredging and Beach Nourishment at Magheraroarty Beach by Donegal County Council over a Five-year Period within the zone of influence of the Ballyness Bay SAC site code 001090 and Falcarragh to Meenlaragh SPA site code 004149

Greentrack Environmental Consultants

December 2020

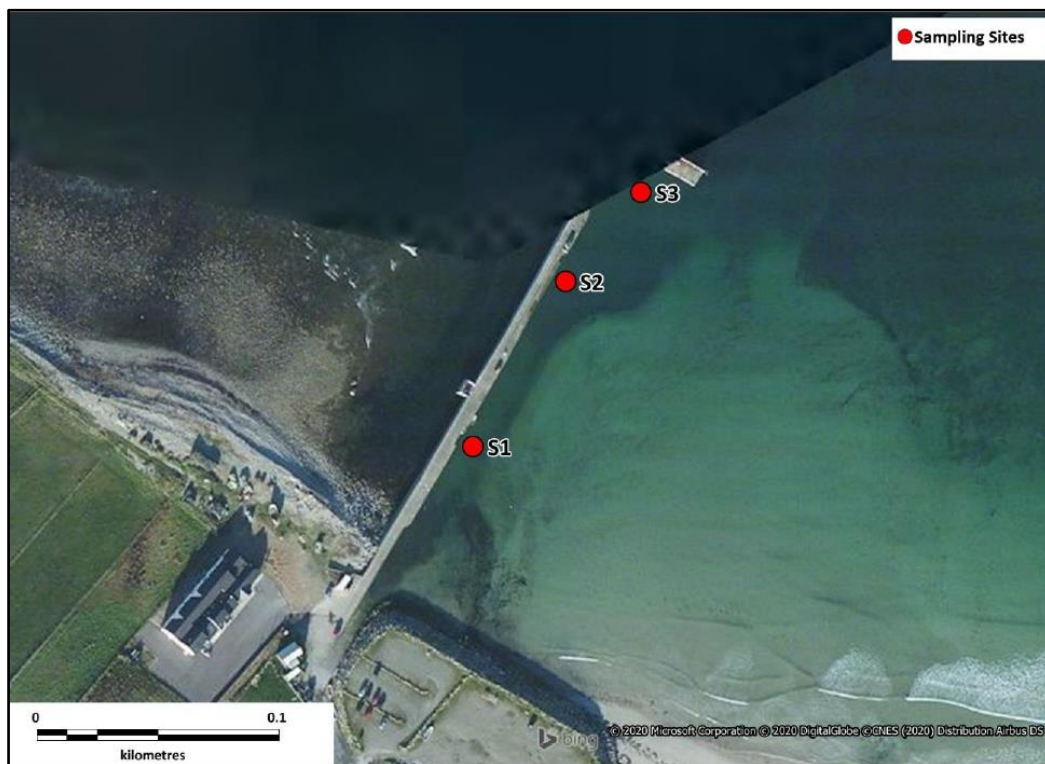
**Figure 4: Location of Sampling Points**

Removal of material is to be carried out by experienced personnel to minimise excess sediment mobilisation. Removed material will then be loaded on to 2.no dump trucks and transported along a marked route along the foreshore, during low tide – mid tide to the agreed disposal site on Dooley Strand for the purposes of beach nourishment (Figure 2). Both the haul route and the area for disposal are to be clearly marked prior to any dredging. C.5000 - 20000 tons of material will be removed from the harbour depending on winter accretion. The minimum amount required to allow for safe navigable depth at the harbour will be removed. Dredging will take place in shifts during daylight hours. The works will take place over a 4-day period. The material to be removed from within Magheraroarty harbour is that of recently deposited sand which has been transported along Dooley Strand and deposited by natural processes. The nature of the deposit was analysed by Aquafact<sup>1</sup>. A brief outline of the deposit analysis is presented in Table 4.1. Three sediment stations were sampled within the proposed dredging area in January 2020 and analysed by Aquafact, the locations of the dredge site sampling points are shown in Figure 4.

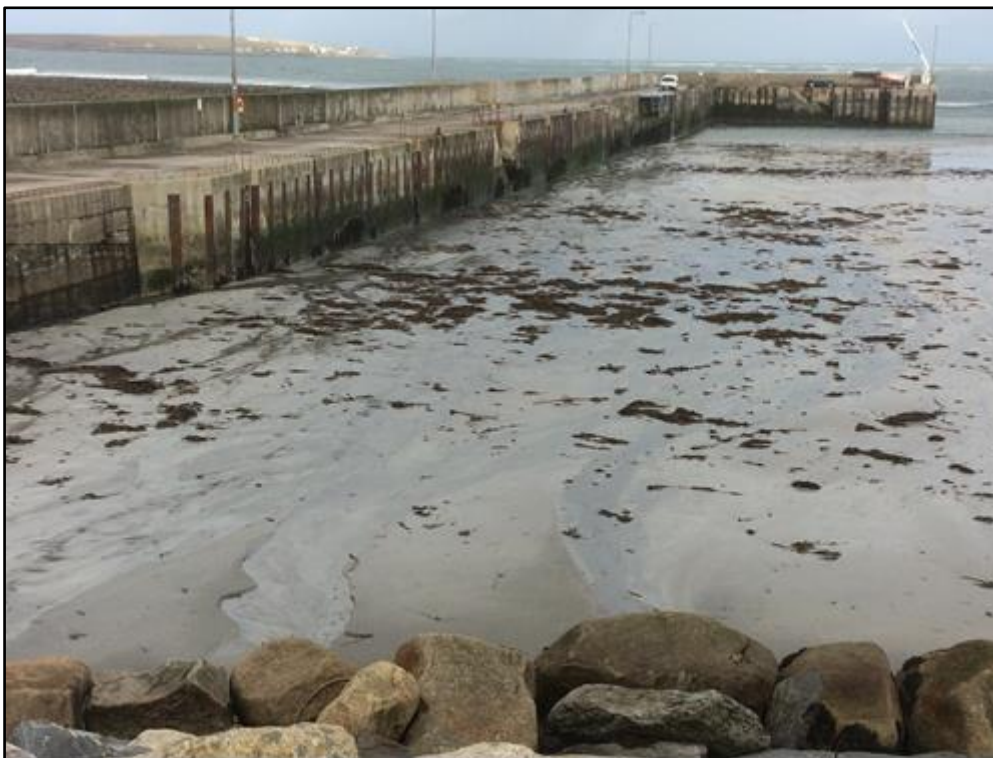
**Photograph 4:**  
**Site for dredging at Magheraroarty harbour (Pre-dredging) at low tide**

Photographs 4 to 5 illustrate the process of dredging carried out in previous campaigns.

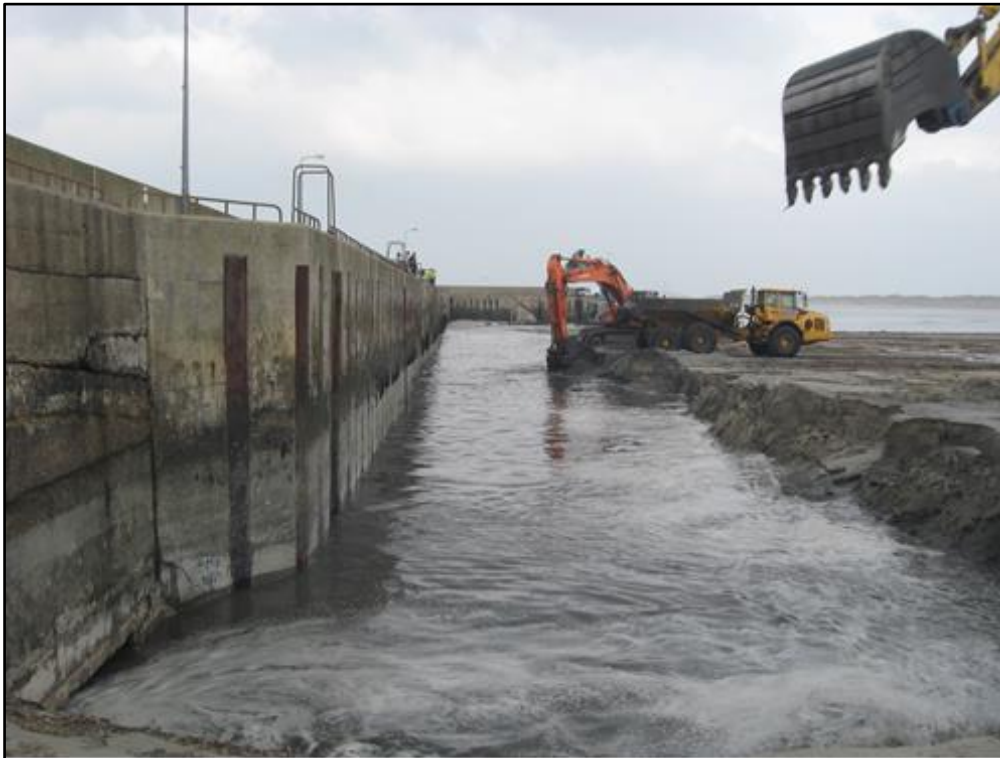
**Photograph 5:  
Site for dredging at Magheraroarty Harbour (during dredging)**

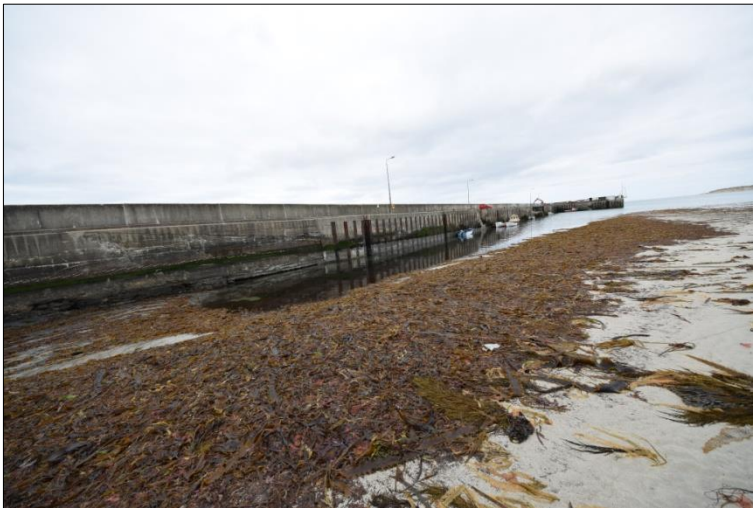
**Plate 2** The subject pier area was dredged prior to the visit. This was not known at the time of the visit and there was no visual evidence that dredging had taken place.

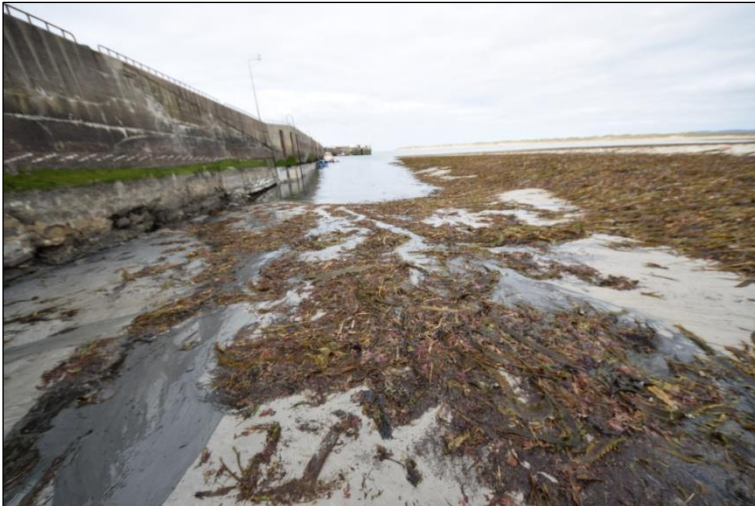
**Plate 4** The subject pier. Water quality / visibility was poor and there was a large accumulation of rotting seaweeds. Sediments were anoxic.

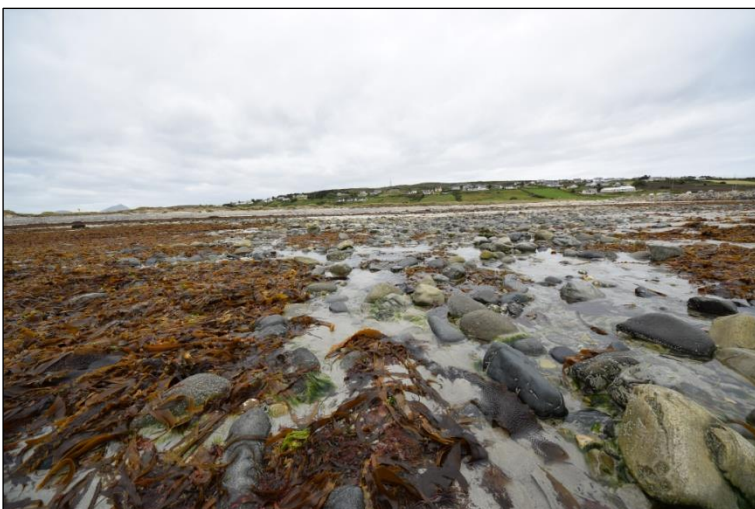
**Plate 6** Some localised mixed substrate on the beach (not affected by the dredging) has higher biodiversity than the subject transect areas.

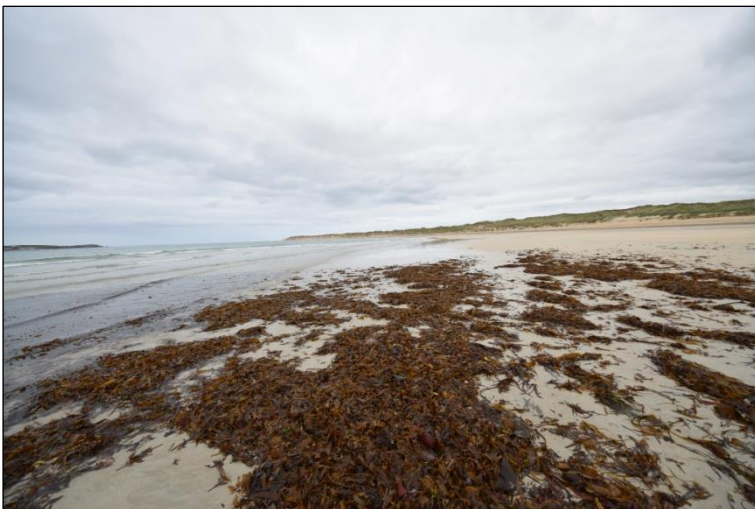
**Plate 8** Looking east to the 'beach nourishment area'. Sand and dead seaweed and very impoverished fauna.

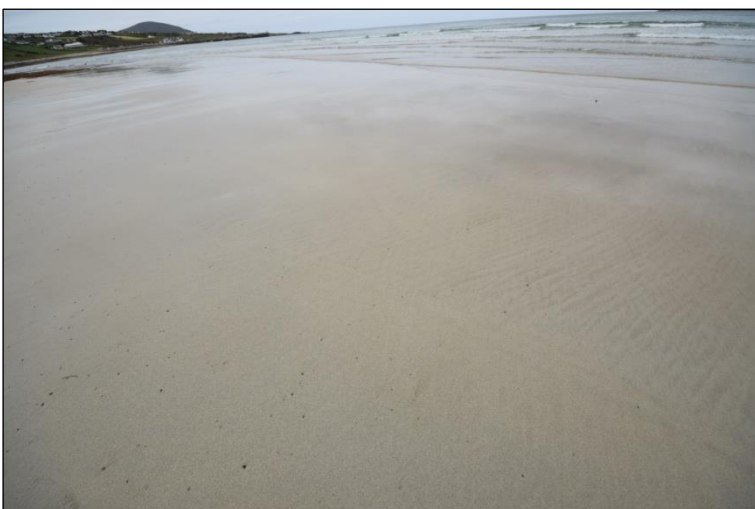
**Plate 9** The 'beach nourishment area'. It is understood that sand had been placed here immediately prior to the survey. But most areas of the beach had a very impoverished fauna.

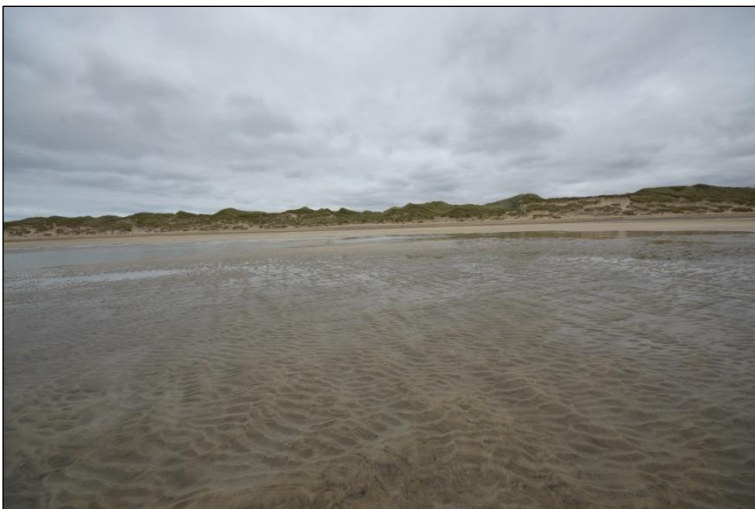
**Plate 11** Reference survey area at low tide on the 8<sup>th</sup> June 2020. This area was not disturbed but also had a very impoverished faunal community.

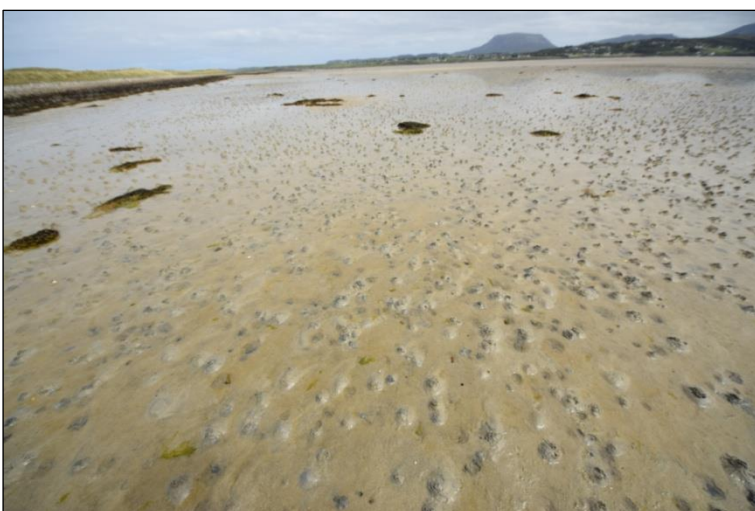
**Plate 15** The Ballyness Bay area – this area is significantly more important for marine intertidal fauna than the Magheraroarty beach area. Very high densities of *Arenicola marina* were present.
