# dublin array

An Offshore Wind Farm  
on the Kish and Bray Banks

Volume 3 of 5 - Appendix D  
Archaeological Impact Assessment

## **Archaeological Assessment for the Kish and Bray Banks Offshore Windfarm Development, Co. Dublin and Co. Wicklow**

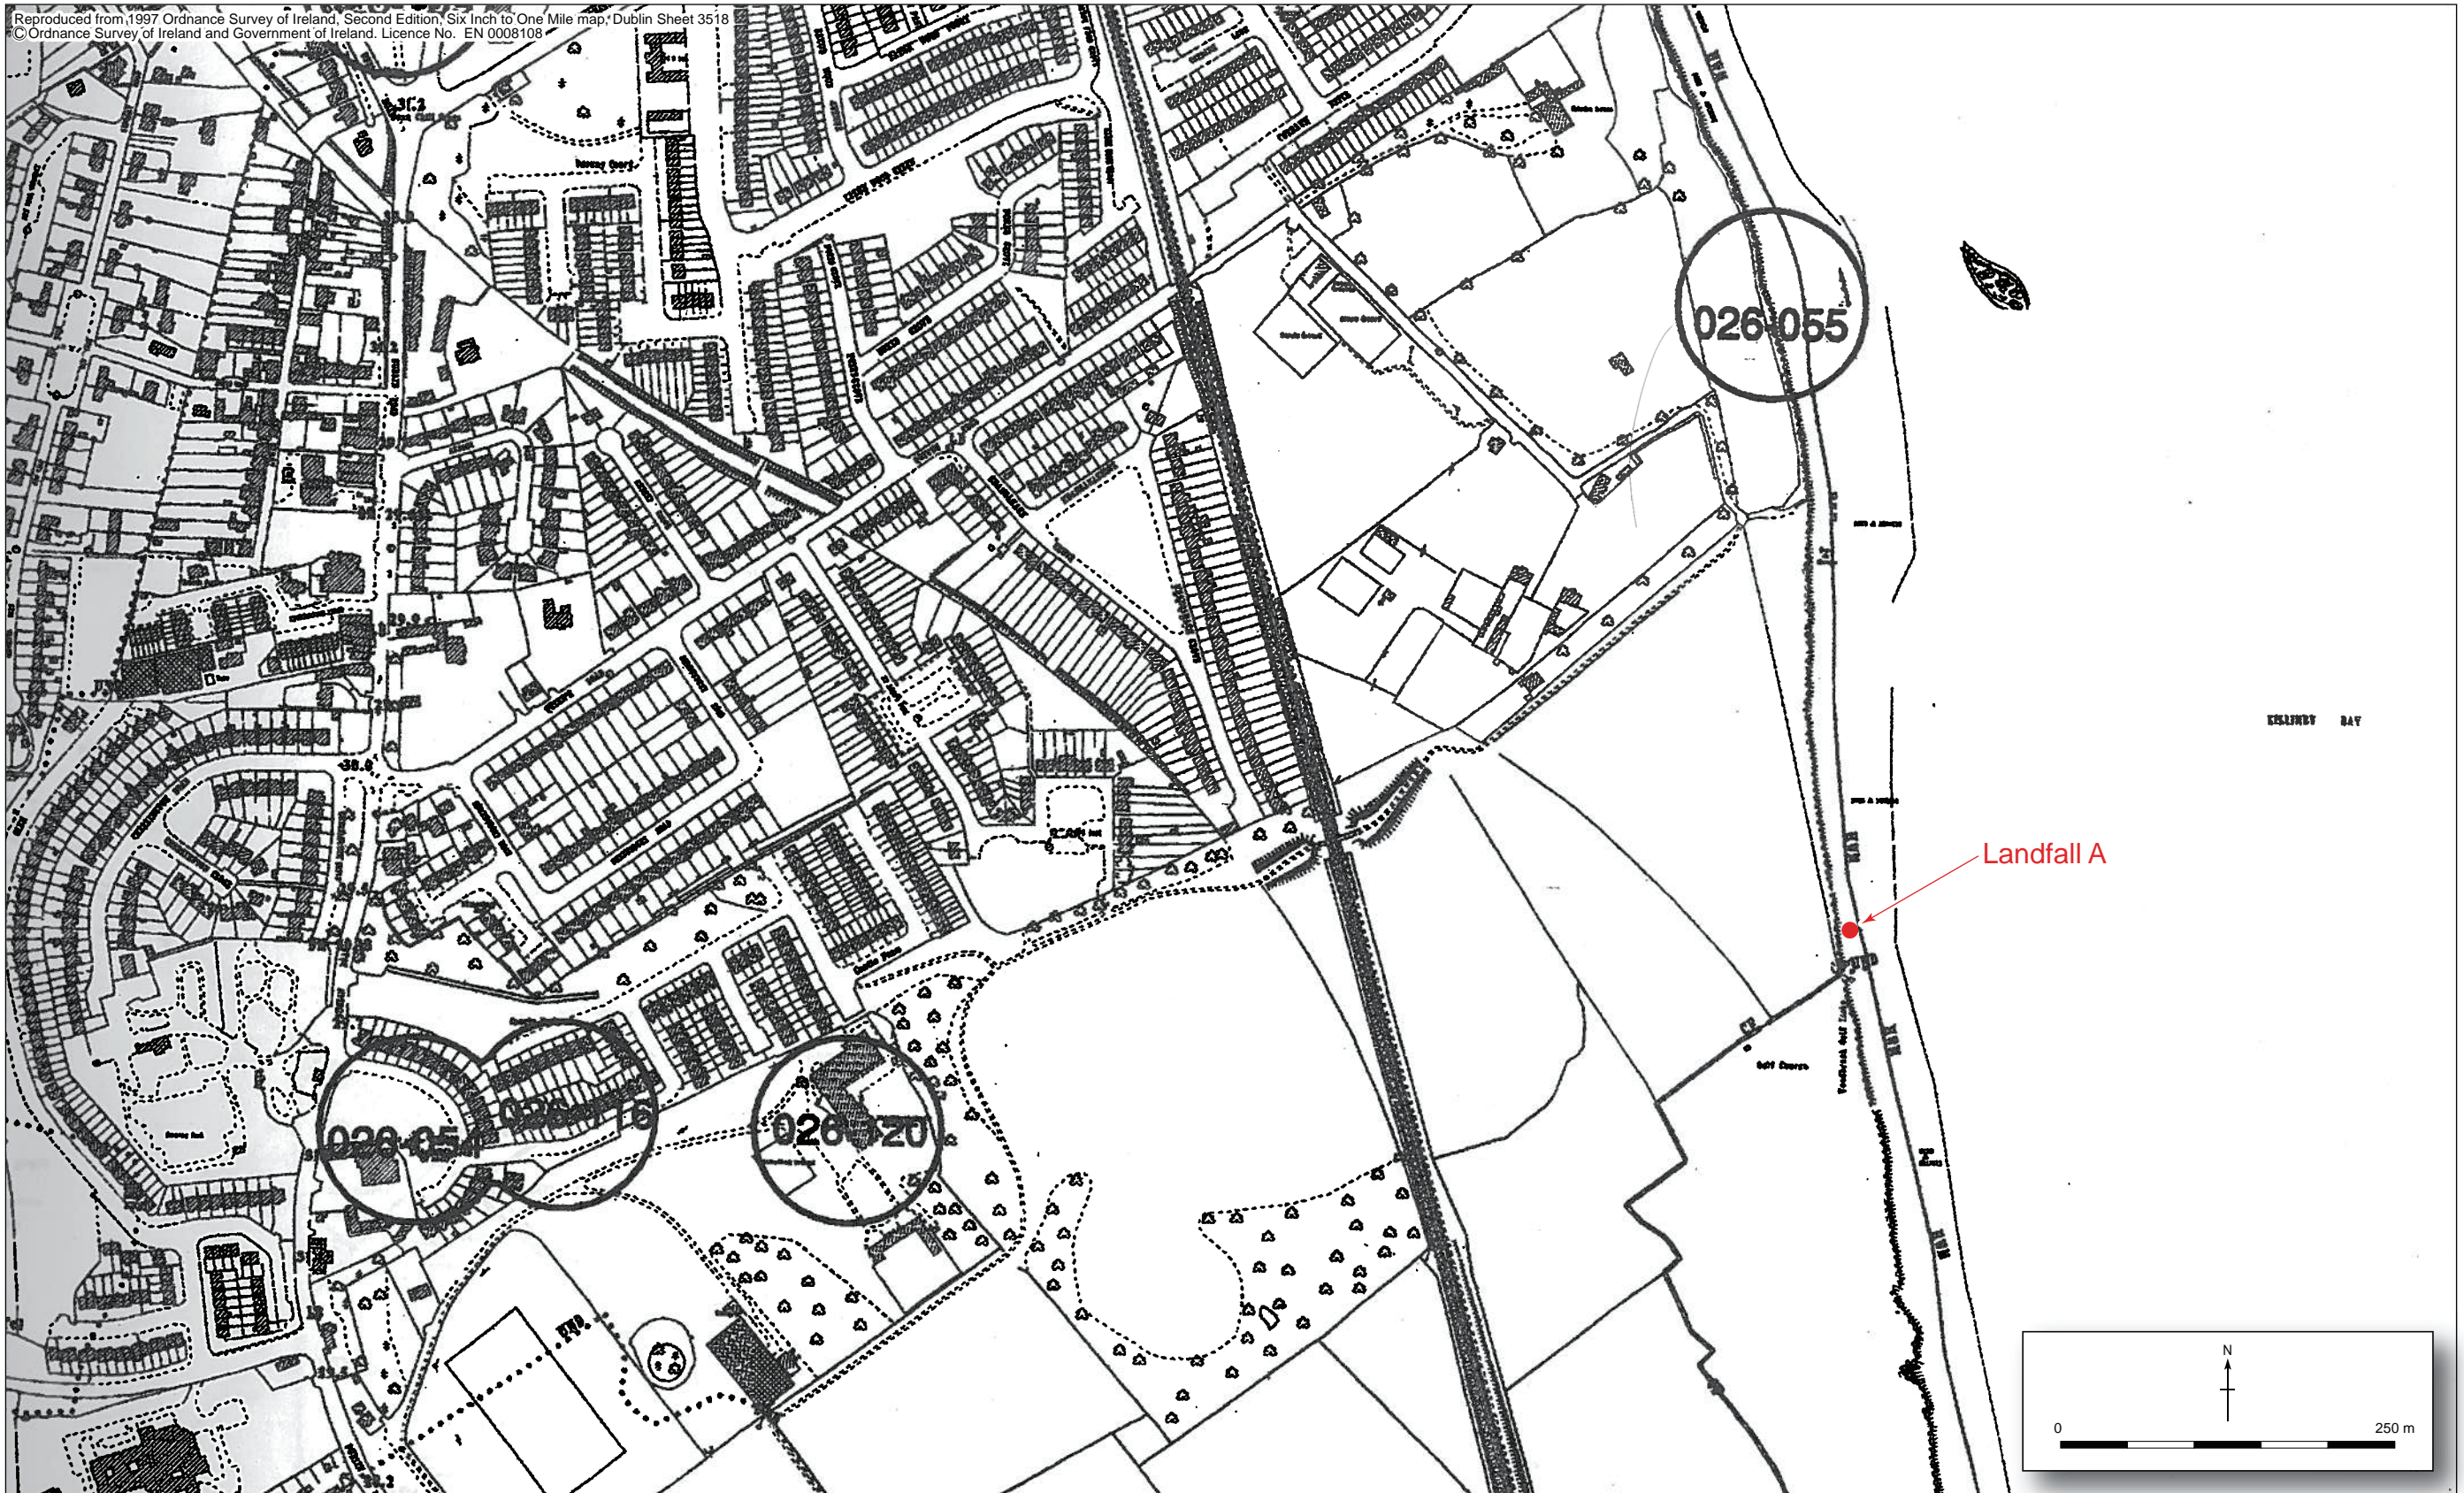
Figure 2 - The Kish and Bray Banks, Co. Dublin and Co. Wicklow: RMP map showing location of landfall site A

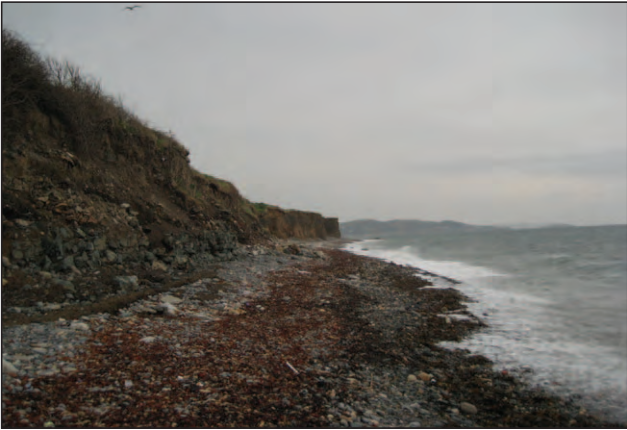
Plate 1 - Landfall A, Facing North

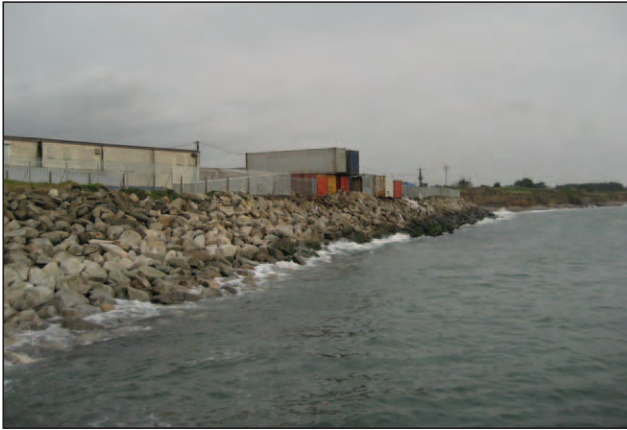
Plate 2 - Landafall B, Facing North

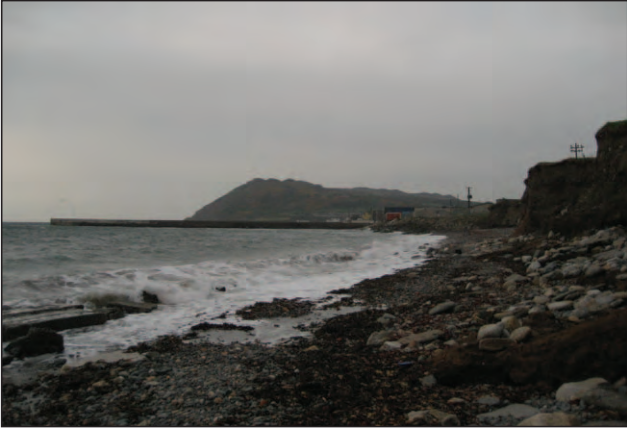
Plate 3 - Landfall B, Facing South

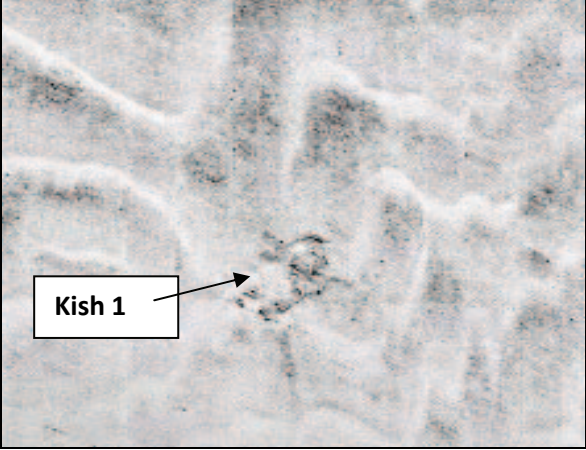
<b>Target Name</b>	<b>Description</b>
<b>Kish 1</b>

<p data-bbox="352 887 1369 1095"><b>Grid Position:</b> 338800E 229960N</p> <p data-bbox="352 943 1369 1095">This target lies in approximately 21 m water depth on a seabed characterised by sandwaves. The magnetometer values remain unchanged around this target. This target does not have any potential impact on the proposed positions of turbines.</p>
<b>Kish 2</b>

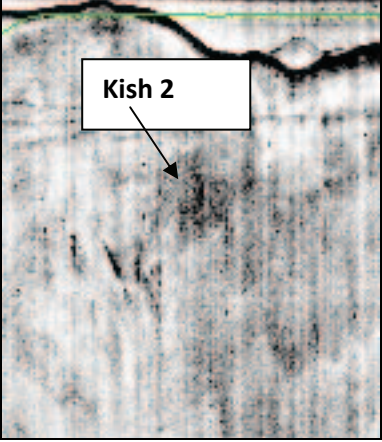
<p data-bbox="352 1563 1369 1816"><b>Grid Position:</b> 337320E 229875N</p> <p data-bbox="352 1619 1369 1816">This target lies in approximately 3.5 m water depth.</p> <p data-bbox="352 1675 1369 1704">There is no change in the magnetometer readings around this target.</p> <p data-bbox="352 1727 1369 1816">It plots 50 m west of the planned position for T2 and so this turbine may have to be moved.</p>

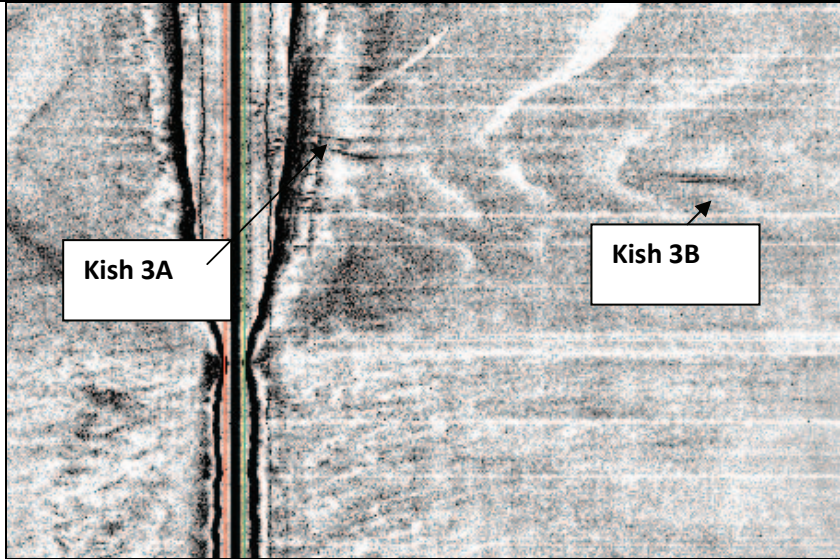
<p><b>Kish 3</b></p>

<p><b>Grid Position: Kish 3A</b> 337320E 228970N  <b>Kish 3B</b> 337820E 228920N</p> <p>These two targets lie in approximately 8.4 m water depth. There appears to be a slight change in magnetometer readings.</p> <p>These plot approximately 150–170 m north-west of the proposed position of T13. The general exclusion zone is in the region of 100 m.</p>
<p><b>Kish 4</b></p>

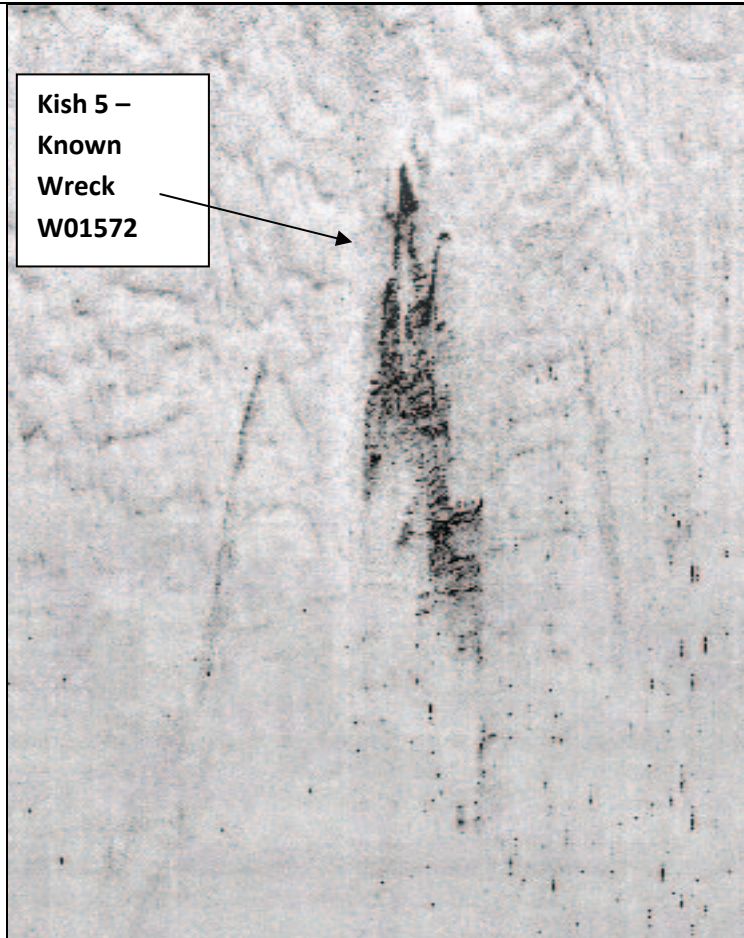
**Kish5**

**Grid Position:** 337930E 227565N

This corresponds with a Known Wreck (W01572) from the DOEHLG files. It appears to be lying in 5 m water depth. This wreck is called the *Glenorchy* and dates back to 01/01/1869. According to the DOEHLG records it became a wreck on its maiden voyage from Greenock to Bombay. Its cargo was coal and railway sleepers. There is a noticeable reaction from the magnetometer.

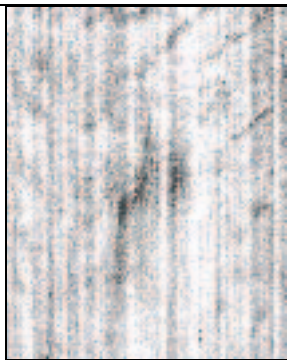
<p><b>Grid Position:</b> 338490E 226810N.</p> <p>This target lies in approximately 5 m water depth. There was no change in the magnetic signature. However it plots approximately 160 m to the south-west of a Known Wreck (W01594). Based on this an exclusion zone has been annotated around these targets.</p> <p>T33 plots approximately 100 m west of the bottom left of this exclusion zone and T34 plots approximately 20 m west of bottom right hand corner. These should pose no potential impact.</p> <p>W01594 Vesper 13/01/1876. 10 year old iron screw steamer. Became stranded on the Kish bank. Vessel broke up.</p>
<p><b>Kish 7</b></p>

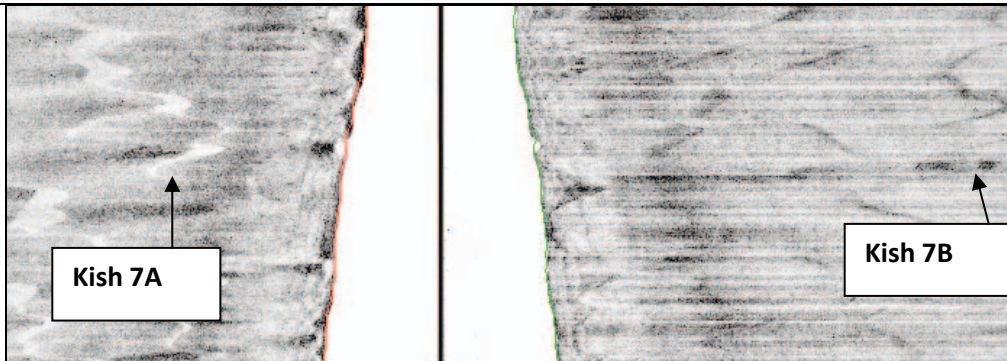
<p><b>Grid Position: Kish 7A</b> 339000E 226515N  <b>Kish 7B</b> 339005E 226385N</p> <p>No change in the magnetic signature. These targets lie in 18–19 m water depth. There does not appear to be any impact on any planned turbines.</p>

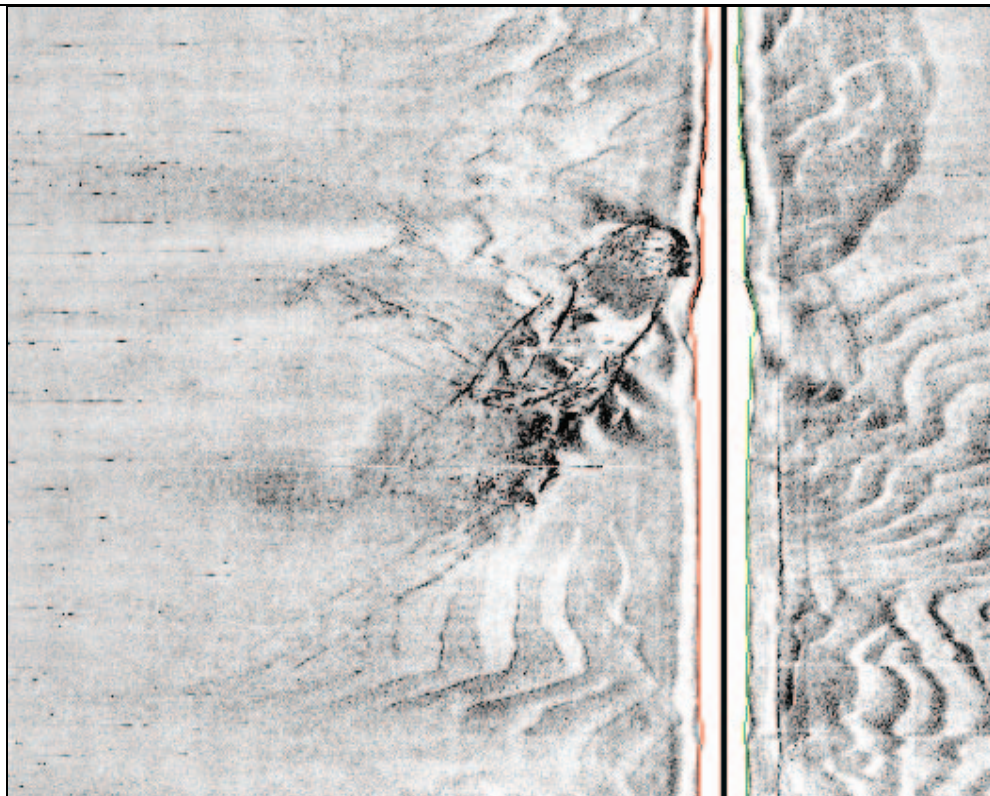
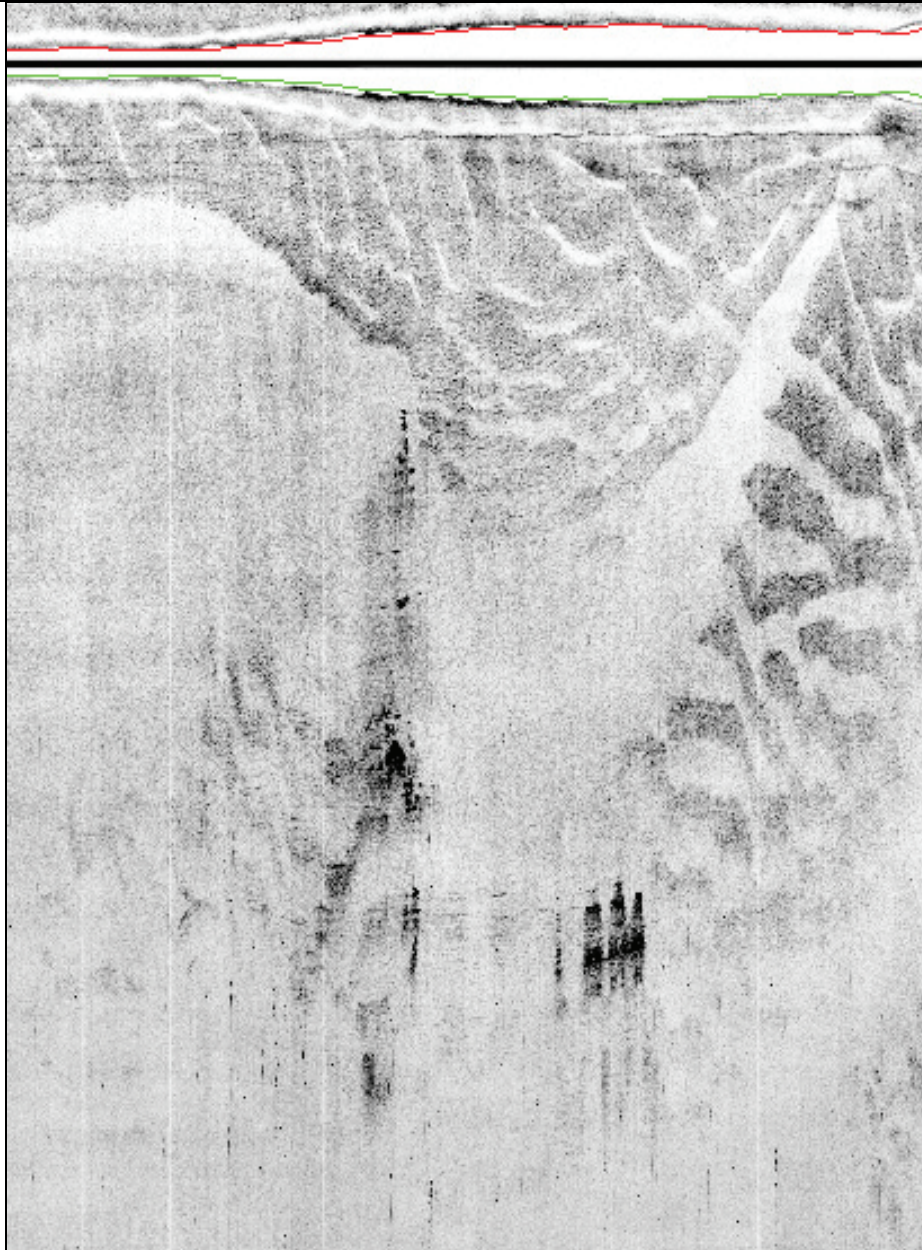
**Kish 8**

**Grid Position:** Middle of Wreck 338440E 226120N. Lies in approximately 7.7 m water depth.

**View of wreck from the adjacent survey line.**

There also appears to be a number of smaller targets that plot in the vicinity of this wreck. These have all been annotated on the interpretation charts. An exclusion zone has also been annotated on the charts to encompass all of these targets.

It would appear more than likely that these are all related to the Known Wreck W01630. The name of this is unknown and it dates around the mid-19<sup>th</sup> century. It is described as a wooden wreck discovered in 2003. The wreck is upside down. The hull is copper sheeted, and so would cause a significant response from the

<p>magnetometer. There is pottery strewn around this which is probably what all the little targets are and why there is no change in magnetic signature at these points.</p> <p>This suggests that the recorded position of this wreck may need to be adjusted.</p> <p>Based on the exclusion zone and targets the proposed location for T38 needs to be changed.</p>
<p><b>Kish 9</b></p>

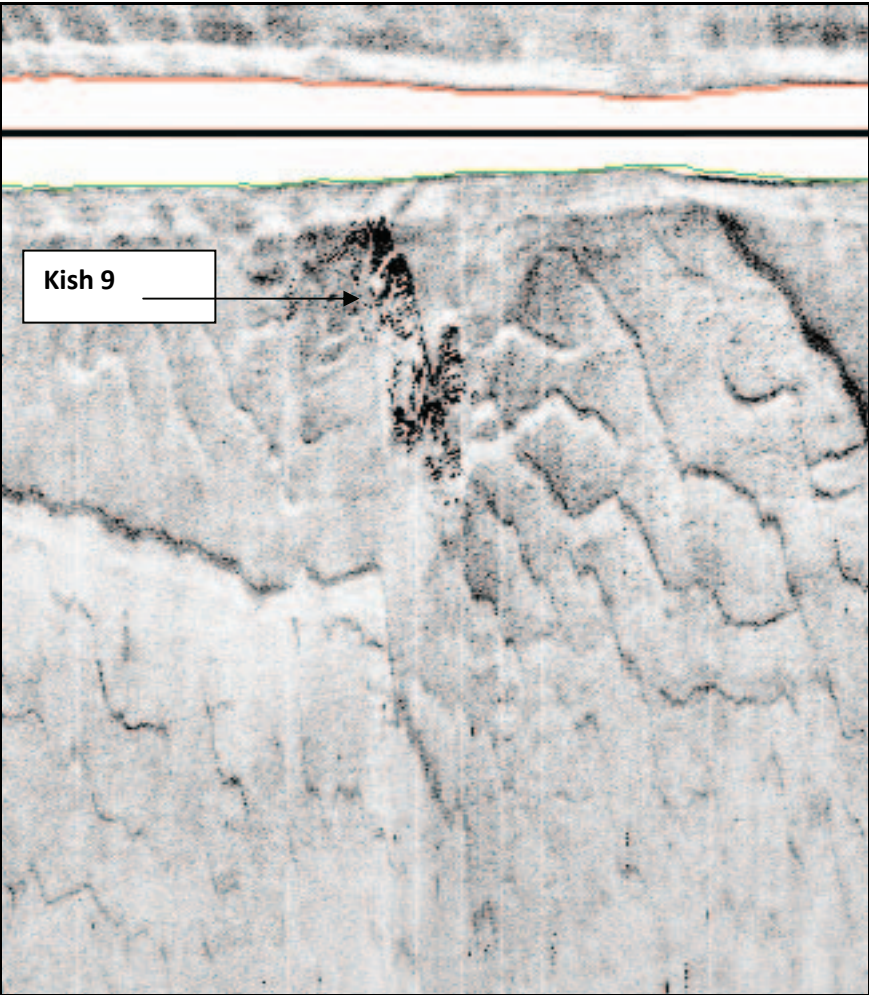
<p><b>Grid Position:</b> 338490E 225519N.</p> <p>This target plots on the position given for Known Wreck W01629.</p> <p>It lies in 7.8 m water depth. An exclusion zone has been annotated around this target.</p> <p>The nearest turbine, T43 plots approximately 25 m to the north of the edge of this zone, so should pose no potential impact.</p> <p>W01629, unknown name remains of a 300–400 ton wooden vessel. Pottery, clay pipes, iron pots, anchors, a capstan and winch were recorded on the wreck site. <i>May</i></p>

<p><i>be Sir Charles Napier.</i></p> <p>There was no noticeable reaction from the magnetometer in the vicinity of this target.</p>
<p><b>Kish 10</b></p>

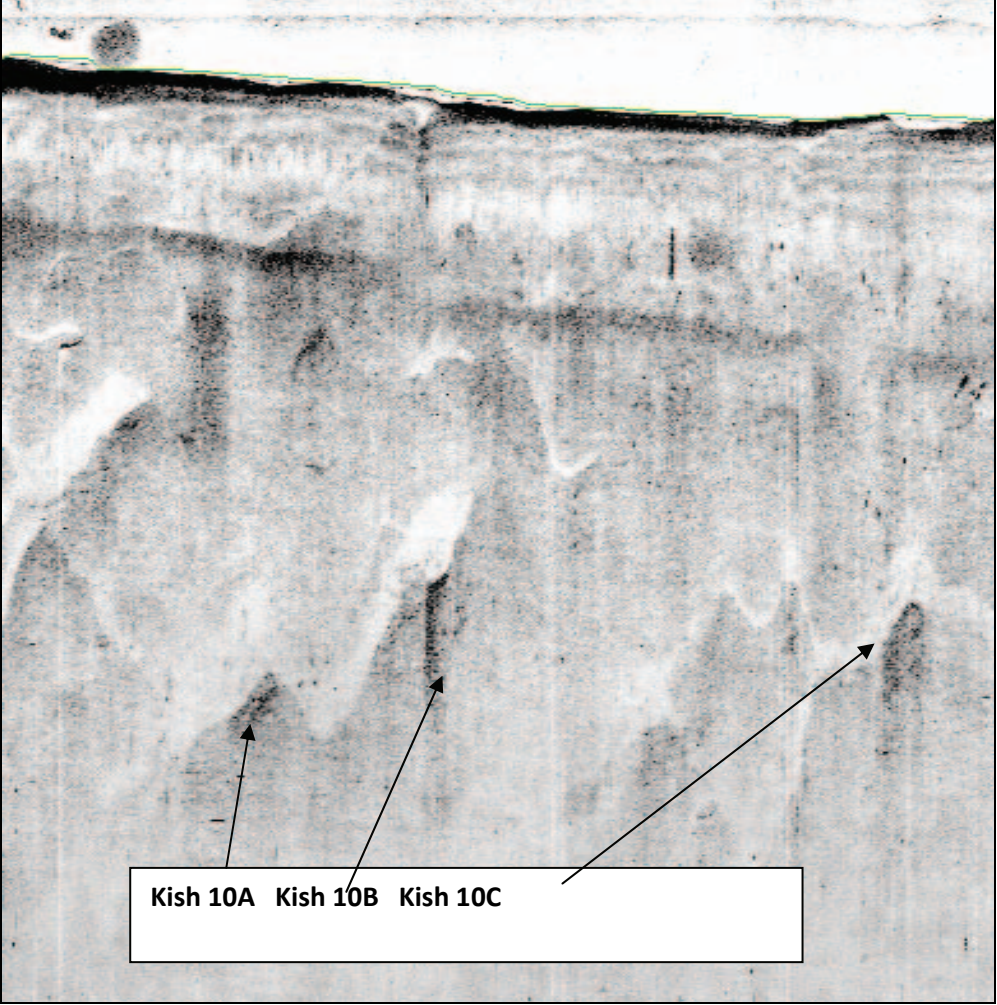
<p><b>Grid Positions:</b> Kish 10A 339400E 225170N          Kish 10B 339434E 225145N          Kish 10C 339575E 225150N</p> <p>An exclusion zone has been put around these targets. They lie in water depths ranging from 18–25 m.</p> <p>There may be a possible impact on the positioning of T50.</p>

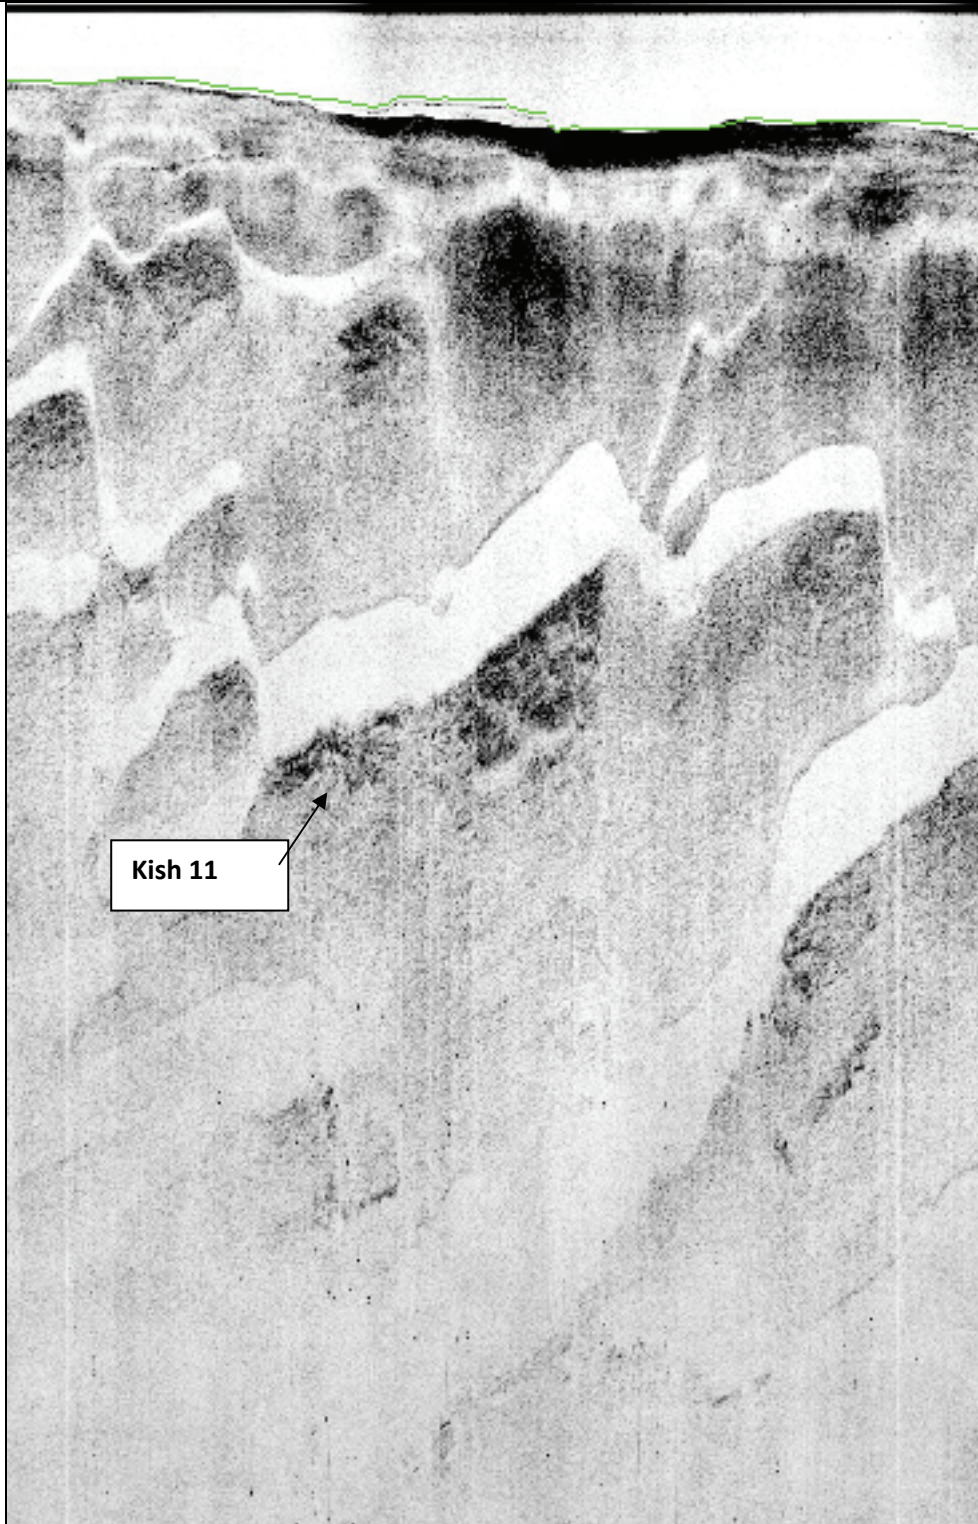
**Kish 11**

**Grid Position:** 337671E 224527N

No reaction from the magnetometer. Lying in approximately 19 m of water. The proposed position of T51 is 100 m to the north-east of this target.

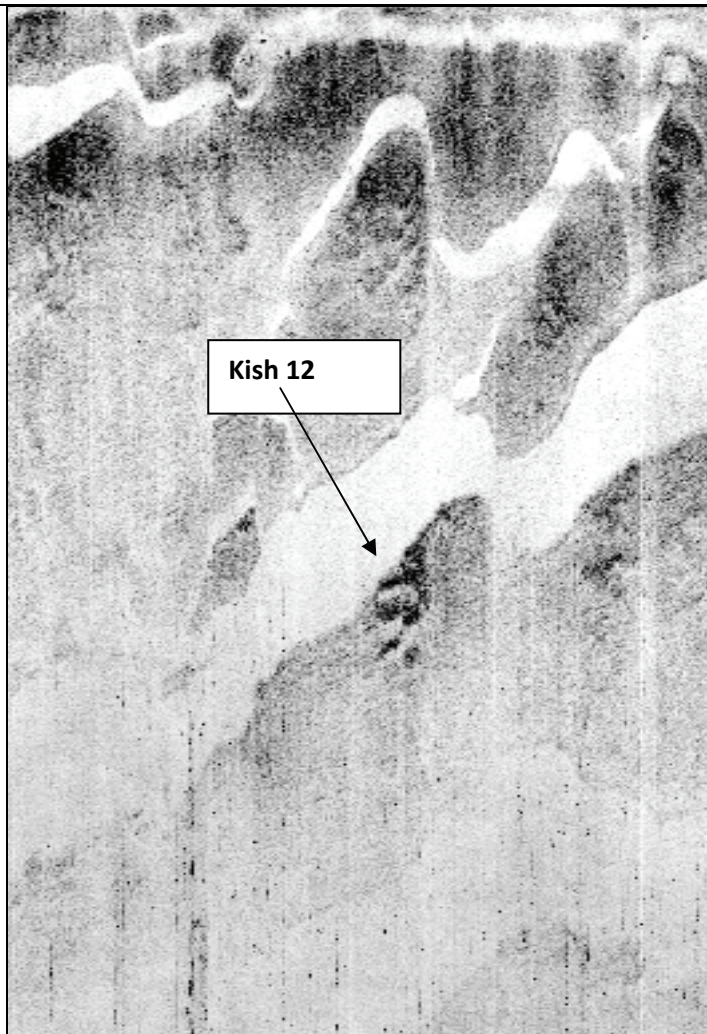
**Kish 12**

**Grid Position:** 337724E 224260N. Lies in 20 m water depth. There was no reaction from the magnetometer. There are no turbines planned in this location.

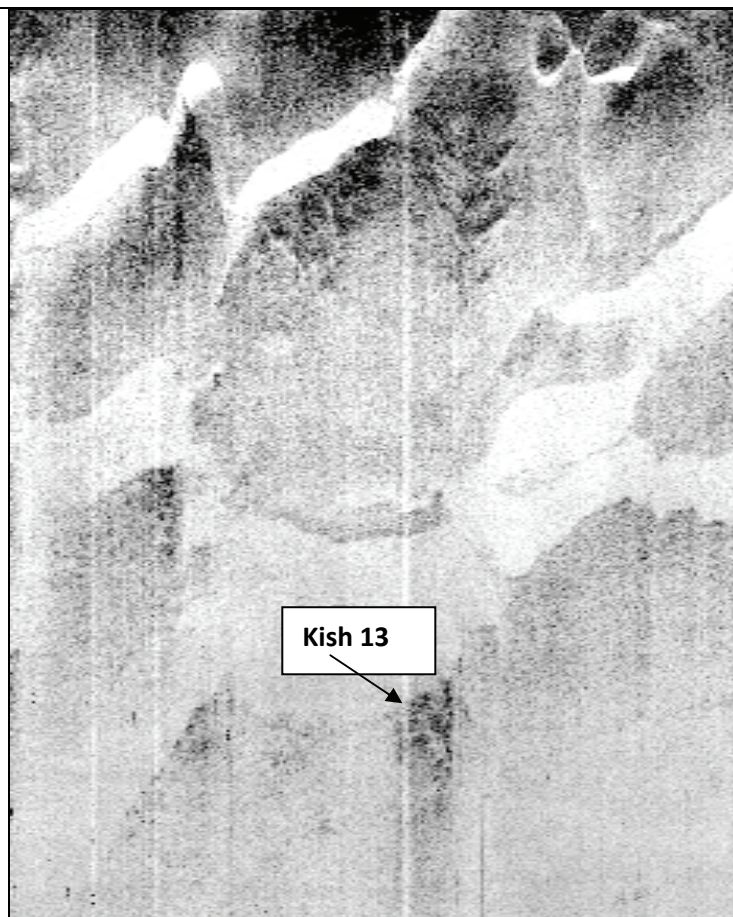
**Kish 13**

**Grid Position:** 337605E 223985N

Water depth 21 m, no reaction from the magnetometer. The planned location of T56 is approximately 35 m east of this target and so has a potential to impact and needs to be adjusted.

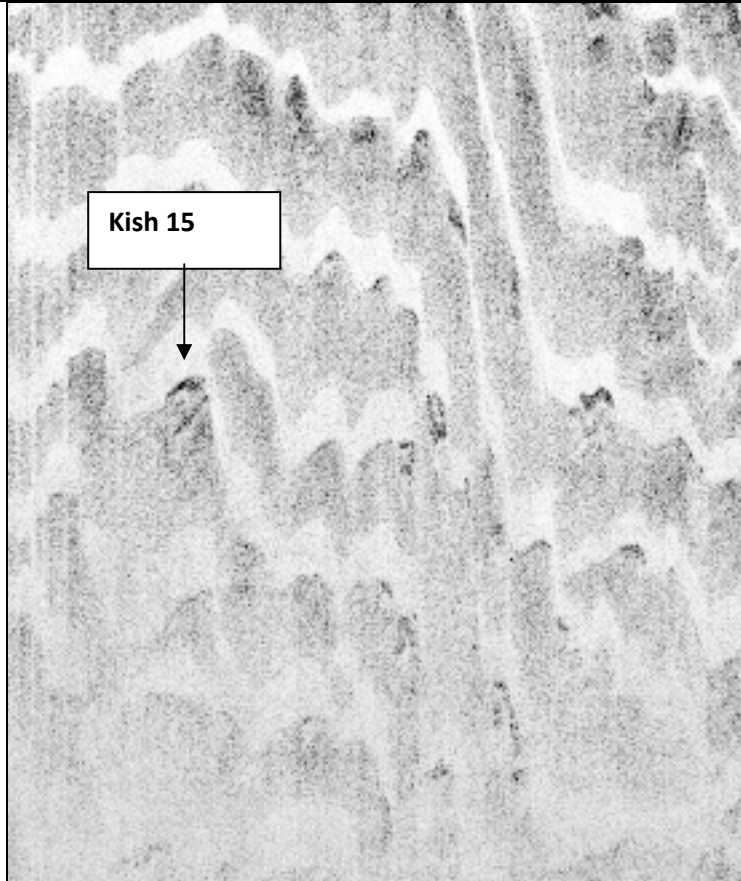
**Kish 15**

**Grid Position:** 339155E 221560N

Lying in approximately 14.5 m water depth. There appears to be a slight change in magnetometer readings. However there are no turbines planned for this area.

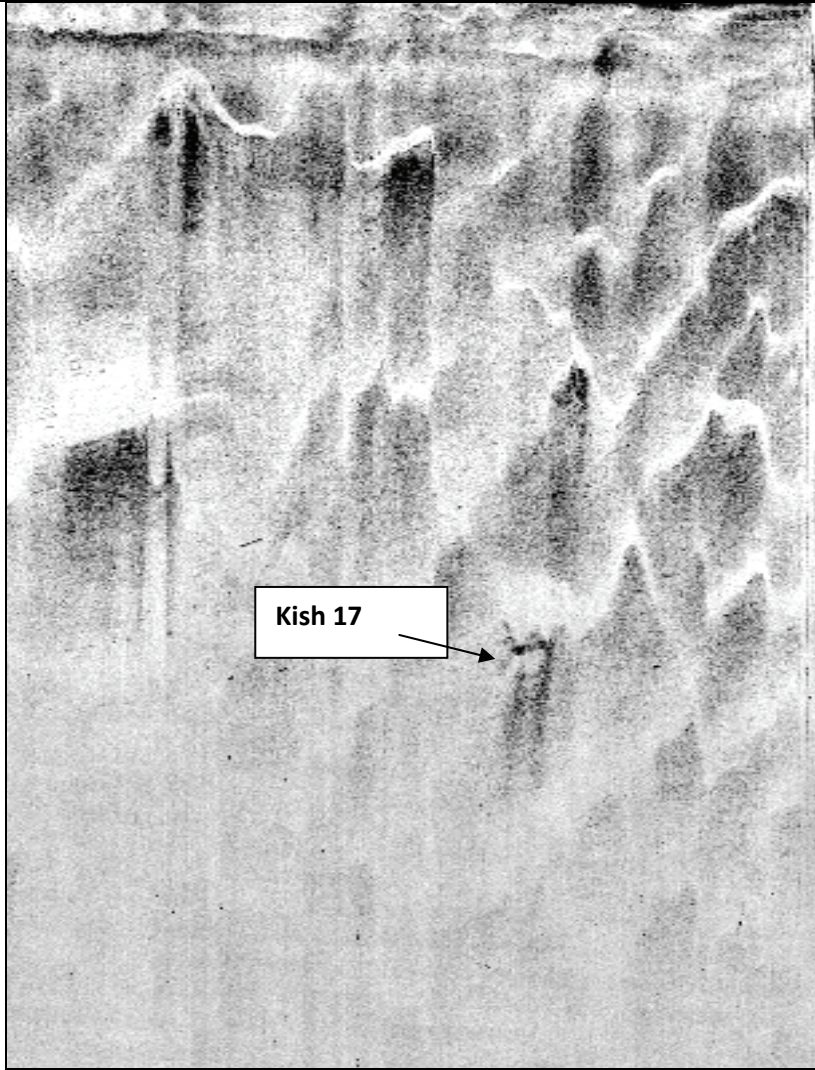
**Kish 17**

**Grid Position:** 340365E 218395N

No change in magnetometer readings and no turbines are planned near it.

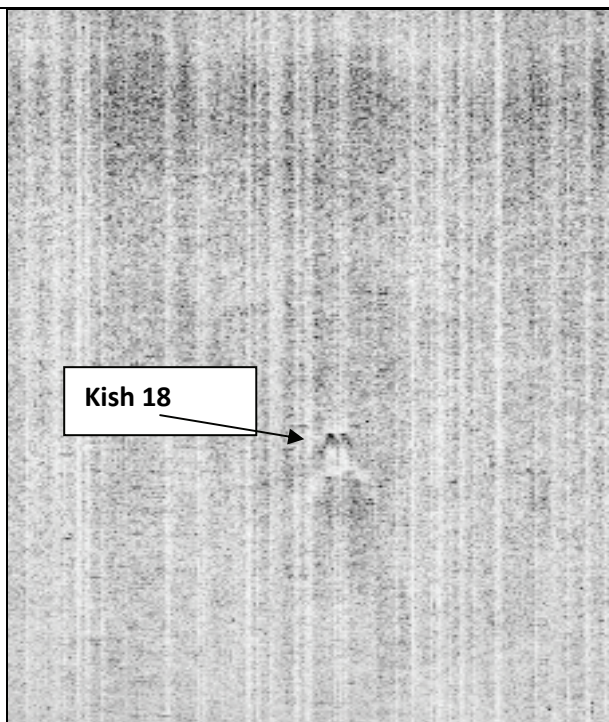
**Kish 18**

**Grid position:** 341243E 218096N

A height of this target has been measured based on calculations performed within the processing program. This object is estimated to have a height of 2.7 m. It is lying in 33 m water depth. There was no reaction observed from the magnetometer.

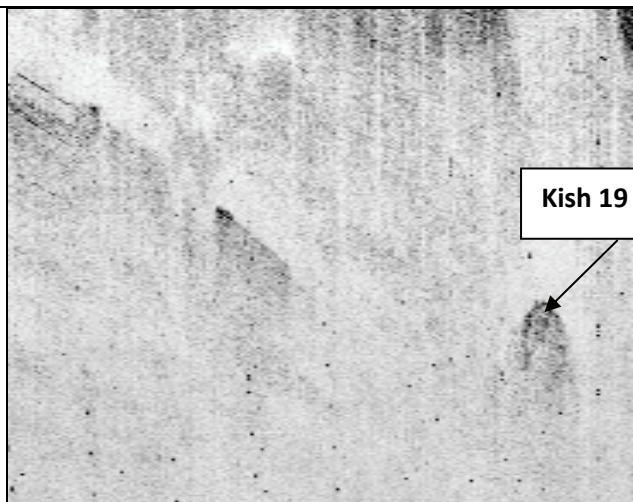
**Kish 19**

**Grid Position:** 340315E 217045N

In 15.6 m water depth. No change in magnetometer readings. No planned turbines anywhere near this target.

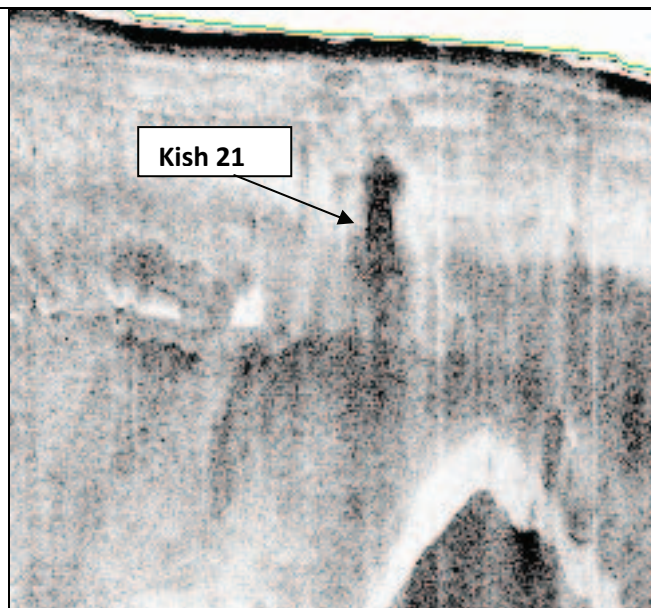
**Kish 21**

**Grid Position:** 340495E 215765N

Lying in 23 m water depth there was no reaction from the magnetometer. The nearest planned turbine is 140 m north-east of this target.

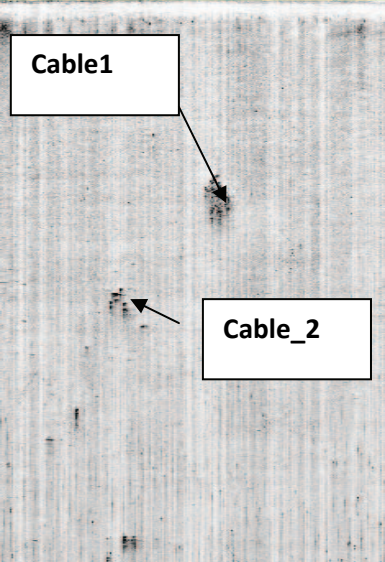
<p><b>Grid Position: Cable_1</b> 326983E 219774N <b>Cable_2</b> 326954E 219801N</p> <p>These two targets lie in approximately 2.1 m water depth. They are outside the range of the magnetometer survey. They lie on a featureless seabed and are over 120 m away from the proposed cable route.</p>

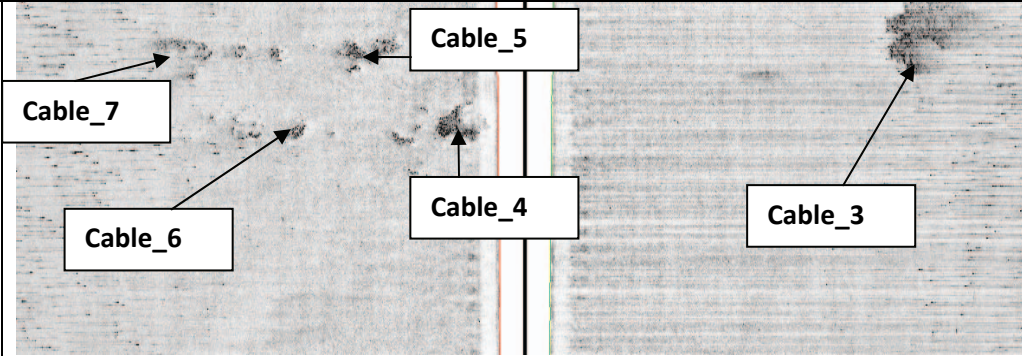
<p>Cable_3 Cable_4 Cable_5 Cable_6 Cable_7</p>

<p><b>Cable_3 Grid Position:</b> 327128E 219526N</p> <p><b>Cable_4 Grid Position:</b> 327167E 219605N</p> <p><b>Cable_5 Grid Position:</b> 327200E 219595N</p> <p><b>Cable_6 Grid Position:</b> 327188E 219633N</p> <p><b>Cable_7 Grid Position:</b> 327225E 219613N</p> <p><b>Cable_3</b> Dark area surrounded by otherwise light and smooth seabed. Magnetometer values at this location are not significant and are likely to reflect the characteristics of the natural geology in the area.</p> <p><b>Cable_4 – Cable_7</b> This comprises of a cluster of small targets. These may represent natural rock outcrops. Water depths are 3.6–4.4 m C.D. in the vicinity. There are no significant changes in magnetometer readings in the vicinity.</p>

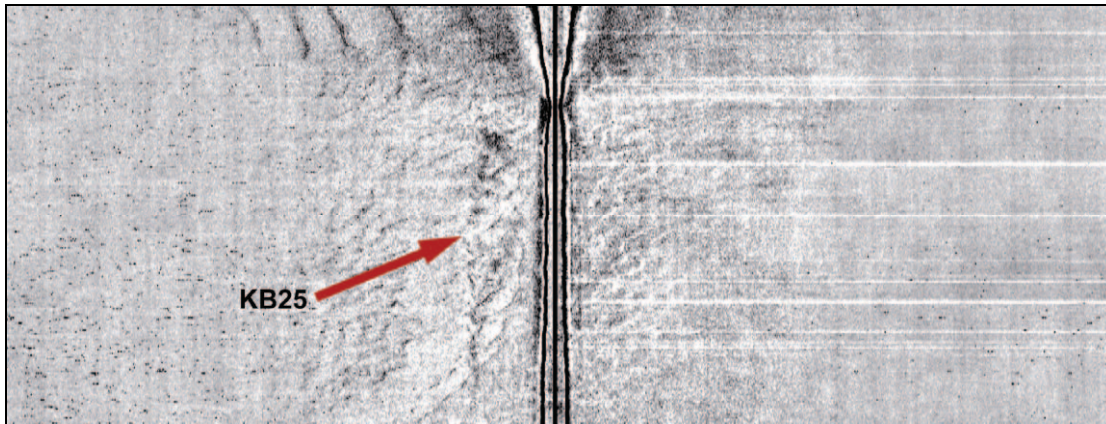
**KB 25**

This potential target represents a linear spread approximately 50 m long by 10 m wide with a possible linear extension roughly 25 m in length. The target is included within the 100 m exclusion zone in association with Kish 3A and Kish 3B as identified by HSL.

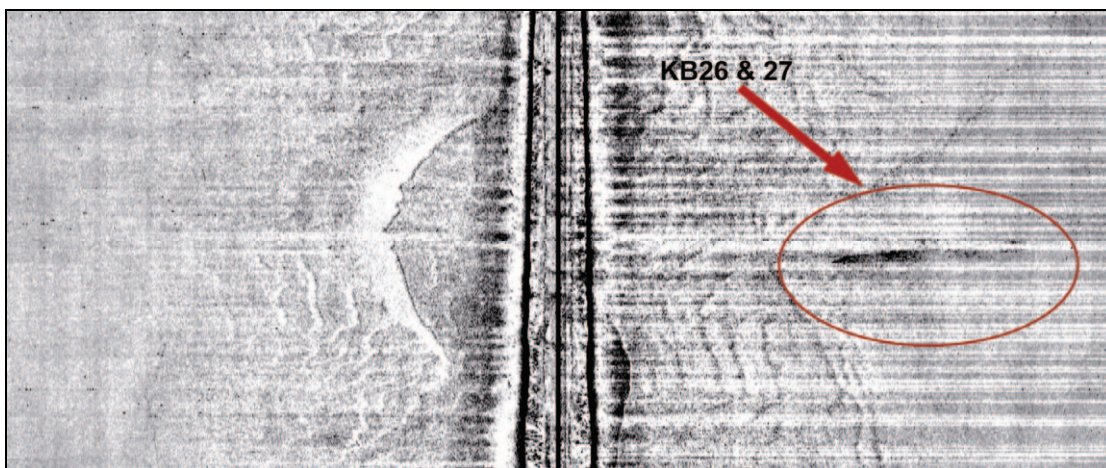
**KB 26 & 27**

These potential targets appear to represent objects that are possibly associated with Kish 8 as identified by HSL. KB 26 represents a linear spread approximately 40 m long by 5–10 m wide. KB 27 represents a possible object several meters long by no more than one meter wide. Kish 8 represents the known wreck WO1630. The targets are included within an exclusion zone established by HSL.

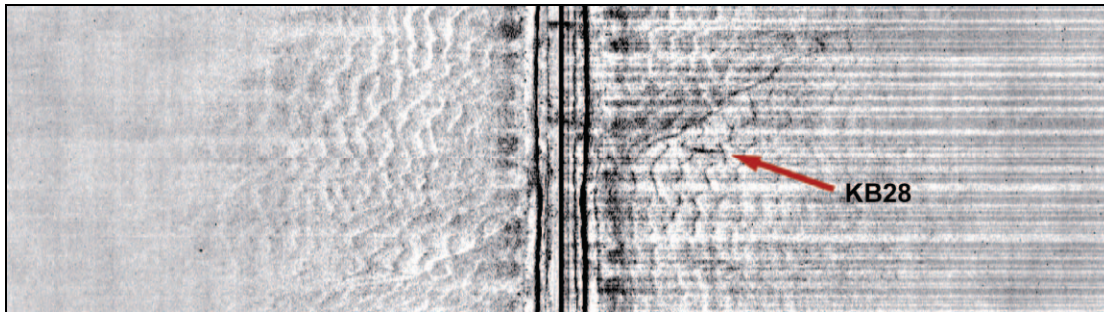
**KB 28**

This potential target represents a possible object approximately 10 m long by 1–2 m in width. This object is in close proximity to Kish 6 identified by HSL and the known wreck WO1594. This target falls within an exclusion zone established by HSL.

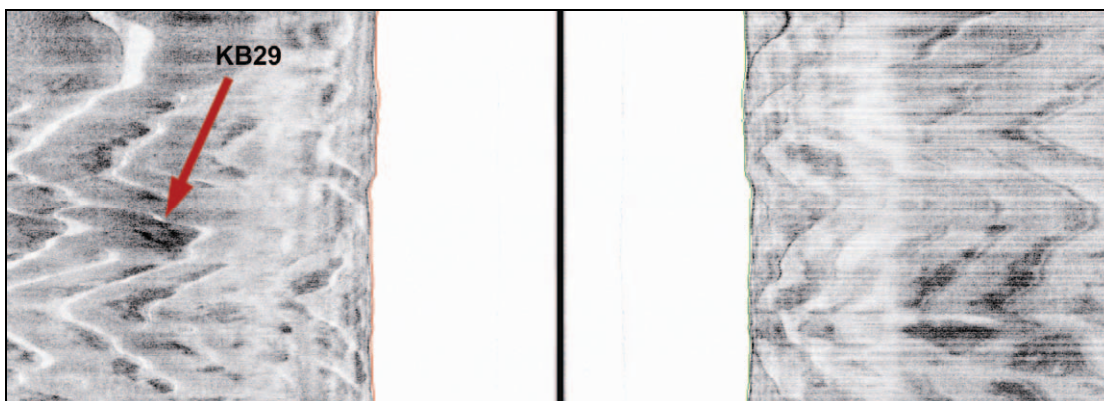
**KB 29**

This target represents a dark oval spread approximately 5–10 m long and 3–4 m in width. Although the target did not cause a reaction with the magnetometer the precautionary principle should be employed as a safeguard against possible impact on a feature of cultural heritage interest. This potential target may have an impact on the positioning of T94.

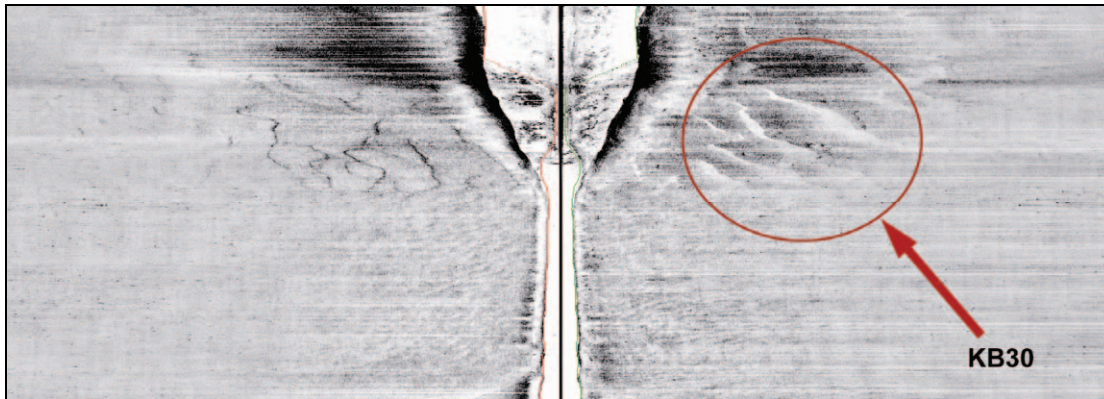
**KB 30**

These targets represent a number of possible objects located within an area approximately 60 m by 60 m. At least six objects were identified although there was no reaction with the magnetometer. Similar to KB29, the precautionary principle should be employed in this instance.

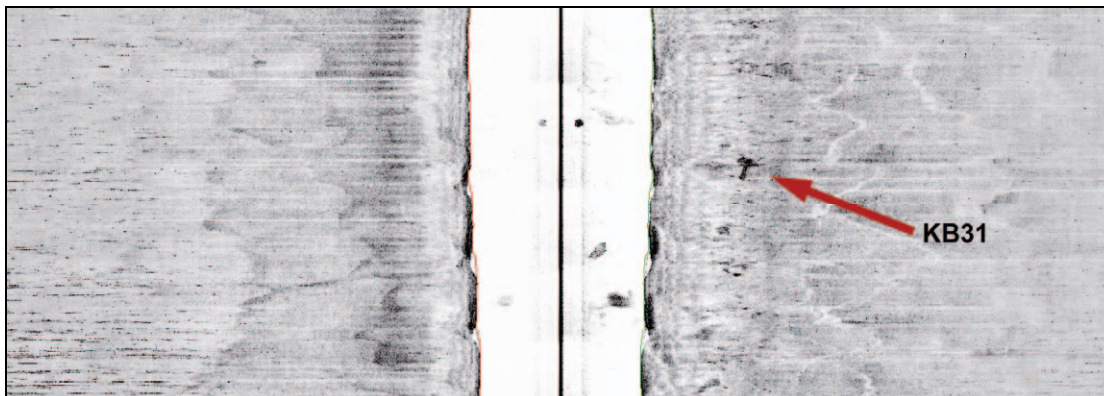
**KB 31**

The target identified as KB31 represents a possible object noted as a T-shape several meters in length. There was no signal on the magnetometer, although the precautionary principle should be employed in this instance.

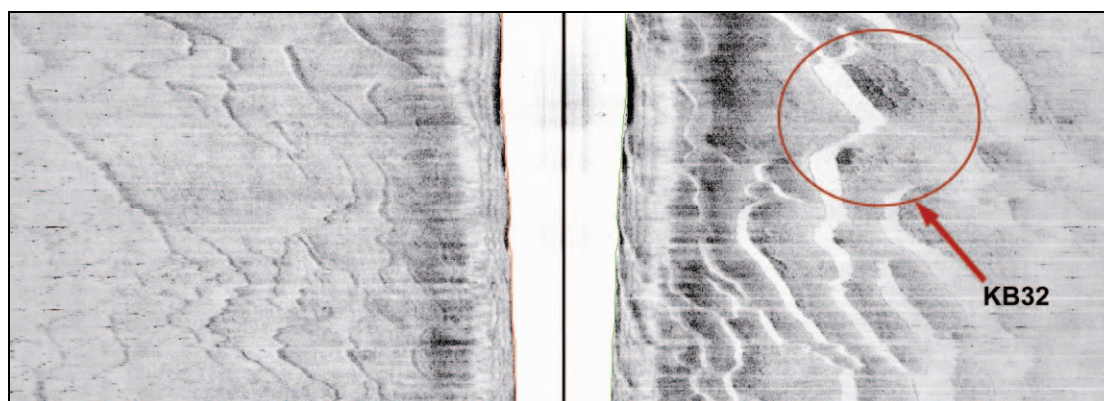
## KB 32

KB 32 represents two possible objects located within close proximity to one another. The first looks like a roughly circular object approximately 5–10 m in diameter; the second represents two parallel lines approximately 30 m long by 10 m wide.

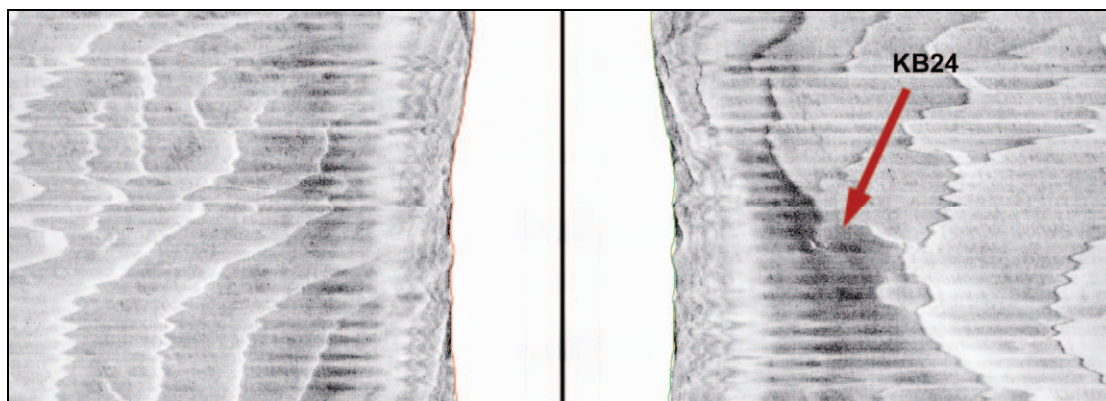
This target was identified approximately 100 m outside the survey area and represents a dark roughly oval spread approximately 30 m by 10 m. There also appears to be a possible object associated with the target. This has been included in the results in keeping with the 'precautionary principle' due to the proximity of the target to the survey area boundary.
