# dublin array

An Offshore Wind Farm  
on the Kish and Bray Banks

Volume 3 of 5 - Appendix D  
Archaeological Impact Assessment

## **Archaeological Assessment for the Kish and Bray Banks Offshore Windfarm Development, Co. Dublin and Co. Wicklow**

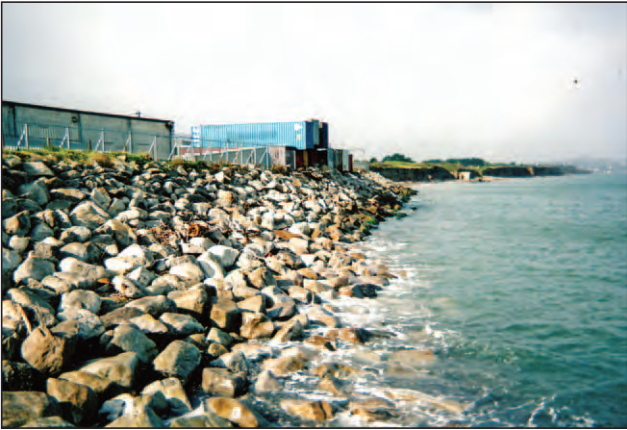
Plate 12.1 - Wave break protecting the compound looking north towards Landfall B

Plate 12.1 – Wave break protecting the compound looking north towards Landfall B

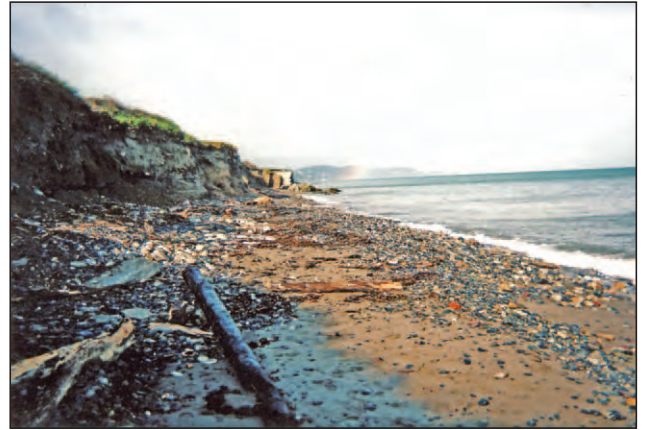
Plate 12.2 - View from behind the compound looking north up the beach from Landfall B

Plate 12.2 – View from behind the compound looking north up the beach from Landfall B

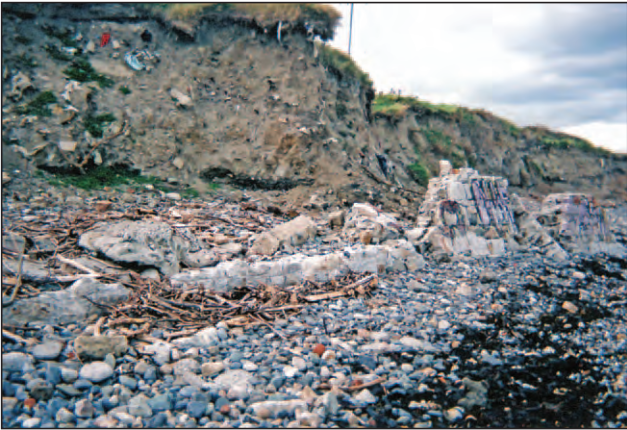
Plate 12.3 - View of consolidated ground with refuse inclusions and the remains of the embankment wall in the foreground, Landfall B

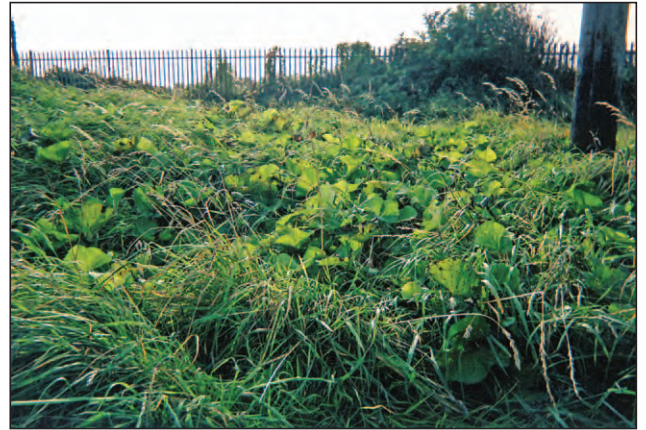
Plate 12.4 - Deep vegetation adjacent to landfall B looking northwest

Plate 12.4 – Deep vegetation adjacent to Landfall B looking northwest

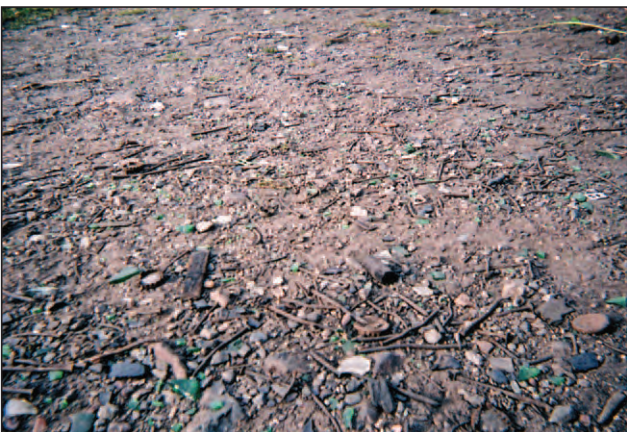
Plate 12.5 - Photograph showing the degree of litter in the area surrounding Landfall B

Plate 12.5 – Photograph showing the degree of litter in the area surrounding Landfall B

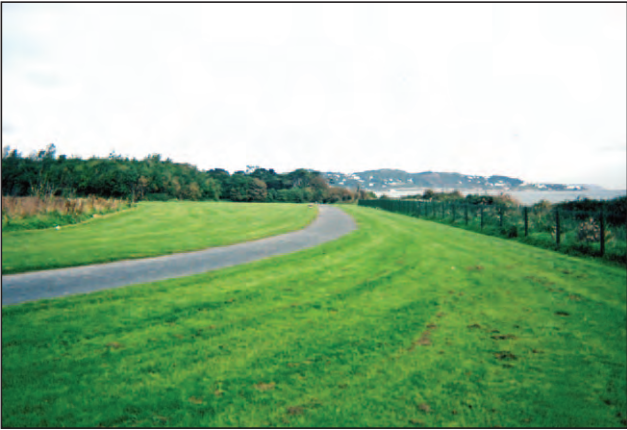
Plate 12.6 - View northwards from the proposed location for Landfall

Plate 12.6 – View northwards from the proposed location for Landfall A

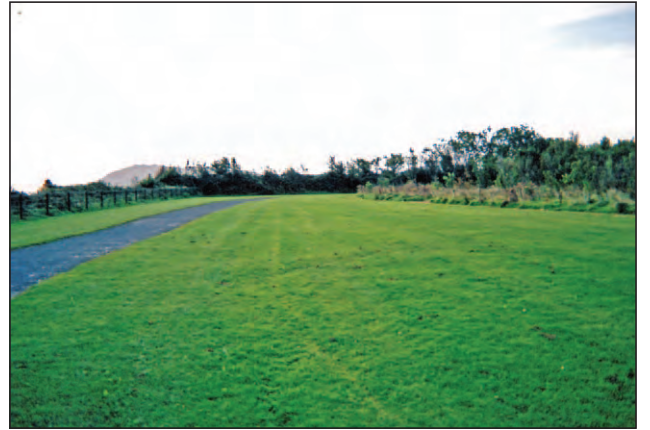
Plate 12.7 - View southwards from the proposed location for Landfall A

Plate 12.7 – View southwards from the proposed location for Landfall A

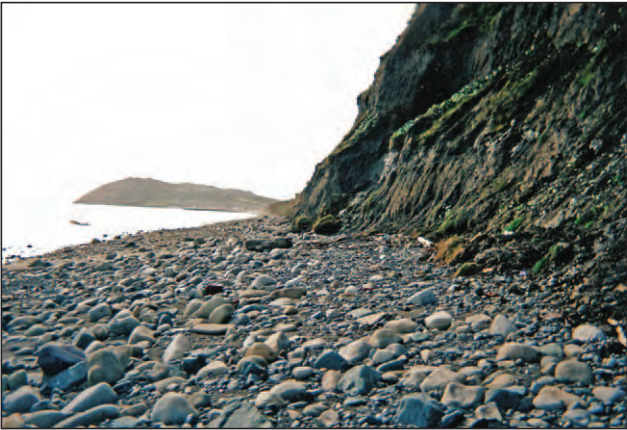
Plate 12.8 - View Southwards from immediately below Landfall A showing cliff erosion

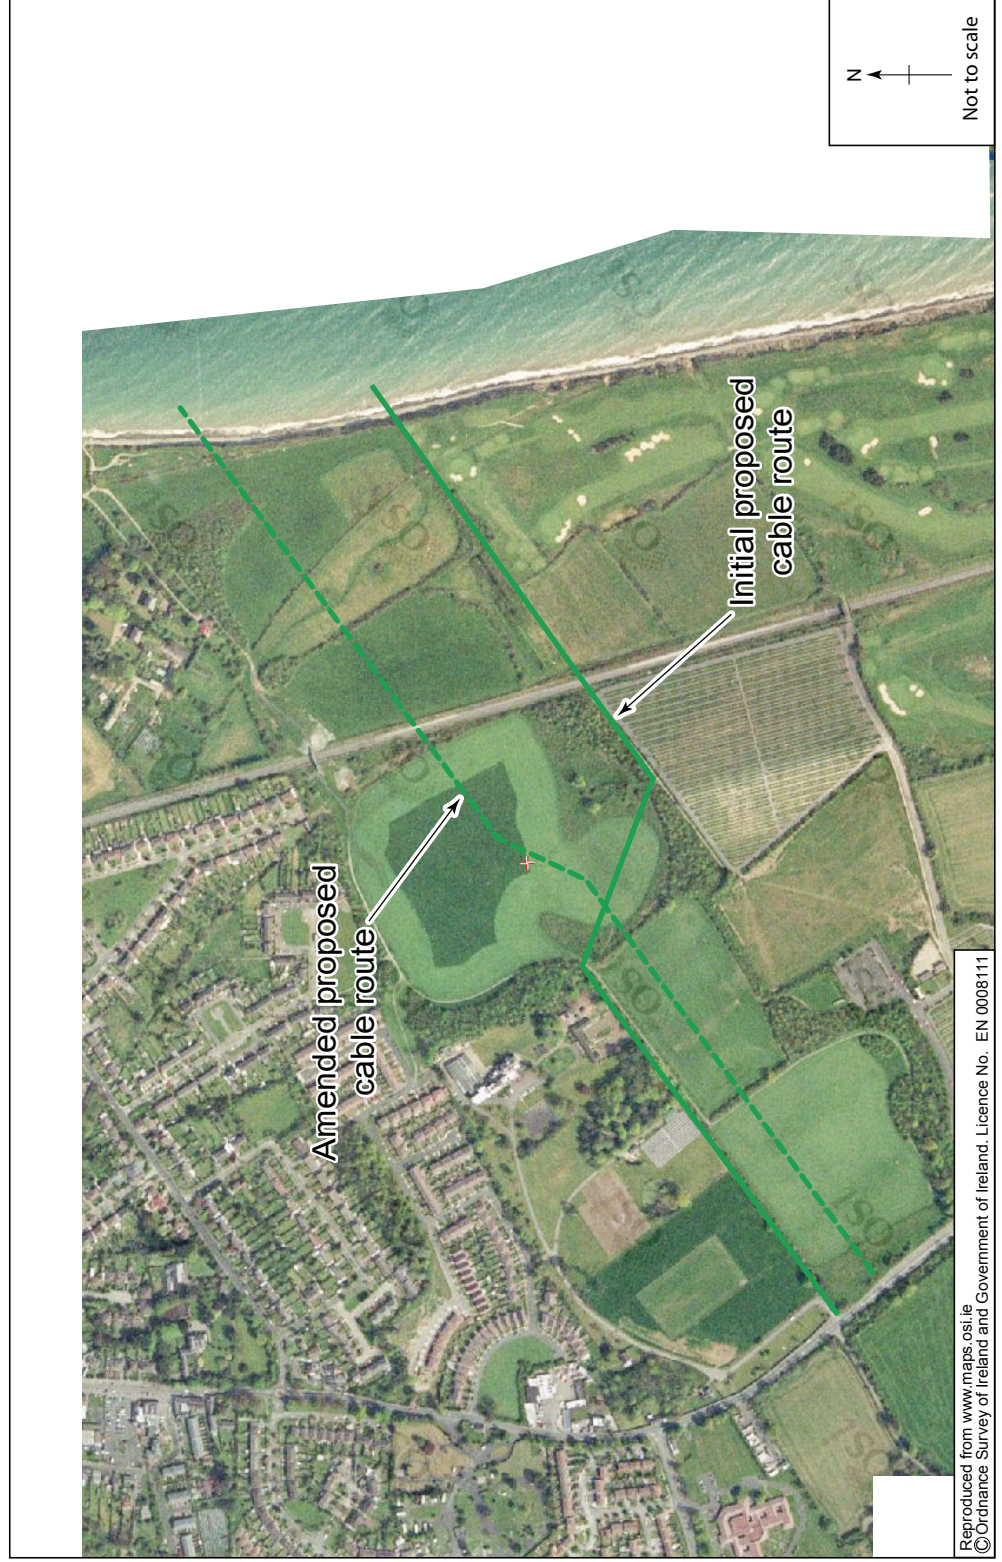
Figure 5 - 2000 Aerial photograph of site showing proposed cable route.

The proposed development comprises groundworks associated with cable installation as part of the Dublin Array offshore windfarm. It is proposed that the cables are brought ashore by directional drilling under the beach to the east of Shanganagh Park with very limited disturbance to the beach and foreshore. The cable will extend west through Shanganagh Park to reach the R119 road (Figure 1). Directional drilling will also be carried out under the modern railway line which traverses the site.
