Ireland-France Celtic Interconnector [EIFI13]

PROJECT TITLE
Celtic Interconnector

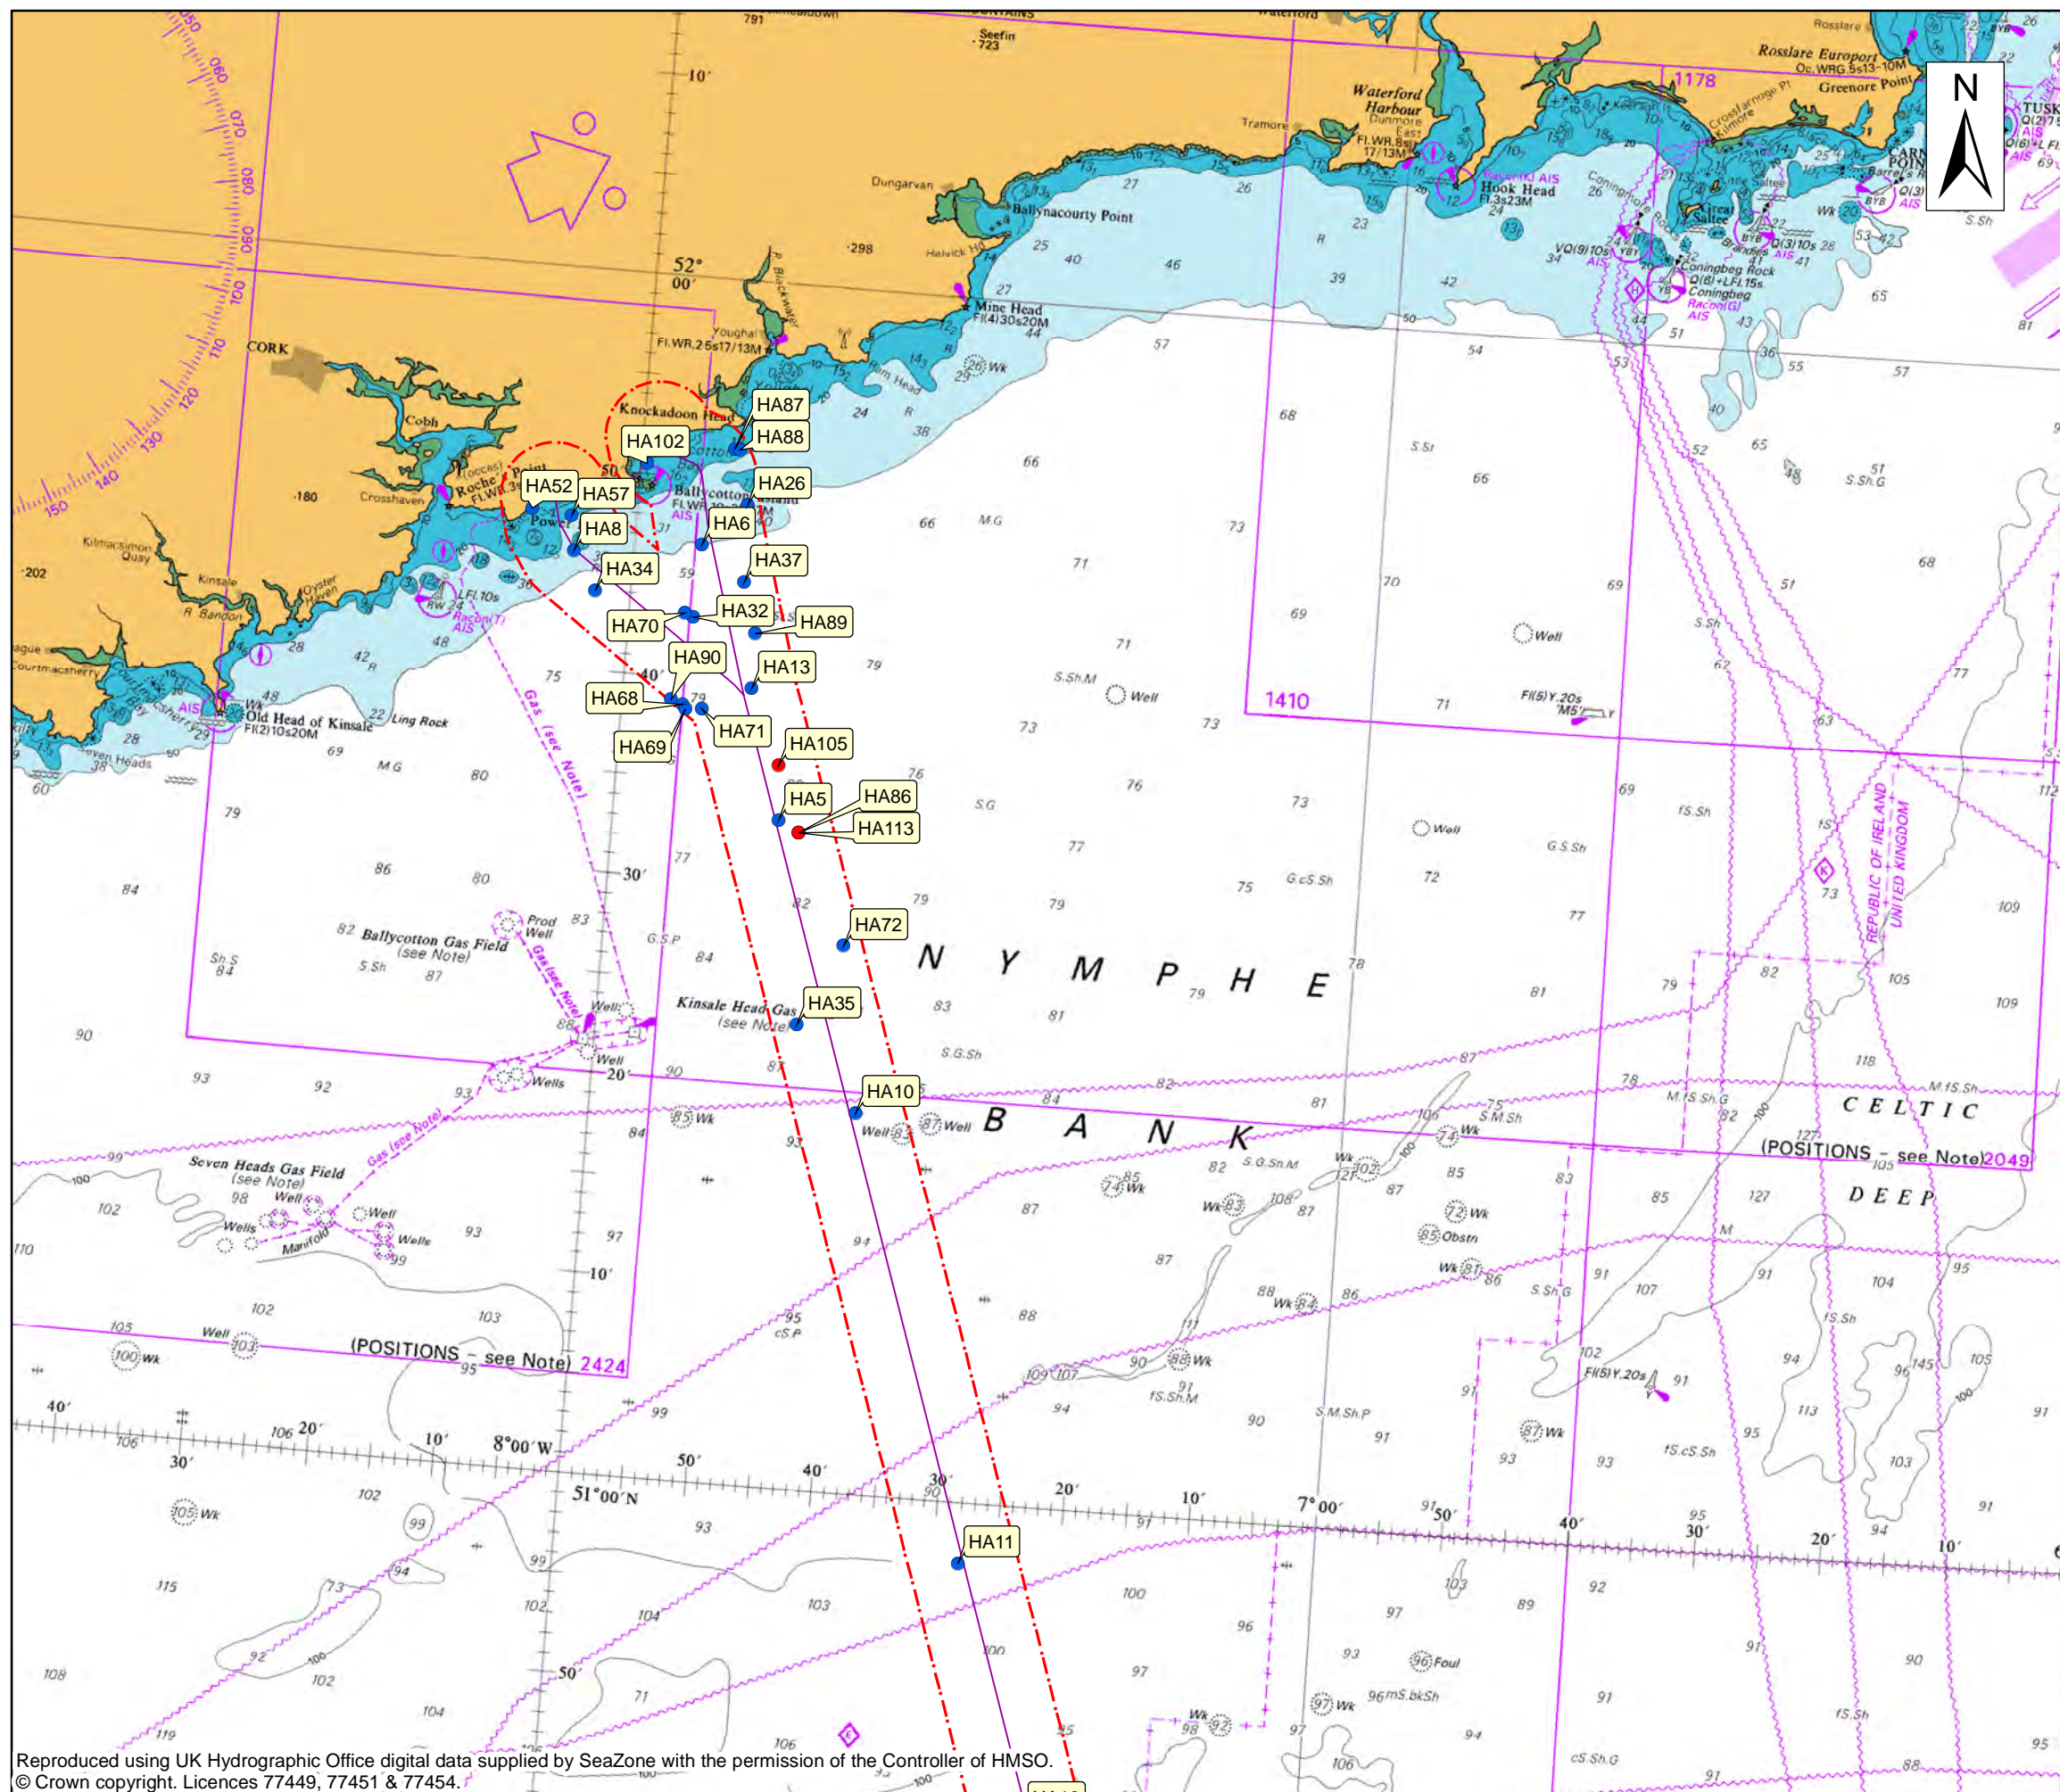
Figure 8 Original map of wrecks and obstructions within the CSC and WSA in Irish waters, provided by Headland Archaeology (2015). No alterations have been made regarding revised routes and redundant sites.

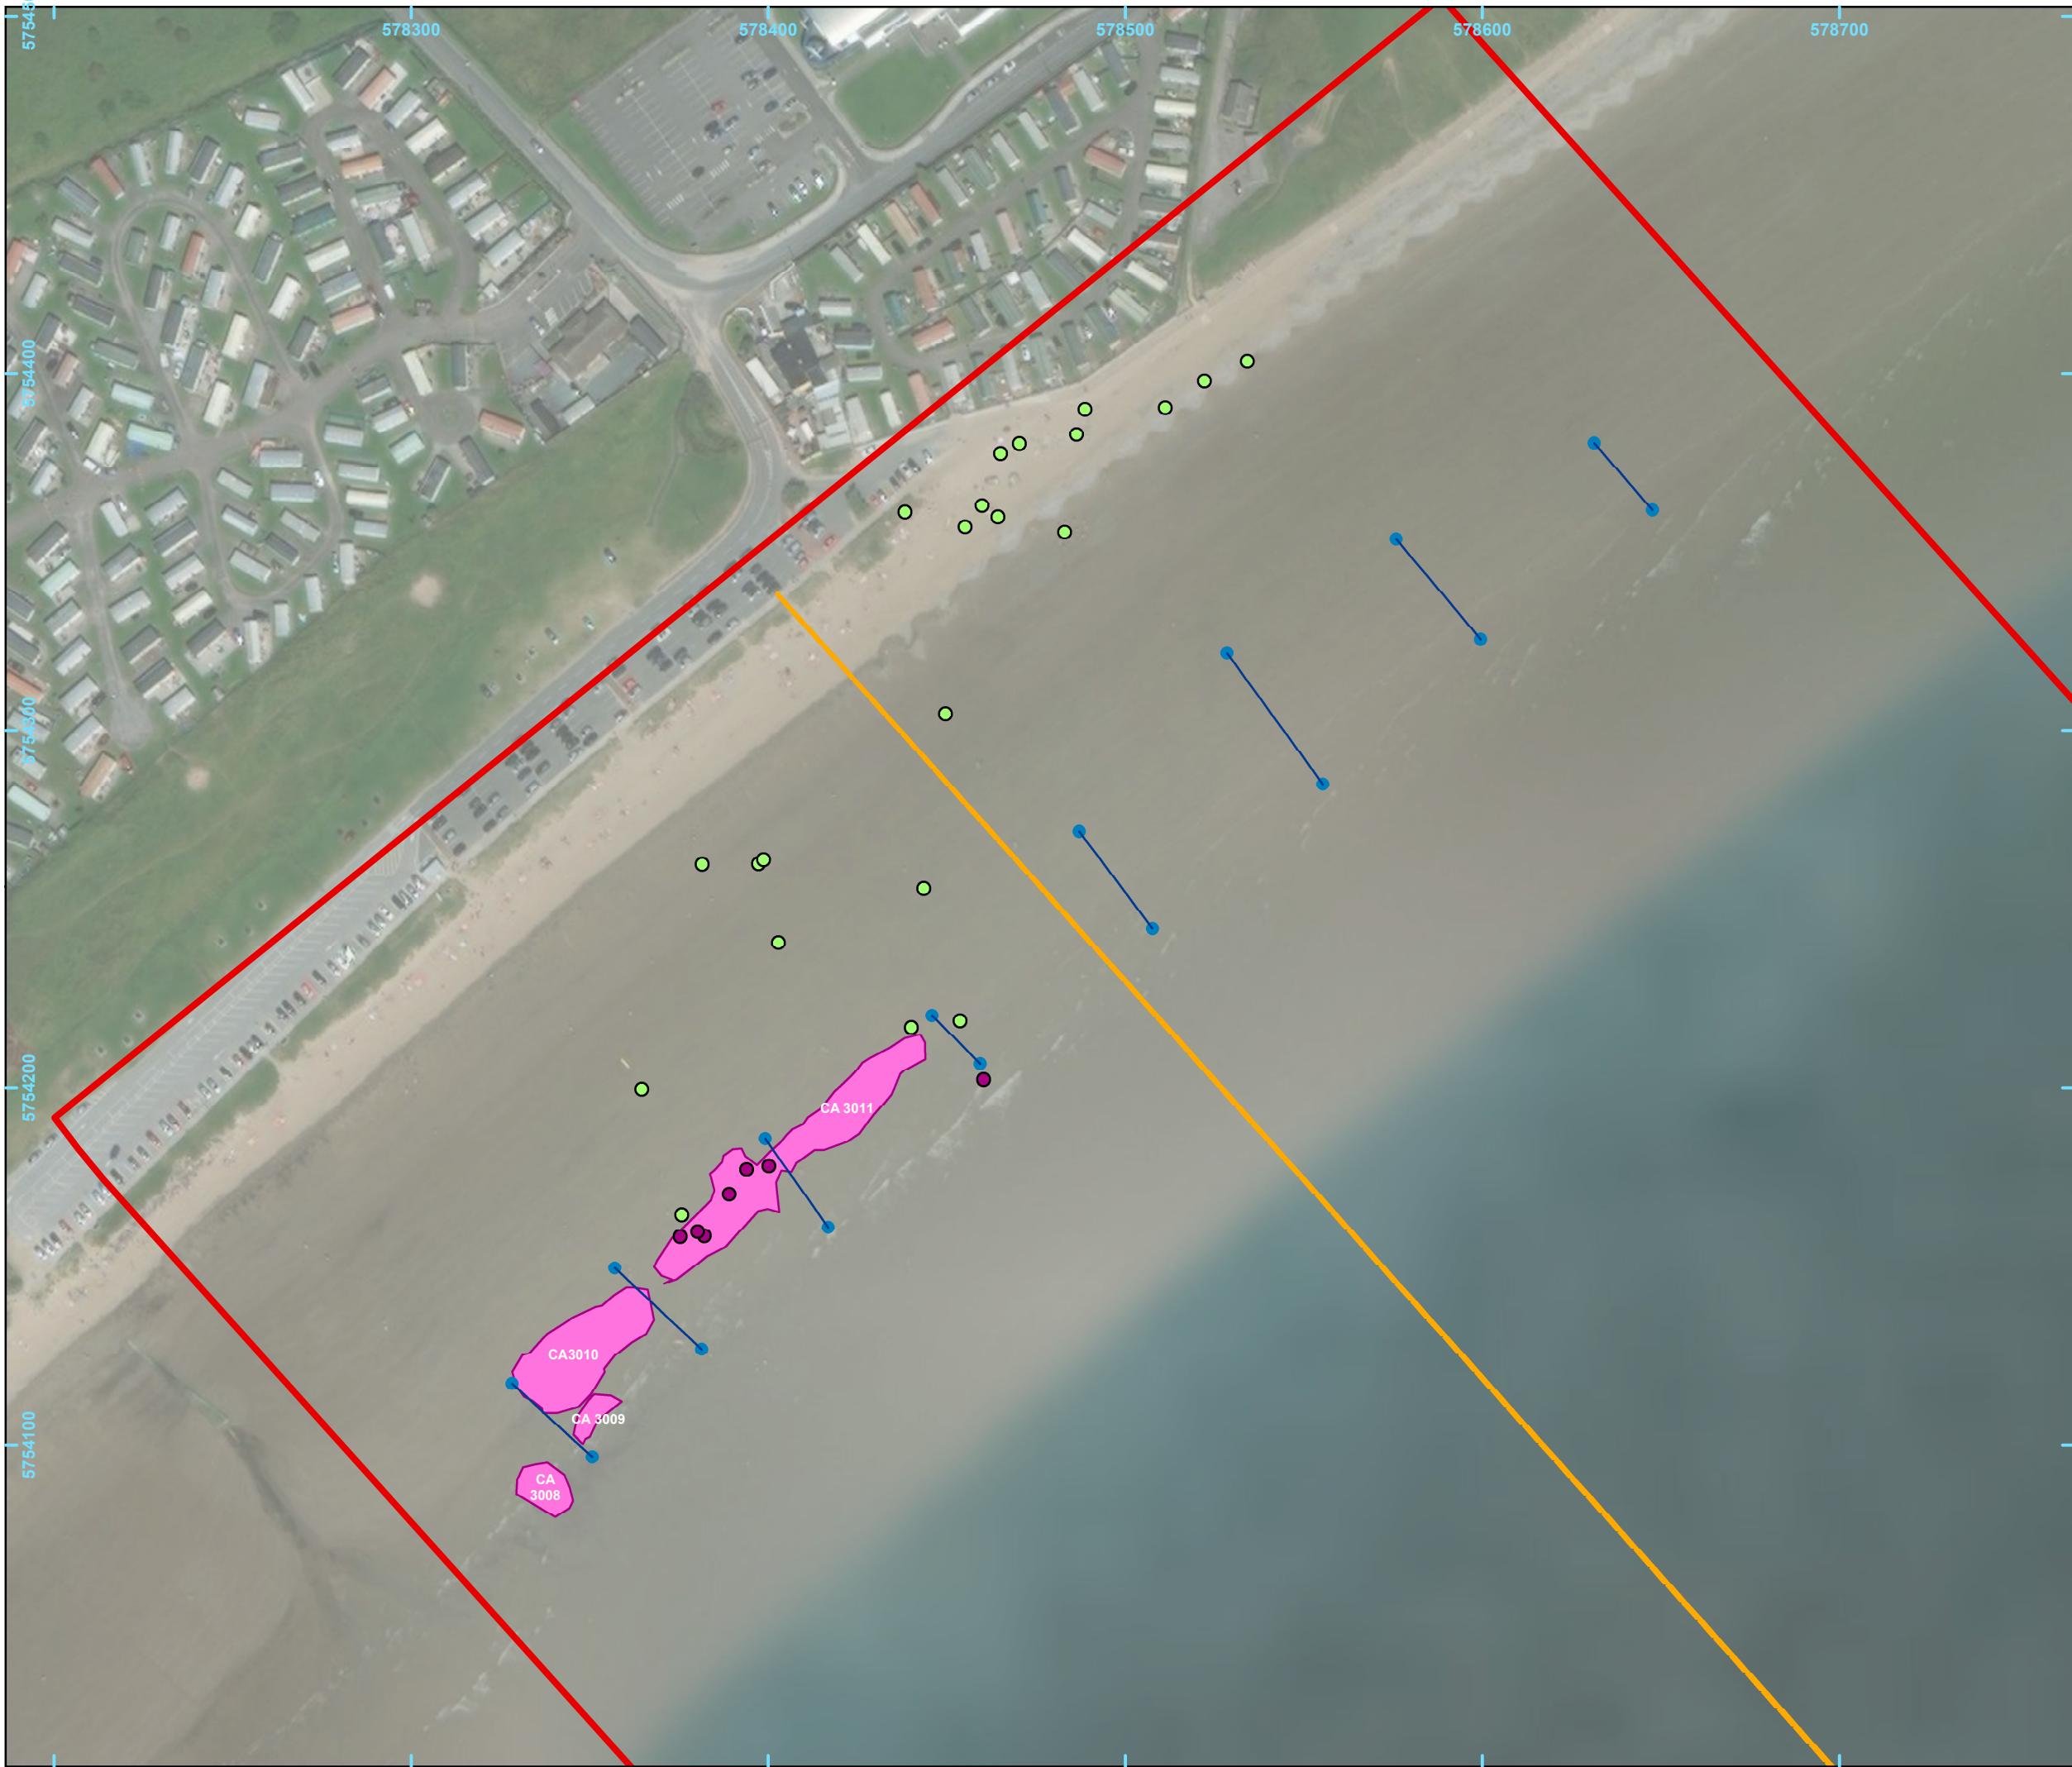
FIGURE TITLE
Walkover and metal detector findspots at Claycastle beach

- 4.41. A series of exposed peat deposits (**CA3008-CA3011**) were observed in the intertidal zone in the south-west of the survey area (Table 6 and Figs 12 & 13). These peat deposits included evidence of plant remains (tree roots; **CA3002-CA3005**), as well as evidence of excavation in the form of recti-linear cuts (**CA3007**), possibly for use as *fulachtaí fia*.
- 4.42. An eroded and heavily encrusted circular object, possibly a pot (**CA3001**) lying half exposed in the intertidal zone (Fig. 13) was also recorded. It could, possibly, be the fossilised remains of a hollowed-out trunk but this seems less likely as the other wooden remains associated with the peat do not appear fossilised.
- 4.43. This section of beach also included the remains of eight dilapidated wooden groynes (**CA3012-CA3018**) that were relatively evenly spaced (c. 60m apart) in the intertidal zone (Fig. 14).

- 4.46. 22 metal anomalies were detected during the metal detector survey at Claycastle beach (see Fig. 12 above & Appendix 1). These were located primarily in the north-east corner of the survey area, close to the high-water mark with a scattering of anomalies spread to the south and west. These were predominantly low detector value anomalies, probably indicating ferrous material.

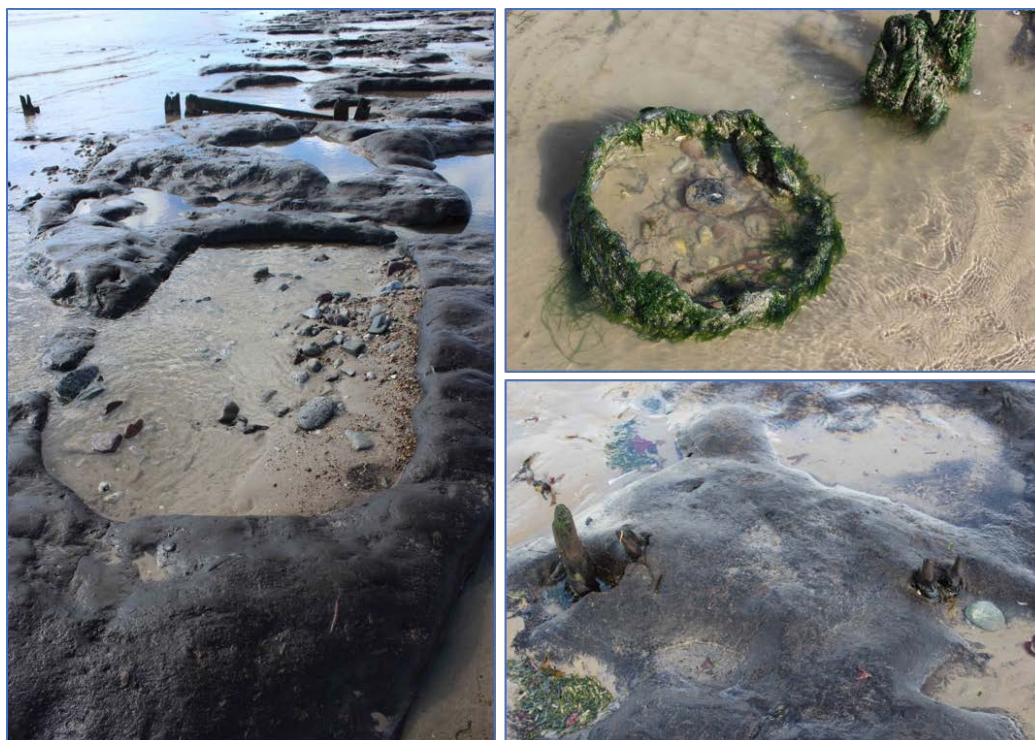
Figure 13 Walkover findspot examples - *left* recti-linear cut in peat (CA3007- facing north-east); *top right* - possible pot (CA3001 – facing north); *bottom right* – wood protruding from exposed peat.

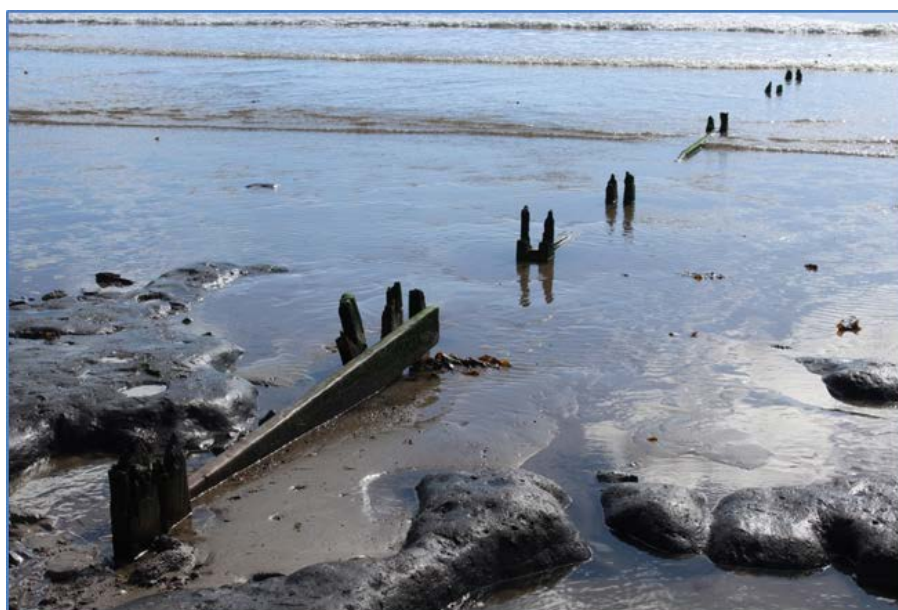
Figure 14 Remains of a groyne on Claycastle beach (facing south-east). Note the exposed peat deposits in the foreground.

- 4.60. The series of dilapidated wooden groynes recorded in the intertidal zone appear to be relatively modern, early 20th century, coastal defences and are therefore considered to be of low archaeological potential.

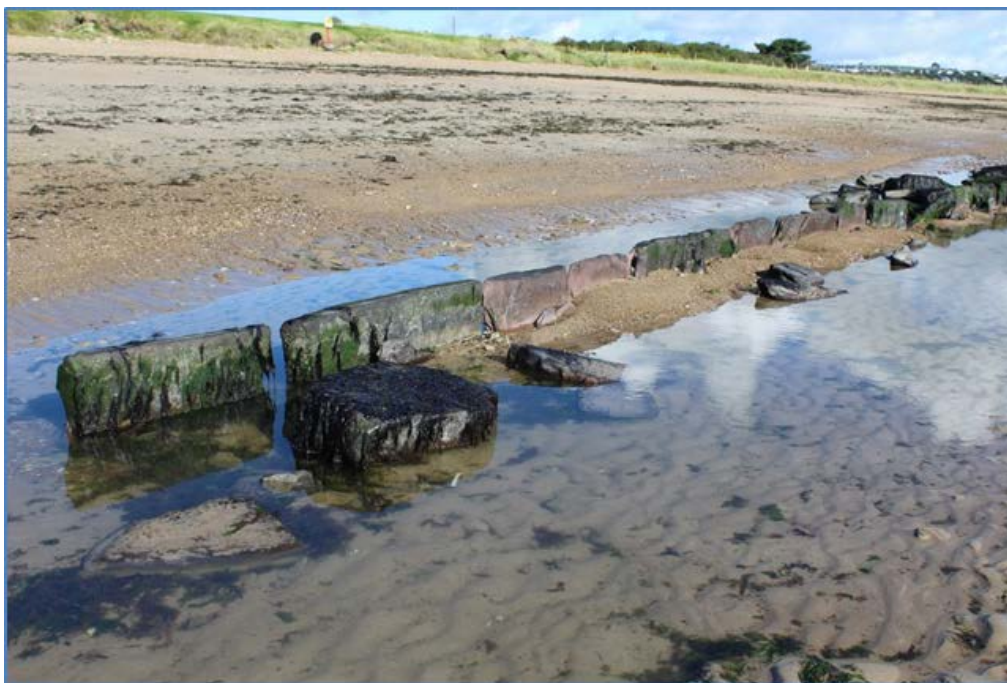
Figure 15 Possible beach defences (CA 3042) along the shoreline (facing north-west)

- 4.44. Two features were identified during the walkover survey (Table 7). These were relatively close to the level of MHWS and appear to be the remains of earlier sea defences (Fig. 15). The remains consist of a line of upstanding stones (**CA3042**), running E-W and standing up to 0.4m high.
- 4.45. The barrier restricting beach access is modern and will not be considered further. A large area of rounded stones was also observed and noted as unusual for this area of the beach.

The upstanding remains of possible beach defences are considered of low archaeological potential.
