Environmental River Enhancement Programme

Annual Report 2020

EREP 2020 Annual Report

Inland Fisheries Ireland & the Office of Public Works

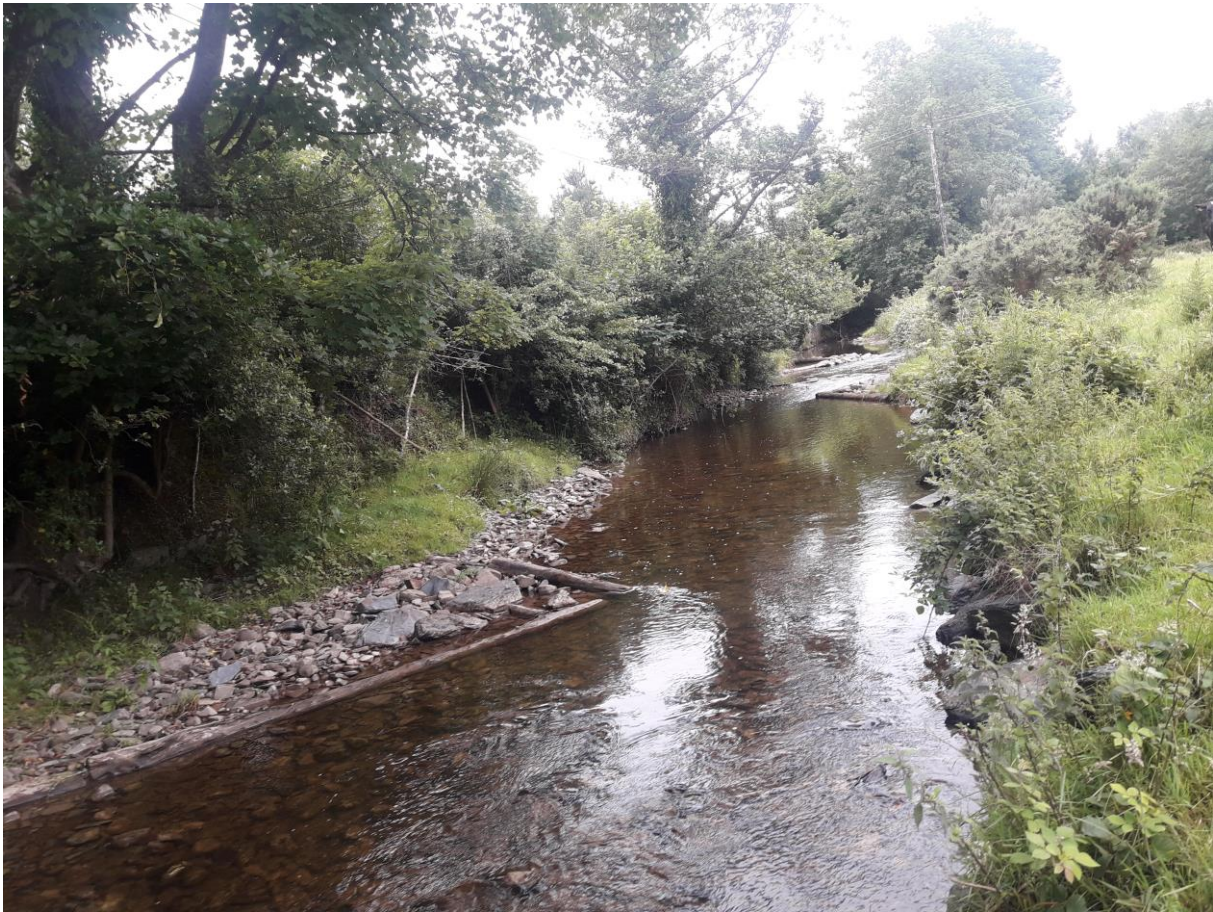
Figure 2.8 Deflectors on the Cormey River.

The Glyde catchment has been below its salmon conservation limit for the last three years, with the preceding years forecasting a slight surplus (IFI, 2021). There is good scope in some of the upper tributaries for enhancement to promote spawning and nursery habitat. Evidence of capital enhancement on the Cormey, a tributary of the Lagan (Figure 2.8) emplaced by an IFI Eastern RBD project approximately 15 years ago supports good flow diversity and substrate heterogeneity. This mixture of hard and soft engineering approaches, using both stone and wood to create deflectors, is a relatively low-cost solution and has positive effects on the channel form and flows in this reach.

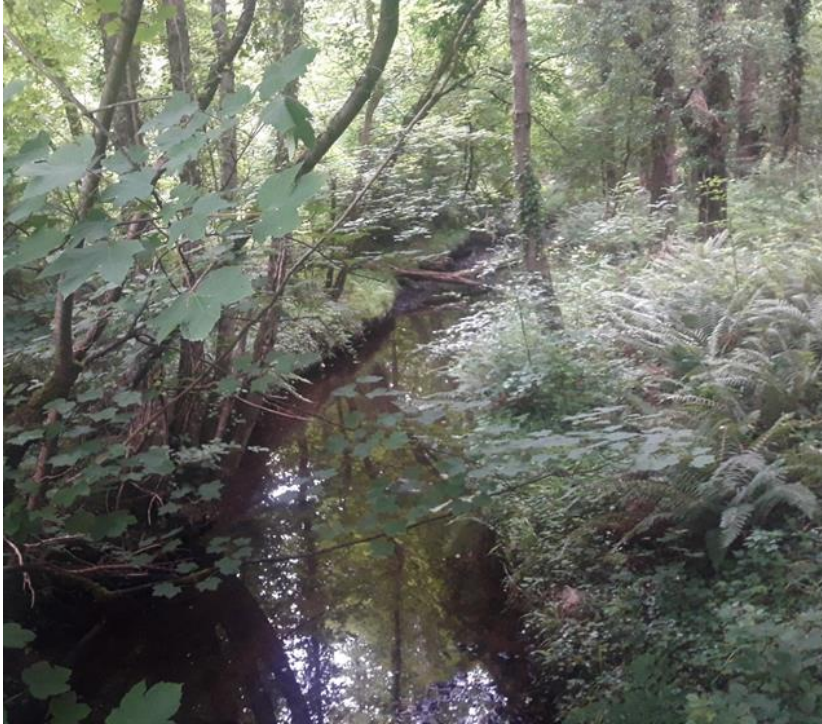
Figure 2.13 Photo of high scoring site on the Corney River.

This photo (Figure 2.13) is from the only high scoring site [C42(1)] in the Glyde Catchment. Both banks are in their natural state. There is evidence of undercutting and eroding which is an expected natural process for this river type. Tree growth extends to the bank top of both banks provide stabilisation. These banks have not been modified or re-sectioned. It is best to leave this section untouched (Step 5.)

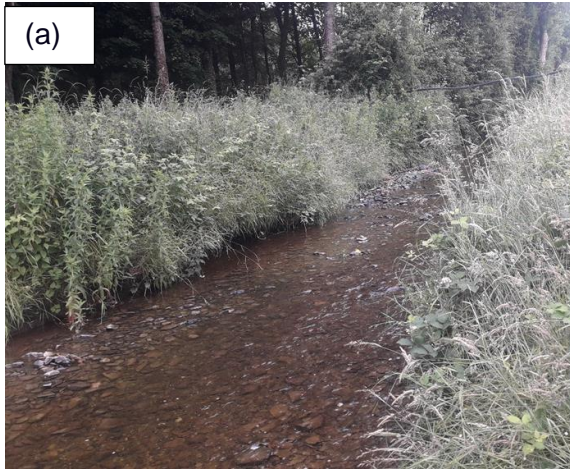
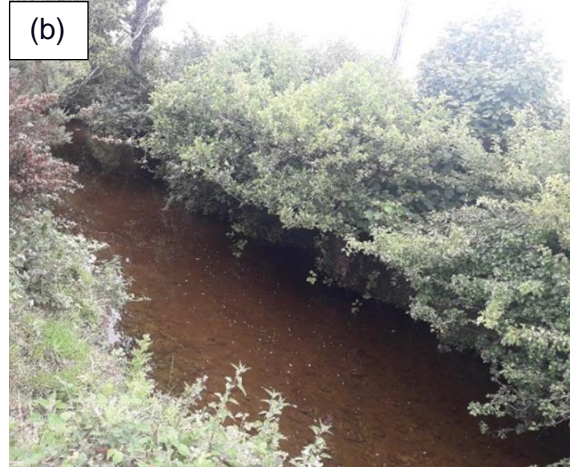
Figure 2.14 Photos showing differences in substrate condition for similar river type – Pool Riffle Glide.

Substrate condition plays a vital role in many stages of a fish's life cycle (Taylor *et al.*, 2019). Clean silt-free gravels are necessary for spawning of salmonids and other aquatic species including sea lamprey. In Figure 2.14, image (a) shows ideal gravels for spawning whereas image (b) shows silted gravels. For gravels to be attractive to adult salmonids for spawning, they need to be clean. To improve substrate condition in [Figure 2.14(b)] Step 9 can be practised (loosen gravel beds). Alternatively, other steps can be practised to ensure the river is self-cleansing including Step 4 (selective vegetation removal), Step 8 (replace stones and boulders) and Step 10 (re-profile channel bed). These steps will change the flow regime of the section of channel in question which will contribute to flushing silt from potential spawning gravels. Selective vegetation removal and strategically positioning boulders into the channel can alter flow direction increase velocities, which will rinse deposited silty substrate downstream. Deepening the thalweg here, creating a simple two stage channel will encourage faster velocities – again washing fine sediment downstream (Fleming *et al.*, 2020).

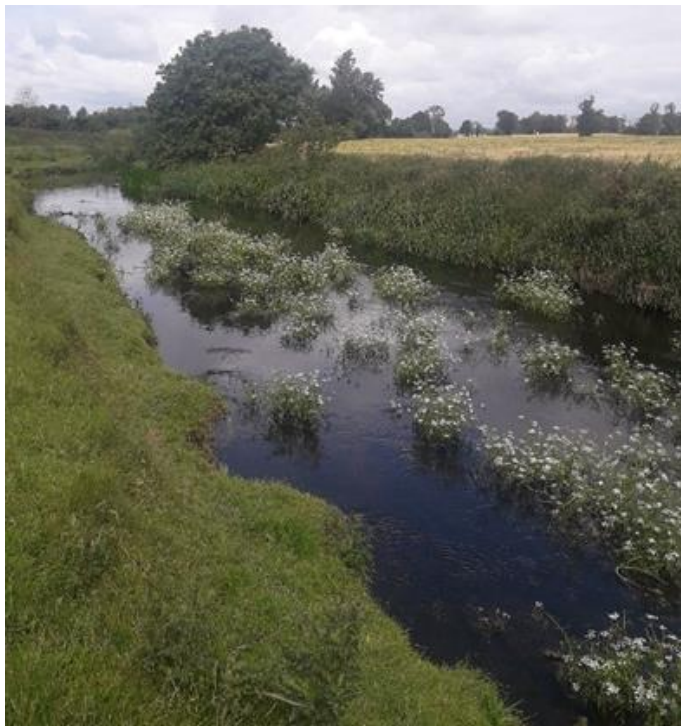
Figure 2.15 Photo taking during a RHAT Survey completed on the Main Glvde in 2020.

This channel received an overall Poor Score for the entire 500m of the RHAT Survey (Figure 2.15).

Factors influencing this score are:

- No flood plain interaction.
- Lack of canopy cover.
- No buffer zones, with human activities extending too close to the bank tops.

Vegetation is typical for a channel with little gradient and no canopy cover.

Run-off of nutrients from agricultural practices supports instream vegetation growth. Leaving this section untouched (Step 5) is advised – as this vegetation provides much need instream canopy. Buffer zone & tree planting required on both banks tops.

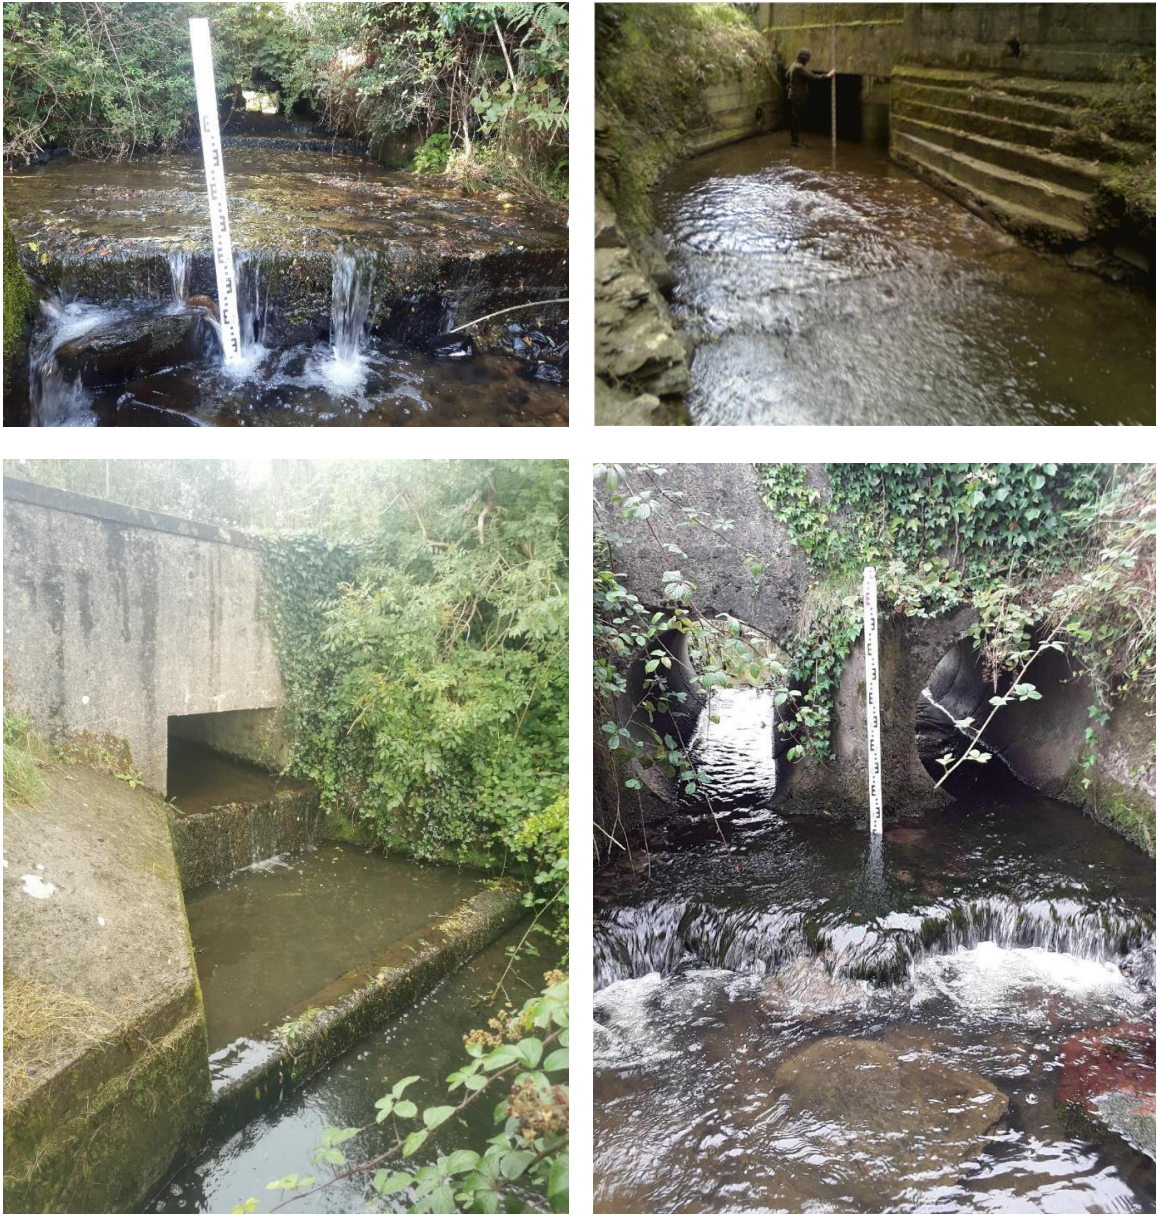
Figure 2.17 Examples of barriers identified during the Glyde survey, including two bridge aprons, a box culvert and double pipe culvert.

431 of the 665 potential barrier points in the Glyde catchment are on the OPW structures database, and at least 15 of those are categorised as barriers, comprising 38% of the total number of barriers in the Glyde catchment. Examples of structures in OPW channels presenting a challenge to fish migration are shown in Figure 2.17. Some show small but significant drops representing a 'jump' barrier – the effect of cumulative jumps presents a more significant challenge. Others show shallow water over the base of the culvert which indicate a 'depth' barrier to both resident and migratory fish during the majority of the year when water levels aren't elevated. Ongoing work by OPW and IFI on barrier mitigation options may offer solutions to fix issues such as these in the coming years.

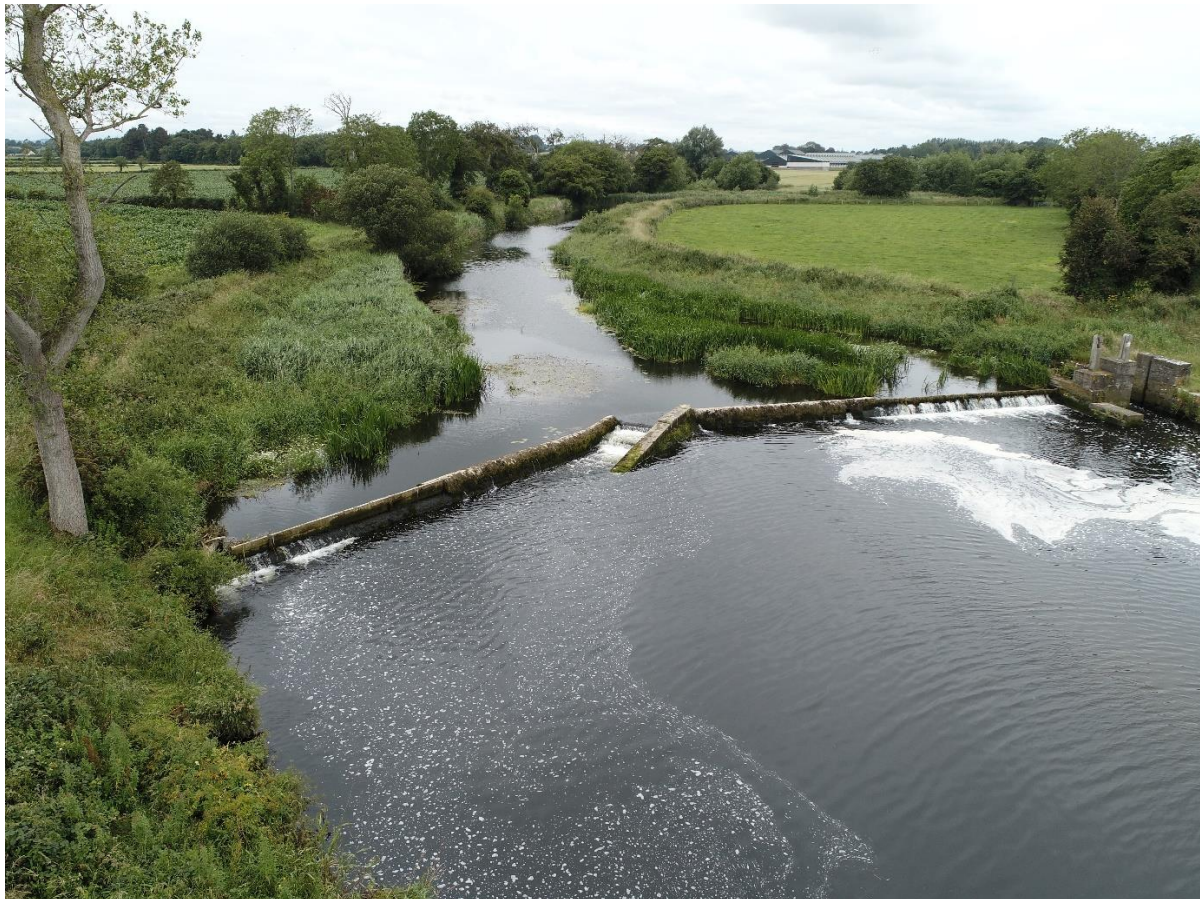
Figure 2.19 Lynns weir has two transversals: fish pass and sluice.

The following is an overview of the SNIFFER surveys at the three weirs in order, from downstream to upstream. The results of all the surveys are specific to the date of the survey and river conditions at the time. Lynns and Castlebellingham surveys were conducted with during slightly elevated water levels and during Tallanstown survey, the water levels were low. Two transversals were examined on Lynns weir – the sluice and a fish pass (Figure 2.19). The sluice is not a passage option and was a Complete Barrier on the day of the survey due to the large vertical hydraulic head and limited flows. Same for eels, the fish pass is the only feasible transversal for the remaining species considered in the survey. The height of steps within the fish pass and turbulence make passage upstream through this transversal challenging. On the day of the survey, the fish pass is a Low Impact Partial Barrier for salmonids, a High Impact Partial Barrier for lamprey and juvenile salmonids, and a Complete Barrier to cyprinids.

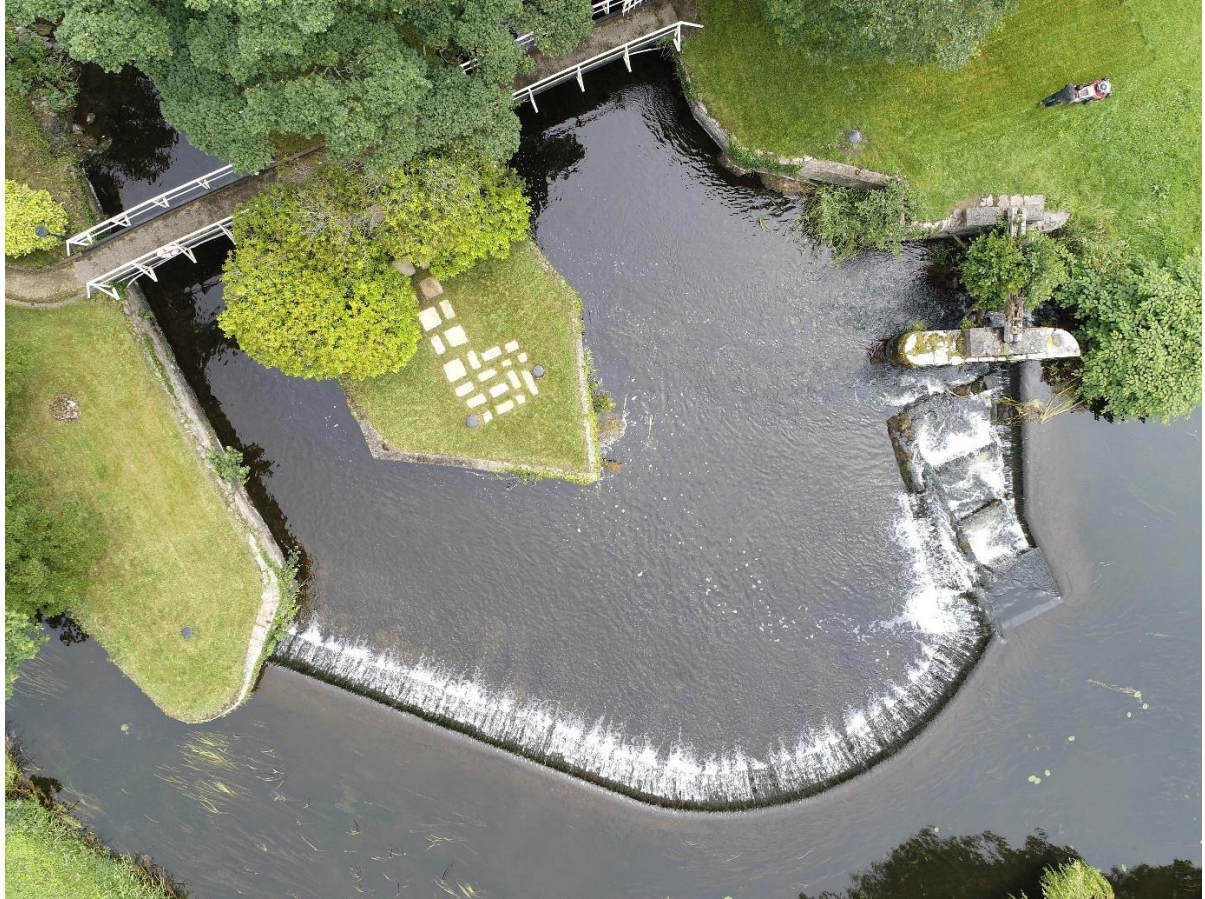
Castlebellingham weir has two transversals – the vertical weir face and a fish pass at the side of the weir alongside the sluice gate (Figure 2.20). The weir face is a Complete Barrier or High Impact Partial Barrier to most species due to the large hydraulic head and shallow pool depth, so the fish pass is a more feasible option for passage upstream. On the day of the survey, the

fish pass is a Low Impact Partial Barrier for salmonids and a Complete Barrier to cyprinids, lamprey and juvenile salmonids. Again the presence of a climbing substrate meant passage for eels upstream was not an issue.

Figure 2.20 Castlebellingham weir has two transversals: fish pass and vertical weir face.

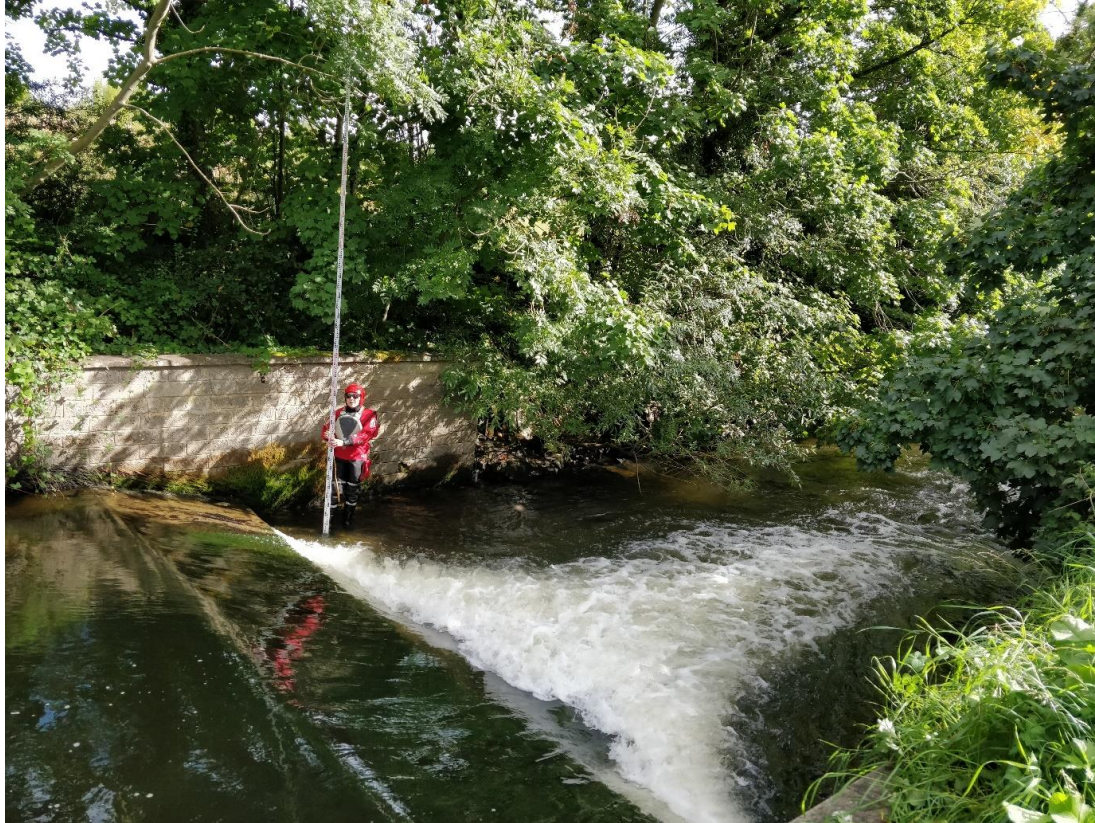
Tallanstown weir has one transversal – the sloping weir face (Figure 2.21). On the day of the survey, it was a High Impact Partial Barrier for salmonids, lamprey and juvenile salmonids, and a Complete Barrier to cyprinids. The angle of the slope, shallow water depth over the surface of the structure, and turbulence beneath the structure make upstream passage problematic. In elevated flow conditions, the relatively small hydraulic head would enable passage for salmonids. The presence of a climbing substrate on the weir face meant passage for eels is not an issue.

Figure 2.21 Tallanstown weir with one transversal: sloping weir face.

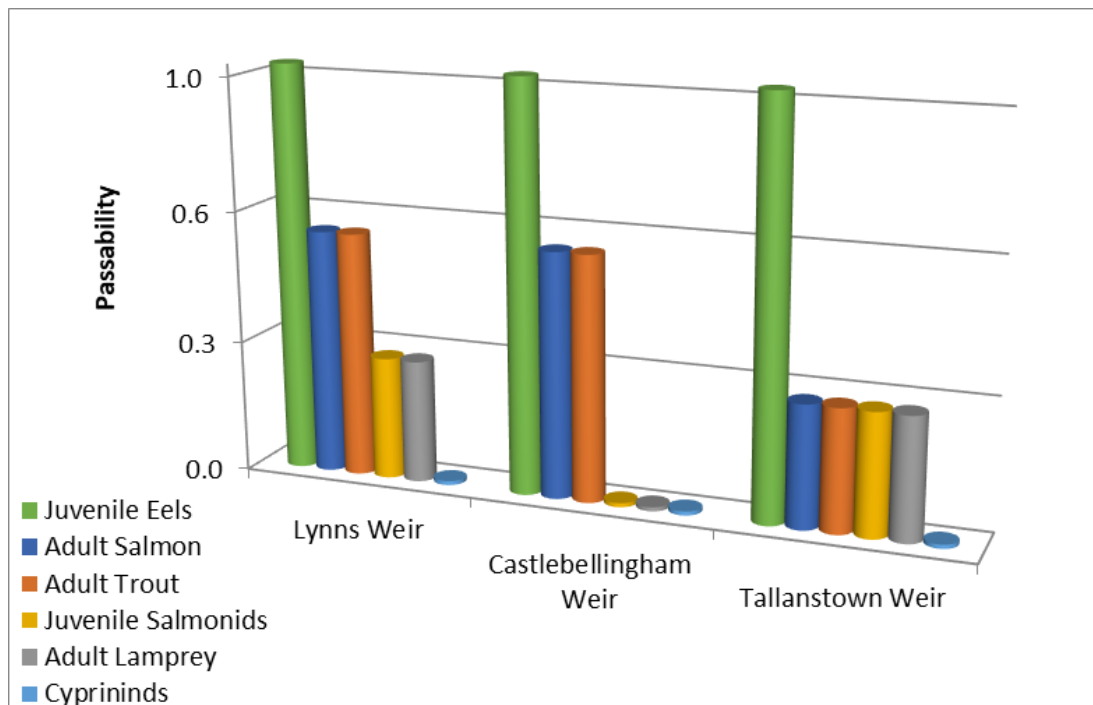
Figure 2.22 Passability assessment for the three weirs on the Glyde. The 0-1 scale is as follows: 0 - Complete Barrier; 0.3 - Partial High Impact Barrier; 0.6 - Partial Low Impact Barrier; 1 - Passable Barrier.

The upstream passability assessment for all three weirs on the main stem can be seen in the summary graphic (Figure 2.22) as concluded on the day of the survey. In elevated flow conditions the passability would vary. All three represent partial barriers for adult salmonids and a complete barrier to cyprinids. Adult lamprey and juvenile salmonids face partial high impact barriers or complete barriers.

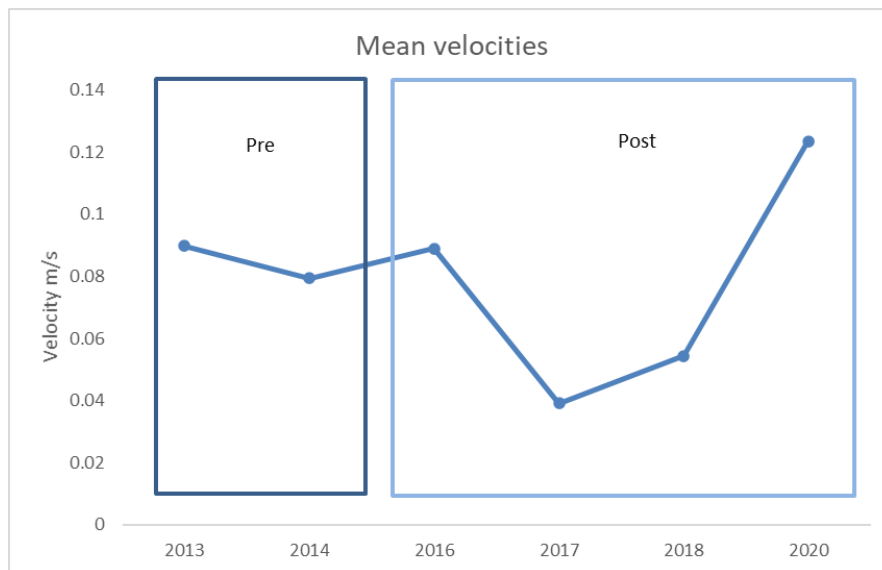
Mean flow velocities showed a marked decline from 2013 to 2017, before recovering to a substantial increase by 2020 (Figure 3.4).

Figure 3.4 Changes in mean flow velocities pre (navy box) and post (blue box) fencing and channel maintenance.

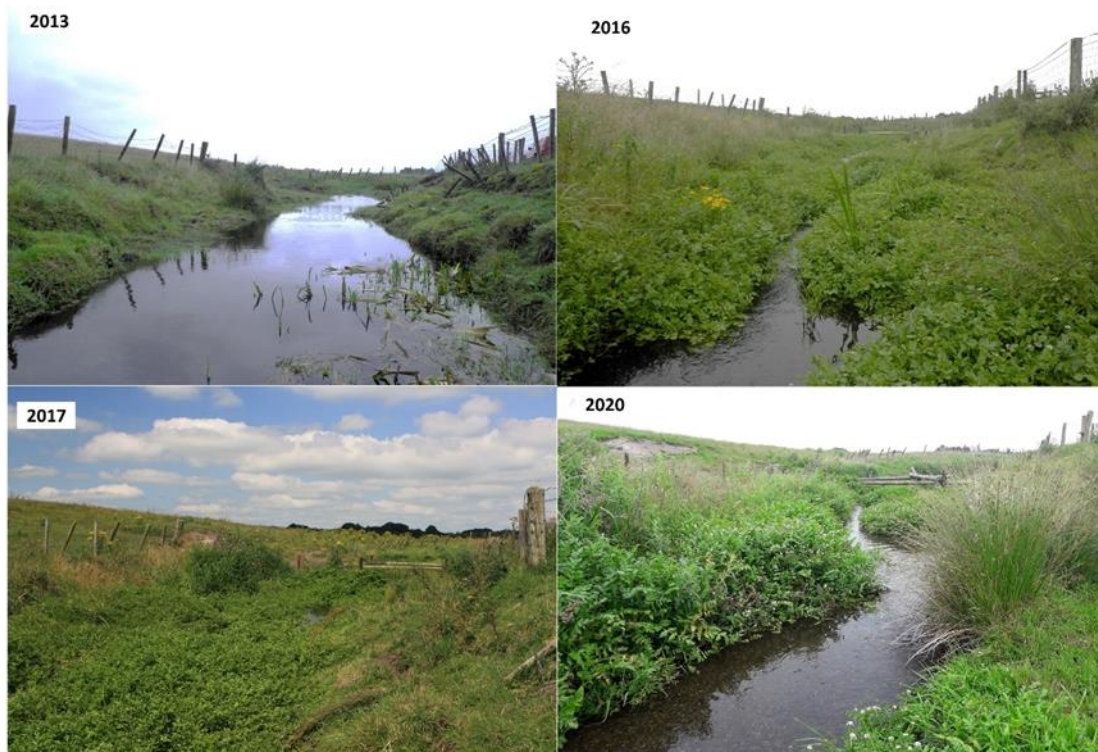
Figure 3.5 A survey reach pre livestock exclusion/dredging in 2013 (top left), three years post in 2016 (top right), four years post in 2017 (bottom left) and seven years post in 2020 (bottom right). Channel adjustments to pressure removal are evident in 2020 from the stabilised margins and the development of a pseudo-meander form within the previously over-widened channel.

cycle from the end of 2014 onwards. Pioneer macrophyte species rapidly established in the channel and promoted greater depth, flow and substrate diversity by trapping sediment and by obstructing and deflecting flow (Figure 3.5; year: 2016). Period three (2017-18) was a lag when macrophytes filled the channel space and widely impeded flow, resulting in low flow velocities (Figure 3.5 year: 2017). In the most recent period, from 2019-2020 and onwards, the channel appears to be adjusting towards a more defined/naturalised form and this is reflected by increasing substrate coarseness and associated higher mean velocities (Figure 3.5 year: 2020).

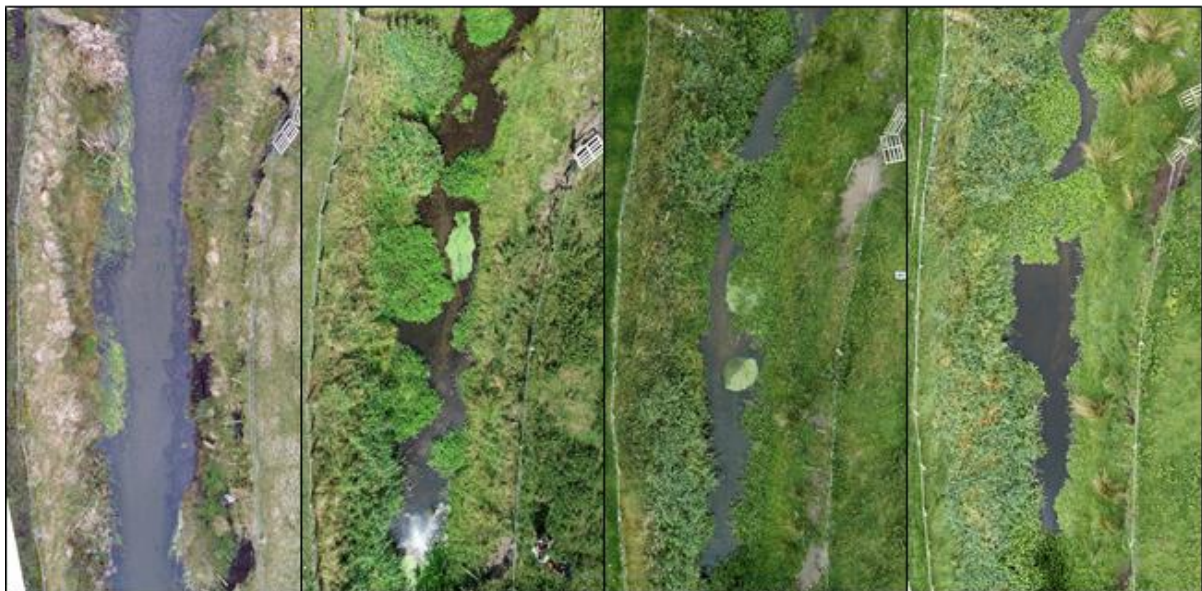
Figure 3.6 Drone imagery of Stonyford experimental Site 3 Left to right – January 2018, July 2018, July 2019 and July 2020. Showing winter conditions (January 2018) and summer growth over a 3 year period.

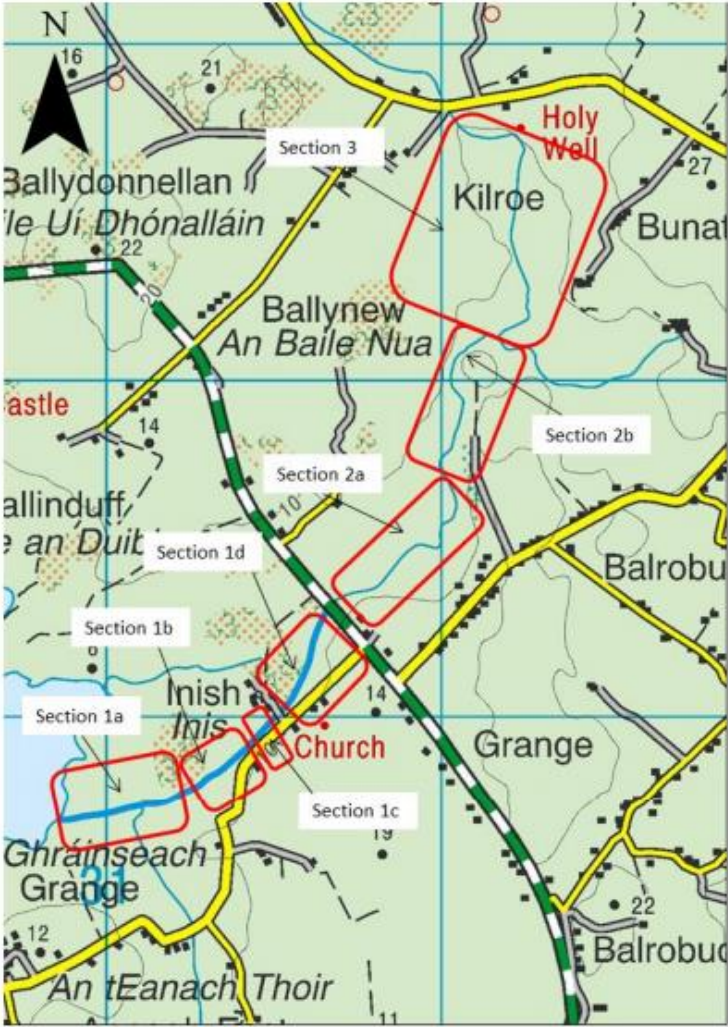
Figure 4.2 Entire stretch of channel walked was divided into sections. Section 2a (Educational Site) is area in discussion below.

Fencing was provided for the educational site using capital works funding under the EREP (Figure 4.2). The entire field was fenced along the bank top comprising 270m fencing in total erected. Stiles were also included for enabling ease of access to the site. Seven step-out enclosures were necessary around the tree plantations/clusters planted as part of the project, to prevent livestock destroying the vulnerable newly planted trees.

The types of trees selected include hawthorn, hazel, oak, rowan, alder, birch, scots pine and apple trees. The location of plantations alternated between both left- and right-hand banks. A restricted area on the plantations ensures that the trees planted on the OPW working bank will not hinder their access to the channel during future maintenance.

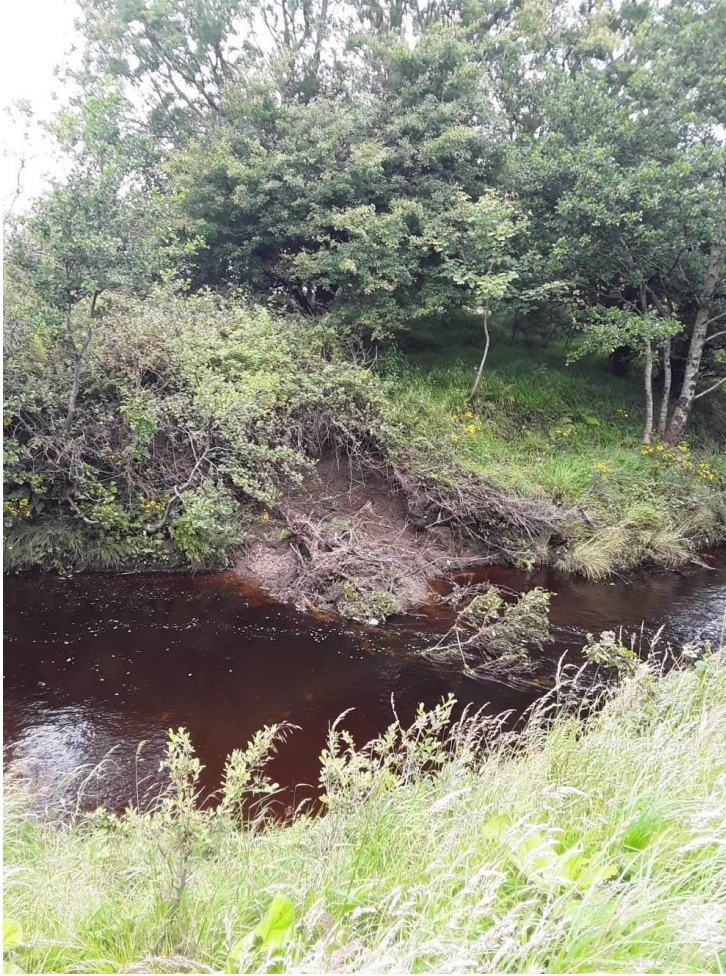
Figure 4.5 Photo of blockage in channel which will impede flood conveyance.

The tree branches located in the middle of the channel obstruct flows and are problematic for flood conveyance. These branches are likely to catch other woody material being transported by the river and over time create a larger obstruction. For this scenario drivers were advised to remove only a percentage of the stump and tree branches so that the pool and habitat which had developed behind this obstruction could remain. A variety of habitat forms provide resting and shelter areas for fish species and so it is important that these stay intact.

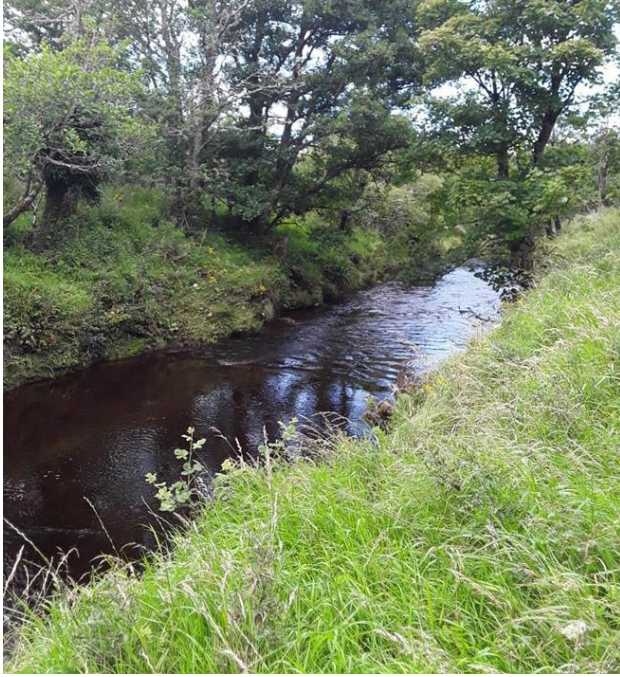
Step 10 was encouraged at this site.

Figure 4.6 Pool and riffle naturally present at this site.

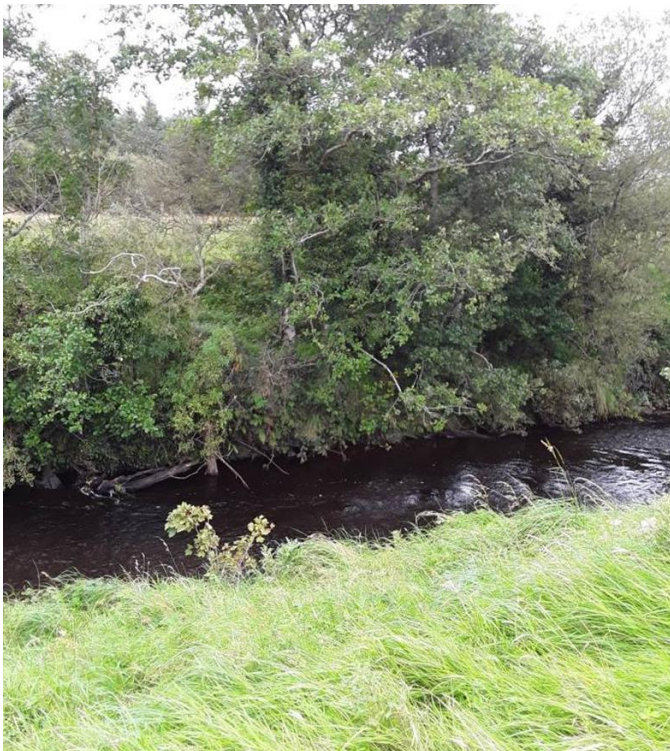
Advice given here was to retain the central gravel shoal (Figure 4.7) which had developed naturally here (Step 5). The staff were also advised to leave woody debris visible on left hand bank as it was not obstructing flood flow but is beneficially directing flows downstream and causing no issues with bank stability on the opposite side.

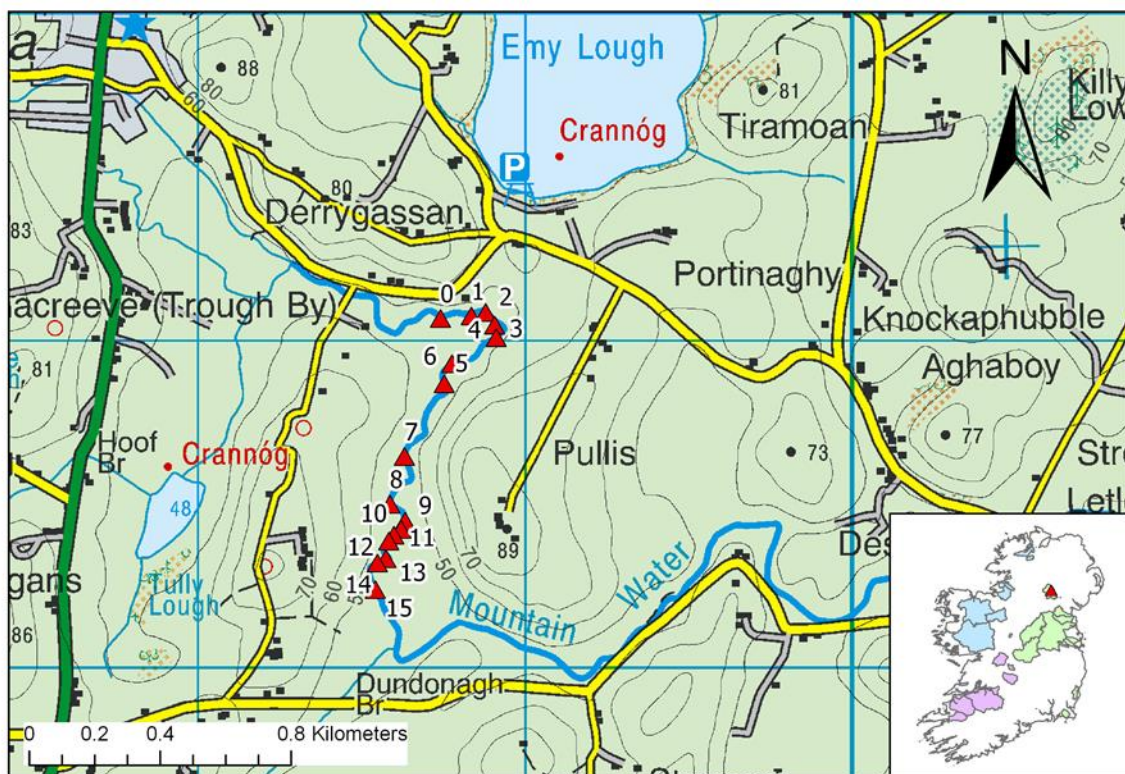
Figure 4.8 Location (red triangles) of walkover completed on the Mountain Water in the Monaghan Blackwater Catchment just South of Emy Lough.

This walkover was completed in December 2020. Attendees ranged from a variety of public bodies including OPW, LawPro and IFI staff from EREP and the Catchment CARE project. In total 16 sites along the channel were discussed in a 1.3km stretch (Figure 4.8).

The main steps encouraged and discussed during this walk over was Steps 2, 5, 6, 7 & 10. Areas located between photo locations (red triangles) were to be left untouched and no maintenance works to be undertaken. Tree management and blockage removal was advised at 11 sites, with berm management discussed at 1 site and digging of pools & riffles were advised at 6 sites. Reprofiling of the channel bed to form new pools and riffles will be subject to bed material and discussed further when the works commence.

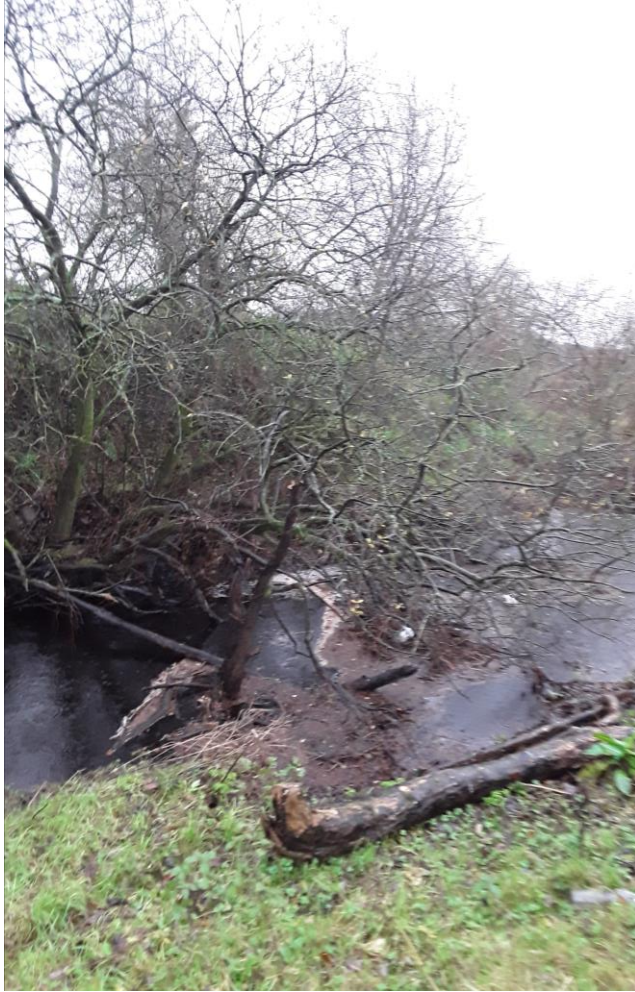
This blockage is problematic and an obstacle for flood conveyance (Figure 4.9). Practice of Step 6 was advised here.

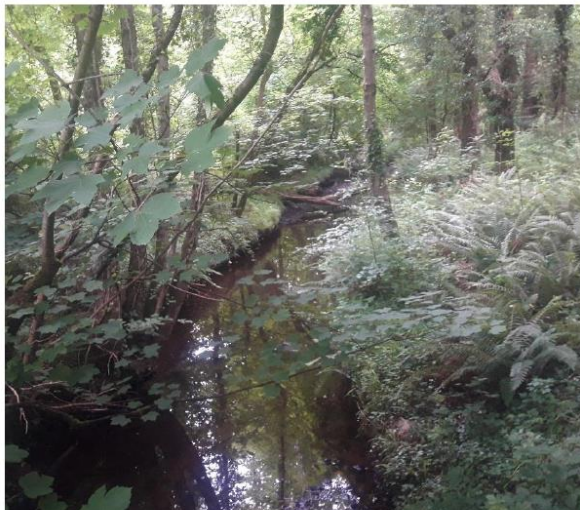
(PRG) Corney River, Glyde catchment, Co. Cavan – High

both banks are in their natural condition. There is evidence of undercutting and eroding which is a natural process for this river type. Tree growth extends to bank top stabilising banks in places. Banks have not been modified or re-sectioned.

Step 5 – Leave sections untouched.

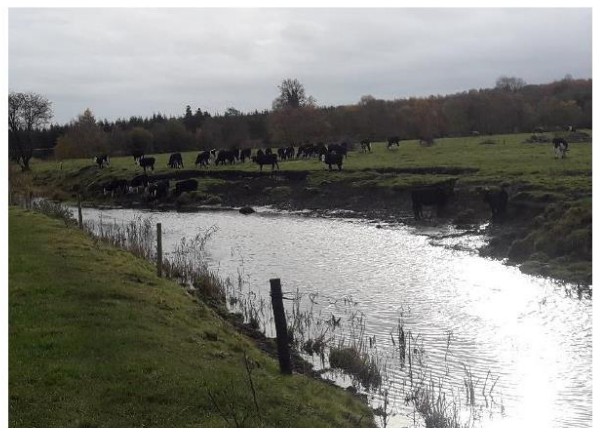
(PRG) Glore River, Inny catchment, Co. Westmeath – Bad

Attribute Score – LHB 0.5 (Poor) & RHB 0 (Bad)
