Environmental River Enhancement Programme

Annual Report 2022

EREP 2022 Annual Report

Inland Fisheries Ireland & the Office of Public Works

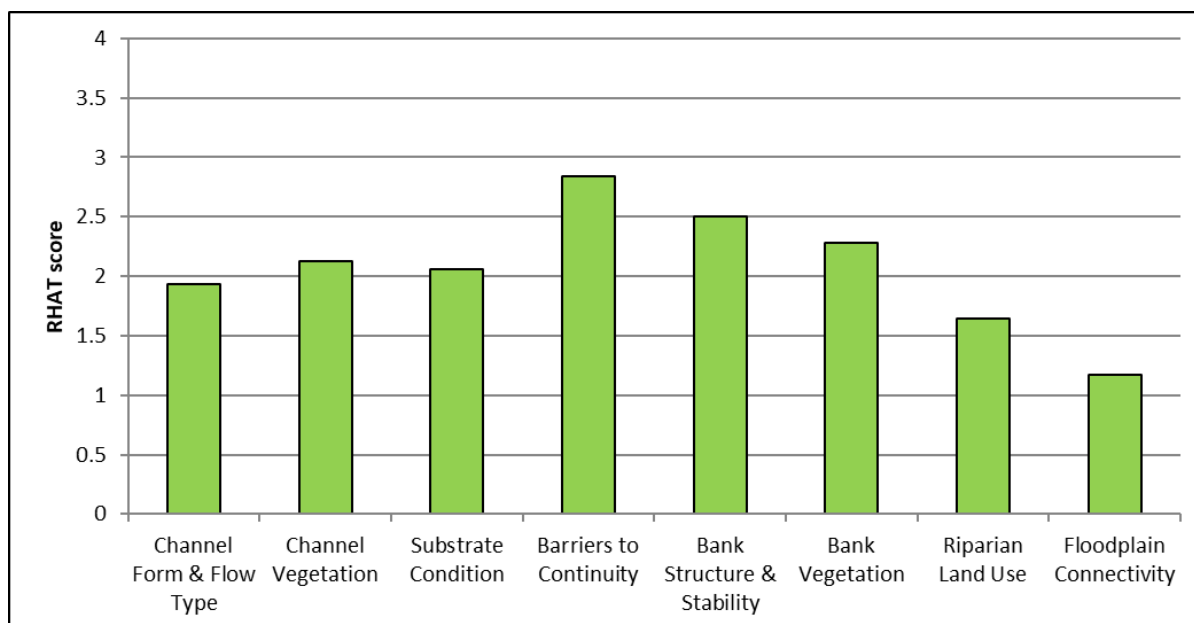
Figure 2.9 Mean RHAT scores for all sites in the Lung (n=32).

When RHAT scores are averaged they ranged from 1.05-2.86 (Figure 2.9). Of the averaged attributes, riparian land use and floodplain connectivity scored lower. Barriers to continuity and bank structure and stability on average score higher within the catchment.

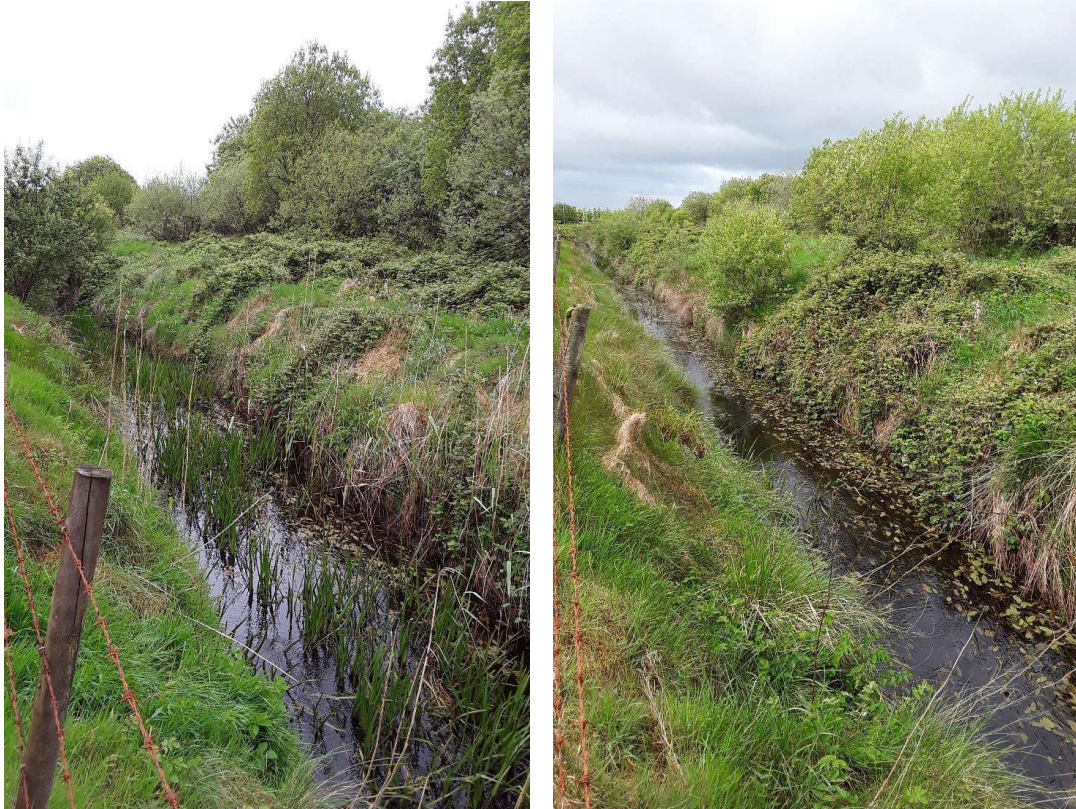
Figure 2.10 Proliferation of in-stream vegetation in areas of low gradient on the Errit stream (C1/24/2/1, Moderate status).

Instream vegetation proliferates in areas of low gradient where tree cover is limited or absent (Figure 2.10). This issue is typically seen in channels which are extremely straight and have limited flows and excessive fine sediment. For example, in the Errit stream (C1/24/2/1), pondweed (*Potamogeton*) and flaggers (*Sparganium erectum*) were both excessive in parts of the stretch.

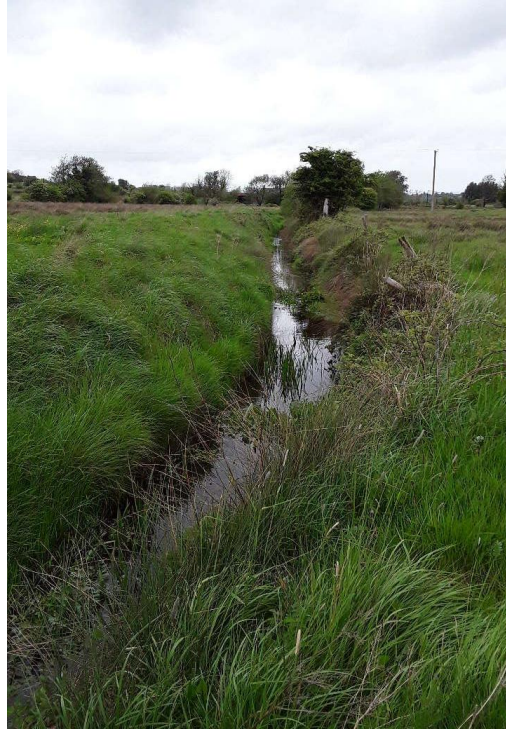
Figure 2.11 Uniform bank vegetation on the Raherlous stream (C1/13, Moderate status).

The RHAT methodology defines tree extent for the entire reach in the following, increasing order: isolated/scattered; regularly spaced/single; occasional clumps; semi-continuous and continuous. When considering the least dense tree cover (isolated/scattered and regularly spaced/single) 23 sites out of the 32 had limited tree extent along at least one bank top. 16 of those 23 sites had limited tree extent along both bank tops, which is 50% of the total number of sites surveyed in the Lung. In areas of limited tree extent, the bank vegetation can often be quite homogenous (Figure 2.11).

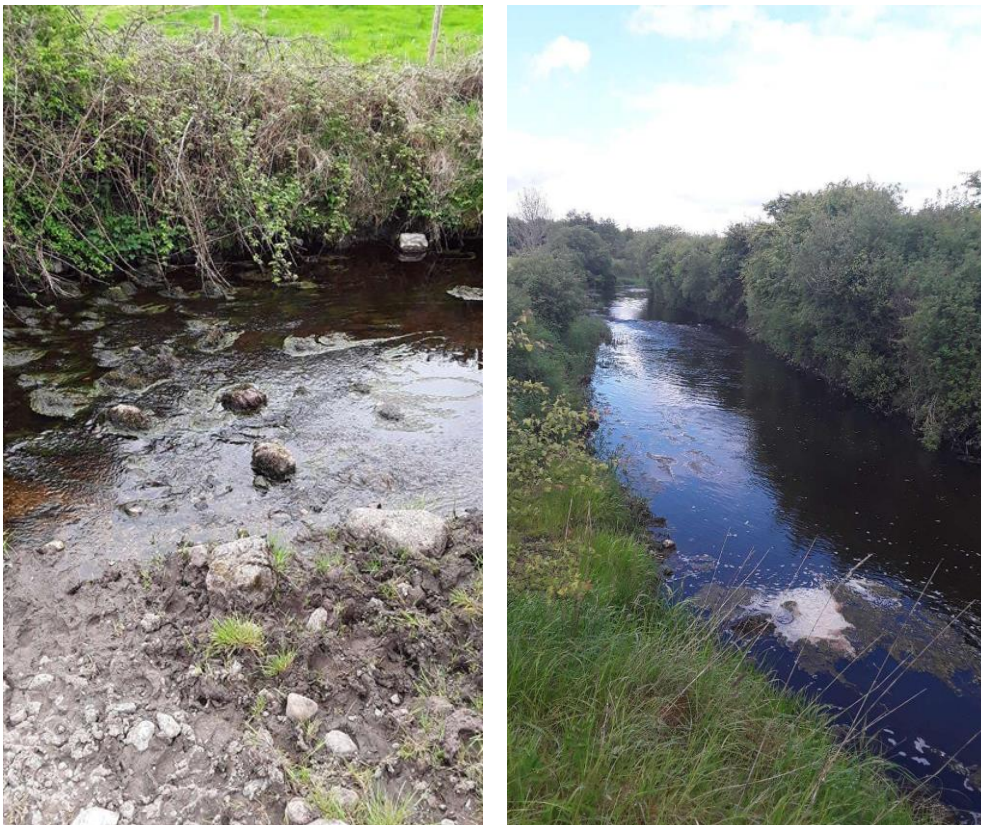
Figure 2.12 Bank trampling and excessive algal growth on channel C6/1 (left, Moderate status) and algae on the main Lung channel (right, C1, Moderate status).

11 sites contain brown or green algae, and it varies whether it is minor or excessive at the site. Where it is excessive, it is often associated with bank trampling (Figure 2.12). In total, 9 sites of the 32 had cattle poaching present on at least one bank. Depending on the extent of this issue, it can affect bank structure & stability. Excessive algal growth would affect the score for channel vegetation.

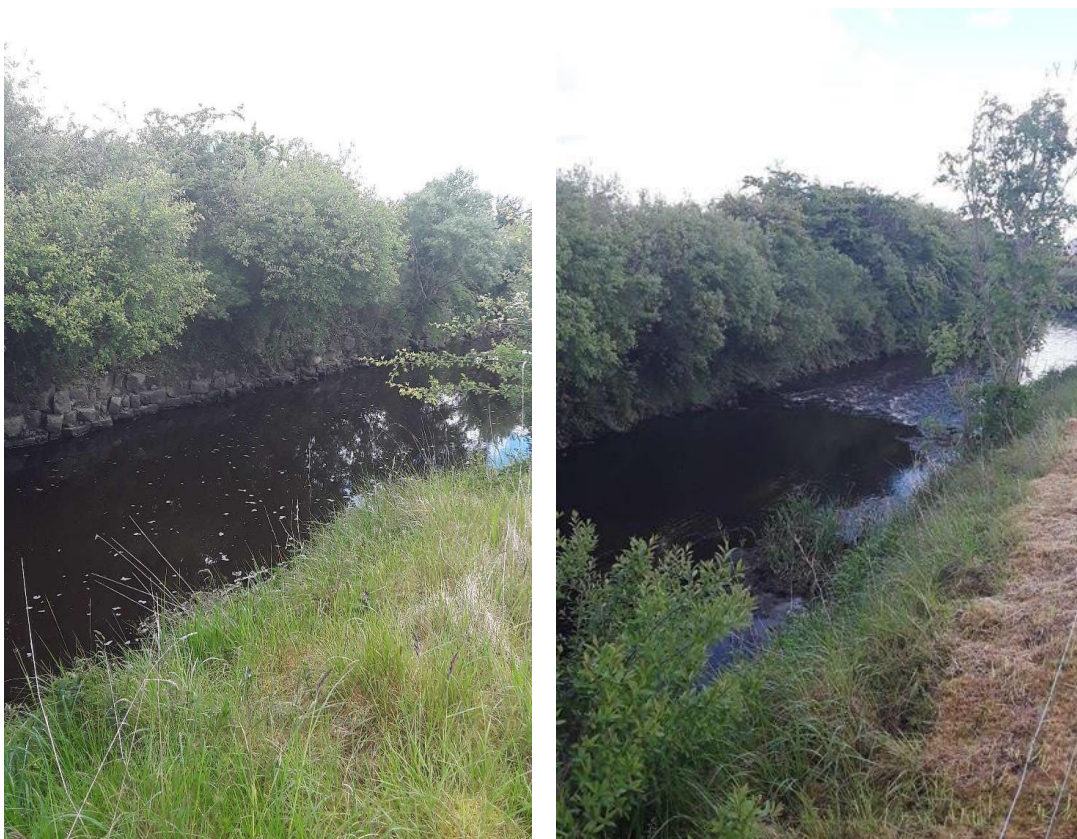
Figure 2.13 Reinforcement along the bank (left) and weedkiller used along the bank top (right) on the main Lung (C1).

8 sites had trash or dumping present instream, which was 25% of the total sites surveyed. Although not directly affecting any of the RHAT attributes, unless it affected the substrate condition for example, it likely has negative effects on water quality. Hard reinforcement was observed at a few locations, usually in close proximity to infrastructure. There were some areas along the main Lung where it was evident weedkiller had been used close to the bank top. Obviously it is an issue for water quality, but also an issue for vegetation, as only homogenous pioneer vegetation gets to establish.

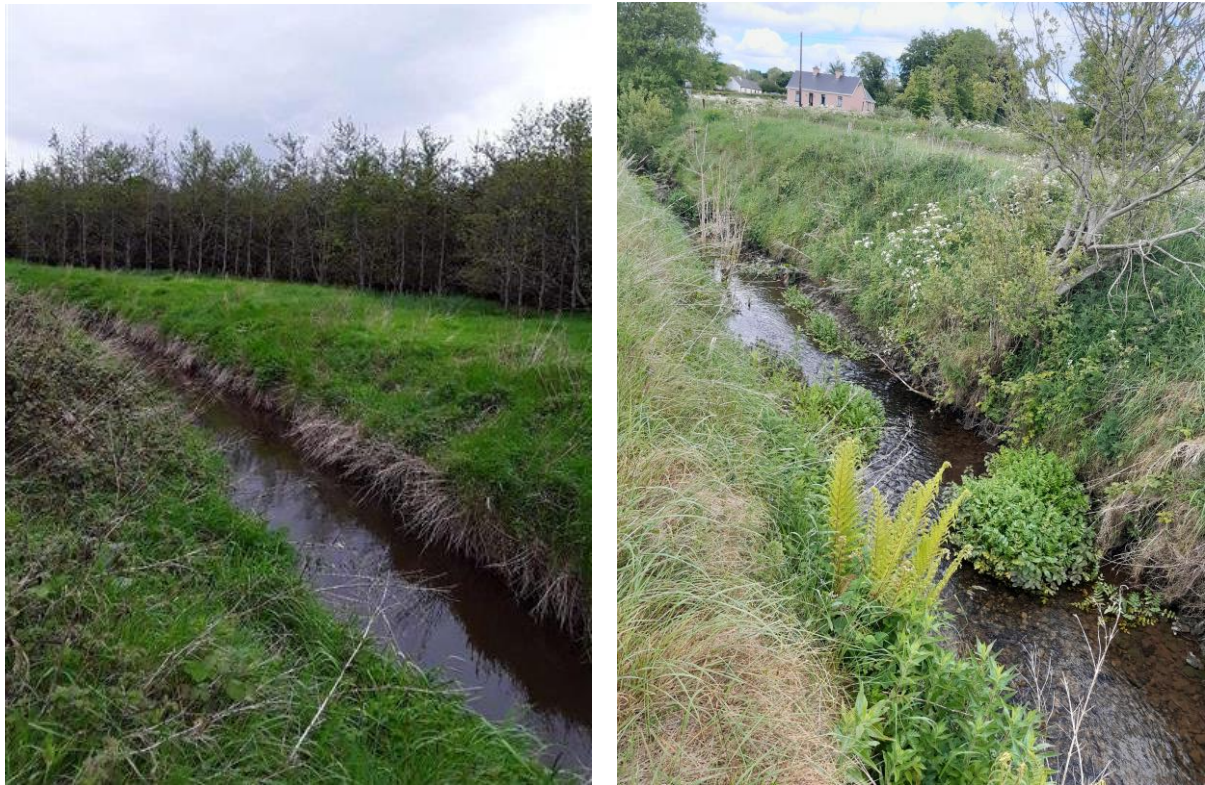
Figure 2.14 Channelised section of the Aghalustia stream (C1/12) with limited flows and coniferous plantation along the banks (left, Poor status). The same channel further upstream, with improved substrate, flows and instream vegetation (right, Moderate status).

This site is on the Aghalustia stream (C1/12) which has undergone extensive re-alignment and was classed as Poor status for hydromorphology (Figure 2.14). Despite a good gradient break at the road bridge, the majority of the site walked has extremely limited gradient, resulting in no perceptible flow for much of the reach. The instream habitat was dominated by excessive fine sediment and instream vegetation including pondweed. The site is over-deepened resulting in limited floodplain connectivity and there was limited bank vegetation as well as coniferous plantation (with a buffer) along the bank top.

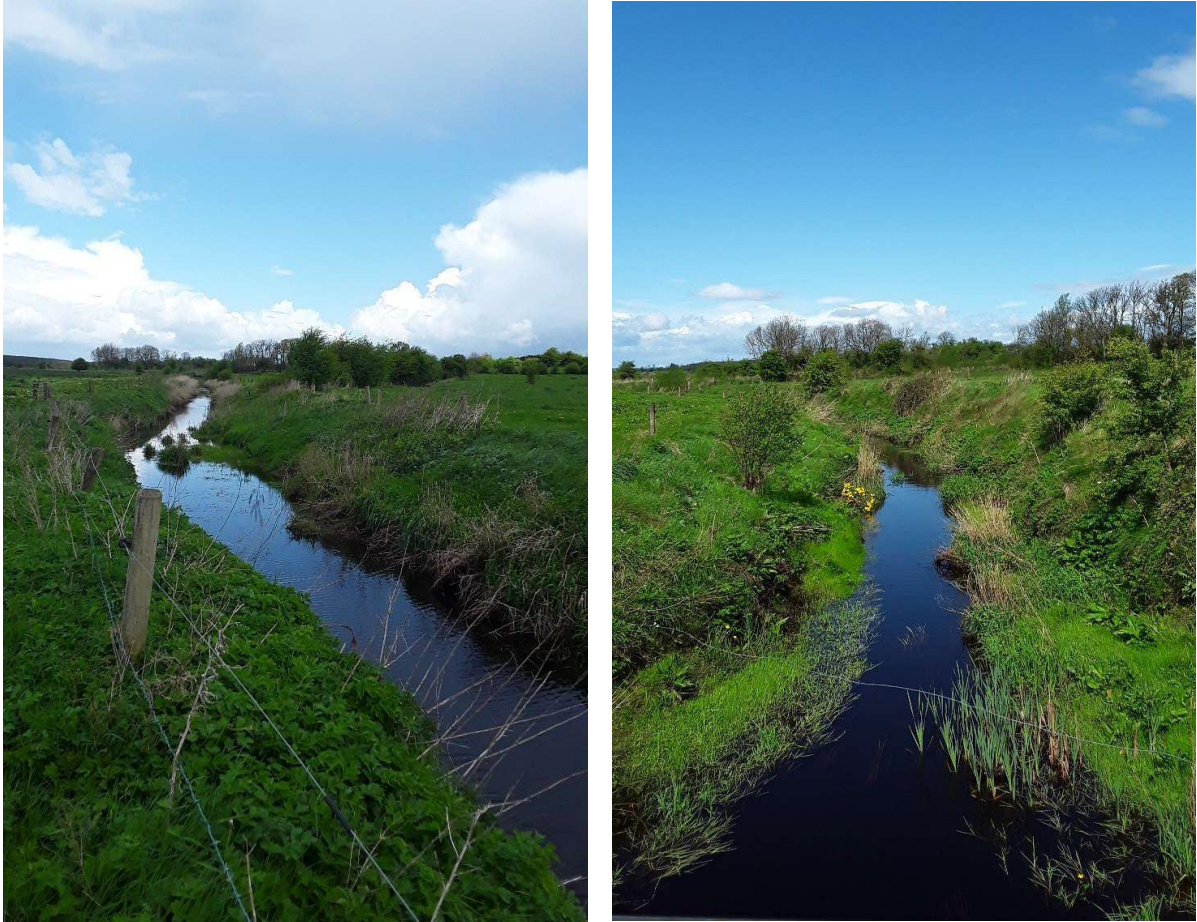
Figure 2.15 Mantua river has limited flows and some instream vegetation (C6/9, Moderate status).

The next example is on the Mantua river (C6/9), which drains into the Breedoge through marginal farmland and bog. The channel has been extensively re-aligned and was classified as Moderate status overall. Limited gradient hinders the channel flows and substrate at this site, and silt is excessive throughout. There are some good examples of instream vegetation at the site and no one type is dominating. There is a lack of bank vegetation and limited floodplain connectivity. This channel is quite typical of the issues encountered in the Lung catchment more widely.

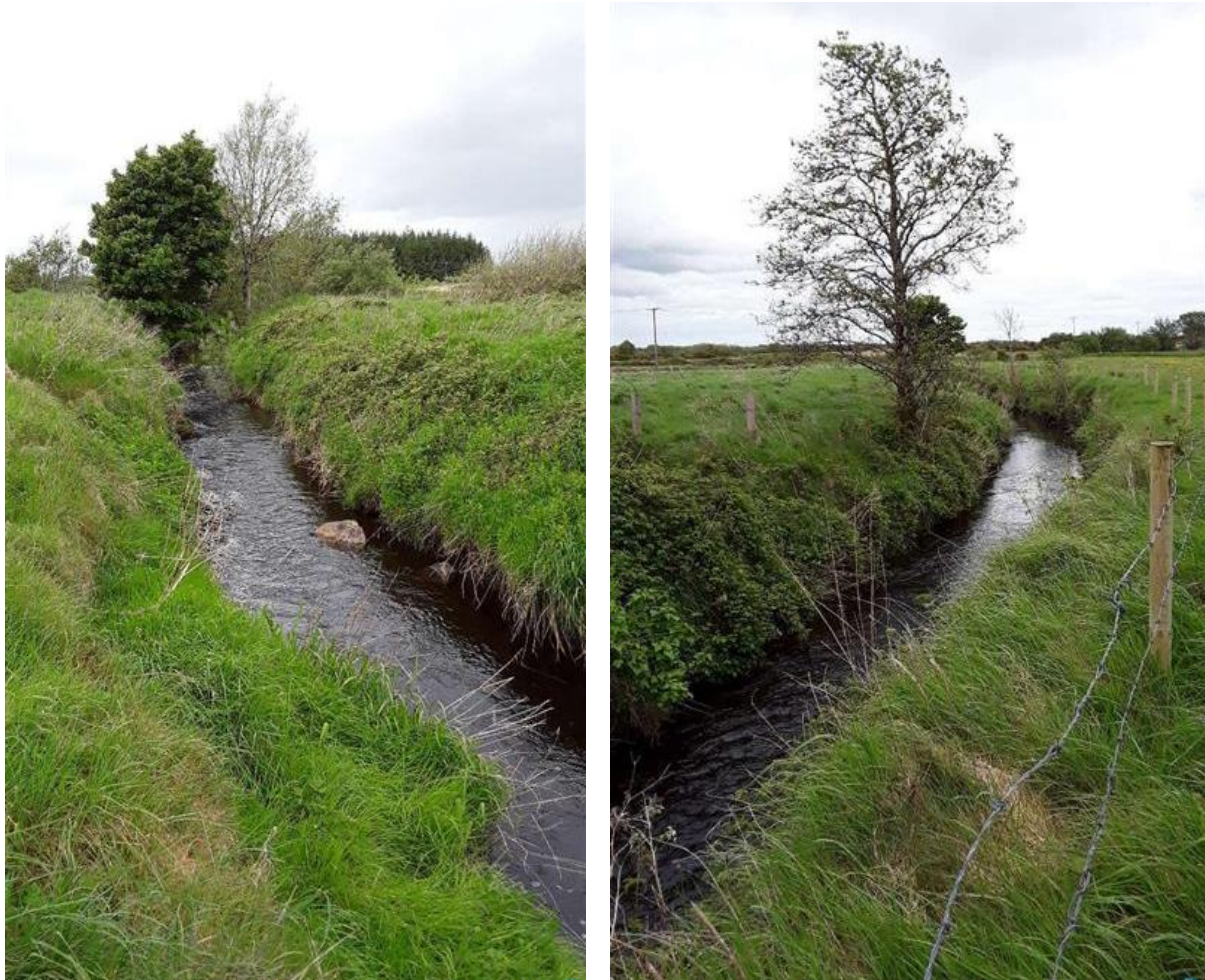
Figure 2.16 Meandering section of channel with diverse flows, limited bank vegetation (C1/11, Good status).

This example is from a relatively large tributary (C1/11) off the main Lung channel, just south of Ballaghaderreen. It was classified as Good status. Clear from the images, there is poor floodplain connectivity and limited bank vegetation. The land use is dominated by rough pasture, a moderately scoring attribute. However it scores highly on other attributes including channel form & flow and substrate condition. There is good variety in flows and depths as well as heterogenous substrate, neither of which are common in OPW scheme channels.

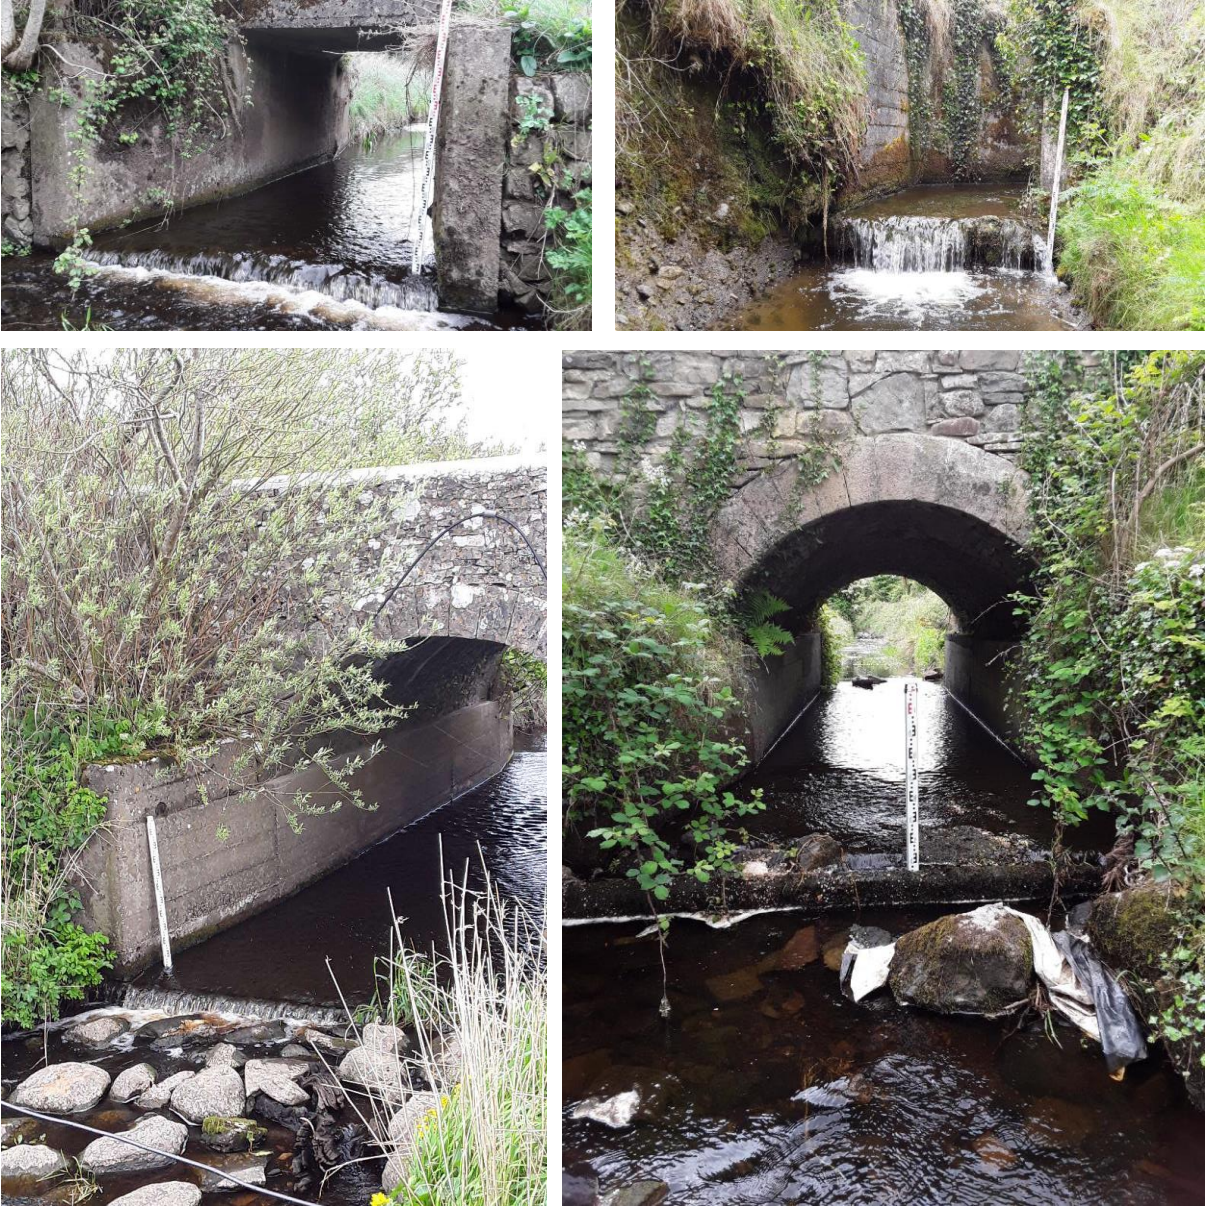
Figure 2.18 Bridge aprons with minor drops in the Breedoge catchment. Bella River (C6/4, top left); upstream tributary (C6/7/5/5); Mantua River (C6/9, bottom left); Owennafreesha River (C6/7/5 bottom right).

Typical issues encountered include perched bridge aprons and pipe culverts. On the Breedoge river system, there are numerous examples of bridge aprons with small drops (Figure 2.18). The majority of minor drops would be passable in higher flows. However in the low flow period, which can extend through a good portion of the year, they all present problems for fish passage.

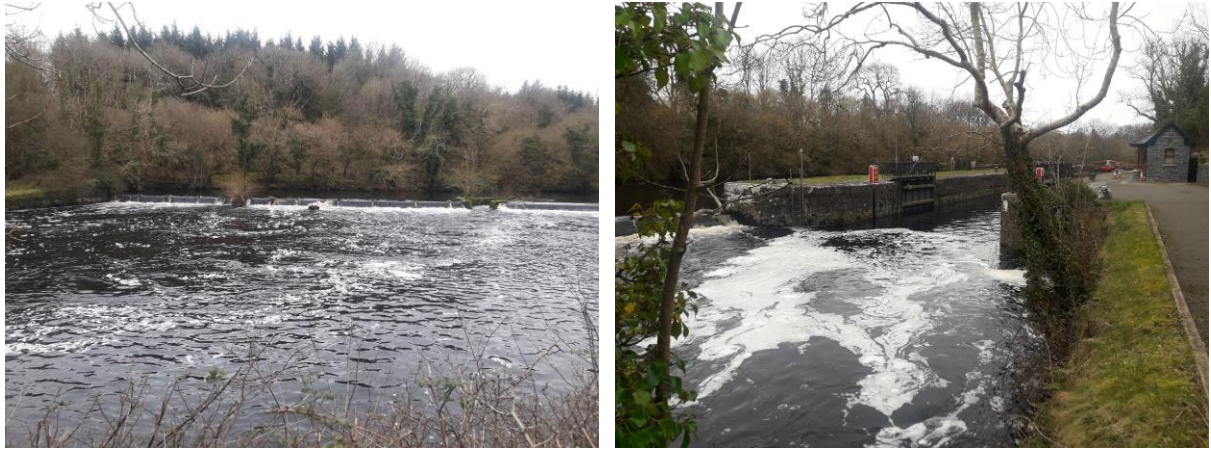
Figure 2.20 Knockvicar weir (left) and lock gate (right) on the Boyle River.

The first encountered going in an upstream direction from Carrick-On-Shannon is the weir on the Boyle River at Knockvicar, which is navigable for boats, and has a lock gate (Figure 2.20). It has not yet been assessed using the WFD111 methodology. Upstream of Lough Key, there is a series of three small weirs in Boyle town, which were measured using the i-BAST tool (Figure 2.21). All have small head heights and fish passes along the weir face.

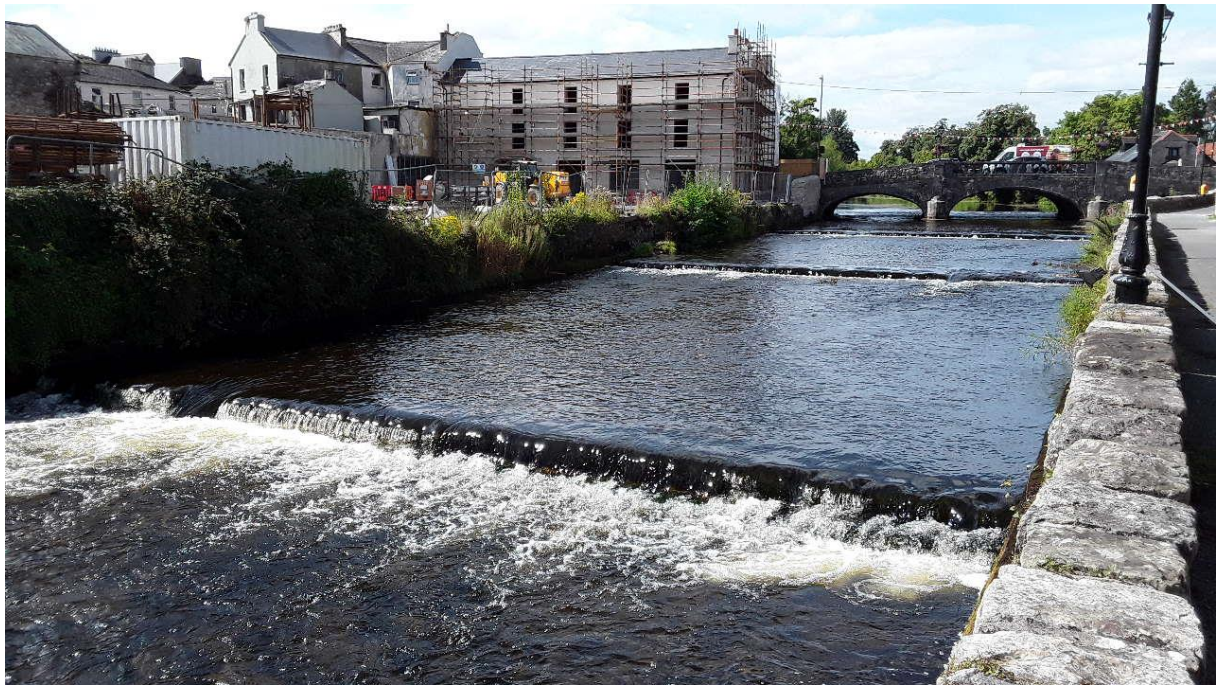
Figure 2.21 Sequence of small weirs on the Boyle River.

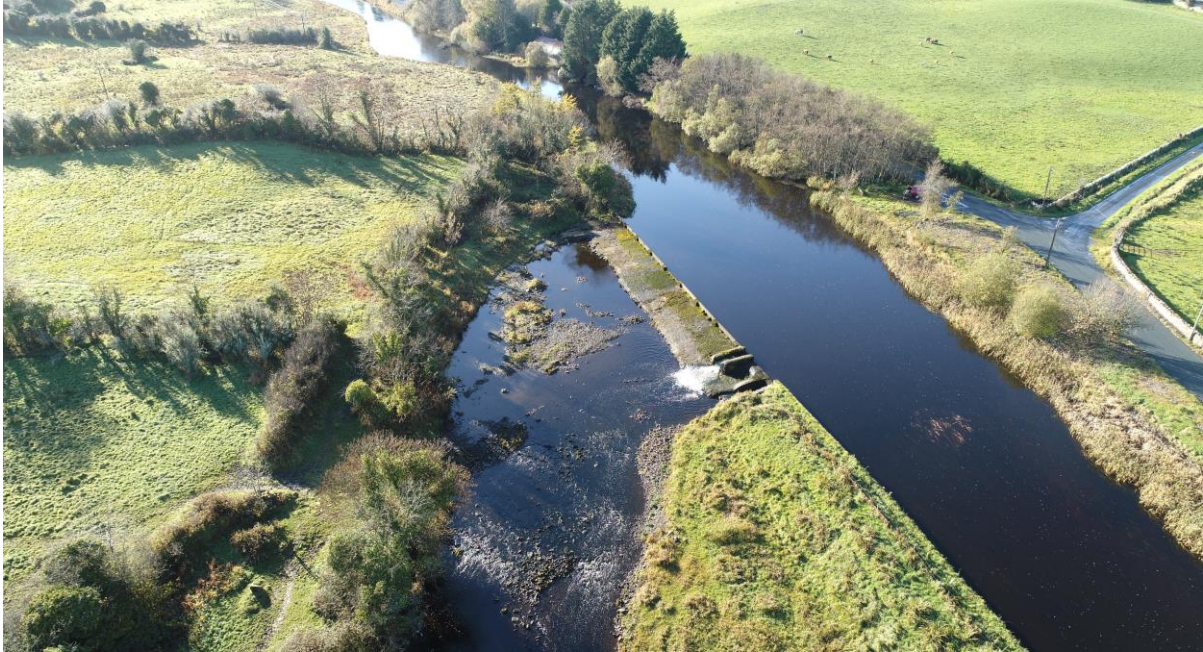
Figure 2.22 Oblique drone picture of Stewart's weir, on the Boyle River.

650 metres upstream of this sequence is Stewart's weir, which has a tailrace offtake to supply industry (Figure 2.22). It was assessed using the WFD111 methodology developed by SNIFFER (Scotland and Northern Ireland Forum for Environmental Research, 2010) in 2018. The weir a 1.4 metre hydraulic head. Two transversals were measured – the sloping weir face and the fish pass. The velocity of waters through the latter impedes fish passage. On the day of the survey, the structure was deemed a High Impact Partial Barrier to adult salmon, trout and juvenile eel, and a Complete Barrier to juvenile salmonids, cyprinids and adult lamprey.

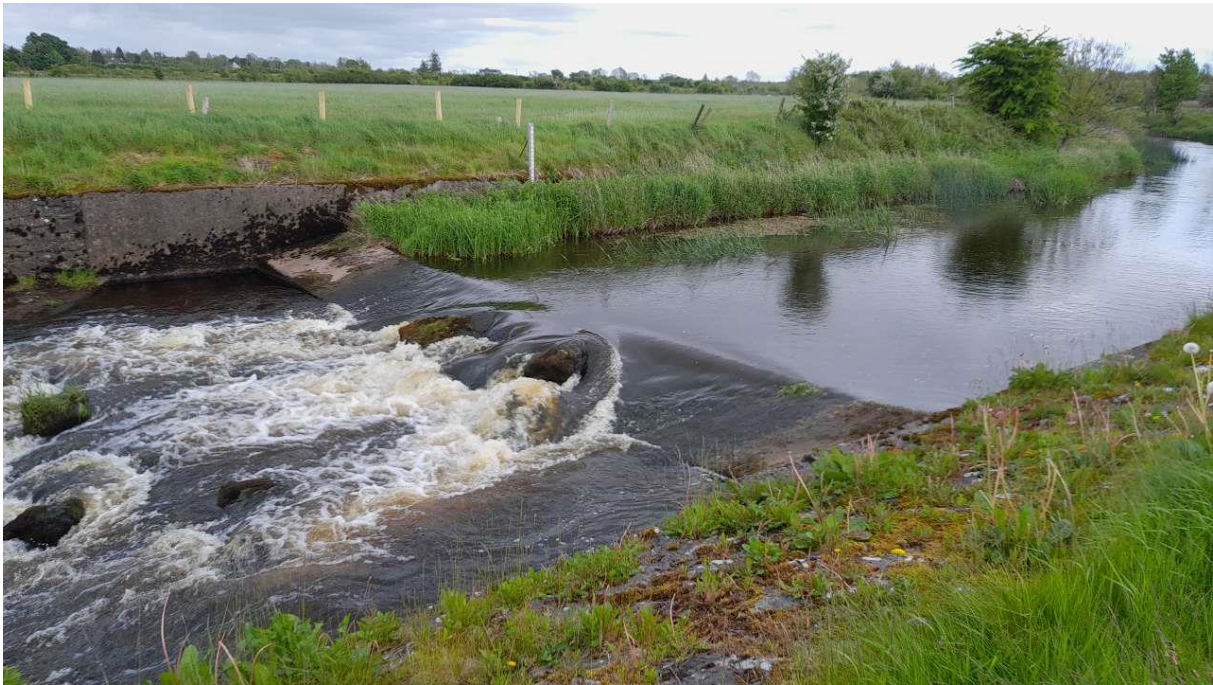
Figure 2.23 Weir on the Lung River at Ballaghadeerreen.

There is one major weir on the Lung River, just east of Ballaghaderreen town. It is a more recent construction than Stewart's or Knockvicar weir. It is a crump weir used to gauge water levels on the OPW scheme at Banada Bridge. It presents a barrier to fish migration but has not yet been assessed using the WFD111 methodology.

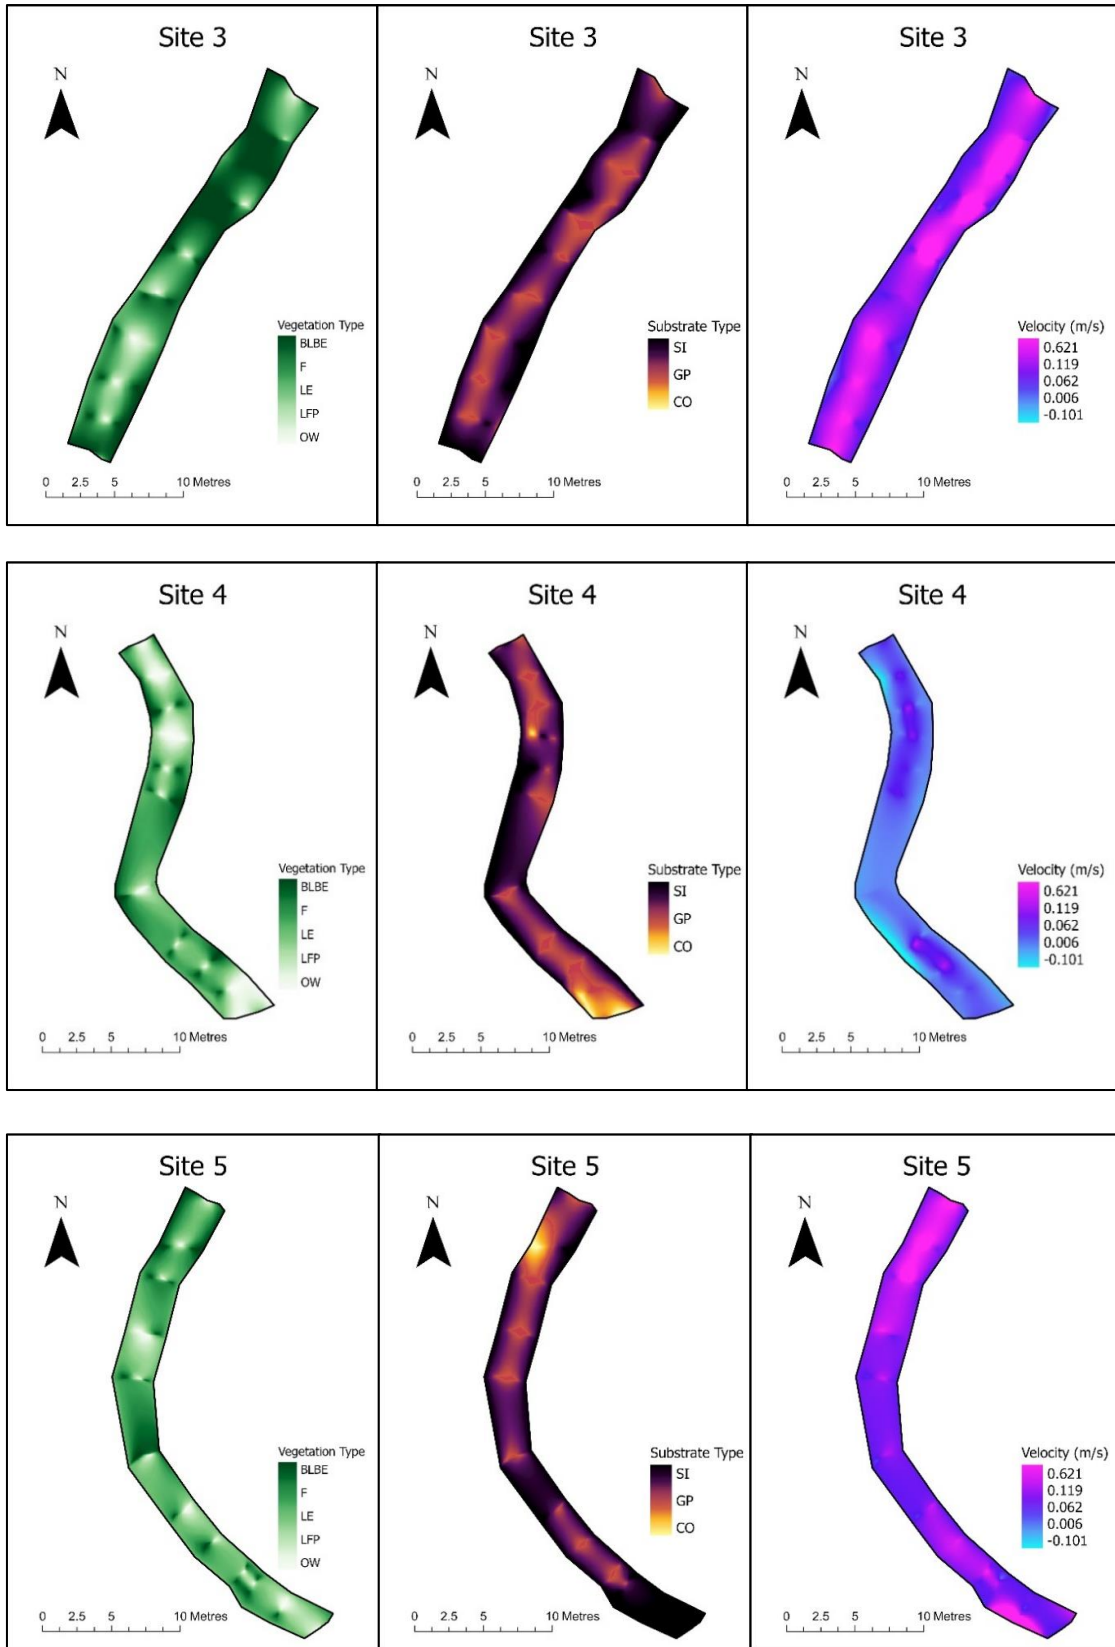
Figure 3.4 Interpolation plots generated for the experimental section (sites 3, 4 and 5) visualising vegetation type, substrate type and velocity.

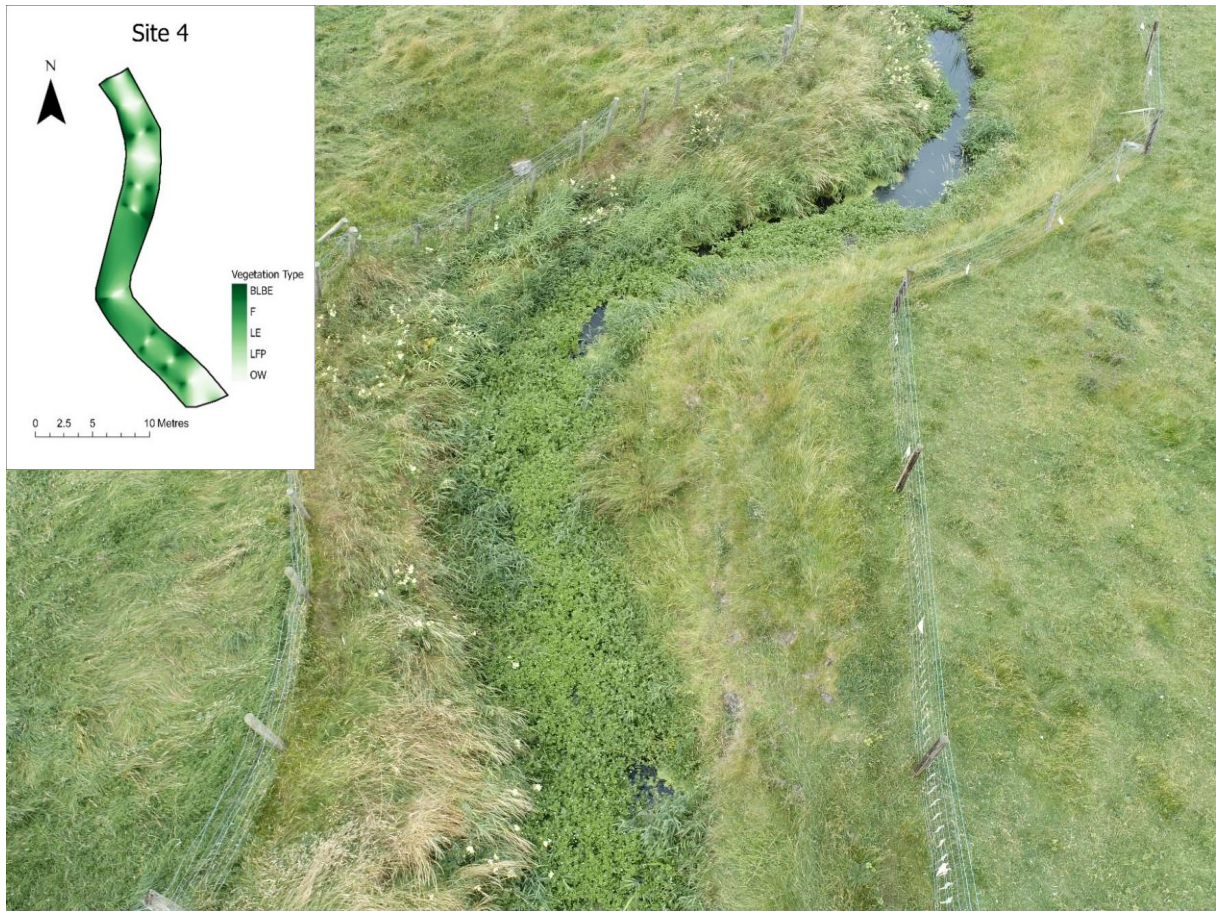
Figure 3.6 Drone image of site 4 in July giving context to the plot generated displaying vegetation patches and open water patches.

The drone image below (Figure 3.6) shows vegetation colonisation in Site 4 before the survey was completed. The inset graphic showing the contour plot generated, demonstrates the plots are representative of the site when point data was collected. From the imagery and the plot, it is possible to identify changes in vegetation type and their distribution within the study site. Open water patches are also visible, which coincides with the plot.

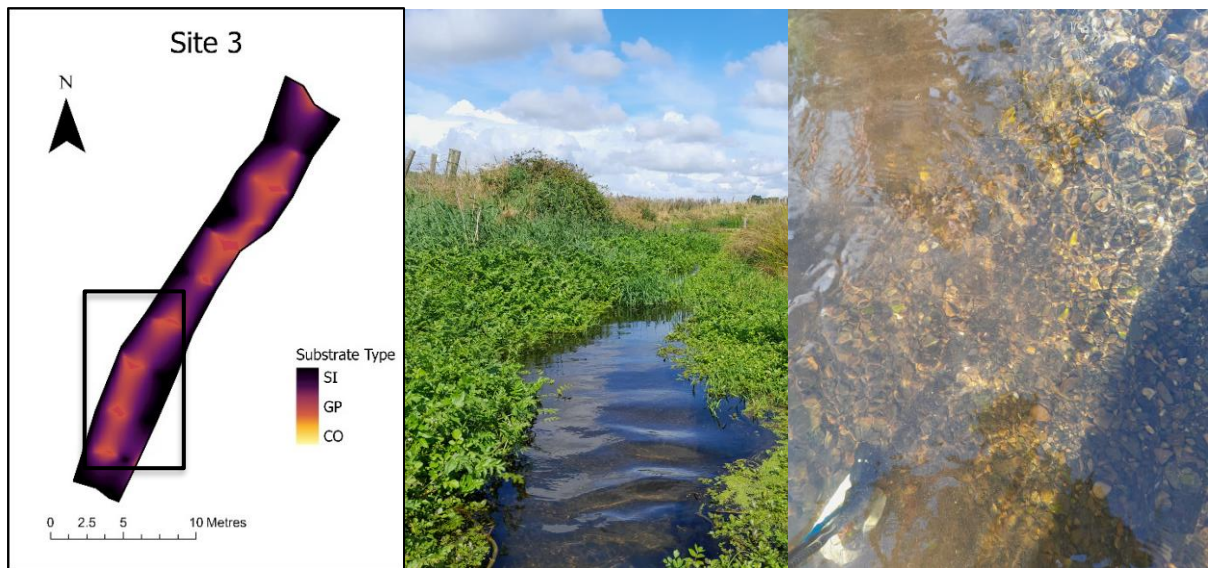
Figure 3.8 On site photos taken of site 3 in September of spawning gravels available giving context to the plot generated displaying substrate condition.

Site 3 – one of the survey sites with better gradient – presents characteristics of a channel with improved velocities (

Figure 3.8). The below pictures show some of the good quality gravels recorded onsite.

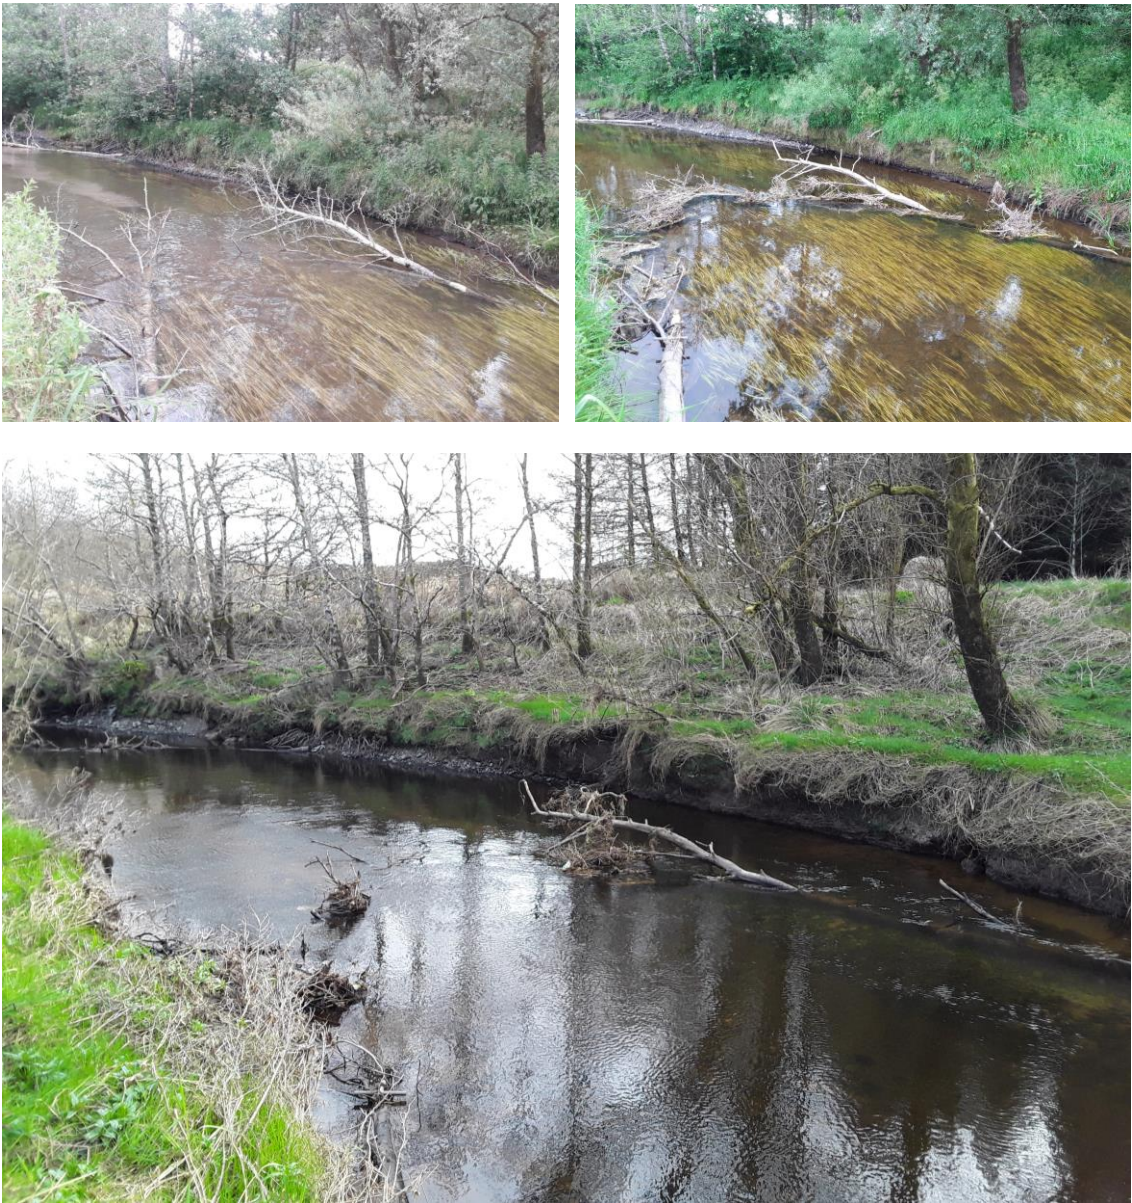
Figure 4.2 Photo of one completed pair of deflectors taken in July 2019 (top left) and photo of same in June 2020 (top right) and again in March 2023 (bottom). All photos were taken in low water levels.

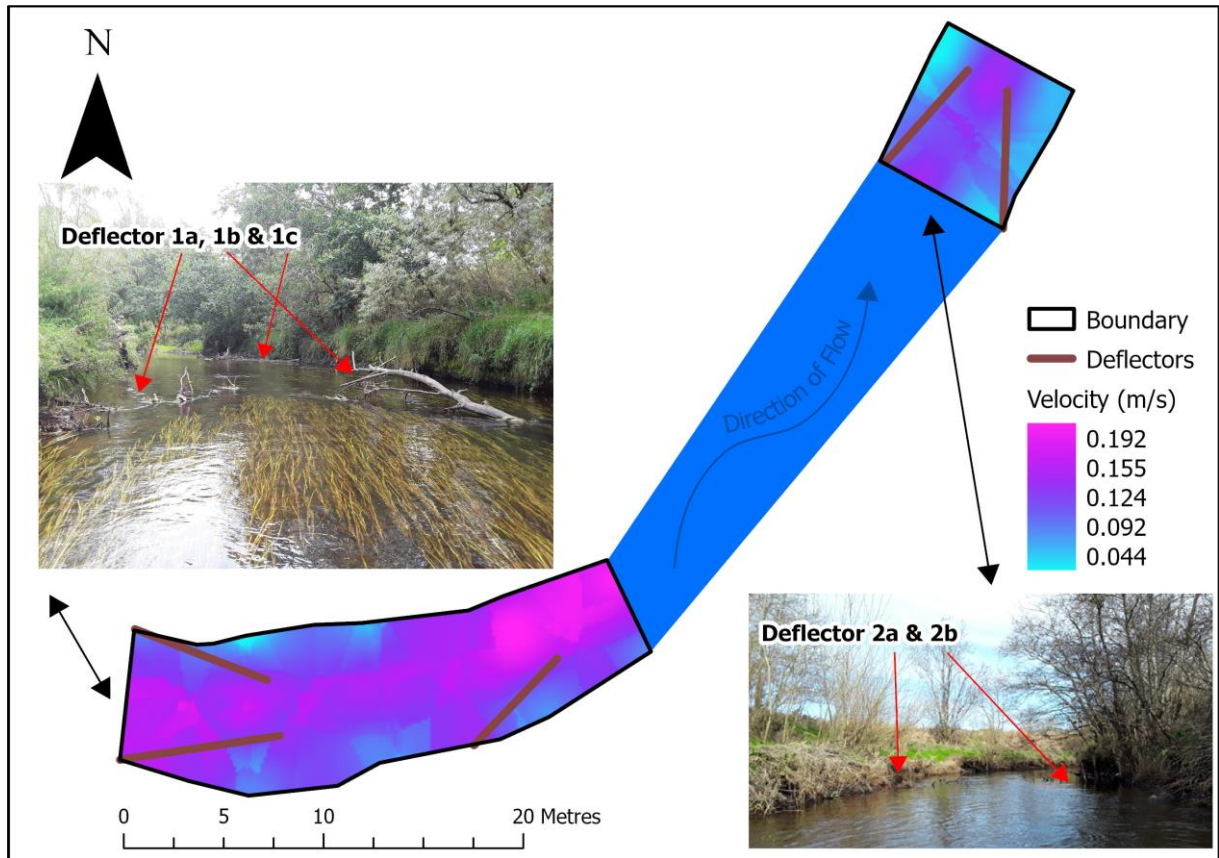
Figure 4.5 Velocities (m/s) recorded throughout the study site in 2022, where deflectors were installed in the Eignagh River in 2019.

Deflectors create variable flow conditions, narrow flow paths, and deepen mid-channel flows. They are suitable structures for use in drained channels where flows can tend to be homogenous. Flow heterogeneity is important for migratory fish species which utilise diverse flows for different stages of their lifecycle. The trapping of material behind such structures can

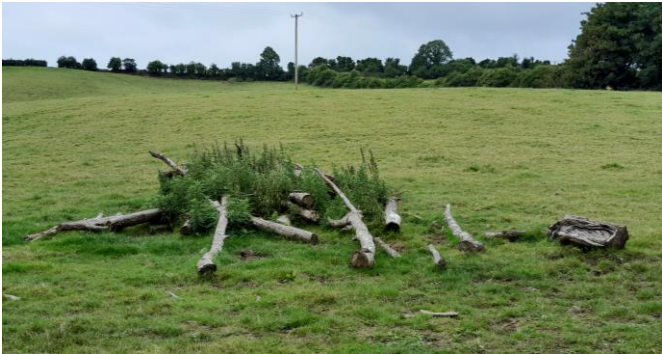
Figure 4.7 Figure – Raw material available on site.

3 kilometres of channel walked, 40 work sites were identified (Figure 4.6) with removal of blockages that hindered flood conveyance the main area of focus. The maintenance crew were also advised to leave many sections untouched where no maintenance was required. In 2022, there were opportunities within this section of channel to trial a new softer bank protection. There was woody material available on site which could be used (Figure 4.7).

The available timber was bundled into the bank where erosion had caused some minor bank slippage. These timbers were supported by vertical stakes and rebar (Figure 4.8). We plan to visit this area of works and monitor its success and naturalisation process over the next few years. Similar works to this could be undertaken on other channels where raw material is available for use.

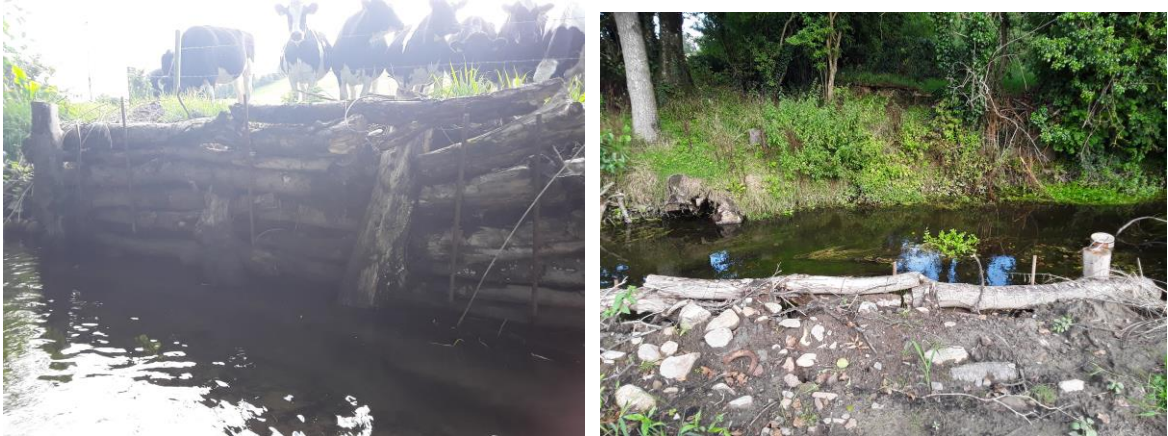
Figure 4.8 Woody bundle as bank protection (left – photo taken from the channel channel; right – photo taken on right-hand bank)

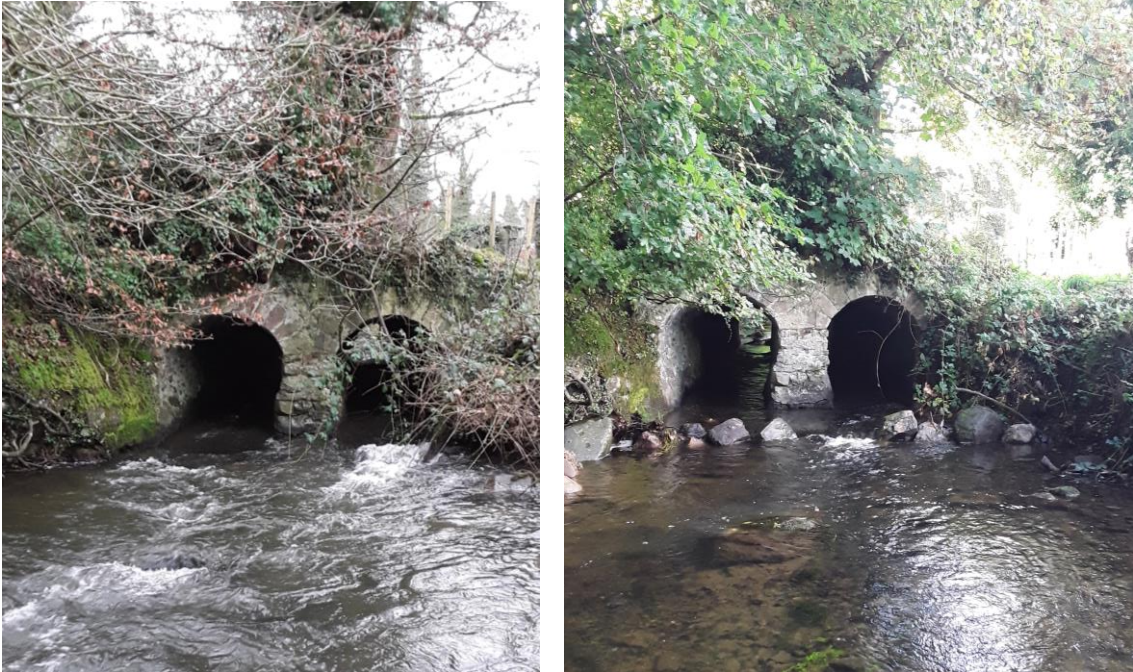
Figure 4.9 Strategic positioning of boulders at a bridge apron to alleviate a minor drop (right). Note that the photo on the right is taken during very low water levels.
