# Environmental River Enhancement Programme

# **Annual Report 2017**

## **EREP 2017 Annual Report**

Inland Fisheries Ireland & the Office of Public Works Environmental River Enhancement Programme

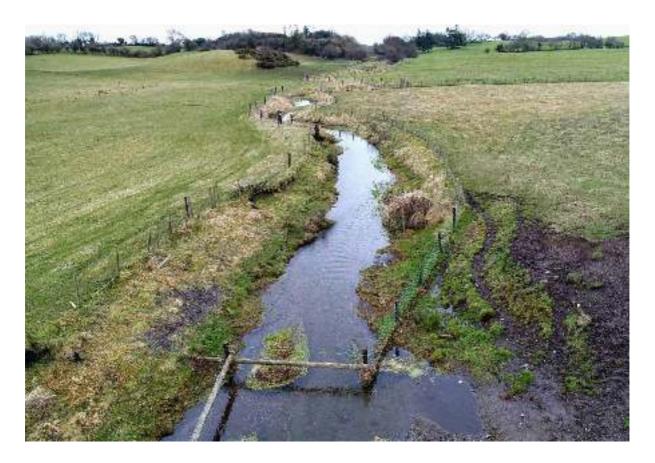
Figure 2.13. Site 3 looking downstream in January 2018, showing extent of instream vegetation dieback during winter months, top of Study Site 3 at cattle drink see figure 2.15

Sample sites (N=5) of 30m length were distributed within a 1.5km non-shaded tributary of the Stonyford river, a tributary of the River Boyne (Figure 2.13). The Stonyford River is a characteristic Irish lowland river with low-moderate flow velocities (maximum recorded velocity at sample sites = 0.75 m s<sup>-1</sup>), abundant macrophytes and a mixed bed load. Its fluvial patterns are typified by a meandering single-thread channel, bounded by cohesive alluvial plains. The average bed width was approximately 4m and average water depth was 0.4m. Water quality was reported as achieving good ecological status based on the macroinvertebrate community recorded in the study site between 2012 and 2015 (EPA 2015). The river has been arterially drained and channel morphology exhibits many characteristics typical of channelization e.g., deeply incised, trapezoidal form that isolates the river from its historical floodplain, and uniform flow dominated by extended glides. The channel has also been subject to cyclical river maintenance which has helped to maintain a very homogenous physical form.

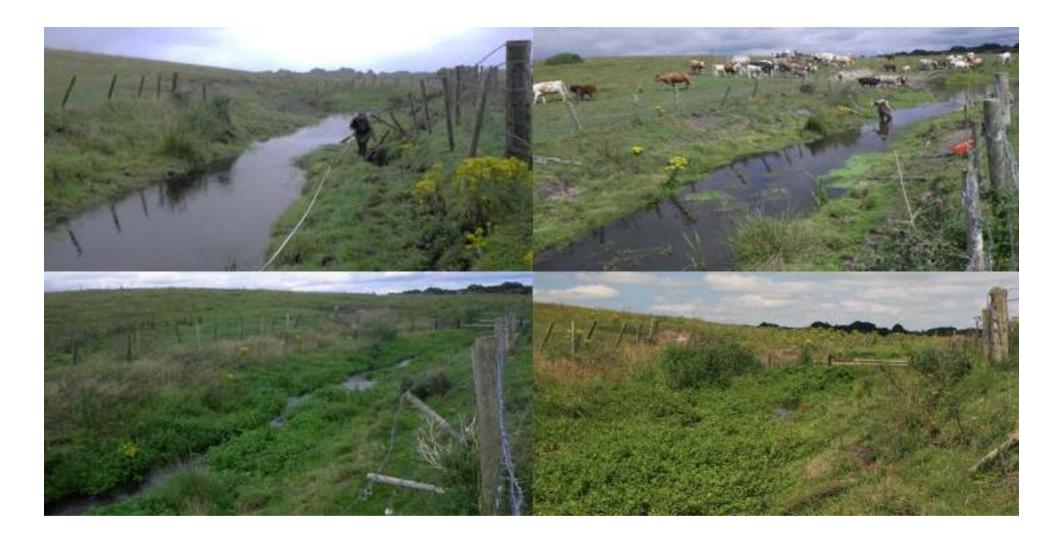
Figure 2.15. Study Site 3 showing changes in macrophyte cover 2013, 2014, 2016 and 2017 (from top left to bottom right). Changes in Plant cover, Velocity, bed type and depth are graphically represented in figures 2.14. and 2.16.

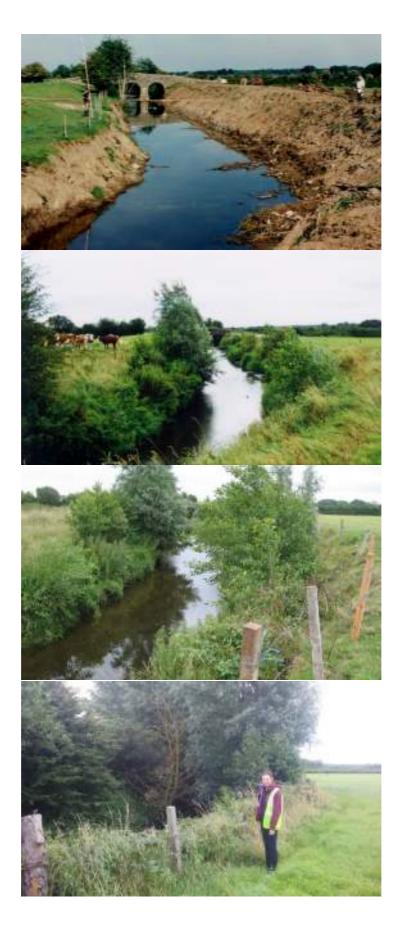
Figure 2.26. Site 4 (Chg 119) on the Clodiagh downstream of Annomoe Bridge, top to bottom: immediately post maintenance 1996, 2002, 2004 and 2017

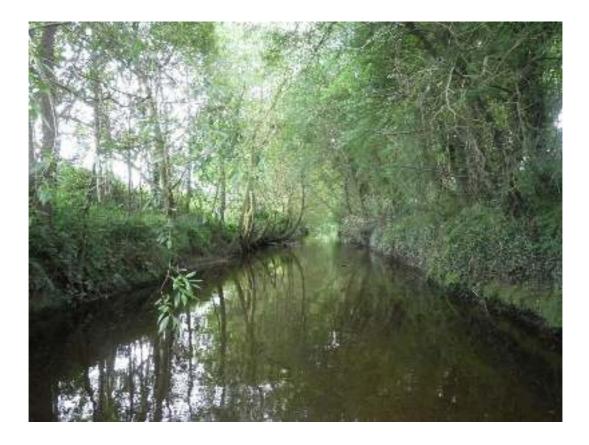
Figure 2.36. Upstream of Annamoe Bridge on the Clodiagh River in July 2017, showing uniform depths and velocities with a high level of canopy cover, no instream vegetation and little large woody habitat.

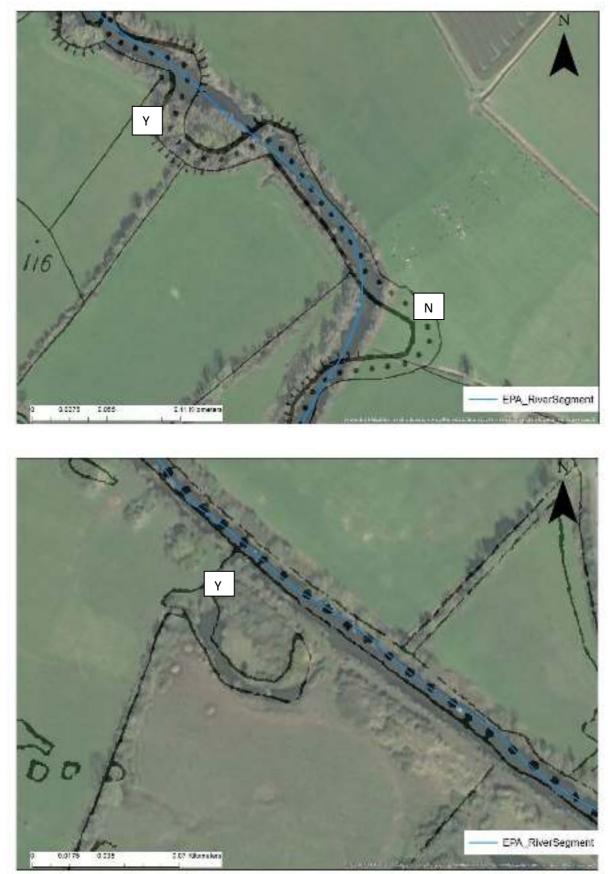
Figure 2.38. Maps displaying ox-bows/historic meanders with potential (Y) along with examples of exmeanders with no potential (N) (Nenagh & Kilmor River).

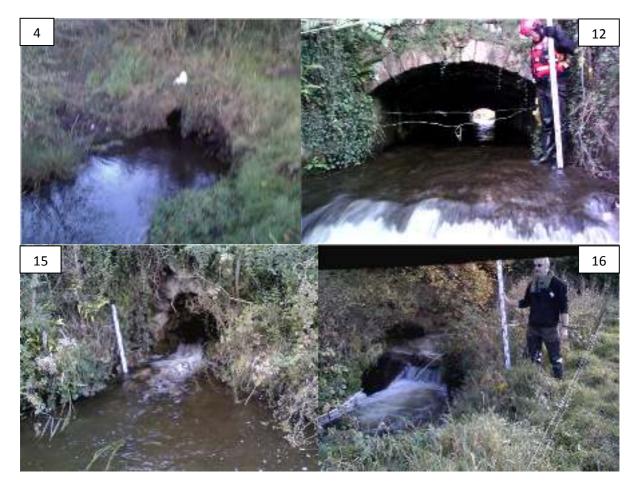
Figure 3.8. Images of barriers on OPW Channels, potentially representing a good investment in mitigation for connectivity (See Figure 3.7 for location)

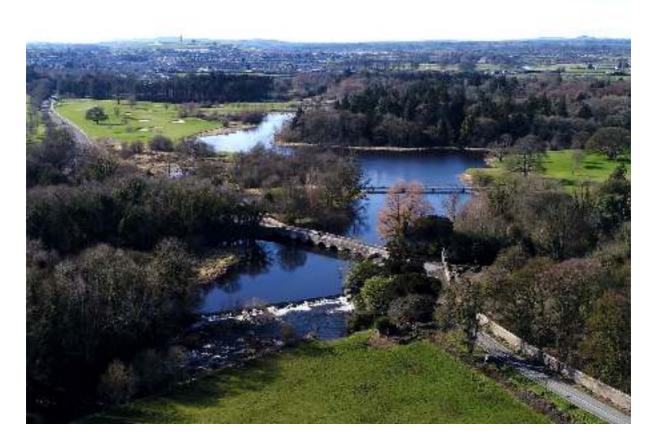
Figure 3.1. Large weir on the Kells Blackwater at Headford Estate (Kells), Boyne System, typical of the scale of structure analysed for fish passage by IFI using SNIFFER protocol.
