Environmental River Enhancement Programme

Annual Report 2016

EREP 2016 Annual Report

Inland Fisheries Ireland & the Office of Public Works

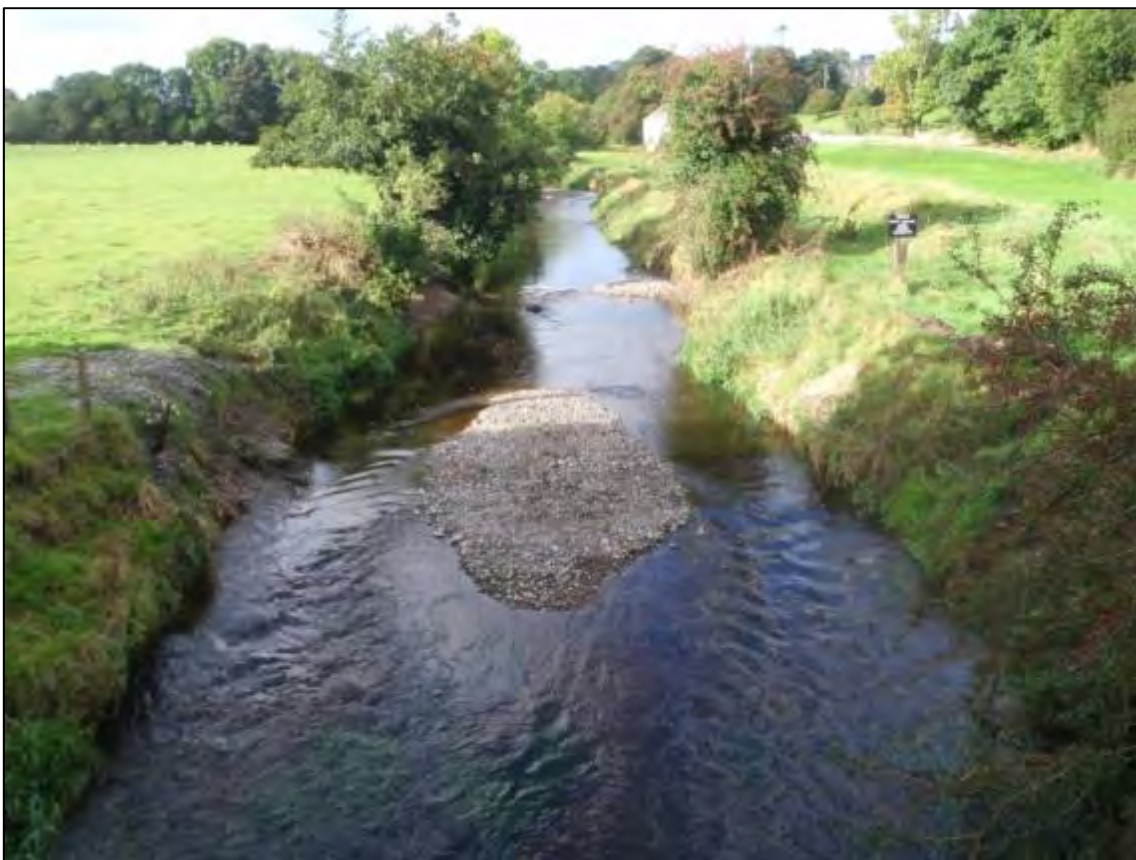
River Dee, C2(1): the addition of gravel shoals was not successful in that the shoal design and gravel size and composition were inappropriate (see Figure 2.2 and 2.3). There was a local constraint with sourcing the correct gravel material and *in lieu* of the shortfall in material, OPW maximised the use of the existing channel bed material. However this was not suitable for the purpose of gravel shoals and will require to be removed or reconstructed with an imported gravel material.

Figure 2.2. Dee River - Inappropriate spawning gravel shoals shape/design.

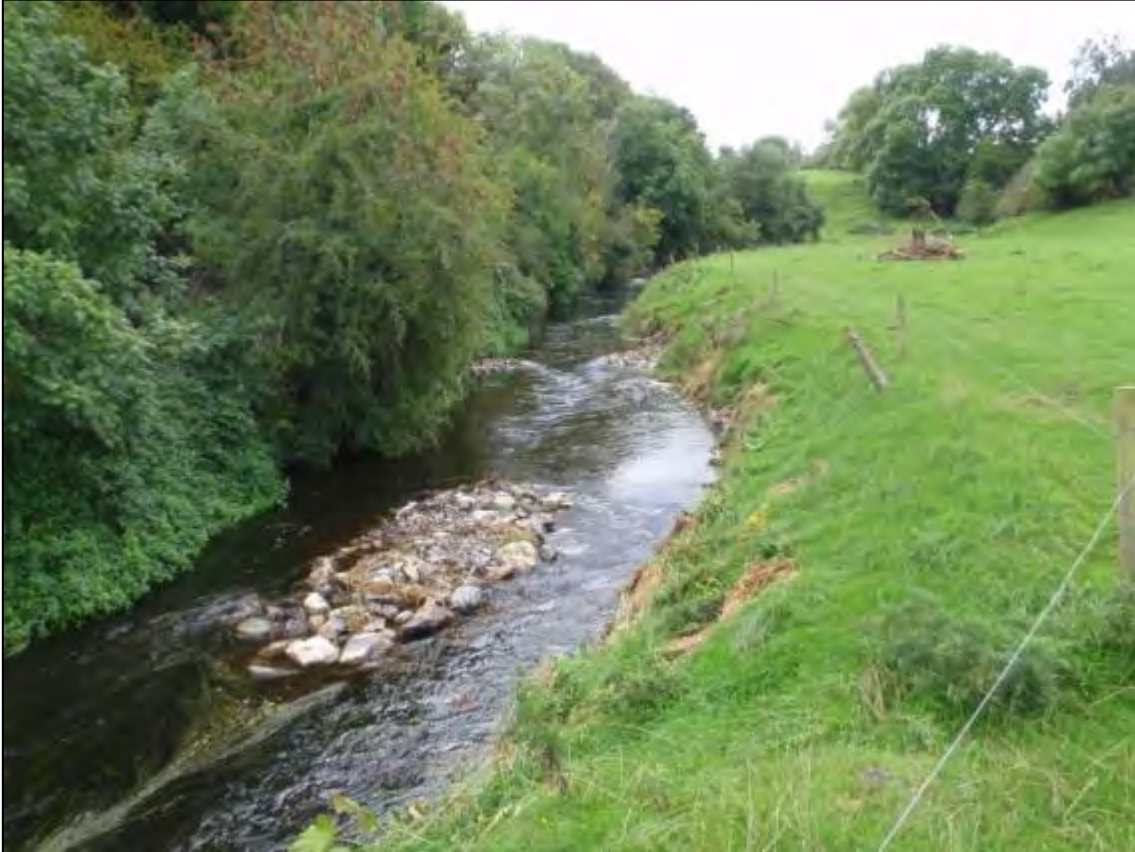
Figure 2.3. Gravel shoal at tail of pool with paired deflector Dee River.

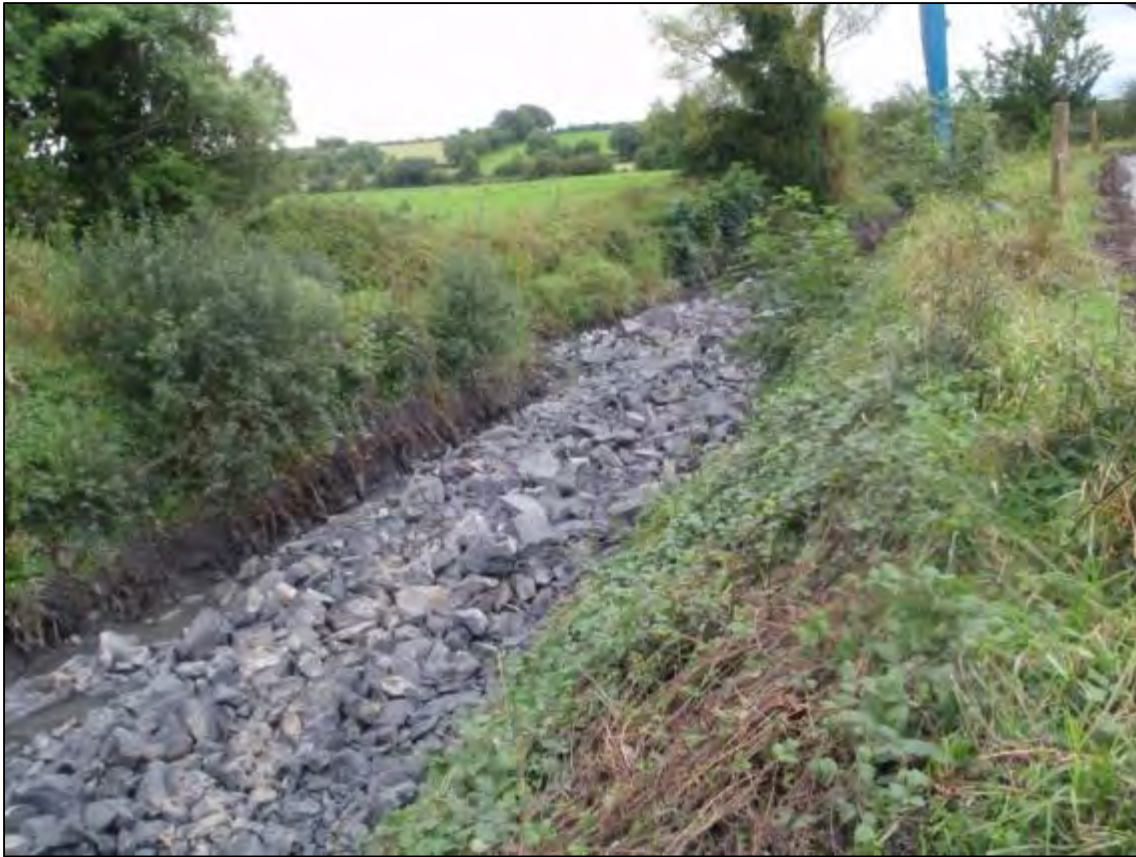
River Kilcrow: The capital enhancement works were carried out in tandem with local flood improvement works which entailed rock breaking a length of the channel to relieve a flood risk to adjoining properties. Significant changes were required to the designed Capital Works enhancement plan to accommodate the changes due to the flood improvement works. While the streamlining of works for channel enhancement and flood relief is entirely appropriate it is unfortunate that IFI was not notified of these proposed changes prior to their implementation. Prior consultation might have led to altered river enhancement design that would have benefitted the final outcome.

Figure 2.4. Rock breaker working on the Kilcrow R. Ballycahill Bridge.

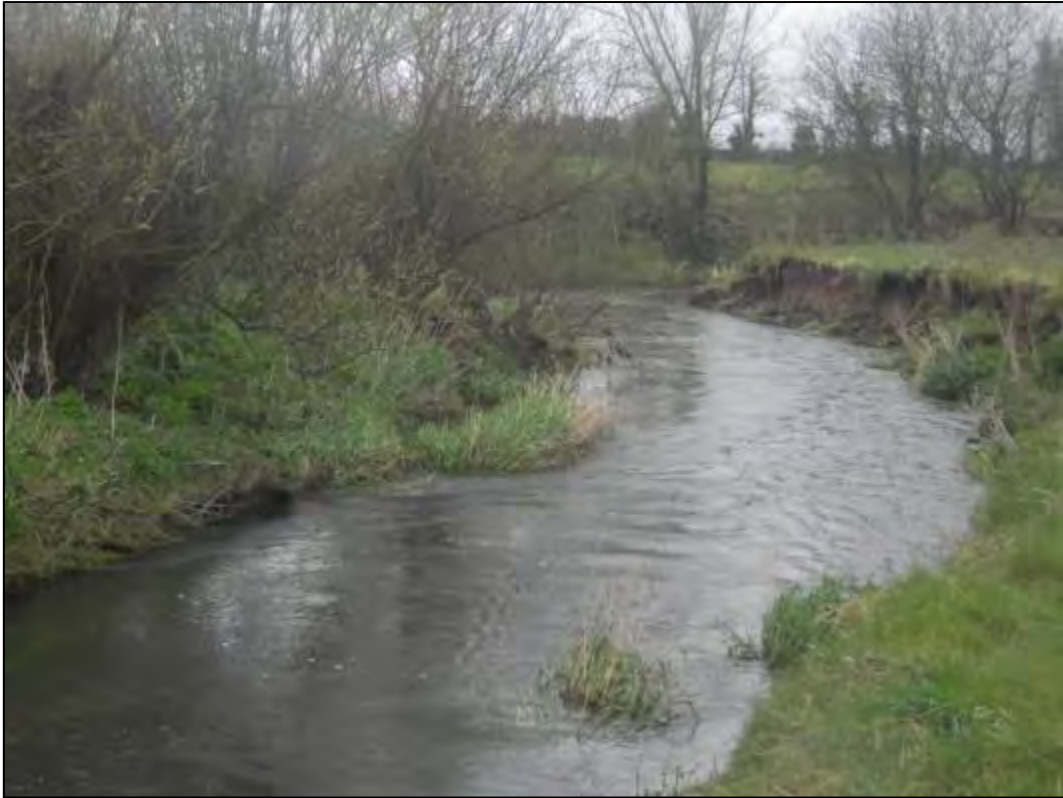
River Loobagh (c1/34 Maigne CDS): A section of channel in this river had been identified as a potential site for experimental river restoration techniques such as the reinstatement of a cut off meander and the reuse of felled trees for bank protection (Fig. 2.5 – 2.7). However the opportunity was missed as maintenance proceeded without these experimental options being revisited when works commenced.

Figure 2.5. Berm management and bank protection work Loobagh R., pre works

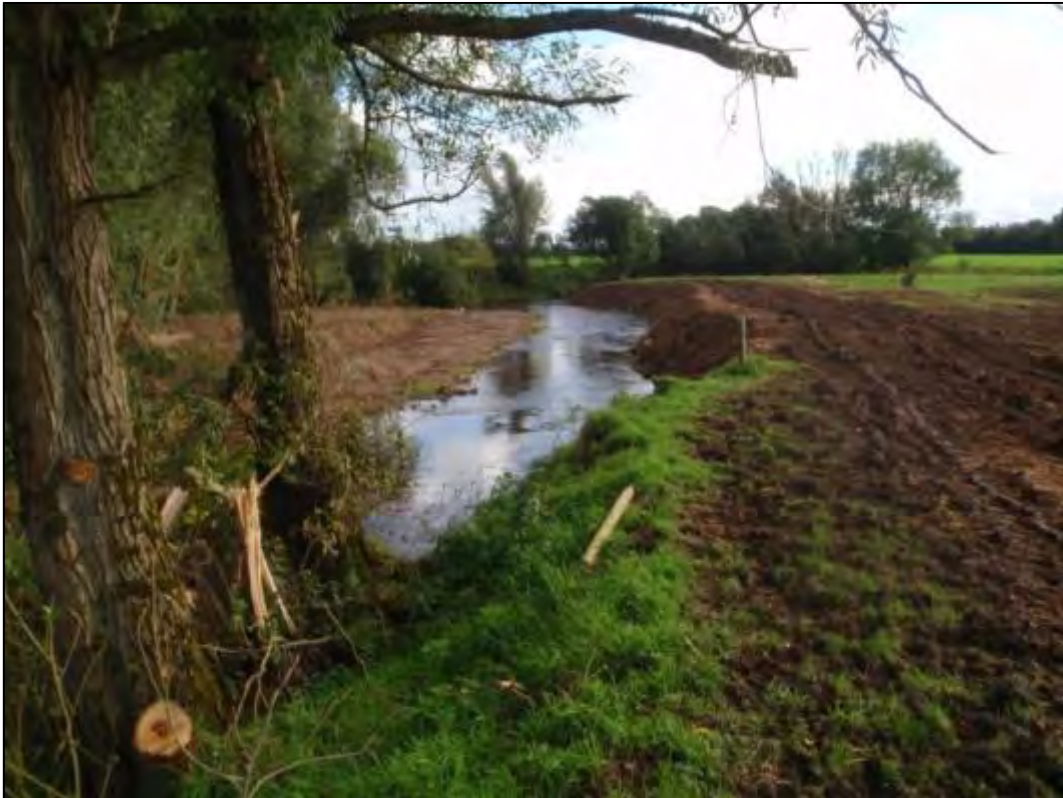
Figure 2.6. Berm management and bank protection work Loobagh R. post works.

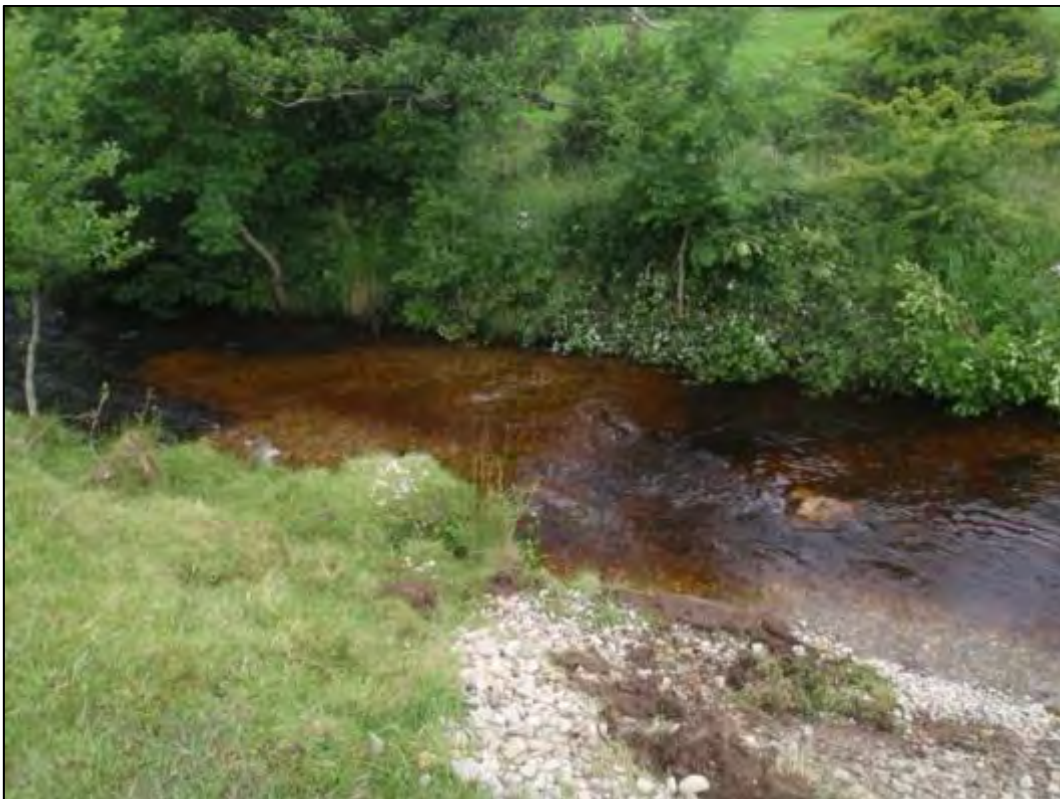
Successful Capital Works were achieved on the Abbey River (Donegal) (Figure 2.8 and 2.9) and Trimogue (Moy) rivers and works carried out on the Grange (Corrib), Loobagh (Figure 2.10) and Cloonbaniff stream (Moy) showed good examples of instream structures.

Figure 2.8. Appropriate spawning gravels and location on the Abbey R.

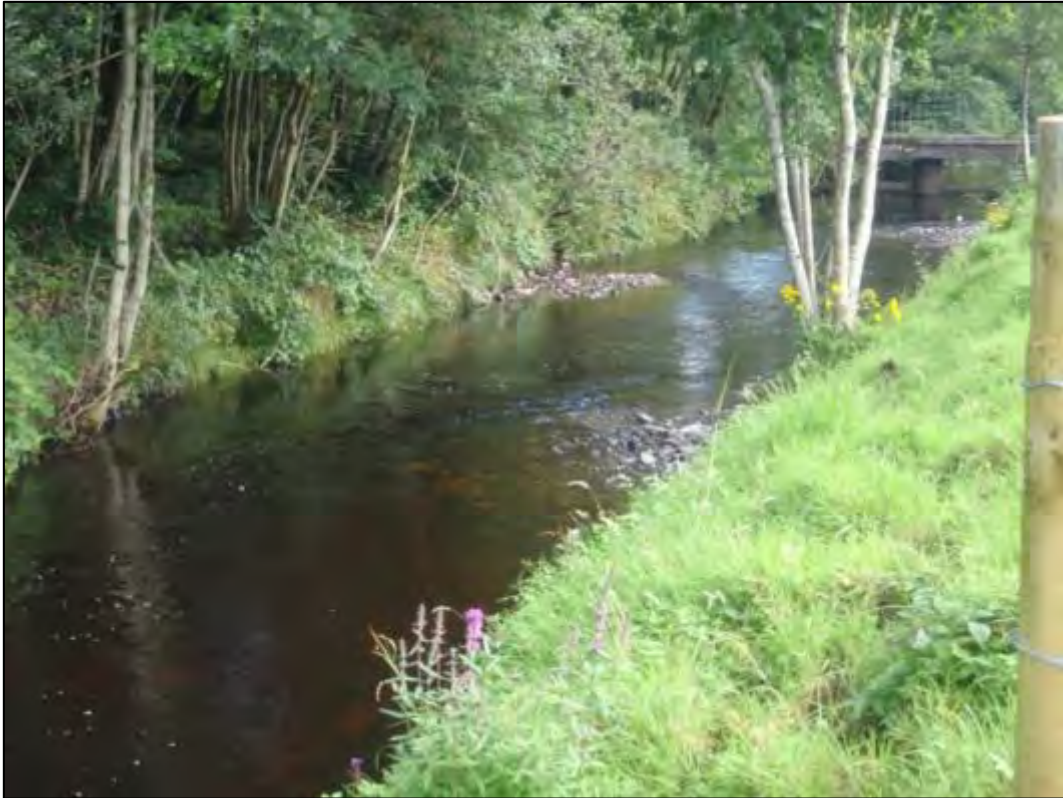
Figure 2.9. Examples of alternating deflectors Abbey R. implemented in 2016.

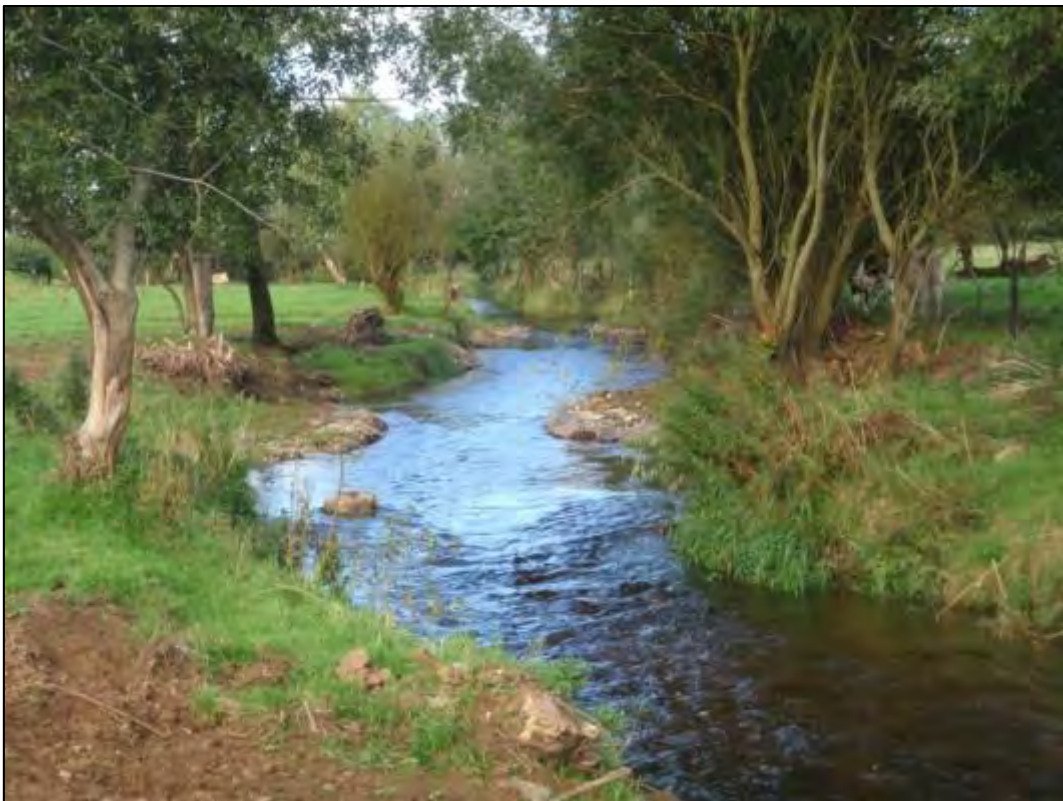
Figure 2.10. Good example of a paired deflector, pool and gravel shoal, Loobagh River.

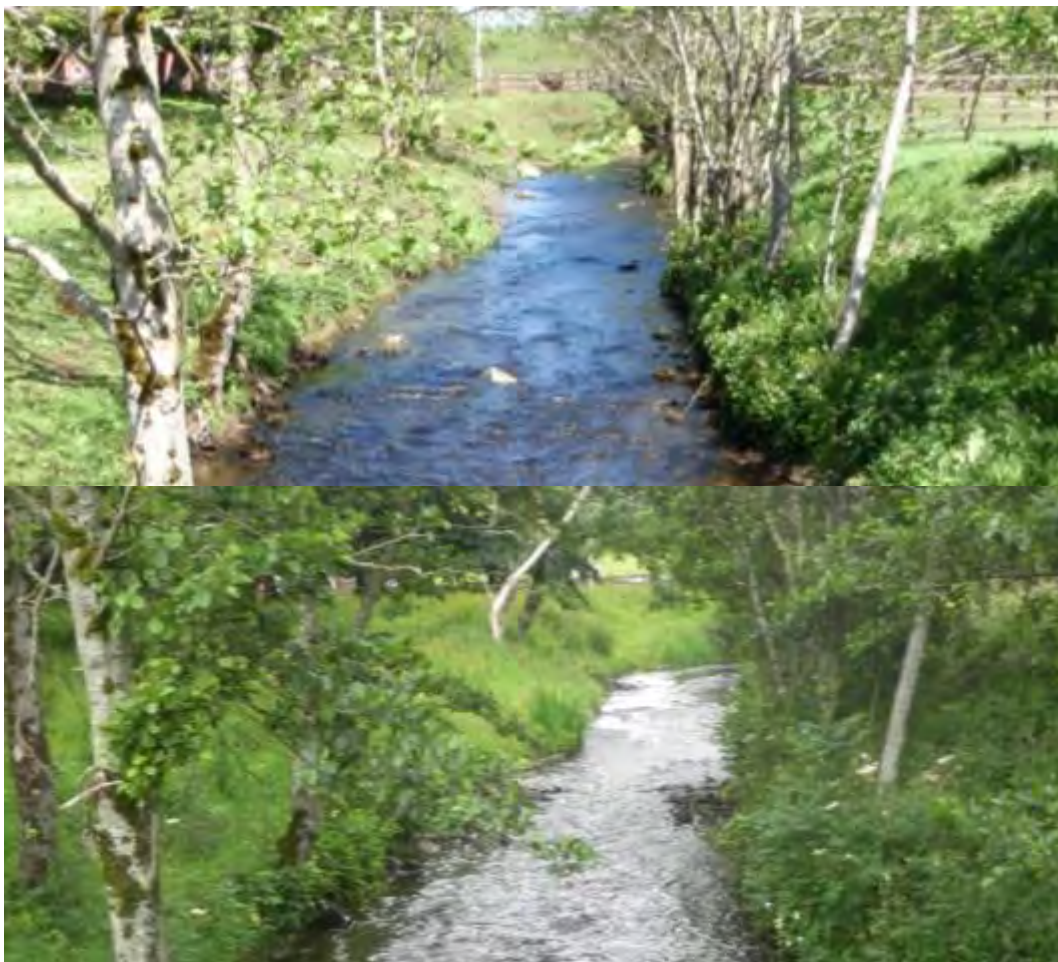
Downstream of the bridge at Parkhill two sets of paired deflector, pool and spawning shoal combinations were constructed (figure 4.5). Pre-works this section lacked water depth in summer low flows and had a bed type dominated by larger cobble/boulders. Works through this section have changed the flow pattern and habitat diversity by locally increasing water depth through the section. The bed material available for salmonid spawning has been augmented with the addition of spawning gravels downstream of the excavated pool areas.

Figure 4.5. Constructed in 2015 Experimental Site 1 consists of two paired deflectors with pools and gravel shoals (Top Pre works: 2014, Bottom Post works: 2016).

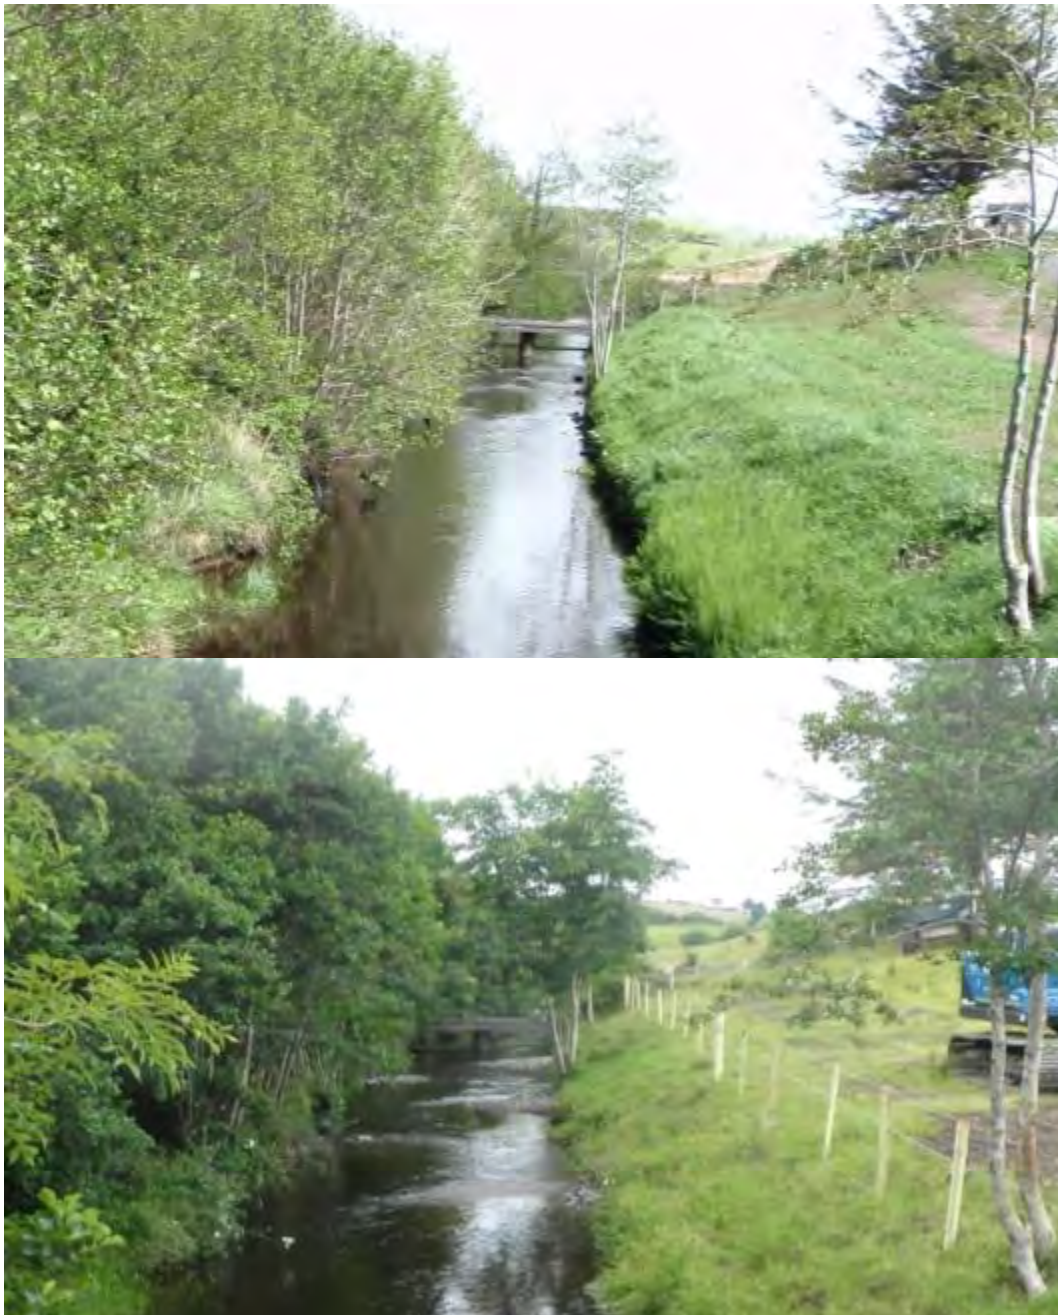
Experimental site 2, a long straight section of medium to low gradient, has a series of low stone alternating deflectors (5) constructed through its length (figure 4.6). Deflectors are increasing instream habitat diversity by creating flow heterogeneity with depositional and erosional areas in an otherwise uniform channel.

Figure 4.6. Constructed in 2016 experimental site 2 consists of a series of alternating deflectors (Top Pre works: 2014, Bottom immediately Post works: 2016) (note: OPW machine still on site)

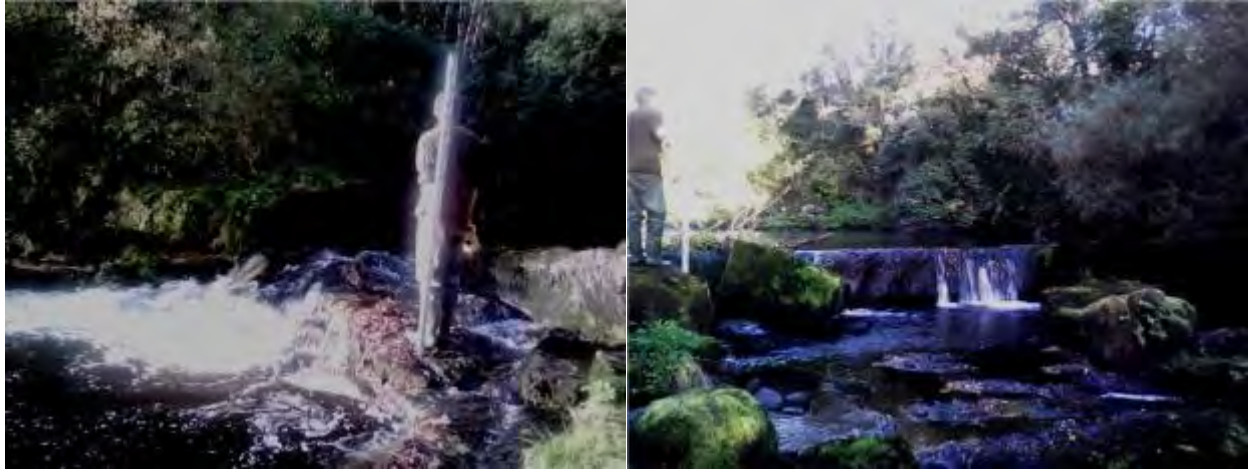
Figure 4.21. Man-made barriers on the Owenmore River, comprising of natural rock outcropping augment with concrete, surveyed October 2016.

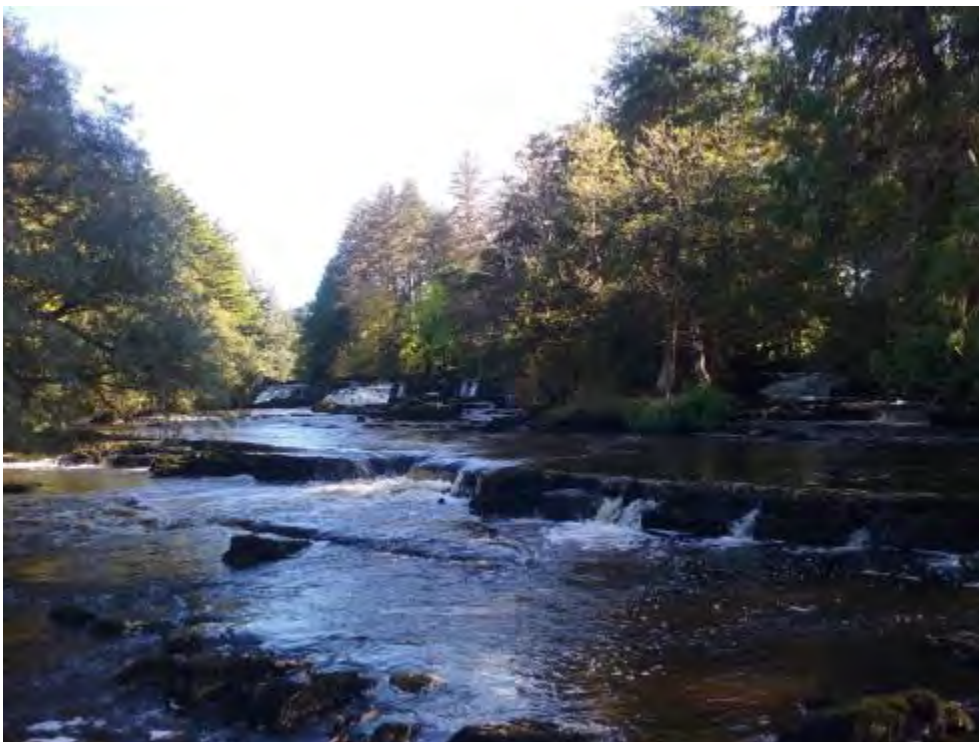
The most significant barrier to fish passage on the Bonet River is the series of rock outcrops at the village of Dromahair. This series of waterfalls (Figure 4.22) represents a “high impact” barrier to adult salmon and an “Impassable” barrier to river and sea lamprey. However, juvenile lamprey (most probably brook lamprey) were recorded upstream of this structure. The main weir upstream of Sligo town needs further investigation as a potential barrier to sea lamprey passage.

Figure 4.22. The natural rock out-cropping/ waterfalls at Dromahair on the River Bonet, surveyed October 2016.

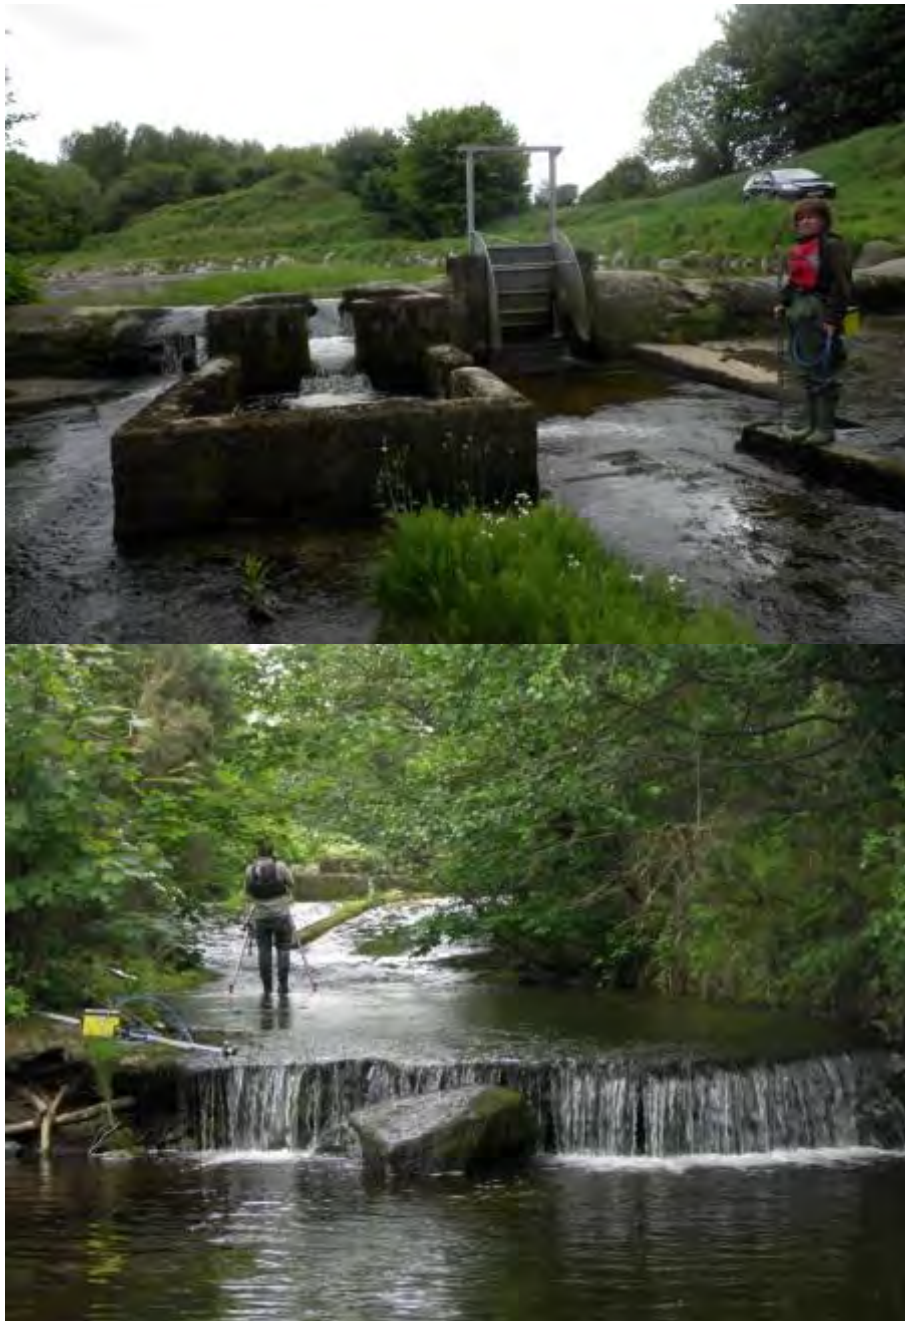
The sand trap on the Kilcormac Silver is located approximately 500m from the top of the OPW scheme, north of Cadamstown. Its function is to trap sediment and prevent its migration downstream through the system. The sand-trap was surveyed in summer low flow conditions (25/5/2016). The structure is approximately 55m long and presents a complete barrier to fish passage in low flow conditions. The structure is comprised mostly of a long (~40m) sloping concrete lined floor, with a drop at the downstream end and a fish pass structure at the upstream end (Figure 6.1). The initial drop presented to fish attempting passage is 0.62m. Fish would then

Apart from juvenile eels, the Cadamstown Sand-trap represents a complete barrier to migratory fish passage in low flow conditions. In high flow conditions it presents a partial barrier high impact to salmonids and a complete barrier to cyprinids and lamprey. Eels will make passage in all flow conditions by using climbing substrate on the rivers margins.

Figure 6.1. Cadamstown Sand Trap on the Kilcormac Silver (Brosna Tributary: C3(1)), Fish pass (top) and downstream end of structure (Bottom) showing drop and long concrete sill.

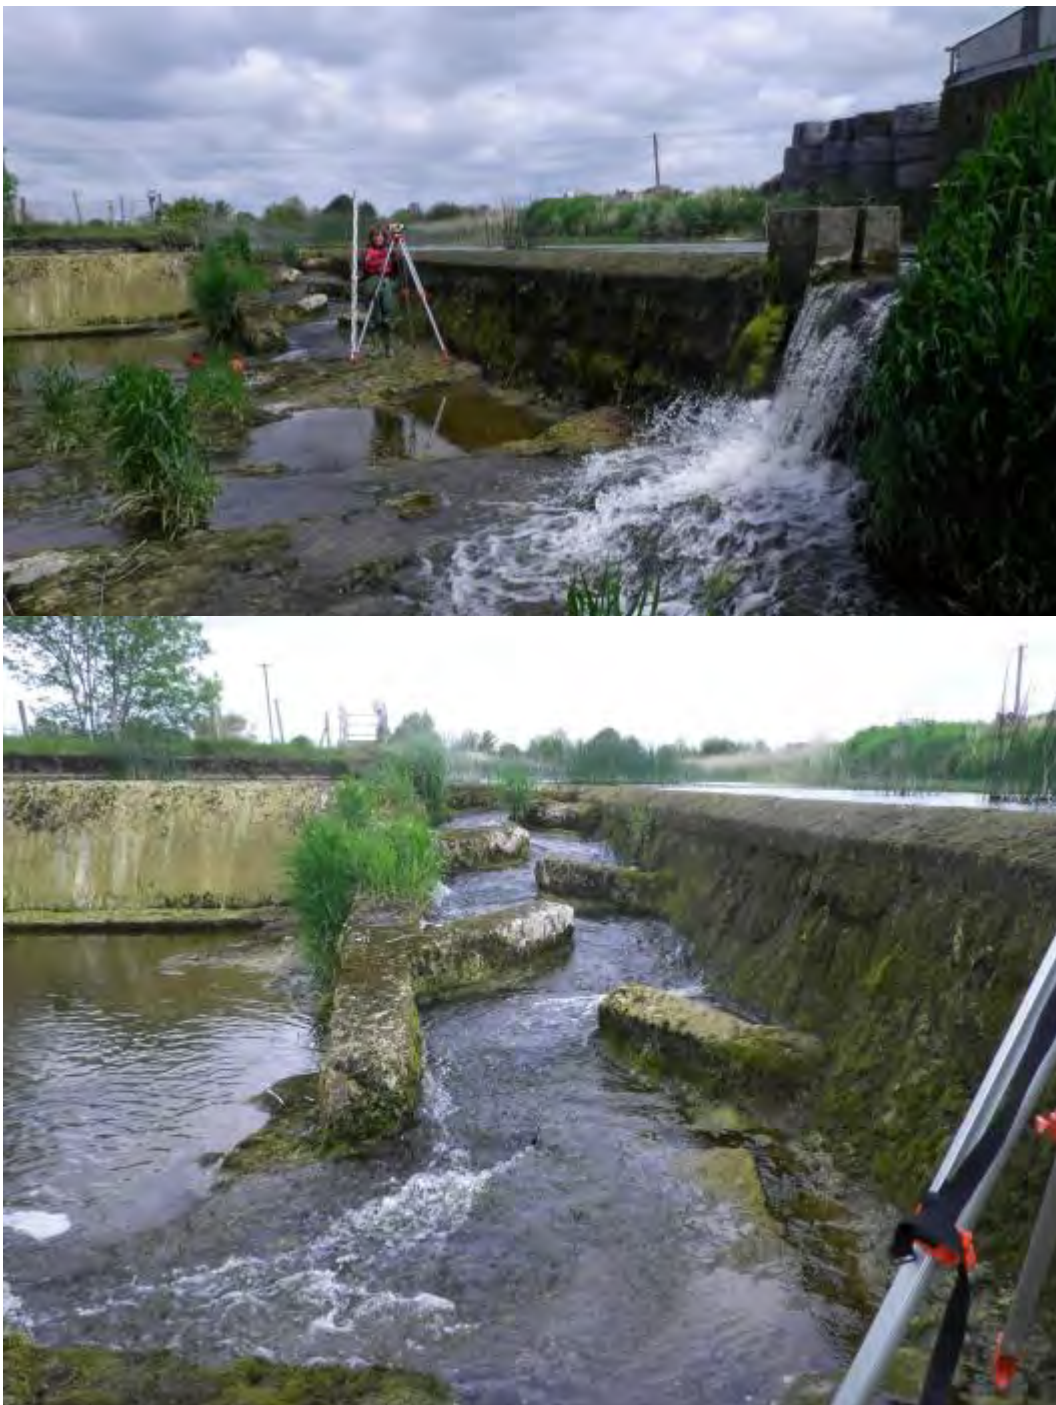
Ballycahill Weir on the Kilcrow River (Killimor scheme C1, Ch: 12600) is located south of Killimor. This weir was constructed to feed Ballycahill mill with water power to process corn. The weir apron begins approximately 25m upstream of Ballycahill Bridge. This structure was assessed in summer low flow conditions (25/5/2016), the bypass channel was not receiving any water at the time and therefore could not be assessed. At time of survey the weir in Ballycahill presented two potential fish passage options - the overflow sluice and the fish pass (Figure 6.2).

Figure 6.2. Fish passage options at Ballycahill Weir (25/5/2016), overflow sluice top, fish pass bottom.

Apart from juvenile eels, Ballycahill weir represents a complete barrier to migratory fish passage in low flow conditions. Any fish passage via the overflow sluice is impossible due to the height of the jump required (1.57m) and the lack of any plunge pool (0.001 m). Fish passage through the fish pass was calculated to be impossible due to its high slope (15.92%), lack of water depth (< 0.04m) and high water velocities (Average 2.52 m/sec, StDev ± 0.86). In high flow conditions adult salmonids will make passage as this structure becomes a high impact partial barrier, however in high flows Ballycahill weir remains a complete barrier to juvenile salmonids, cyprinids and lamprey.
