16 CULTURAL HERITAGE

16.1 Introduction

John Cronin & Associates has been commissioned by RPS, to assess the cultural heritage impact of the proposed Carlingford Ferry between Greenore, Co. Louth and Greencastle, Co. Down. The Archaeological Diving Company Ltd. (ADCO) was appointed to conduct an underwater/foreshore archaeological assessment of the landing stages for the Greenore-Greencastle Ferry Project, by John Cronin & Associates. The landing stages are located in Greenore townland, Co. Louth, and Greencastle, Co. Down, at ING 322473E 311019N and ING 324887E 311569N respectively.

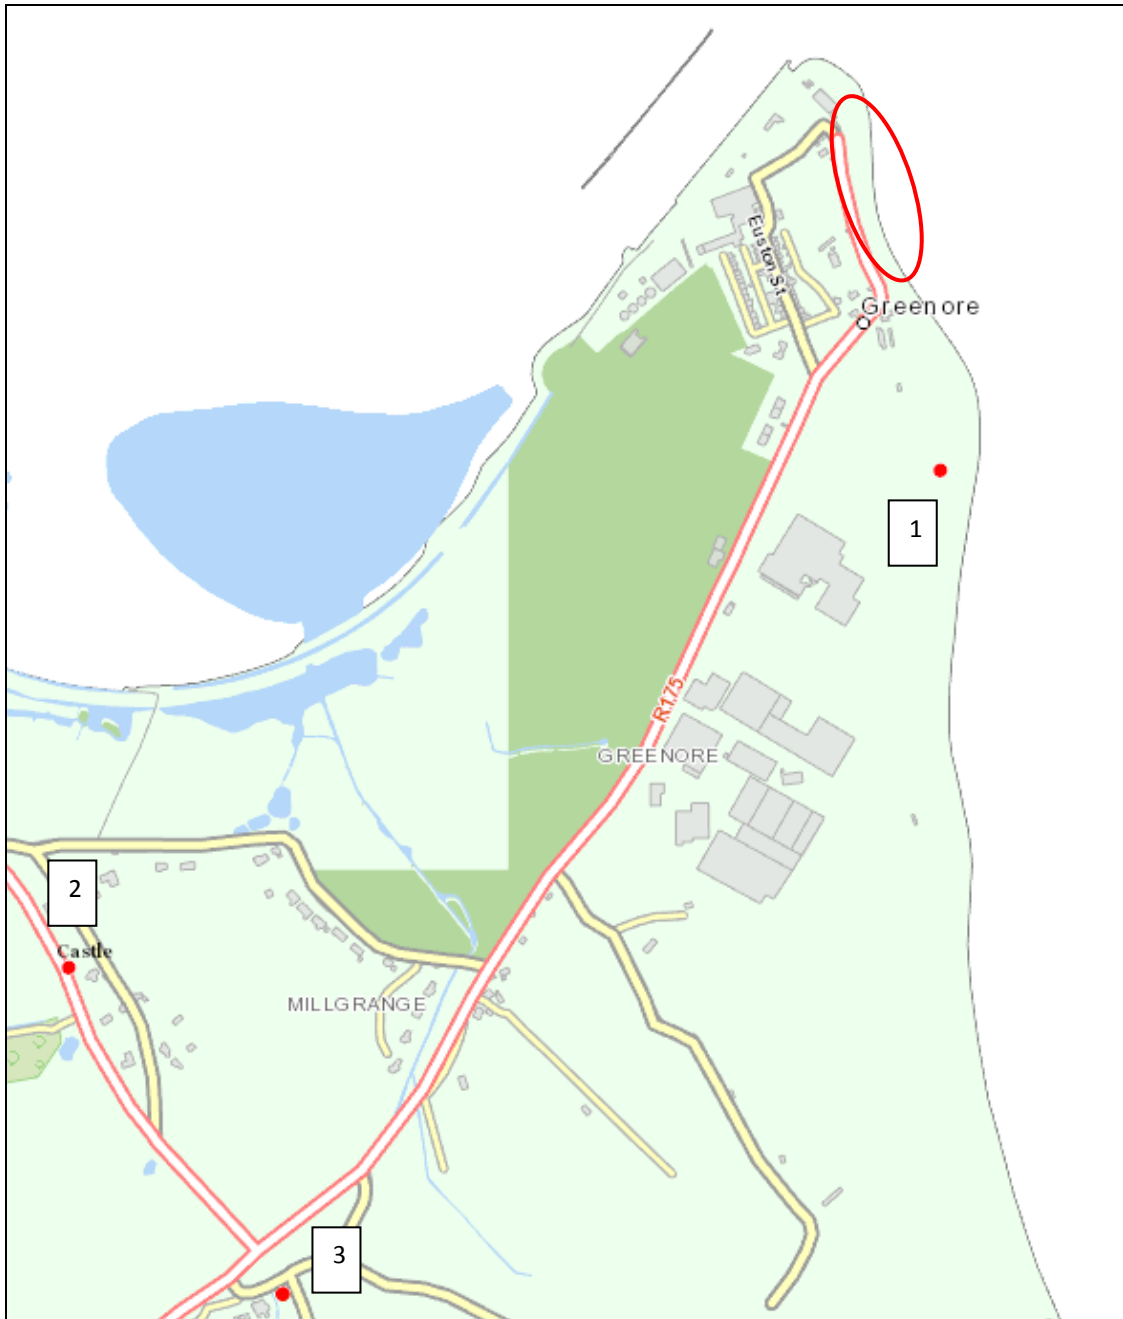
Figure 16.1: Archaeological Constraints within Approx. 1km of Greenore Proposed Development Site (Red)

A total of three archaeological sites were identified in the RMP within approximately 1km of the development at Greenore. None of these sites will be directly impacted upon by the proposed development (see Figure 12.1 & Table 12.1).

There are three recorded archaeological sites located within the environs of Greenore (1km) (see Figure 16.1): a prehistoric lithic scatter (LH009-012---; an unclassified castle (LH009-001---) and an ecclesiastical site (LH009-002001-, LH009-002002- & LH009-002003-). The lithic scatter is described in the Co. Louth Inventory (Buckley, 1986) as *'large quantities of flint have been noted on the raised beaches at Greenore. Most of the flint has been heavily rolled though some diagnostic 'Larnian' and Neolithic material is recorded*

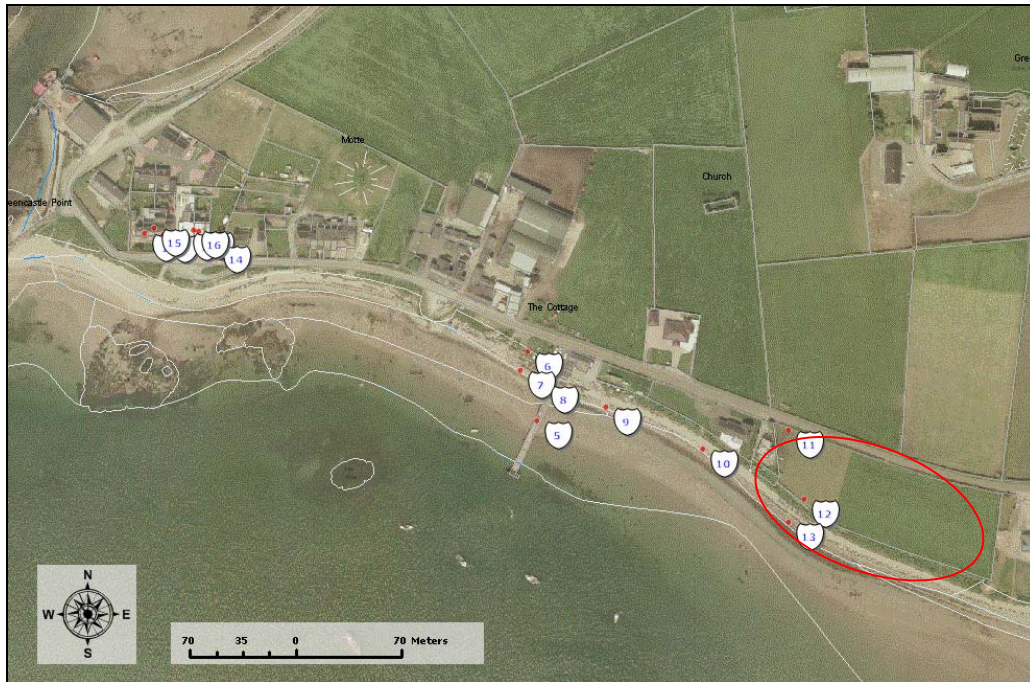
Figure 16.5: Listed Buildings Located Within Approximately 500m of the Proposed Development Site at Greencastle

There are a total of 14 listed Buildings recorded within approximately 500m of the proposed development site at Greencastle (see Table 12.6 & Figure 12.5). Three of these structures are located within the proposed development site area.

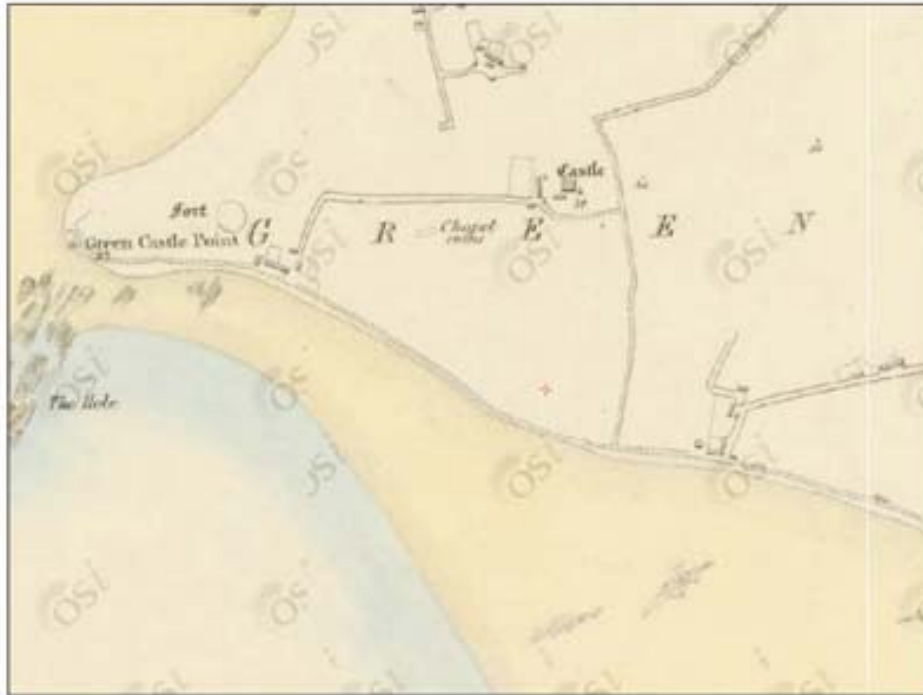
A. Extract from OS 6-inch First Edition map showing the shoreline at Greencastle in the mid-1800s. The site of the motte (Fort), the church and the castle are clearly recorded, as is the undeveloped nature of the foreshore at the proposed slipway location.

The map showing Greencastle records an undeveloped green-field area adjacent to a natural sandy beach which extends seawards (Figure 12.8). There is no suggestion of change through the years, and there is no indication of features or structures of archaeological interest in the location of the proposed slipway, despite the relative proximity of the medieval church and castle features to the northwest.

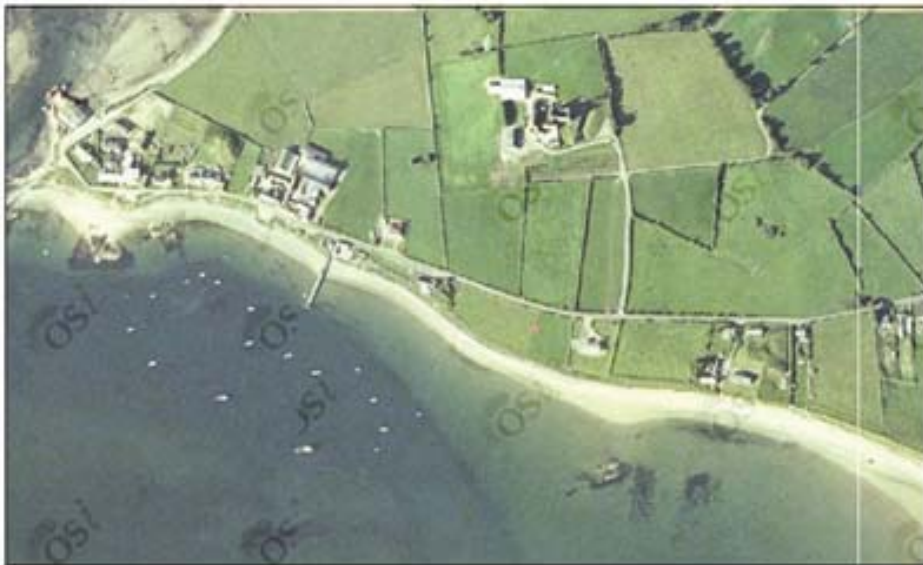
Figure 16.8: Cartographic Regression at Greencastle (www.osi.ie)

B. Extract from OS Ortho image dated 2005 showing the present-day shoreline at Greencastle. One can appreciate the development of a short jetty to the west but the shoreline remains largely unchanged from its portrayal in the 1800s.
