Marine Archaeological Assessment

Proposed Marine Survey and Site Investigation Works within the Havfrue Cable Route Corridor

Client: McMahon Design and Management

Date: 19/12/2017

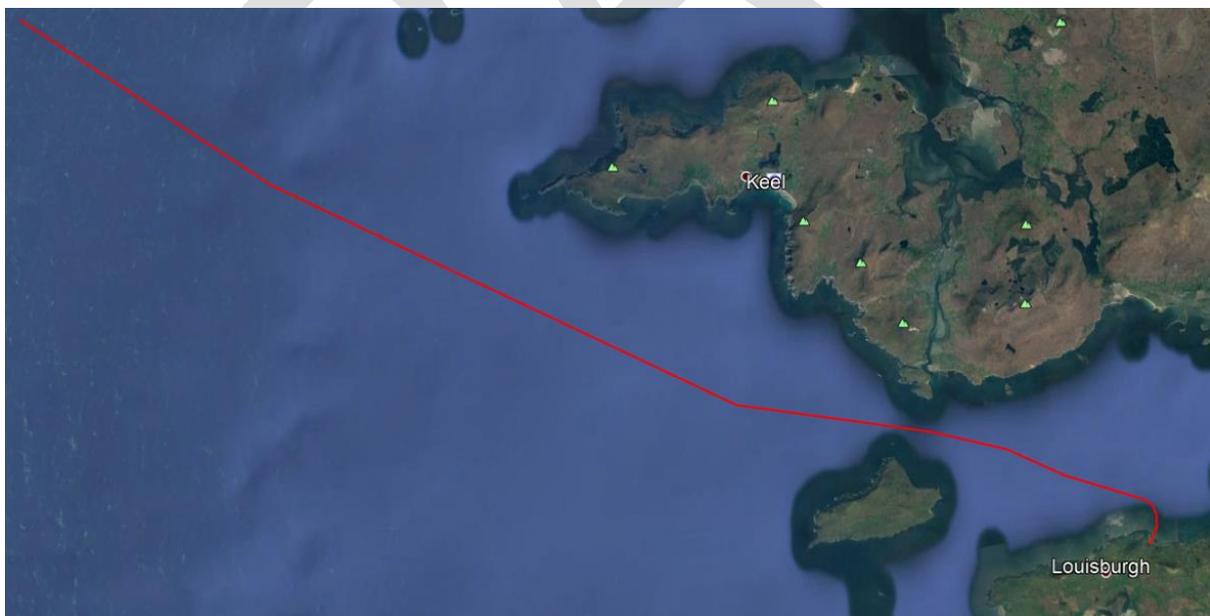
Figure 1. HAVFRUE Cable Route From 12NM Limit to Landfall at Old Head

The proposed cable route comprises a 500m corridor over a distance of 71.571km, extending from the limit of the Irish territorial waters in a NW- SE orientation to run between Achill Island and Clare Island and into Clew Bay before turning south to make landfall at Old Head Beach on the south side of Clew Bay

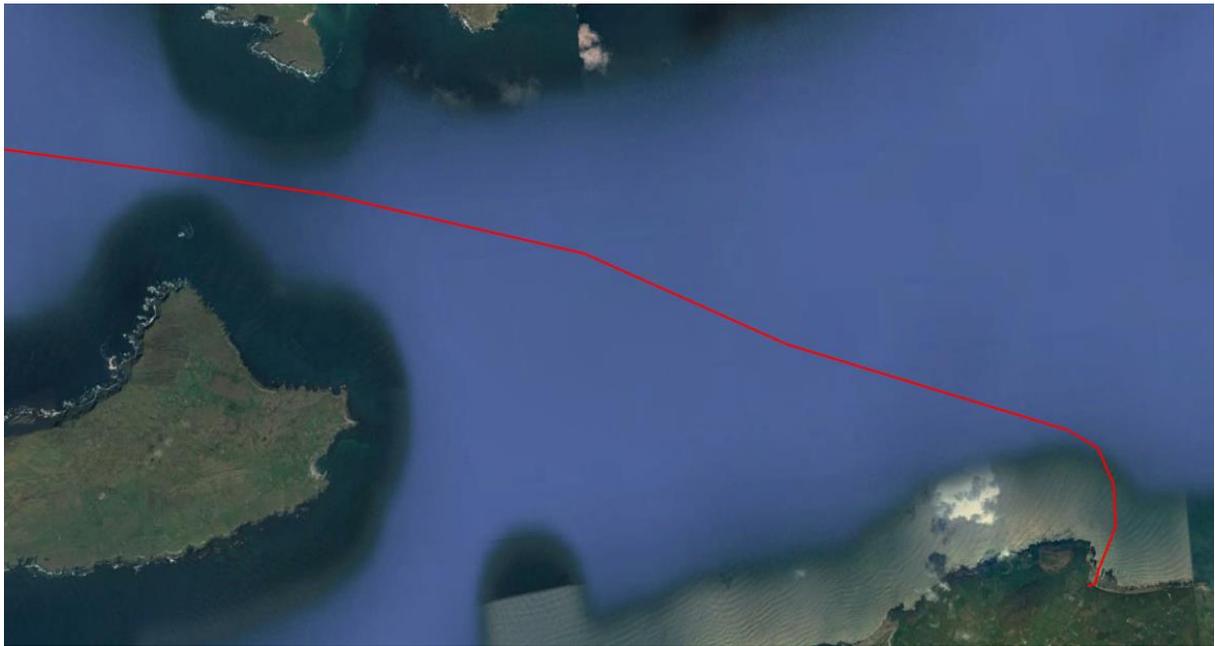
Figure 2. HAVFRUE Cable Route through Clew Bay

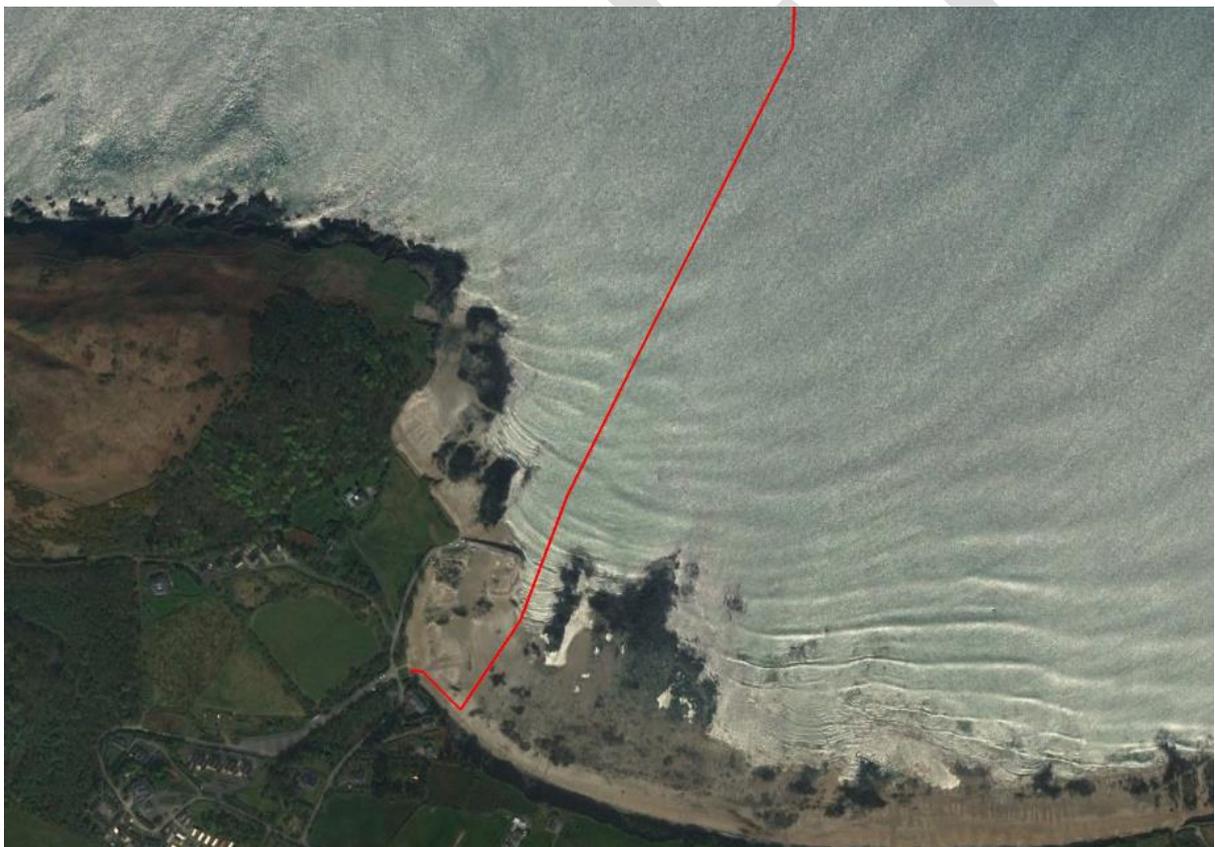
Figure 3. Havfrue cable route at the landfall at Old Head

KEY TURNING POINTS (TO WGS-84)			
Turning Point	Chainage	Latitude	Longitude
TP 0	0	53°46'35.88	09°46'14.24
TP 1	0.02	53°46'35.86	09°46'13.25
TP 2	0.06	53°46'36.00	09°46'10.85
TP 3	0.18	53°46'38.24	09°46'05.51
TP 4	0.38	53°46'44.10	09°46'01.80
TP 5	1.11	53°47'05.34	09°45'43.86
TP 6	1.787	53°47'26.88	09°45'42.36
TP 7	2.407	53°47'45.93	09°45'52.99
TP 8	2.963	53°47'56.39	09°46'17.71
TP 9	7.567	53°48'51.35	09°50'11.53
TP 10	11.071	53°49'46.00	09°52'59.32
TP 11	15.272	53°50'26.93	09°56'38.40
TP 12	17.075	53°50'39.70	09°58'14.61
TP 13	26.27	53°51'42.61	10°06'26.24
TP 14	54.855	53°59'16.68	10°29'10.73
TP 15	71.541	53°04'44.22	10°41'19.37
TP 16	95.658	53°12'37.62	10°58'55.31

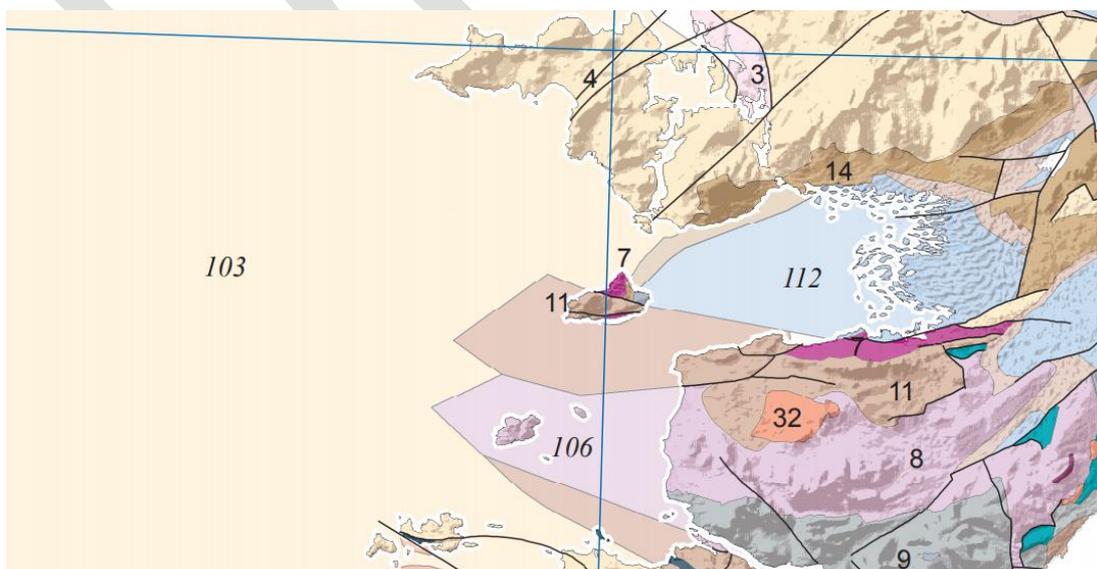
Figure 4. Extract from the GSI Bedrock Geology of Ireland 1:1,000,000 map

Clew Bay is dominated by a spectacular example of a drowned drumlin field. These elongated hills are composed of glacially derived sediments which were inundated by rising sea levels at the end of the last glaciation. The Geological Survey of Ireland (GSI) Bedrock Geology of Ireland 1:1,000,000 map indicates that the area of landfall at Old Head is composed mainly of Paleozoic Serpentinite and sedimentary melange. Further within the bay area between Louisburgh and Mulranny and towards Clare Island the geological formation is comprised mainly of Mississippian limestone and calcareous shale. The ridge between Achill Island and Clew bay is composed of a Silurian sandstone/siltstone conglomerate. Further offshore to the west, beyond Clare Island and Achill, are paleozoic metasedimentary rocks.

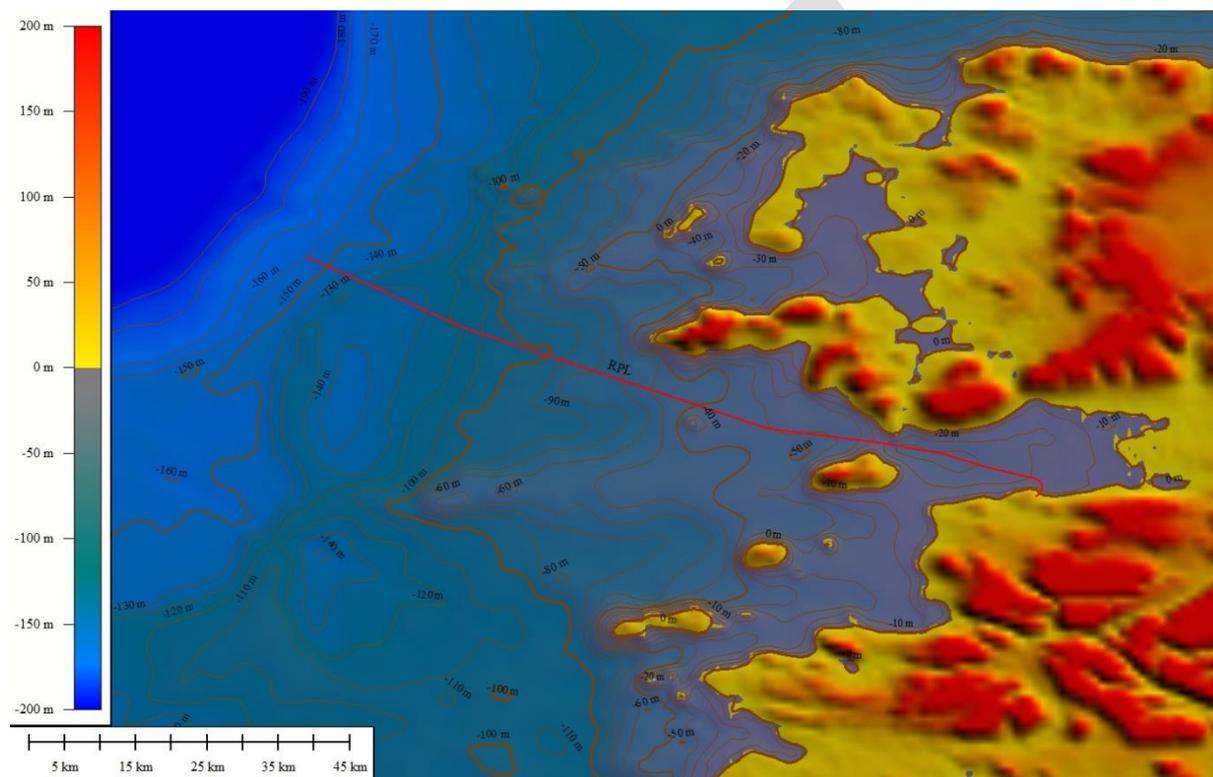
Figure 5. Proposed Cable route overlaid on the GEBCO gridded bathymetry data set with contours

The proposed cable route runs from the 160m contour roughly south west where it passes across a ridge which rises to approximately 25m between Achill Island and Clare Island. It then crosses the relatively flat expanse of Clew Bay before turning southward to make landfall at Old Head.

The maps and profile below show the cable route overlaid on the GEBCO (General Bathymetric Chart of the Ocean) gridded bathymetric data sets which are available at 30 arc second of latitude and longitude. The profile of the route clearly shows the high ridge encountered between Achill Island and Clare Island.

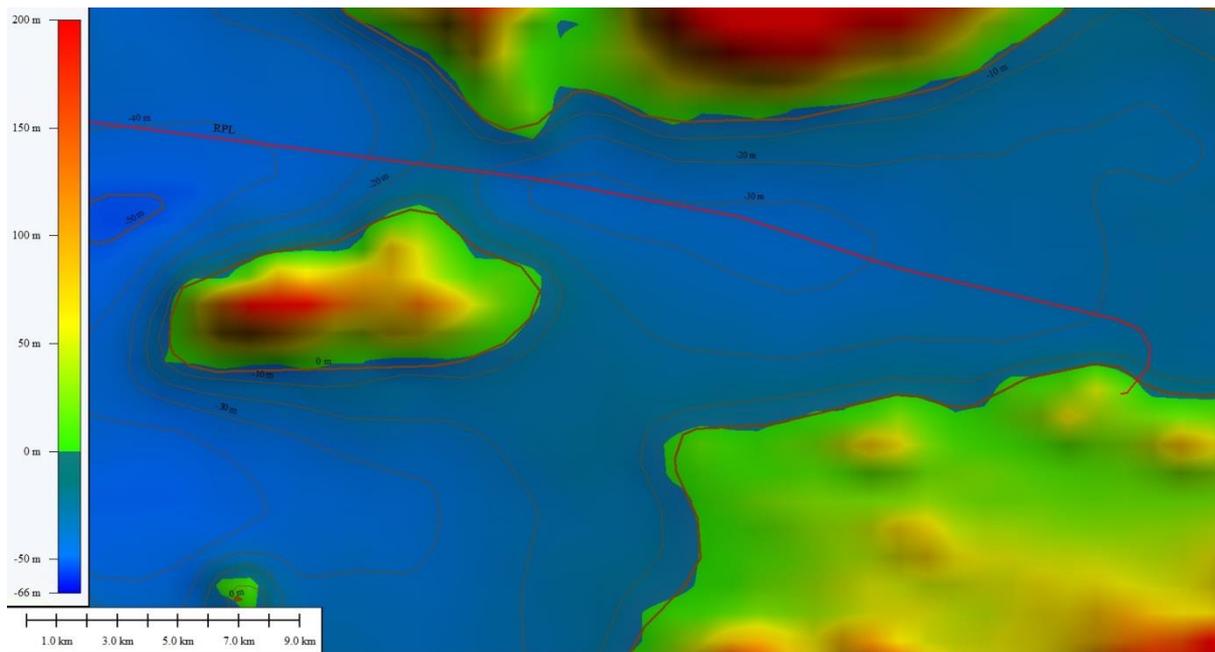
Figure 6. Proposed Cable route through Clew Bay overlaid on the GEBCO gridded bathymetry data set

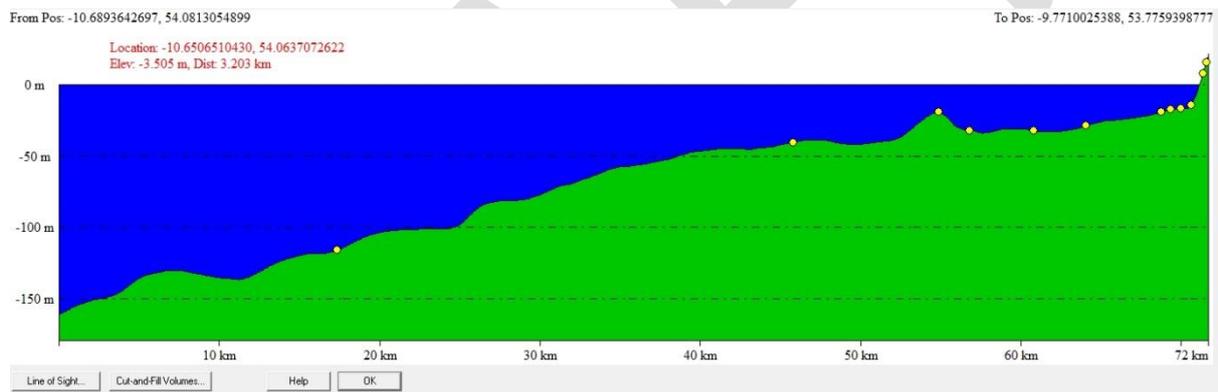
Figure 7. Profile of the proposed cable route from the 12NM limit to the landfall at Old Head

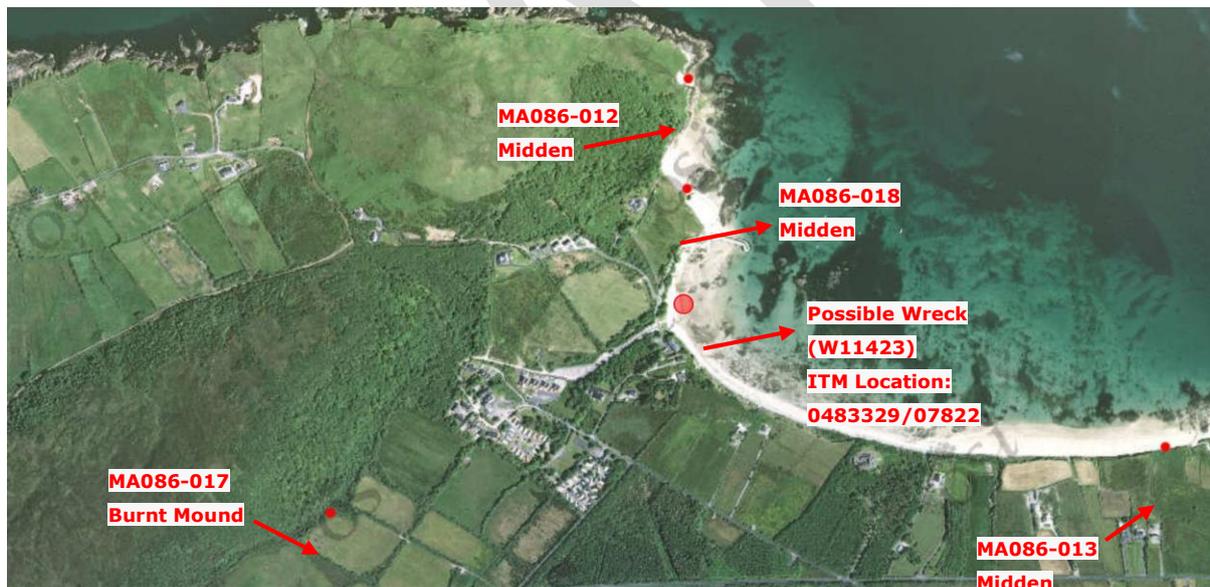
Figure 8. RMP site locations at Old Head including the possible wreck site (W11423)

Cartographic sources indicate that the landfall location and the surrounding area is a sandy beach area with only one possible discernible cultural heritage asset which is noted to be in the immediate vicinity of the cable route where it makes landfall. The aerial view below indicates a possible wreck (**W11423**) or the remains of the Coastguard station or Salt Pans which are recorded as in ruins on the 1st Ed. OS 6-inch map.

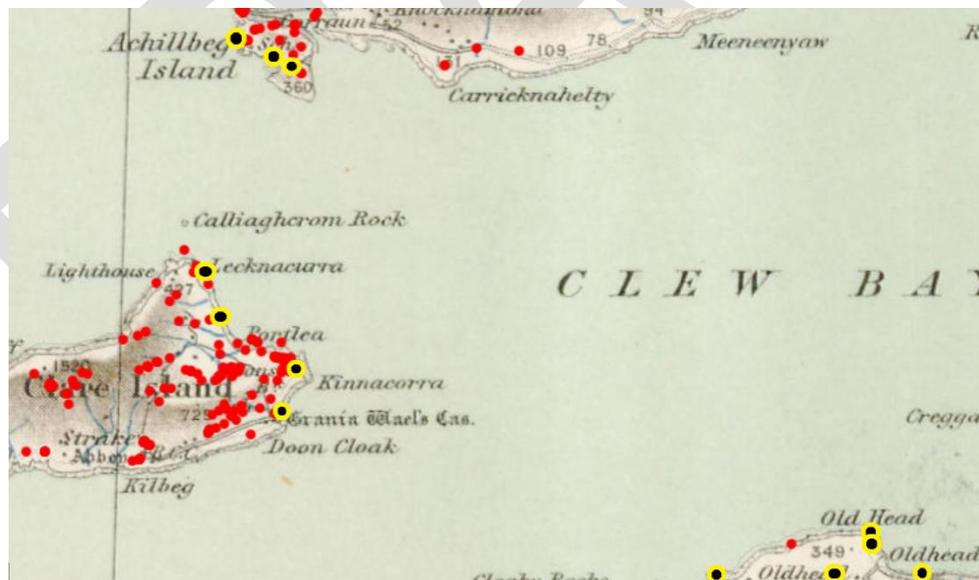
Figure 9. Six inch OSI Map indicating RMP's including sites and monuments nearest to the cable route

There are four known archaeological sites in the vicinity of the proposed route corridor. These are listed on the Sites and Monuments Record of the DAHG. A Fulacht Fiadh (**MA086-017**) this is located 1km west of the proposed cable route. The three other SMR's are located directly to the north and one to the southeast of the proposed cable route where it makes landfall. The two archaeological sites to the north are middens (**MA086-012 & MA086-018**) these are roughly 300m and 500m away from the cable route. The last midden (**MA086-013**) is in the townland of Falduff almost 1km to the southeast. None of these sites will be affected by the proposed development.

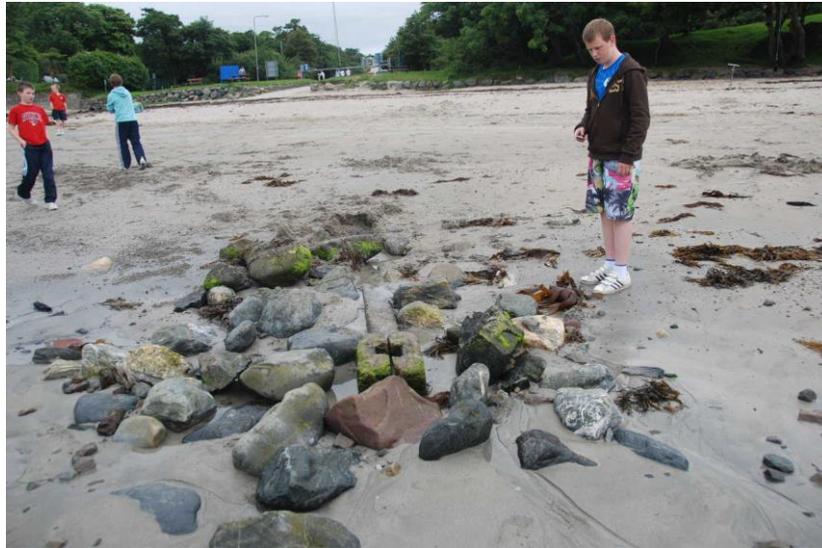
Plate 1. Timber beam and block on the beach at Old Head

There is one known possible wreck (**W11423**) which was reported and identified in 2010 on Old Head beach which may be impacted by the proposed cable route making landfall. The timbers are c. 150m from the wheelchair access ramp for Old Head and are located at ITM co-ords: 0483329, 0782279. The timbers have

been allocated a wreck no. W11423 with the National Shipwreck Inventory of Ireland. There is a possibility of the timbers being part of the Coastguard Station or Salt Pans shown on the 1st Ed. OS Map but due to the uncertainty of the amount of timbers they have been left in-situ on Old Head Beach. The initial proposed route has been modified to stay further away from this feature.

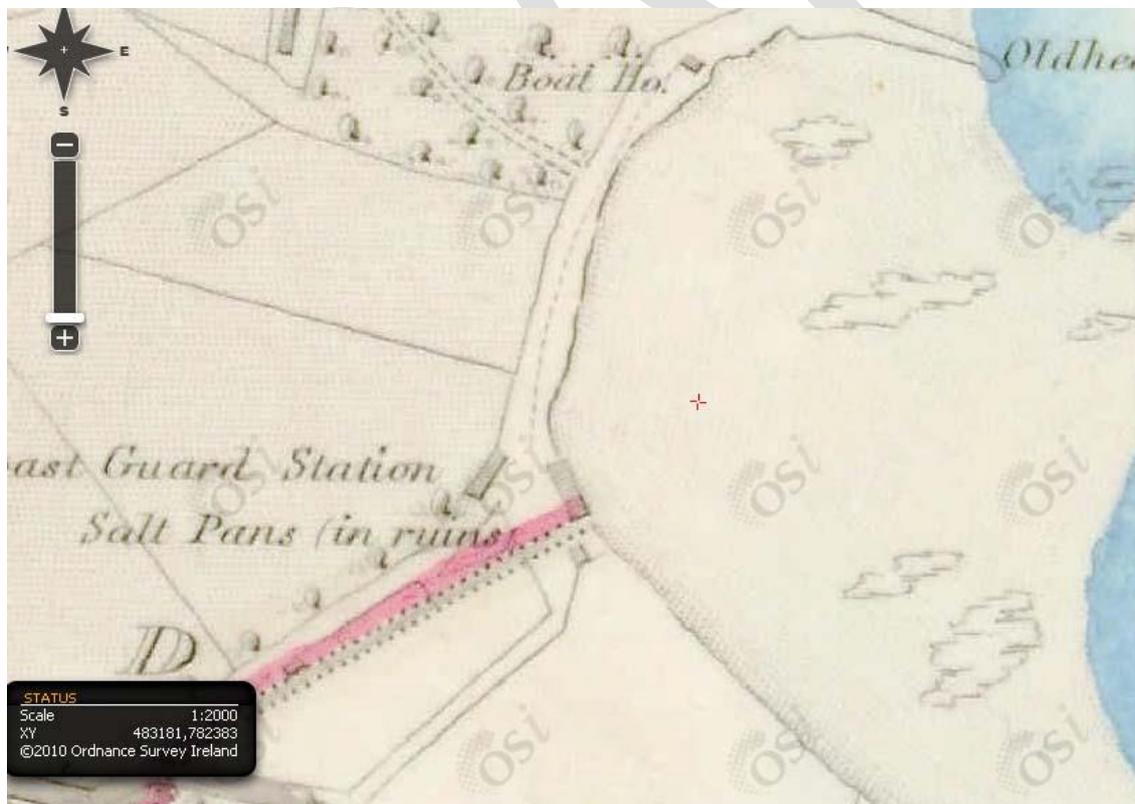
Figure 10. Coast Guard Station, Pier and Salt Pans are all marked on the Ordnance Survey six inch map. The location of the timbers on the beach are marked by a red cross

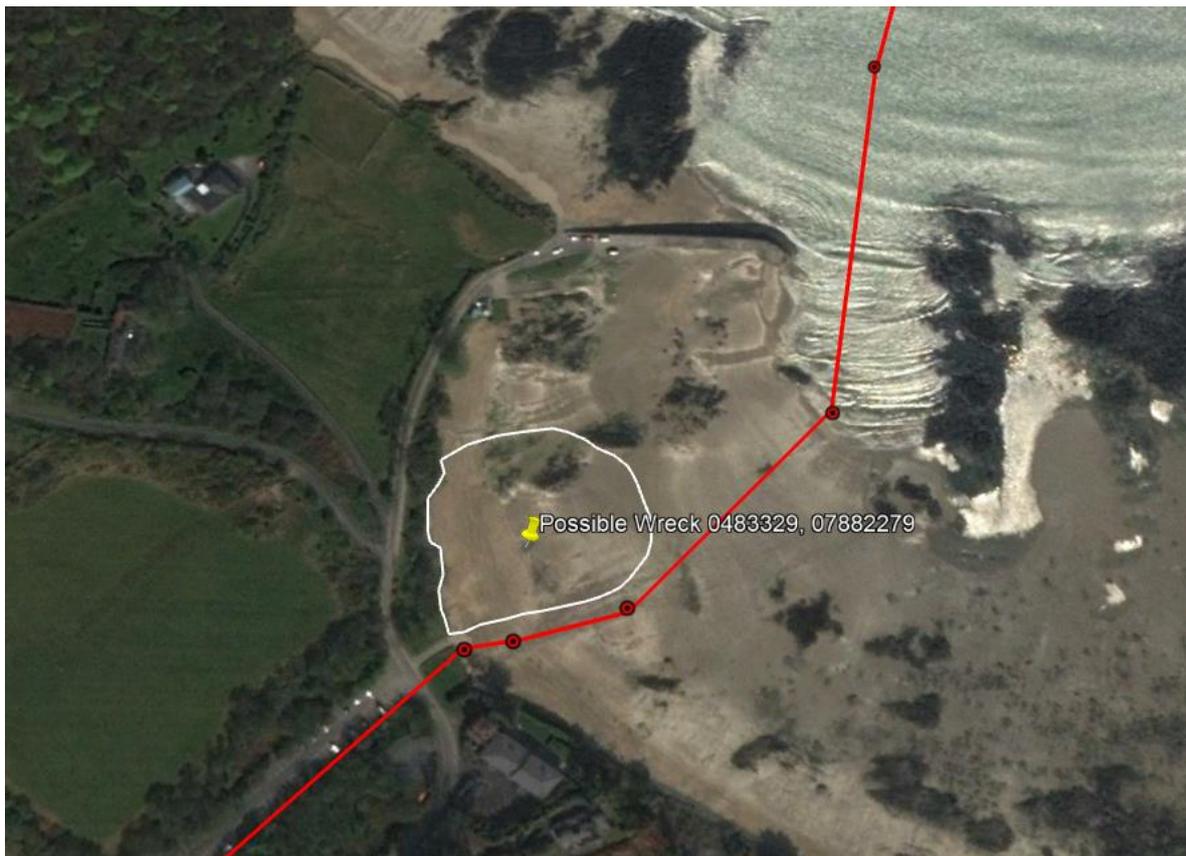
Figure 11. Cable route and possible wreck site overlaid on an aerial photograph of Old Head beach
