**REPORT OF
THE EXPERT
PANEL ON
CONCRETE
BLOCKS**

June 2017

Report of Expert Panel on concrete blocks in counties Donegal and Mayo.

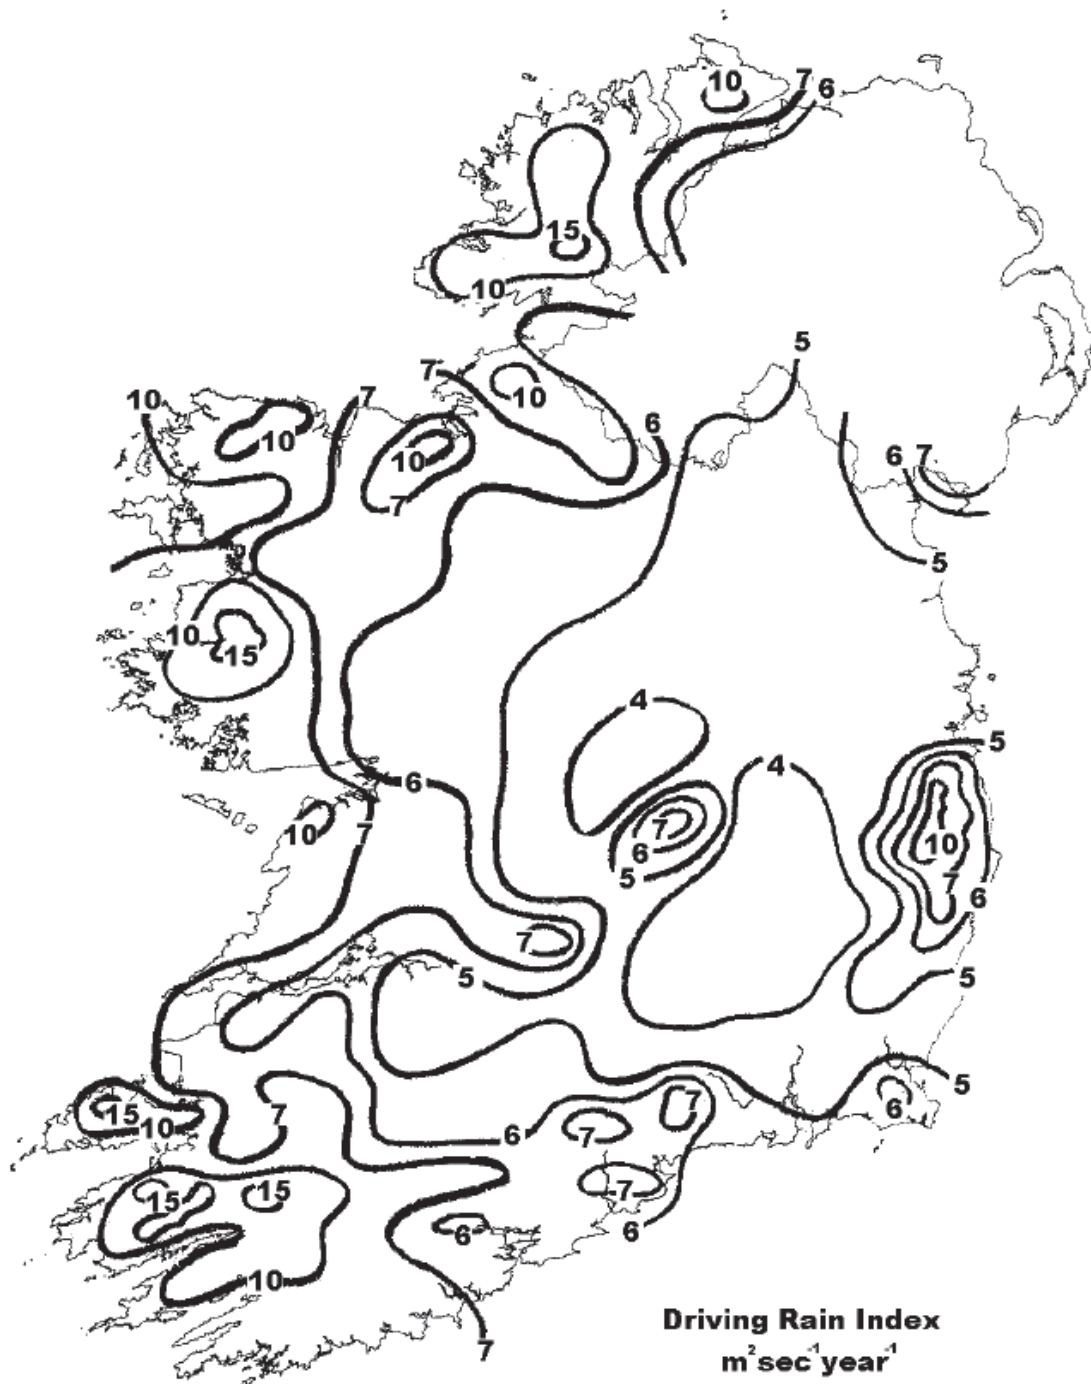
Figure 2.5 Driving Rain Index map of Ireland

The Panel noted that both of the affected areas in Counties Donegal and Mayo are mainly located in Severe Exposure zones, see Figure 2.5 overleaf.

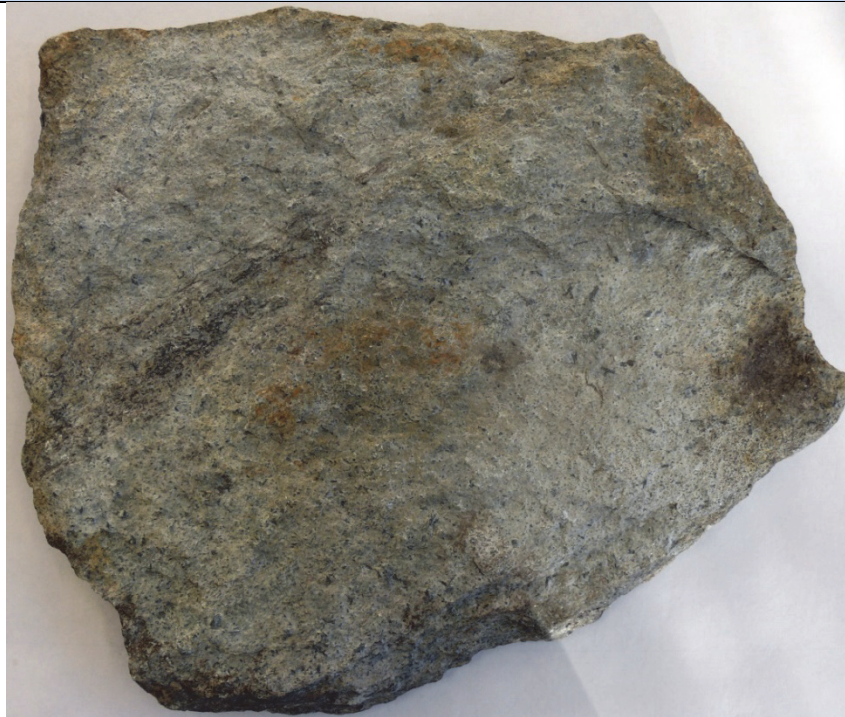
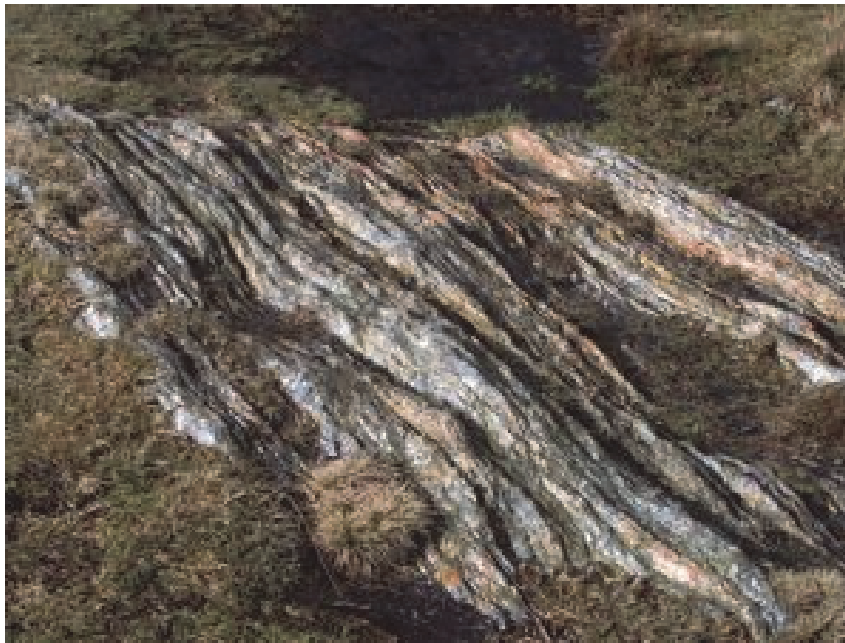
Figure 2.9 **Examples of Mica Schist from County Donegal**

Muscovite mica which is found in mica schist, see Figure 2.9, has a pearly lustre and can range in colour from colourless to white, yellow, brown, grey, green, pink, purple or red and can be translucent or transparent. It is relatively soft, with a hardness of 2 - 2.5 on the Mohs hardness scale and has a monoclinic crystallinity. The crystal aspect tends to be flat, tabular, foliated, flaky and scaly, one dimensional flakes that have the ability to flex or bend and have a very well-developed cleavage. While muscovite mica is relatively chemically inert, it can be altered under certain conditions to form kaolinite. Mica has hydrophilic properties with the ability to absorb and store water along cleavage planes.

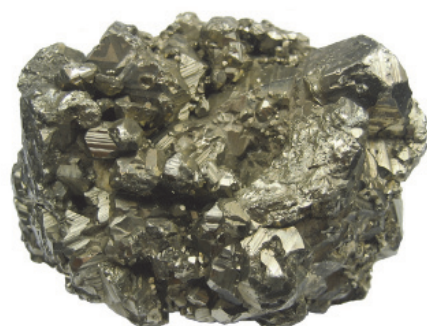
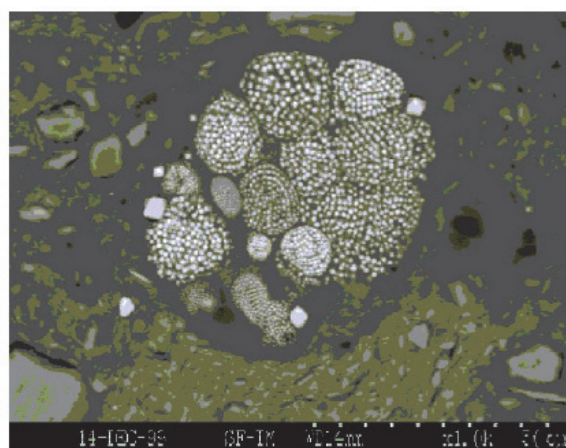
Figure 2.12 Examples of Pyrite

Pyrite is a naturally occurring mineral comprised of the elements iron and sulfur (see Figure 2.12 overleaf). In general, pyrite may be described as being either reactive or non-

reactive²⁰. When reactive pyrite in aggregate material is exposed to moisture and oxygen under certain conditions, the pyrite will oxidise to form sulfuric acid which may, in turn, react further with other minerals found in the aggregate to form calcium sulfate in the form of gypsum. Gypsum, formed under these conditions, will have a significantly greater volume than that of the pyrite, expanding to approximately twice that of the original pyritic material. Where this expansion occurs in the aggregate constituent of concrete blocks, it may result in cracking in individual concrete blocks.

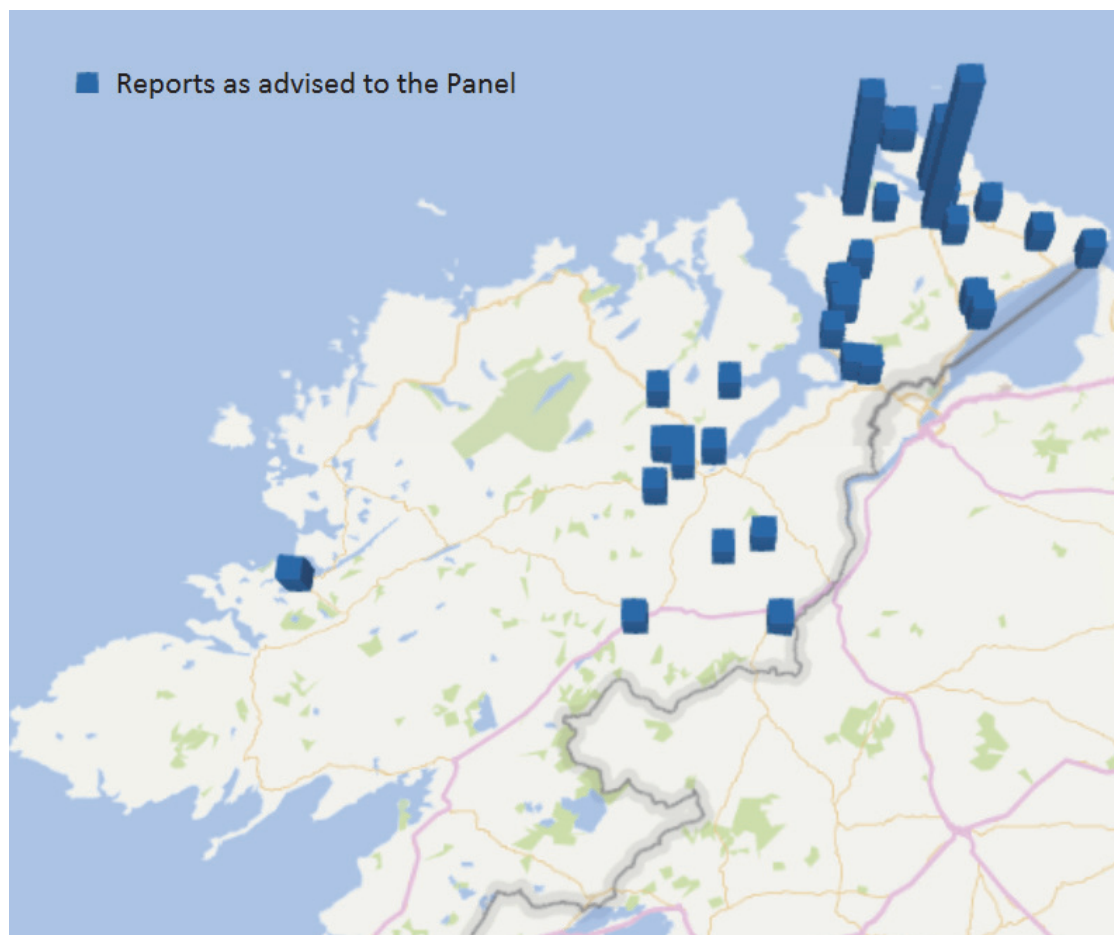
Figure 4.1 General location of affected dwellings (as advised to the Panel)

Figure 4.1 below, shows the general locations (where known) that these reports related to.

Taking into consideration the geographical distribution of technical reports on affected dwellings throughout the Inishowen and Letterkenny Municipal Districts (see Figure 4.1), the Panel consider that there appears to be a greater probability of affected dwellings being located in the Inishowen Municipal District than the Letterkenny Municipal District.

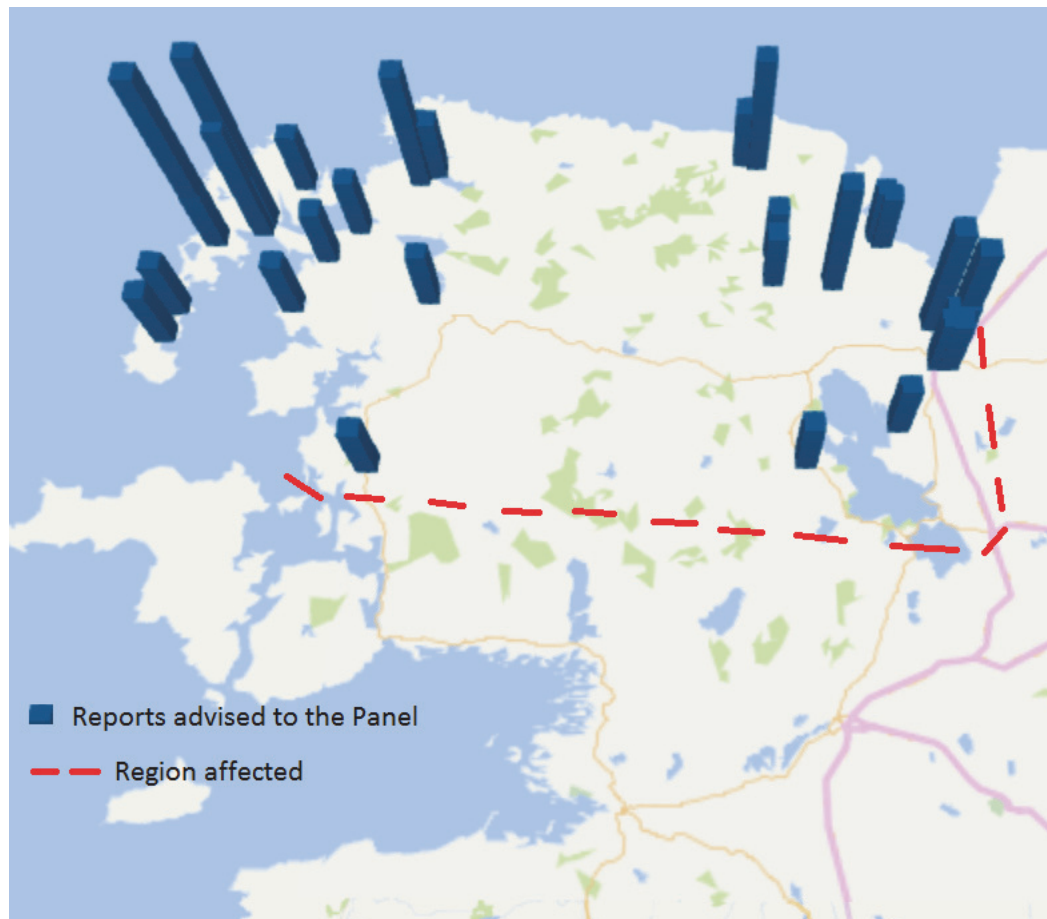
Figure 4.3 General location of affected dwellings (as advised to the Panel)

Figure 4.3 below, shows the general locations (where known) that these reports and photographs related to.

From analysis of the locations of reported incidences in County Mayo, the Panel is of the view that the geographical area affected is confined to the north / north-west of the county as indicated by the dashed red line in Figure 4.2. Accordingly, Commencement Notices notified to Mayo County Council between 2000 and 2006 reflects approximately 3,600 private dwellings in this geographical area. The Panel do not believe that all of these dwellings are affected due to multiple variables such as the utilisation of different builders, block suppliers, variable quality of workmanship employed, local exposure conditions etc.
