**Cultural Heritage Assessment  
Greenore Port, Berth 2  
Greenore, Co. Louth  
17D0032, 17R0051**

25 May 2017

Project Director  
**Beverley Studios, Church Terrace, Bray, Co. Wicklow**

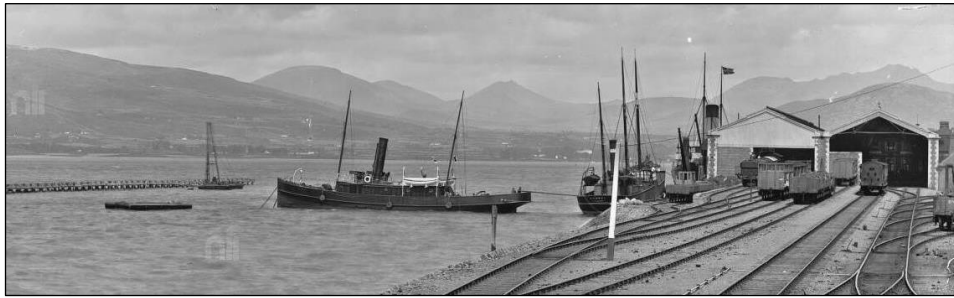
**Plate 1:** Historic photograph of Greenore quayside looking north, showing the railhead. Source: National Library of Ireland, Robert French, 1841-1917.

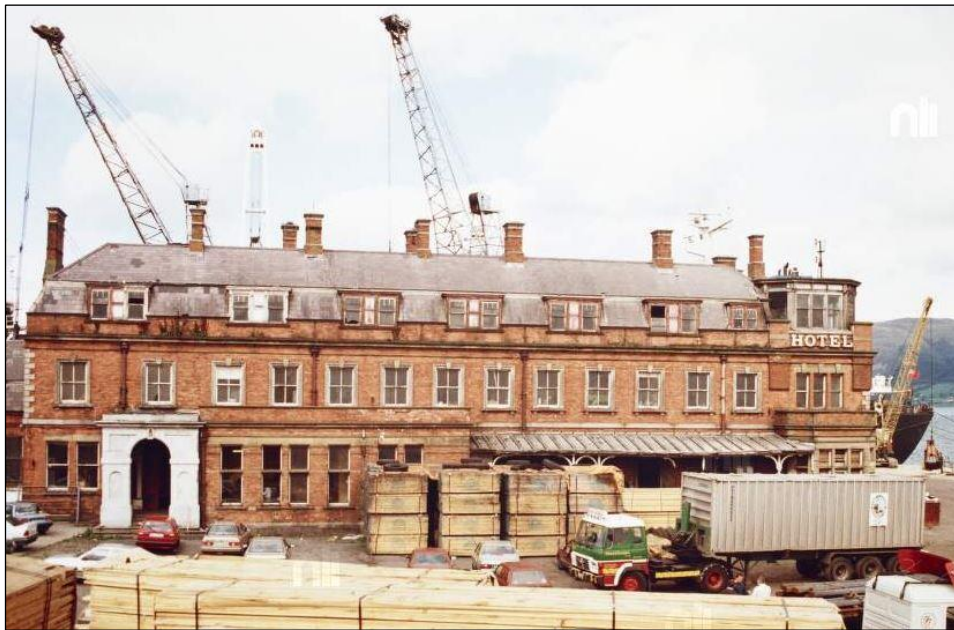
**Plate 2:** Historic photograph of the Hotel at Greenore.  
Source: National Library of Ireland, James Green, 1990-91.

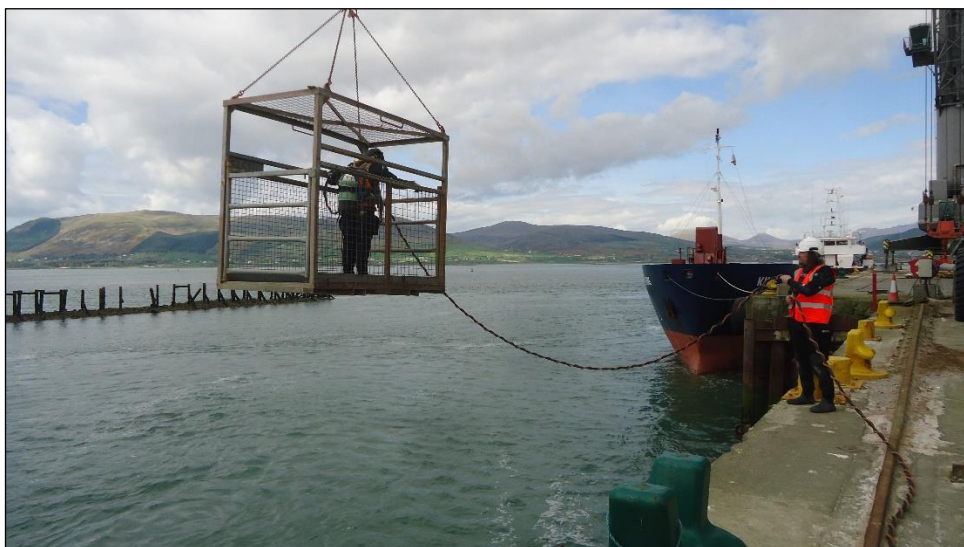
**Plate 3:** View showing diver being lowered in steel cage from quayside, with tender.

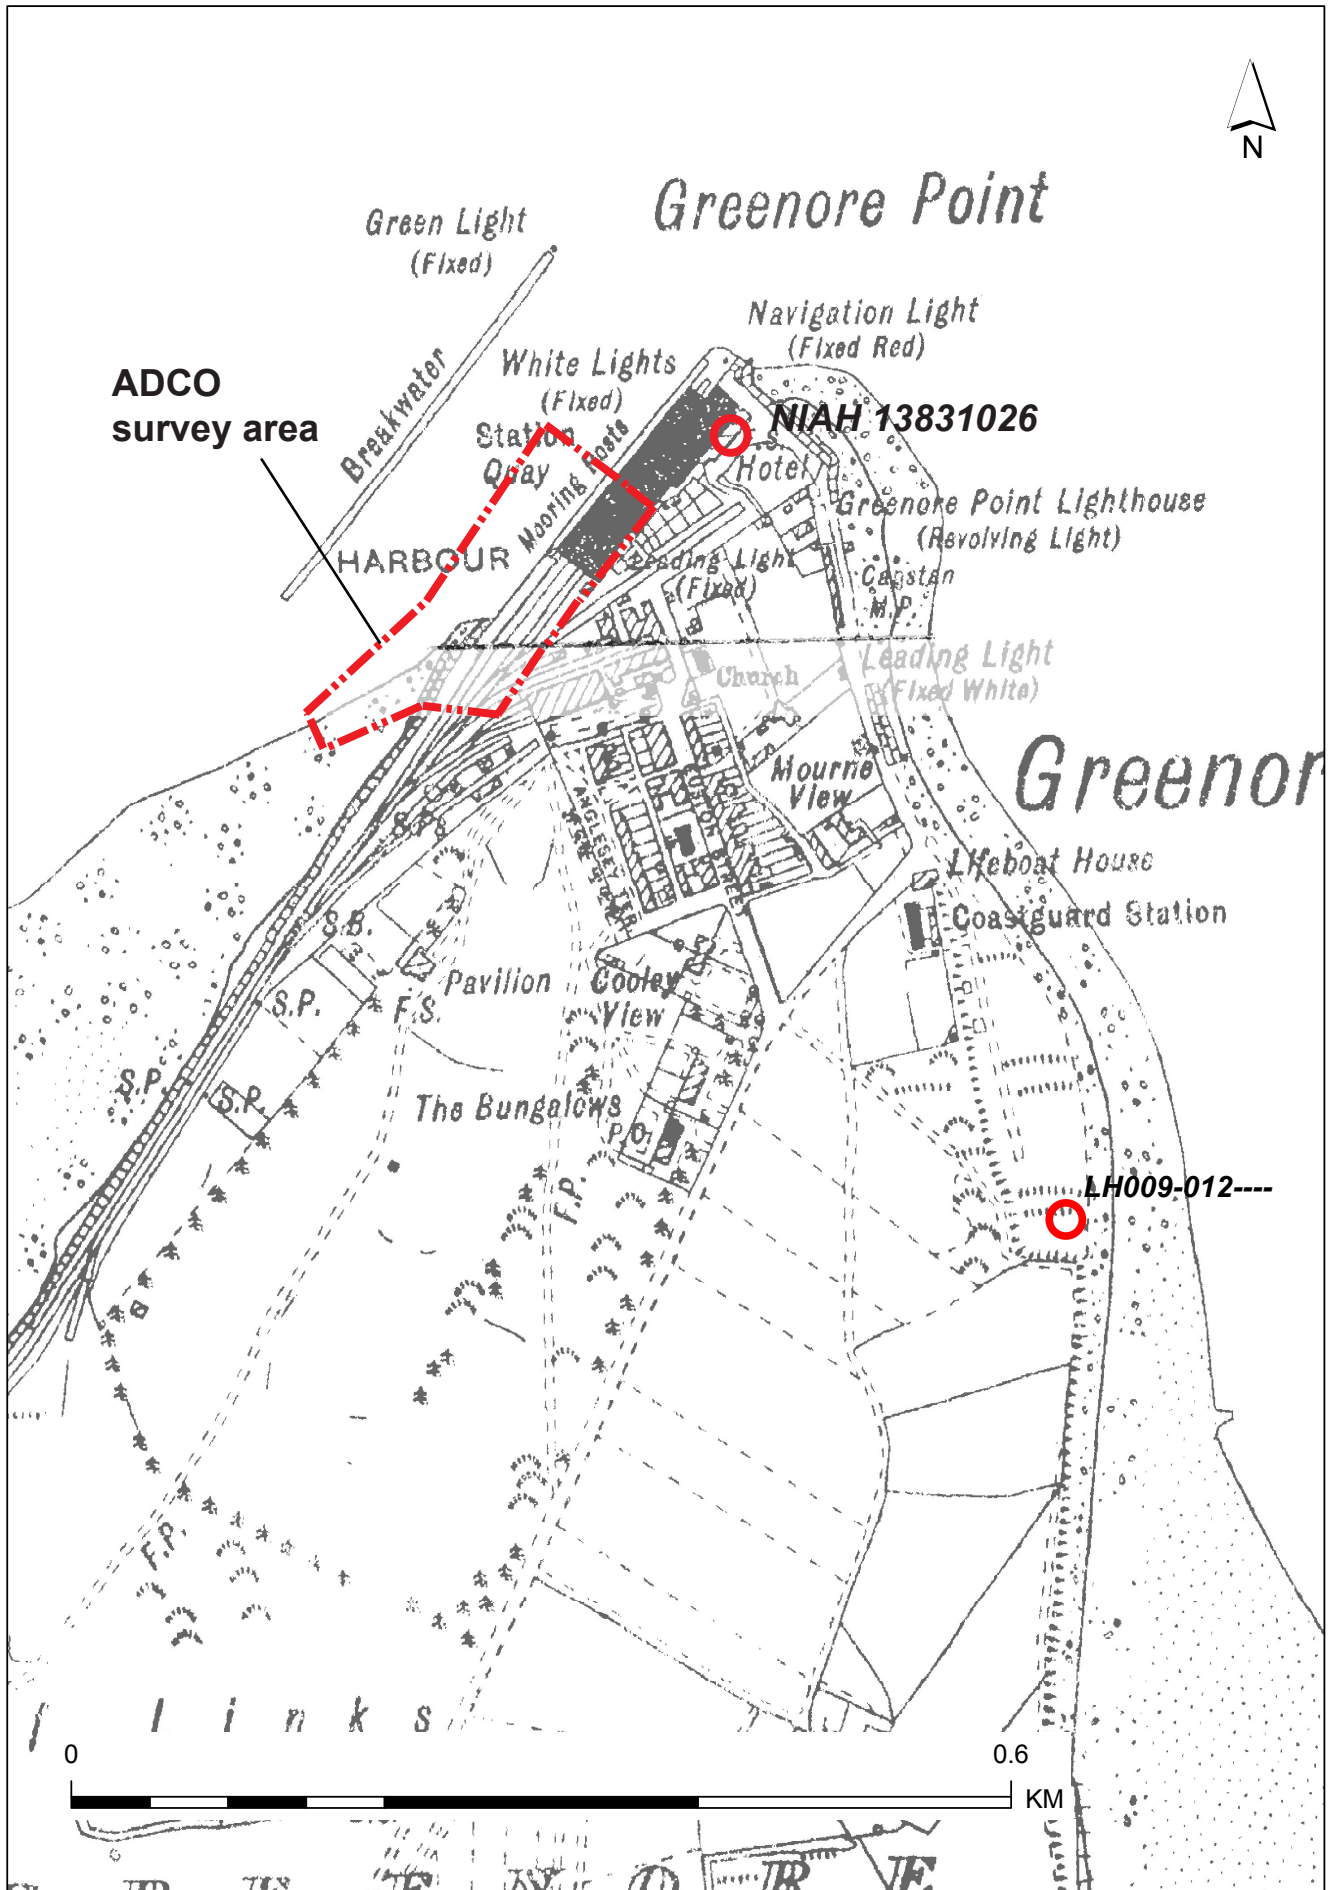
In terms of known archaeological sites, there are no recorded SMR sites within the development area, and the closest site is that of the supposed flint scatter, located outside the port, on the beach to the southeast (Figure 3).

Figure 3: Distribution of archaeological sites at Greenore, with ADCO survey area and NIAH site within the port area indicated.
