Dun Laoghaire Baths

Investigation Works

Dr Jason Bolton

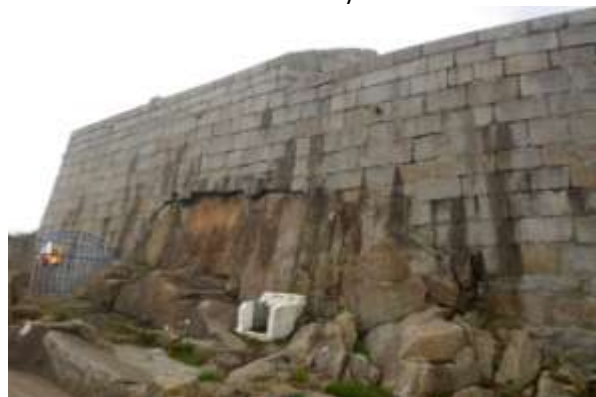
Fig 17: The north face of No. 11 Sandycove Battery illustrates how the ashlar masonry of the battery could incorporate the granite bedrock within the defences. Similar to the bedrock within the baths (seen in Fig 16), the granite outcrop has been cut back and slightly beveled and forms part of the defences of the battery. This double-effect of using a source of building stone to form part of the defences is common to fortifications from all periods in Ireland and internationally^{vi}.

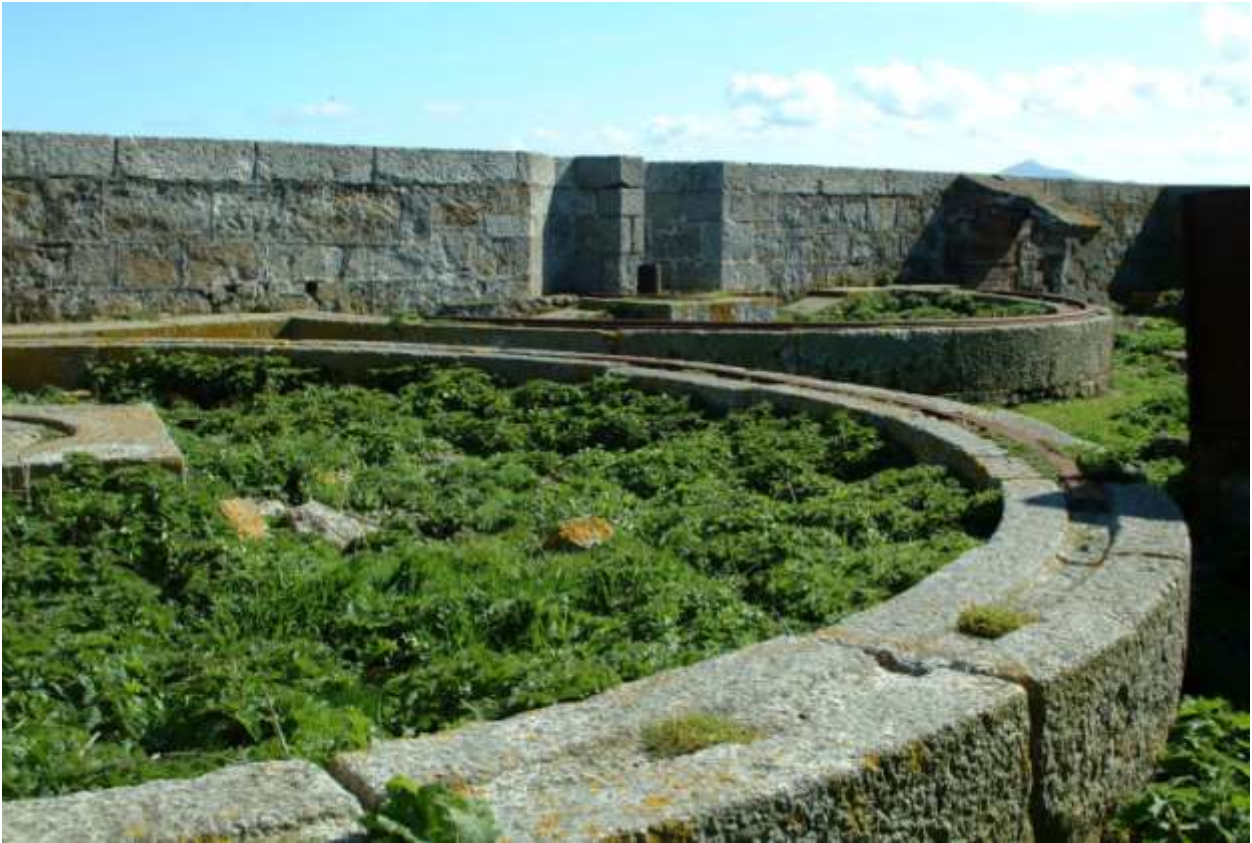
Fig 30: Granite gun emplacement, No. 9 Dalkey Island Battery showing grooves cut into the top surface of the granite masonry blocks forming the semi-circular gun positions. Glasthule battery had three similar emplacements armed with 24-pounder cannons. Each emplacement had a 24-pounder gun mounted on a wooden carriage with wheels that can along an iron racer which was set into these grooves. The corroding iron racers can be seen on half of the emplacement in the foreground, and survives entirely on the emplacement in the background in the photograph above.
