REPORT on
18 MOORE STREET, DUBLIN 1
On behalf of
THE RELATIVES OF THE SIGNATORIES
TO THE 1916 PROCLAMATION

Date: March 2014

ISSUE – REV. (A)

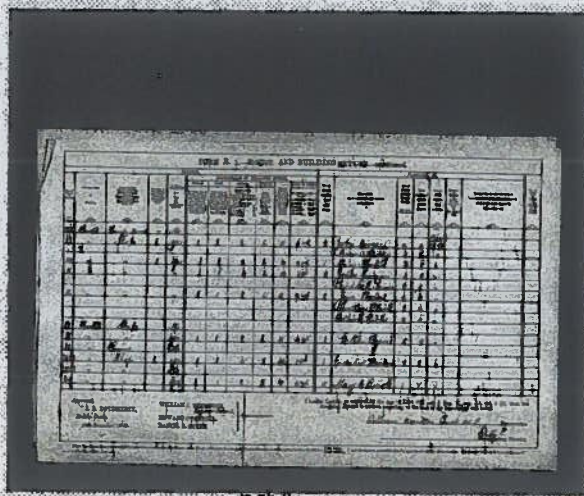
Records show that in 1911 no. 18 Moore Street was a single domestic dwelling over a fishmonger/poultry shop on ground floor, occupied by Ms. Ellen Byrne (widower) and her 8 sons and daughters. The building is recorded as having 6no. windows in the front elevation and 5 or 6 internal rooms. This would confirm the fact that the original building would have been 3 floors over basement, which would have matched the height of all buildings in the terrace.

1911 Census

no.18 Moore Street
