# Environmental River Enhancement Programme

## Annual Report 2014

## Inland Fisheries Ireland & The Office of Public Works

## **Environmental River Enhancement Programme**

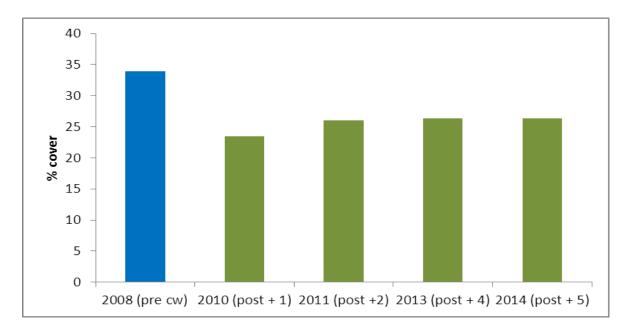
Figure 3.1: Tall emergent vegetation % cover pre and post works in the experimental site.

Monitoring of the channel flora at Sheepwash bridge has been ongoing since 2008. The tall emergent vegetation is predominantly comprised of *Scirpus lacustris*, and *Sparganium ercetum* with some *Phalaris arundinacea*. Capital works in 2009 resulted in a 32% reduction of tall emergent vegetation one year post-works (Figure 3.1). The decrease can be attributed to the construction of a series of stone deflectors at sites where tall emergent vegetation was previously present. In recent years, these deflectors have been colonised by terrestrial plant species that are tolerant of damp conditions (Plate 3.1). Following capital works, tall emergent vegetation has continued to occupy approximately 25% of the channel area year on year (Figure 3.1).

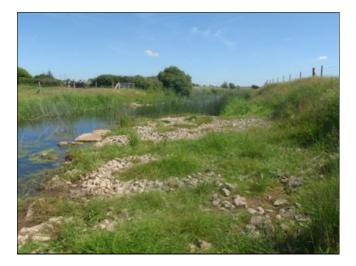
Plate 3.1: Deflector occupied by terrestrial grasses one year post works (2010).

Excessive vegetation removal, carried out by the external contractor hired by OPW in 2013, is the most likely cause of the reduction in crayfish numbers in the control site in 2014 (Plates 3.1 and 3.2).This control site can now not be considered a 'control site' any longer. Tall emergent vegetation is an important component of crayfish habitat in Ireland and its wholescale removal represents severe habitat degradation from a crayfish perspective. Removal of vegetation upstream and downstream of the experimental will have caused crayfish throughout the channel to migrate to the experimental where refuges were still available (Peay, 2003) despite increased silt loads. 78% of crayfish captured in the experimental works site were in the fyke net closest to the control site (>200m) as evidenced by the very large standard deviation (Figure 3.3).

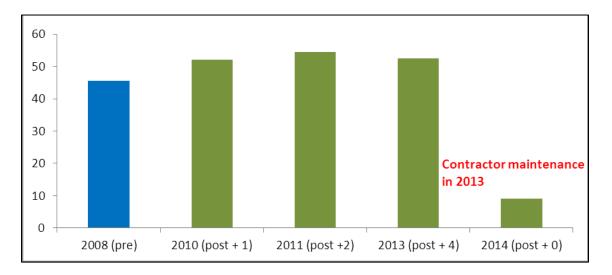
Figure 3.2: Tall emergent vegetation % cover pre and post works in the control site. Maintenance by the private contractor in 2013 occurred post the 2013 survey work. The experimental site was not maintained by the private contractor.

Prior to 2013, tall emergent vegetation cover remained relatively unchanged in the control site (Figure 3.2). In 2013 maintenance work on the Robe main channel was carried out by an external contractor hired by OPW (as part of a benchmarking exercise) and as part of their drainage operations the control site downstream of Sheepwash Bridge was maintained. The extent of this maintenance work resulted in an 85% decrease in tall emergent vegetation (Plate 3.2). This reduction in tall emergent vegetation is not consistent with OPW's environmental protocol and has obvious adverse implications for other river biota including brown trout and crayfish. These are discussed below.

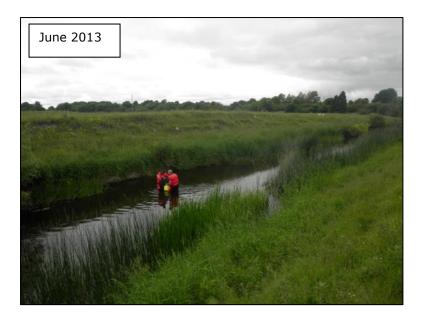
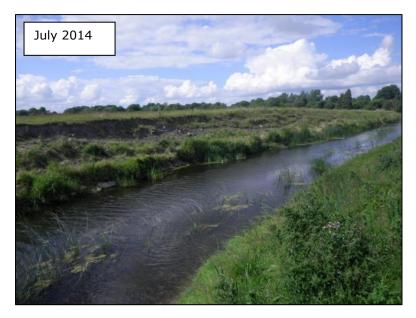
Plate 3.2: Robe control site pre works in 2013 (top) and post works in 2014 (bottom).

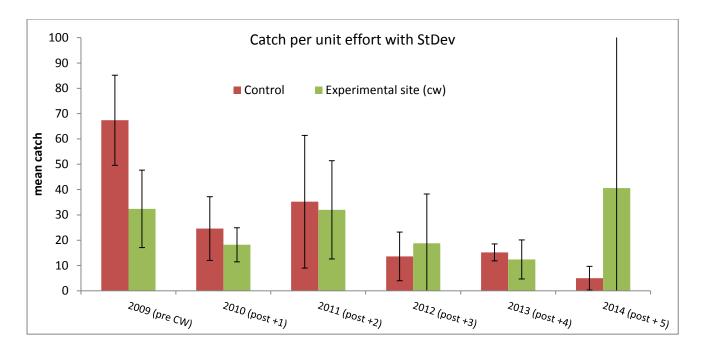
Figure 3.3: Mean crayfish catch per unit effort, 2009 -2014. Maintenance by the private contractor in 2013 occurred post the 2013 survey work. The experimental site was not maintained by the private contractor.

Following capital works in 2009, crayfish numbers in the experimental site showed no significant change in any subsequent years (Table 3.1 and Figure 3.3). In contrast, the control site experienced a significant decline (Table 3.1) in crayfish numbers one year post capital works in 2009 and post maintenance works in 2014. It is not clear why crayfish numbers declined so severely in the control site after works carried out within the experimental site in 2009. One possibility is from additional silt deposits that might have occurred during the instream work phase carried out within the experimental site which was immediately upstream of the control site. Some literature suggests that excessive siltation can have a negative impact on crayfish populations (Holdich, 2003). The increased

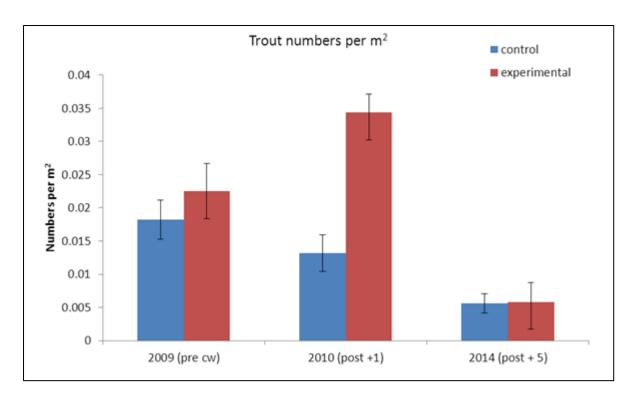
Figure 3.4. Brown trout numbers per m<sup>2</sup> in the Robe R. experimental and control sites in 2009, 2010 and 2014. Maintenance by the private contractor occurred in 2013. The experimental site was not maintained by the private contractor.

In common with crayfish in the control site, brown trout numbers were substantially reduced post maintenance works in 2014. This was also the case in the experimental site which experienced a more pronounced decrease (Figure 3.4). Similar to the crayfish results, habitat loss is the most likely explanation for the decrease in trout. The 2013 maintenance works consisted of maintaining 9km of the Robe main channel and 6km of a major tributary. Trout use aquatic vegetation for cover and as feeding areas. The removal of significant lengths of tall emergent vegetation over an extended area (approx. 16km) represents a severe degradation of riverine habitat and a very visible and serious departure from enhanced maintenance protocols.

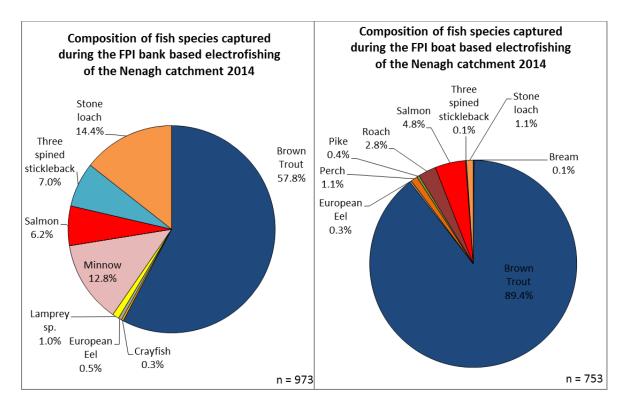
Figure 3.6. Composition of fish species captured in the Nenagh Catchment FPI survey using boat and bank electrofishing equipment.

The fish community in the Nenagh catchment is dominated by trout (Figure 3.6). Trout were present at all sites surveyed (Figure 3.7). Salmon (*Salmo salar*) were only present in the Nenagh, Ollatrim and

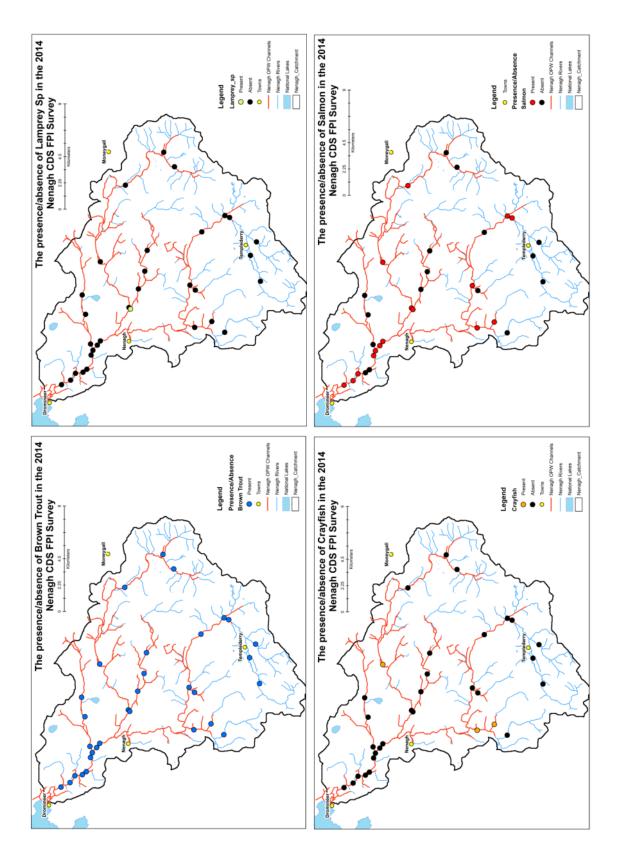
Figure 3.7. Presence / absence of brown trout, salmon, crayfish and lamprey sp. captured during the 2014 Nenagh FPI survey.

Dolla rivers and not in large numbers (Figure 3.7). Total number of salmon captured in the FPI Nenagh Survey from both boat and bank was 96, compared to the trout total of 1235.

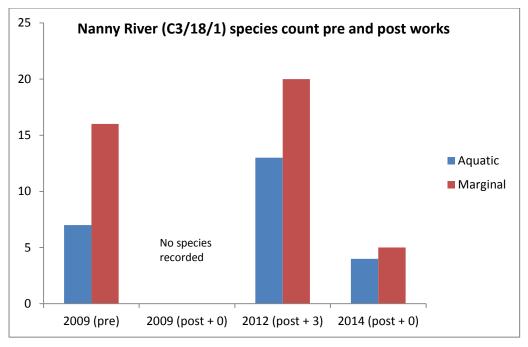
Figure 3.8: Channel species diversity pre and post works.

The 2012 botanical survey results indicated that the marginal and instream flora was recovering 3 years post maintenance (2009) (Figure 3.8) and channel flow/form was improving as a result. Vegetation removal and de-silting was undertaken again between 2013 and 2014. In 2014, a follow up survey of the channel flora demonstrated a substantial decline in plant diversity post works. Furthermore, survey results indicate that spoil spreading on the banktop is changing the plant assemblages from wet grassland species to dry grassland species, by raising the local topography along the machine access corridor at the top of the bank.

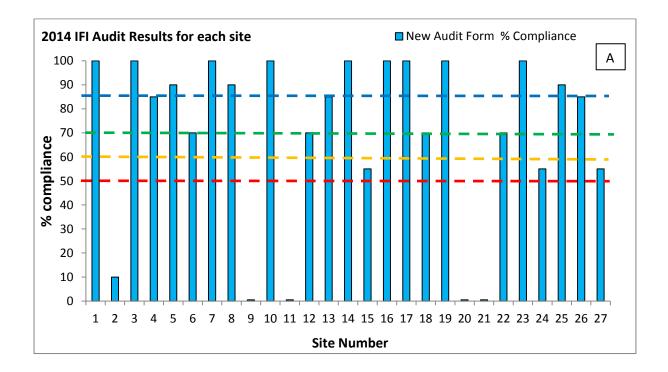
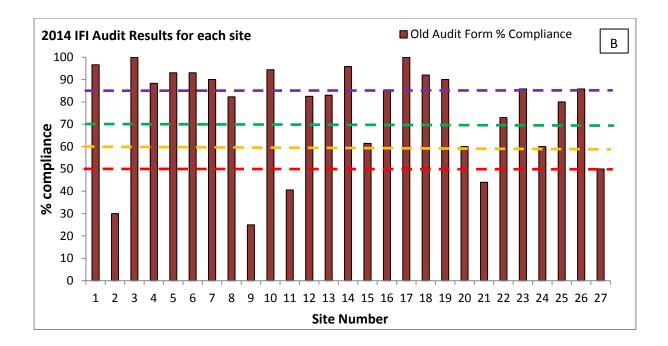
Figure 4.1. IFI 2014 Audit Results (based on both new form (A) and old form (B)).

For comparison, both the new and old audit form were completed during each audit visit in 2014. The old and new form proved to be very comparable, with 76% and 68% of drivers falling into the acceptable /or higher scoring categories respectivelty (Tables 4.4 & 4.5 and Figure 4.1 ). Similarily, 24% and 32% of drivers failed to achieve a score of acceptable or higher based on the old and new form respectively (Tables 4.4 & 4.5 and Figure 4.1 ).

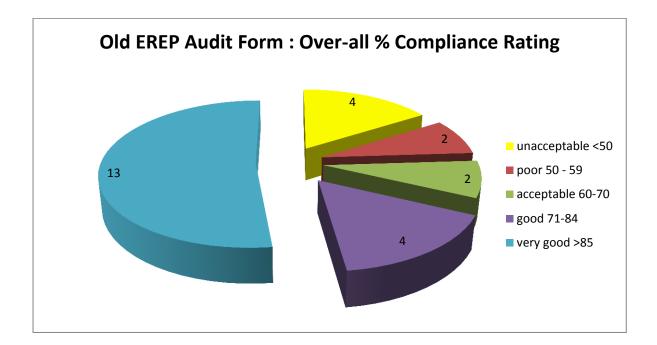
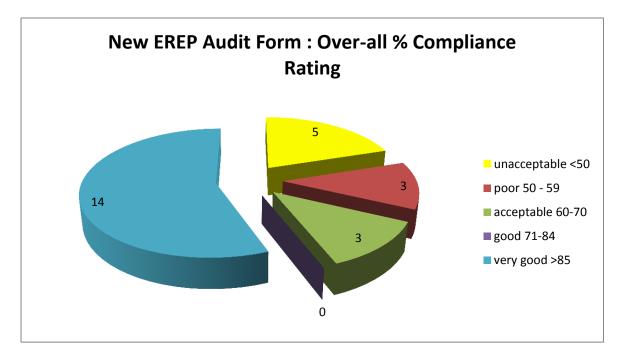
Figure 4.2. Comparison of EREP audit results based on the old and new form % compliance.

A comparison of the over-all % compliance rating from all audits is presented below (Figure 4.2). These results indicate a good similarity between the two scoring system. However the new form elaborates out each of the 10 steps in more detail which provides more useful information back to OPW on the performance of their drivers to in relation to environmental maintenance. It should help identify areas for improvement as well as promote areas where OPW are doing well.

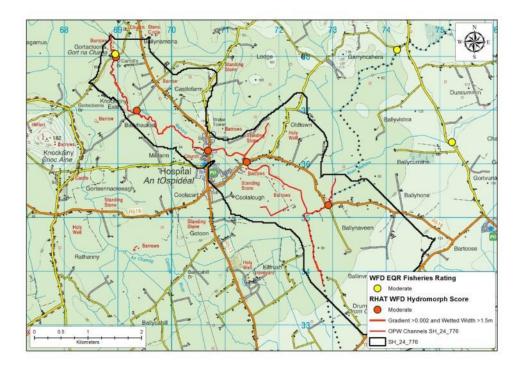
Figure 1. WFD EQR Fish rating and RHAT Scores for sub basin SH\_24\_776

5 River Hydromorphology Assessment Technique (RHAT) scores were taken in SH\_24\_776 (Figure 1) all were classed as moderate.

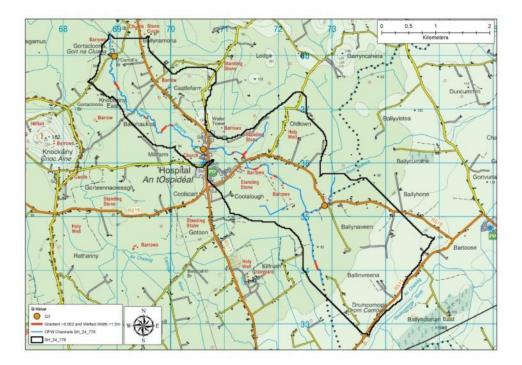
Figure 2. EPA Q-Values for sub basin SH\_24\_776

Possible Capital works locations (Gradient > 0.002 and wetted width >1.5m) are isolated and scattered throughout the waterbody. Poor water quality would not give value for money in terms of capital works investment for salmon (Figure 2, EPA Q-Value Q3). This water body would be more suited to enhanced maintenance works.

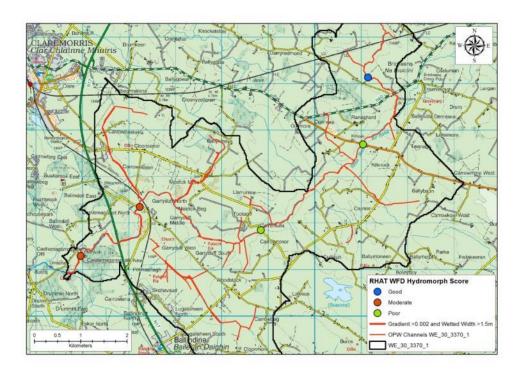
Figure 3. RHAT Scores for sub basin WE\_30\_3370\_1

5 River Hydromorphology Assessment Technique (RHAT) scores were taken in WE\_30\_3370\_1 (Figure 3) one was good, two were moderate and two were poor. The site classified as good had river enhancement works done under the Tourist Angling Measure (TAM) in the mid 90's.

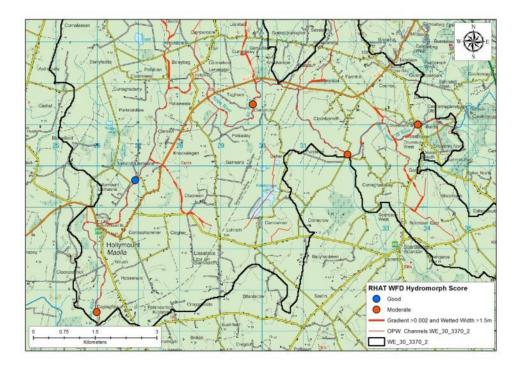
Figure 5. RHAT Scores for sub basin WE\_30\_3370\_2

5 River Hydromorphology Assessment Technique (RHAT) scores were taken in WE\_30\_3370\_2 (Figure 5) four were classed as moderate one as good. The site classified as good had river enhancement works done under TAM in the mid 90's and in 2014 had fresh gravels added.

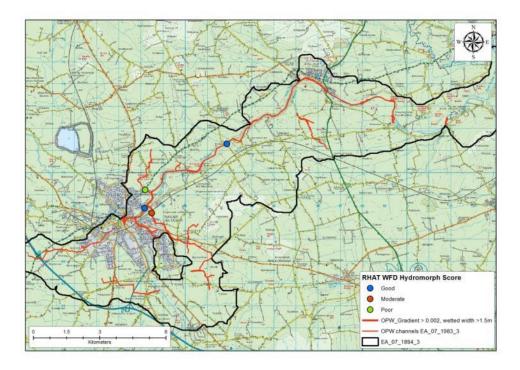
Figure 7. RHAT Scores for sub basin EA\_07\_1894\_3

4 River Hydromorphology Assessment Technique (RHAT) scores were taken in EA\_07\_1894\_3 (Figure 7) two were good, one was moderate and one was poor.

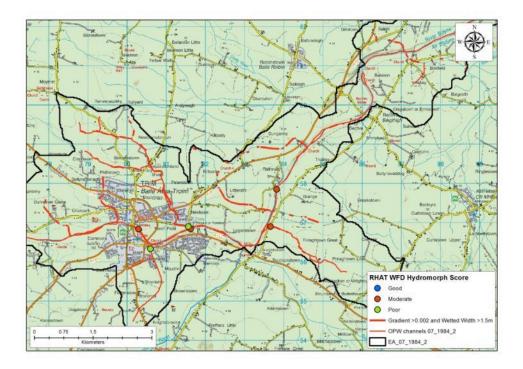
Figure 9. RHAT Scores for sub basin EA\_07\_1894\_2

6 River Hydromorphology Assessment Technique (RHAT) scores were taken in EA\_07\_1894\_2 (Figure9) four were moderate and two were poor.

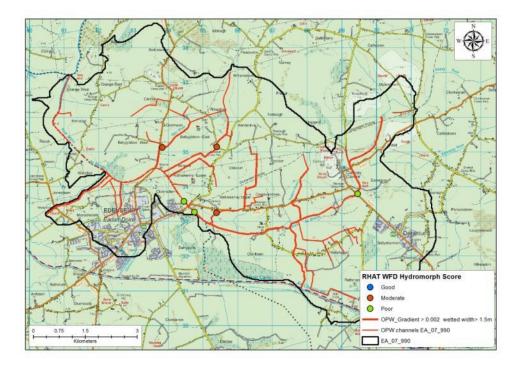
Figure 11. RHAT Scores for sub basin EA\_07\_990

5 River Hydromorphology Assessment Technique (RHAT) scores were taken in EA\_07\_990 (Figure 11) three were moderate and two were poor.
