# DUN LAOGHAIRE BATHS

(5009)

<b>ROYAL HASKONING 2008 STUDY - A BASE FOR TECHNICAL DATA</b>	<b>1</b>
---	----------

## **DUN LAOGHAIRE BATHS SCHEME (5009)**

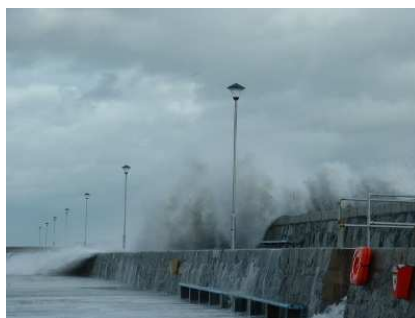
- A. The height of waves formed by wind depends on the length of open sea (the fetch) over which the wind can freely pass when pointing directly at the subject site. The longer the fetch the higher the potential waves. In shallow water they can peak and break, depending on water depth relative to open sea wave height.
- B. Dun Laoghaire baths and the proposed pier face north east and in north easterly storms are open to waves which have had a long open sea passage over which to build up height –Scotland would be the nearest land in that direction .
- C. Very large waves have been recorded in such storms in this corner of Scotsman's Bay. For example in 2010 waves broke over the top of the nearby Harbour East Pier near its root, at level 6.00 OD (see photo).
