Proposed Interim Works at Dún Laoghaire Baths

Environmental Impact Report

The Proposed Interim Works at Dún Laoghaire Baths

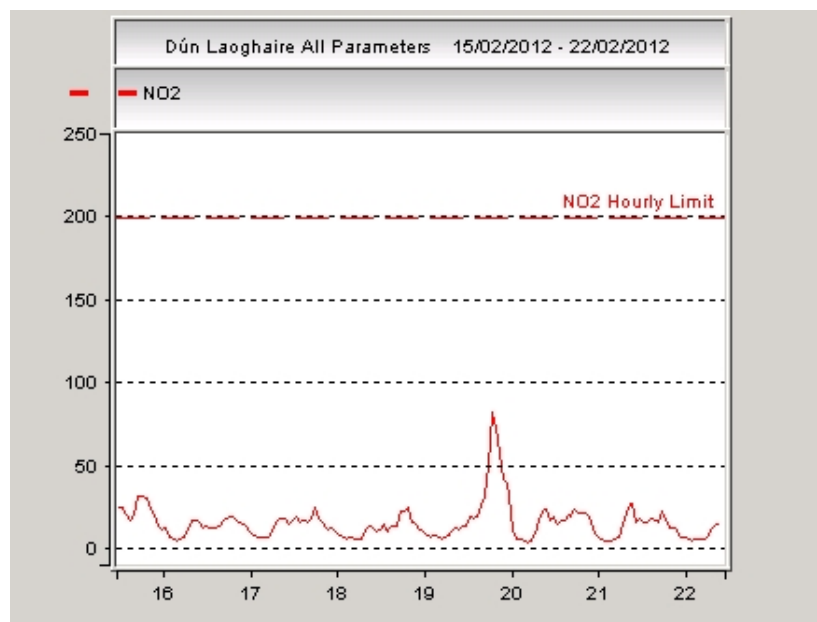
Figure 5.1 Nitrogen Dioxide Levels at Dún Laoghaire

The measurement units are microgrammes per cubic meter ($\mu\text{g}/\text{m}^3$). The NO_2 hourly limit of $200 \mu\text{g}/\text{m}^3$ is deemed breached if more than 18 exceedances have occurred within a calendar year. There have been no exceedances at this site to date in 2012.

Nitrogen dioxide (NO₂) is classed as both a primary and a secondary pollutant. As a primary pollutant NO₂ is emitted from all combustion processes (such as a gas/oil fired boiler or a car engine). As a secondary pollutant NO₂ is derived from atmospheric reactions of pollutants that are themselves, derived mainly from traffic sources. NO₂ has been shown to reduce the pulmonary function of the lungs. Long term exposure to high concentrations of NO₂ can cause a range of effects, primarily in the lungs, but also in the liver and blood. The results of the latest available monitoring data for NO₂ is presented in **Figure 5.1**.

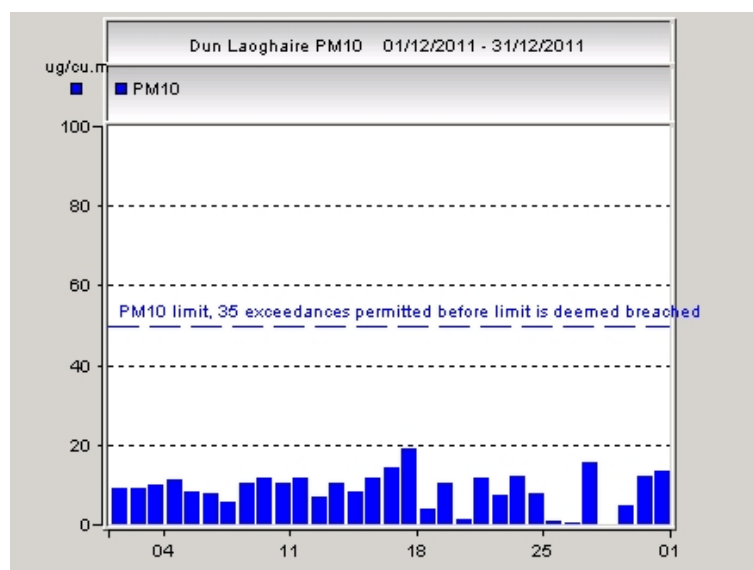
Figure 5.2 Particulate Matter Levels at Dún Laoghaire

The measurement units are microgrammes per cubic meter ($\mu\text{g}/\text{m}^3$). The PM_{10} limit of $50 \mu\text{g}/\text{m}^3$ is deemed breached if more than 35 exceedances have occurred. There were 11 exceedances at this site in 2011.

Particulate matter (PM_{10}) may be emitted as a primary pollutant from road vehicle exhausts, which is the main source in urban areas. In rural areas, sources will include traffic, agricultural activities and natural processes. Also point sources such as combustion, i.e. domestic fires, industrial boilers etc. are primary sources of PM_{10} . PM_{10} may also be formed as secondary pollutants from the condensation or reaction of chemical vapours in the atmosphere. Health effects associated with PM_{10} , in the long term, include chronic effects such as increased rates of bronchitis and reduced lung function. The results of the latest available monitoring data for PM_{10} is presented in **Figure 5.2**.

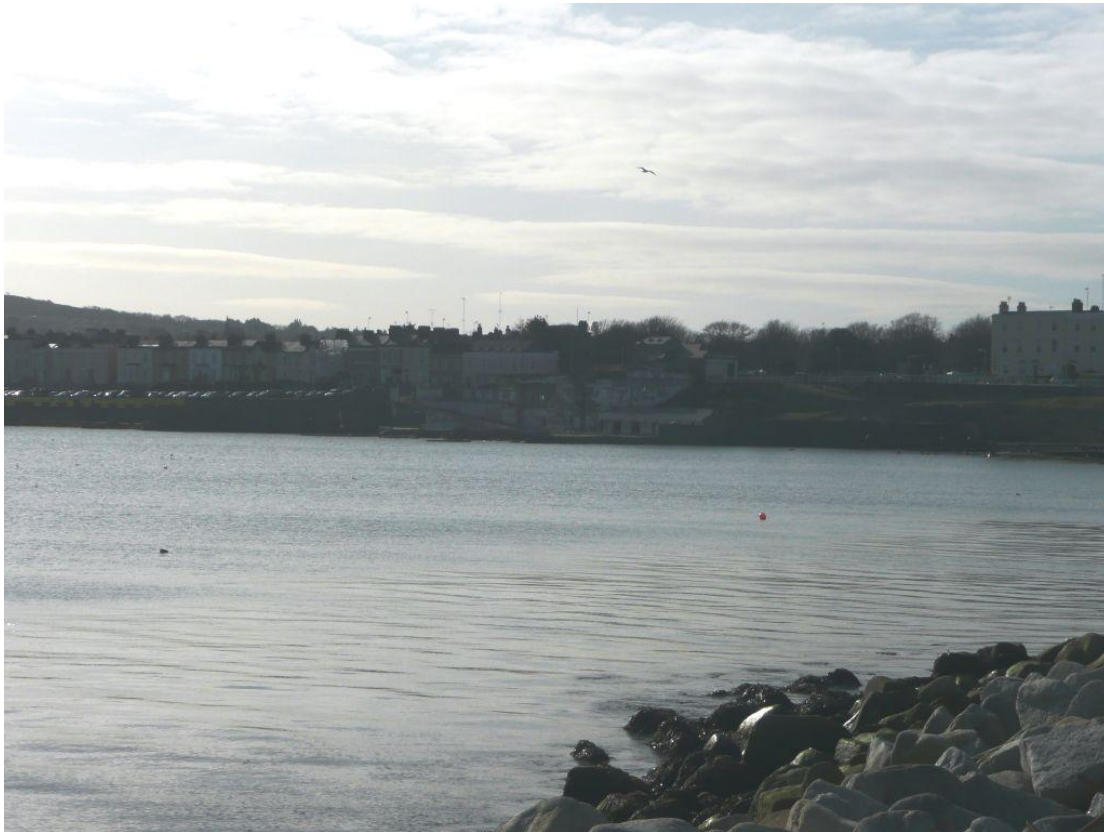
Viewpoint 1: View east from Harbour Pier

Viewer sensitivity: This view is from East Pier available to tourists and recreational users. The viewer sensitivity is high.

Existing visual resource: The existing view is available from the East Pier in Dún Laoghaire looking South along the promenade. The view is urban, open and coastal. In the centre of the view the water meets the existing baths which are in a dilapidated state. This structure rises over two storeys with the pavilion complex on an elevated position above and behind the baths. Moving to the right from the pavilion there is a single story building. At street level a three storey Victorian style terrace meets the skyline.

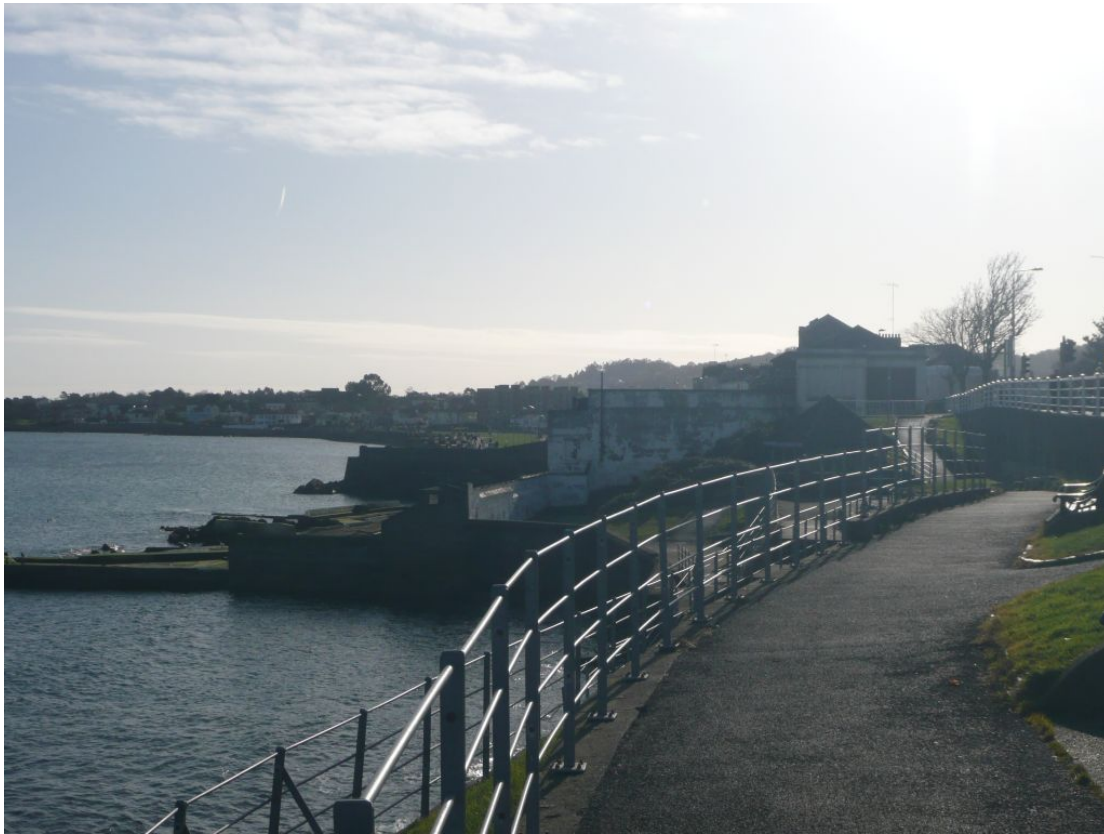
Viewpoint 2: View South East from Promenade

Viewer sensitivity: this view is available from the promenade at Queens Road and is available to the local community, tourists and recreational users. The viewer sensitivity is high.

Existing visual resource: The existing view is from the promenade parallel to Queens Road. The promenade offers views to Dún Laoghaire Bay and the baths. The immediate foreground is the asphalt footway curving to the right bounded by a 4 tier metal fence. To the front of the pavilion building there are the remains of the baths stepping down levels to meet the water. The unattractive baths and pavilion dominate the view. Beyond this the harbour can be seen curving away to the left with residential houses dwellings, trees, grass and overhead lights.

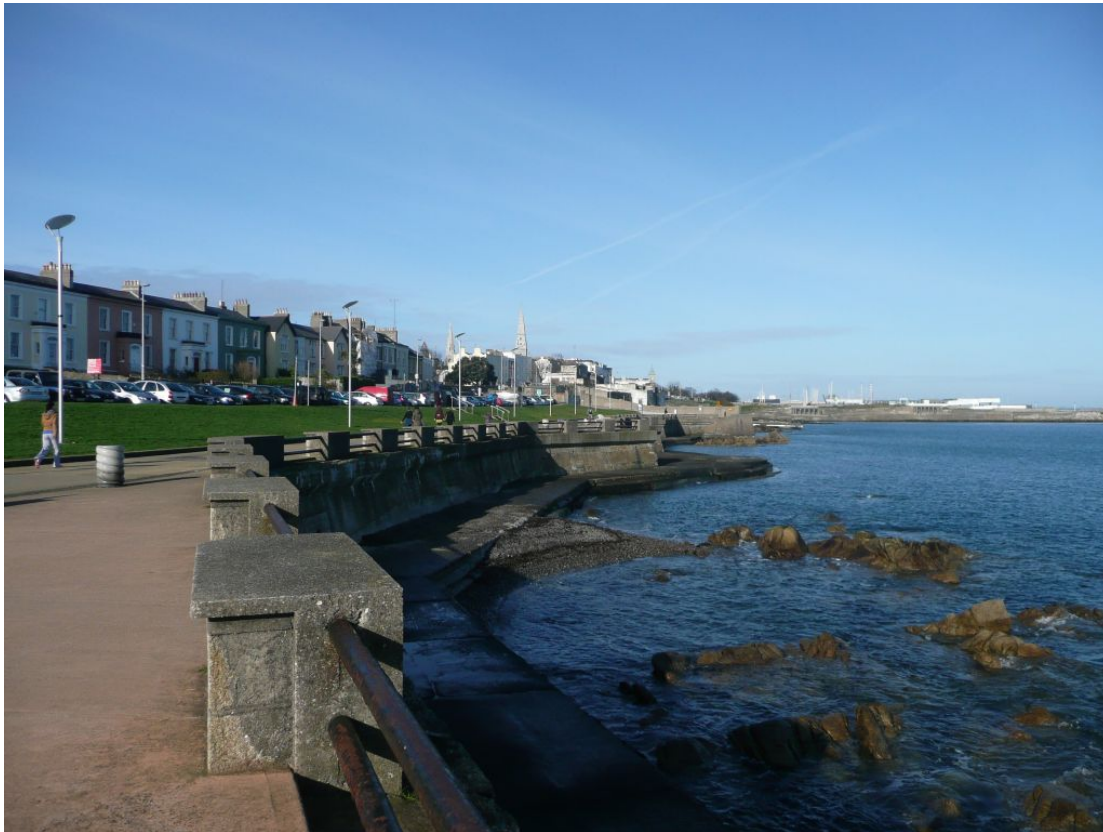
Viewpoint 3: North West from Windsor Terrace Car Park Viewing Point

Viewer sensitivity: This view is from the terraced promenade at Windsor Terrace looking north west and is available to the local community, tourists and recreational users. The viewer sensitivity is high.

Existing visual resource: The existing view is dominated by the promenade. This structure is geometric in shape and design. The existing baths can be seen rising from behind a wall occupying the centre of the view. Beyond the baths the harbour curves around to the right where fencing marks the walkways and grassed areas. Vertical boat masts can be viewed in the distance. A line of trees come from behind the pavilion to the right side of the view along the promenade.

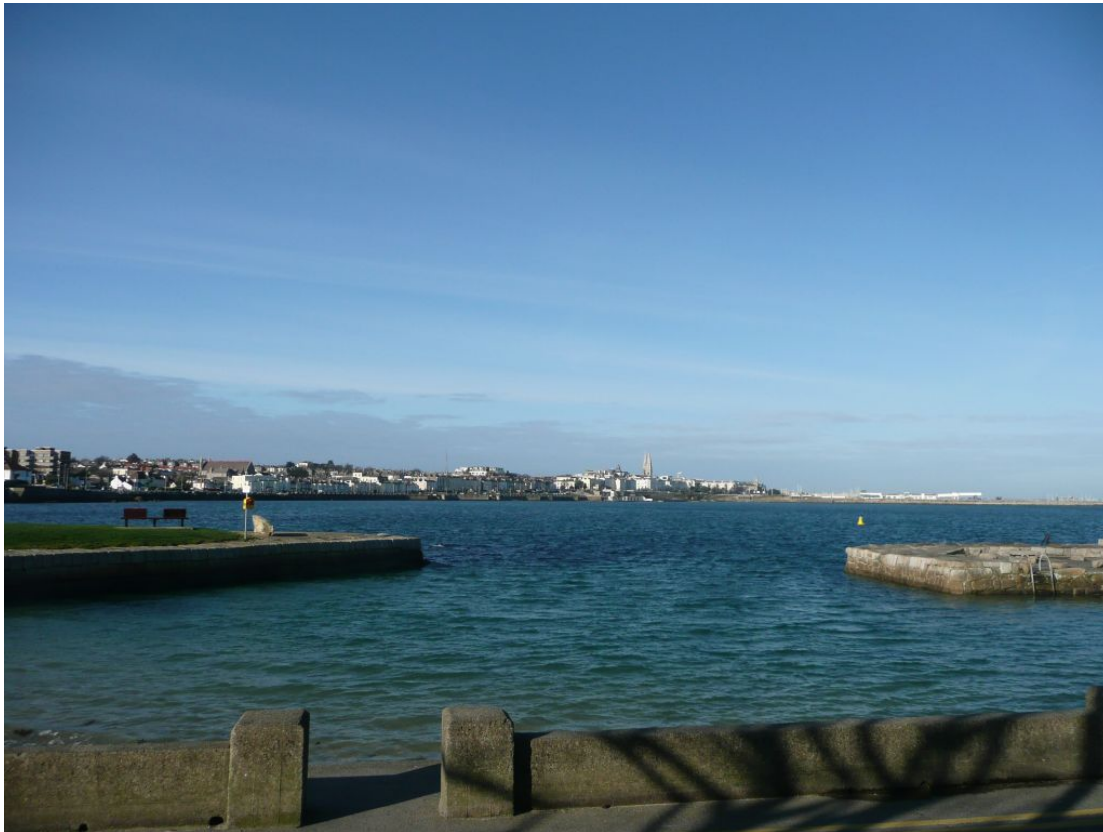
Viewpoint 4: View west from Sandy Cove Pier

Viewer sensitivity: This view is available from a local pier and is available to the local community, tourists and recreational users. The viewer sensitivity is high.

Existing visual resource: This view from Sandy Cove Pier. In the immediate foreground there are jetties coming towards the middle of the view from both sides of the view. The distant view is of a built up seaside town. In the centre of the view the existing baths can be just discerned with the pavilion rising up behind it. The urban setting of Dún Laoghaire can be seen sprawling from the right of the view towards the left. It has the usual character of a seaside town with painted terraces and church spires.

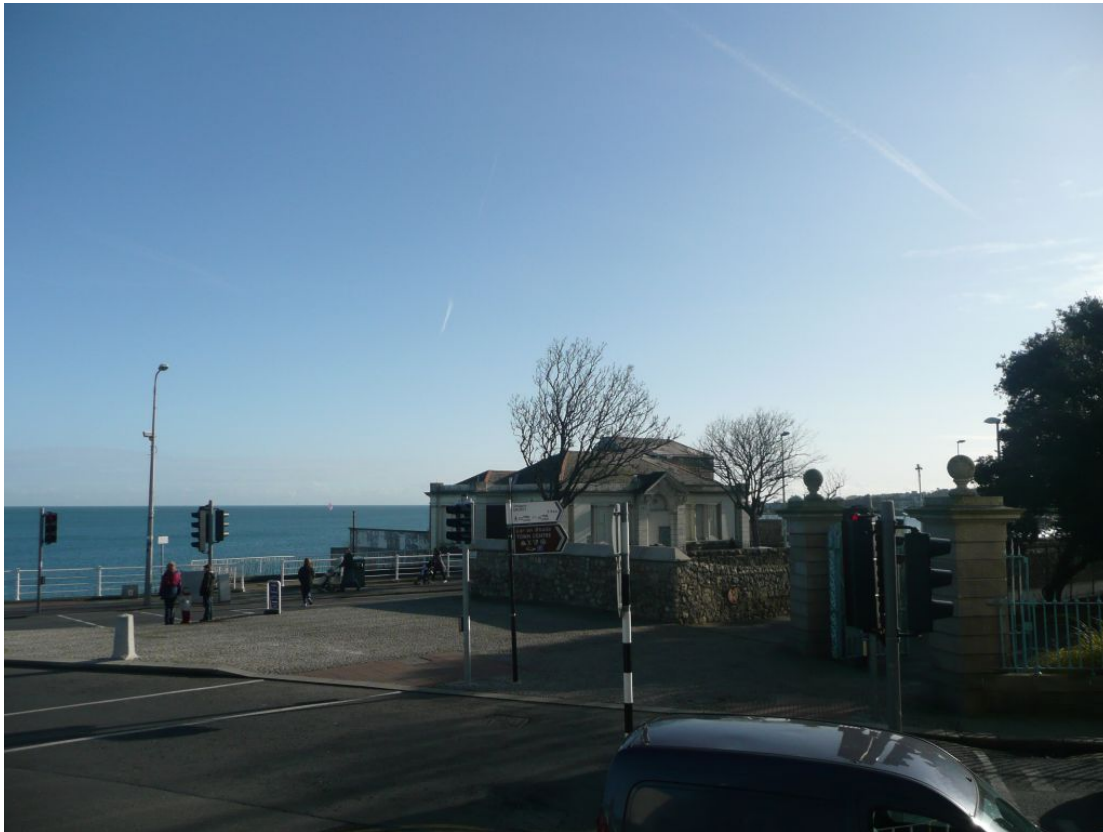
Viewpoint 5: View north east from Marine Terrace and Park Road junction

Viewer sensitivity: This view is available from a junction of two local roads (Park Road and Marine Terrace) available to tourists, recreational users and local town visitors. The viewer sensitivity is high.

Existing visual resource: This view is from the junction of two local roads. It is an open urban character. The immediate foreground is dominated with asphalt road, cobbled footways, street signs and street lighting with the area being bounded by a metal fence before the Dún Laoghaire harbour. The existing pavilion building is located in the centre of the view but the shoreline is not visible.

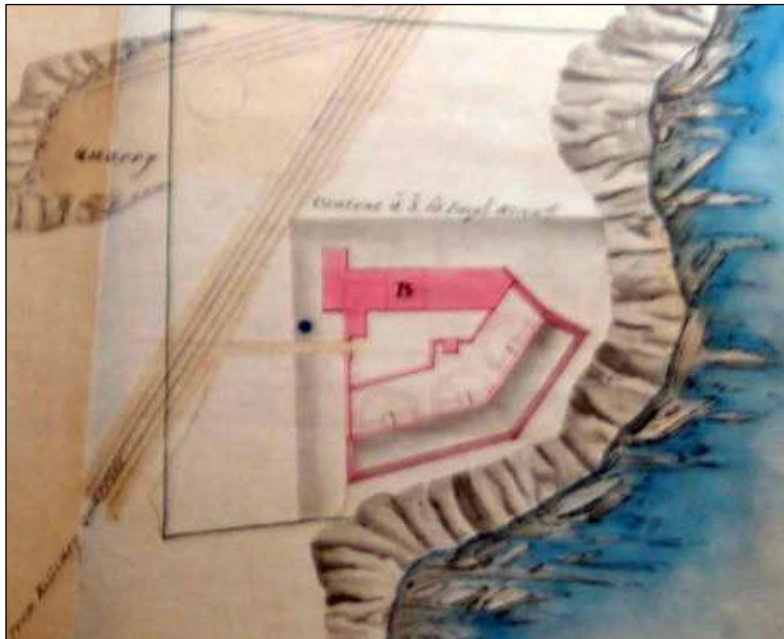
Figure 9.2 The 1831 Board of Ordnance Plan of "No. 12 Glossdool"

The two plots of land at Glashule were purchased for £90 and 10 shillings from "Lords Longford, De Vesci, and Mr Daniel Sexton" in 1806; though the lands had already been legally transferred in trust to Benjamin Fisher the year before. The "three gun battery at Glasstool" was built by John Murray, who was also responsible for the batteries and towers at Dún Leary, Sandycove, and Seapoint. Glashule battery was armed with three 24-pounder guns positioned behind an angled bastion on the rocky foreshore of Scotsman's Bay (**Figure 9.2**).

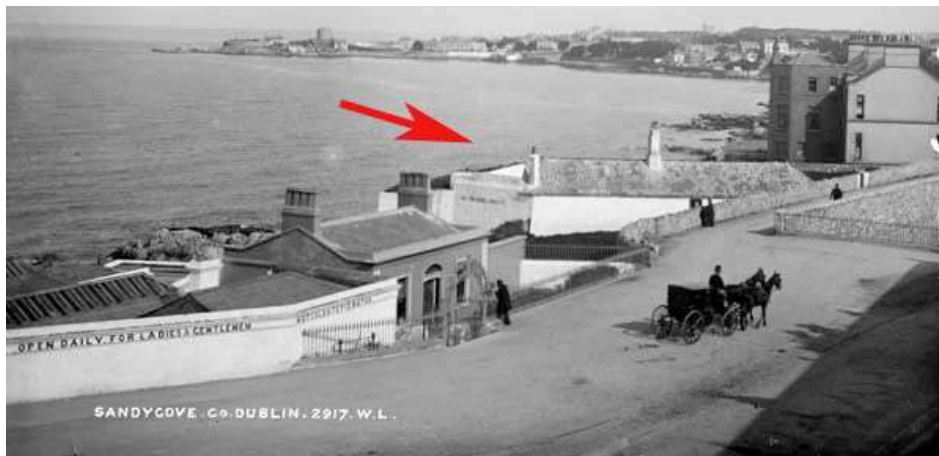
Figure 9.5 Historic Photograph Showing the Whitewashed and Slate-Roofed Guard House and Part of the Battery Walls (arrowed) Positioned below the then Street-Level (after Bolton 2011).

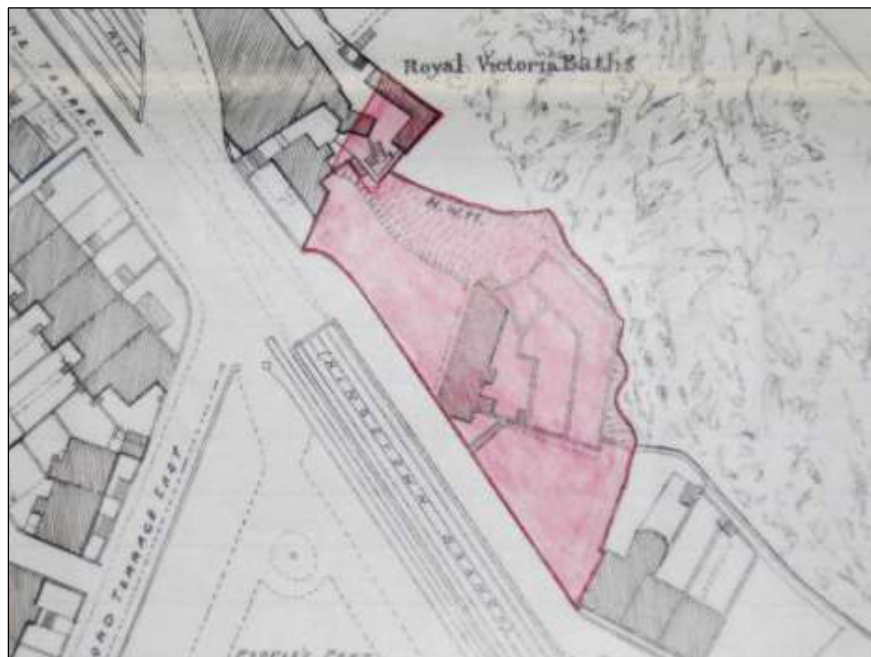
Figure 9.6 Copy of the 1907 Deed Plan Map Showing the Battery and the Extent of Property Purchased by Kingstown Urban District Council.

On the 14th March 1907, the Commissioners of Kingstown Harbour sold the battery to Kingstown Urban District Council “at the price of five hundred pounds ..”. The detailed plan of the site accompanying the 1907 title deed (**Figure 9.6**) shows the battery almost unchanged from an 1831 Board of Ordnance plan (Fig. 2).

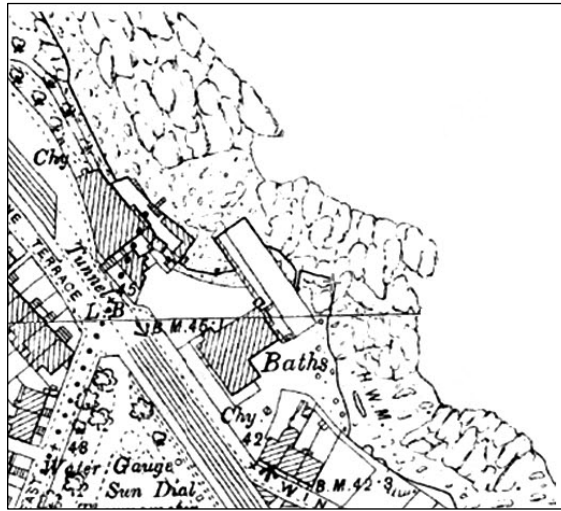
Figure 9.7 Revised 1908 Ordnance Survey Map Showing the Baths Complex

The battery was quickly removed to develop the site as a public baths, and cannot be traced on the 1908 Ordnance Survey 25-inch map of the site (**Figure 9.7**). The baths were further developed and extended throughout the 20th century.

The early twentieth century development also involved the phased reclamation of the foreshore. The ordnance survey 25-inch map sheet (published in 1908 but based on an earlier survey) shows a pier in front of the battery (**Figure 9.7**) and consequently removed the ashlar masonry of the seaward side of Glasthule Battery.

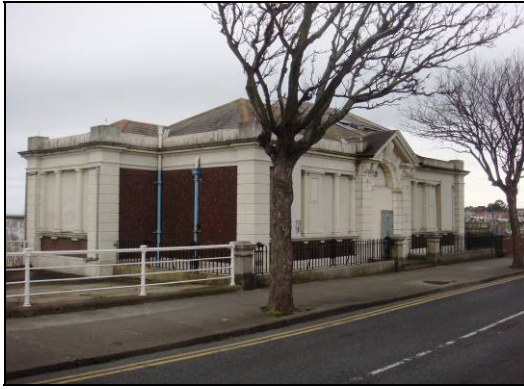
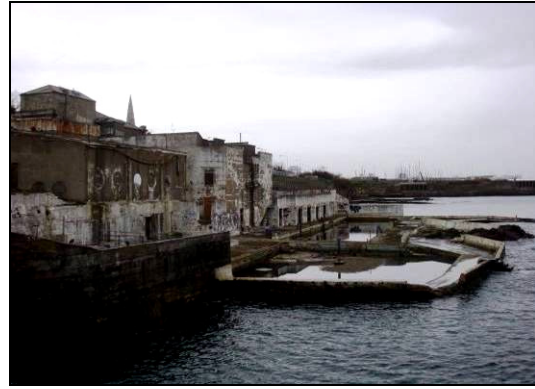
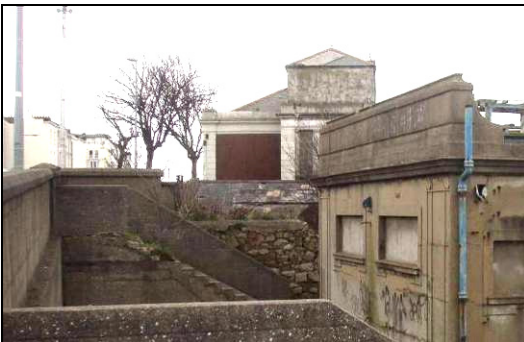
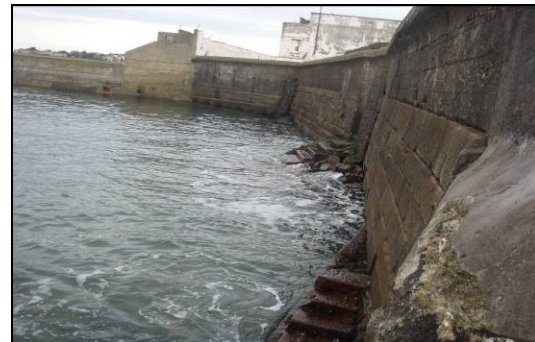
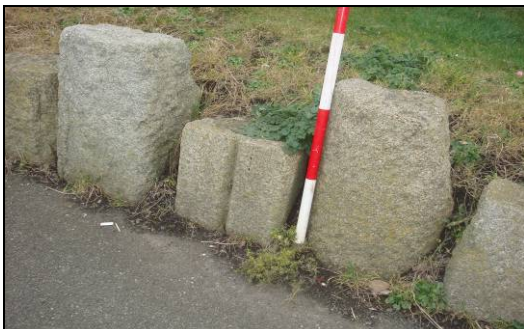
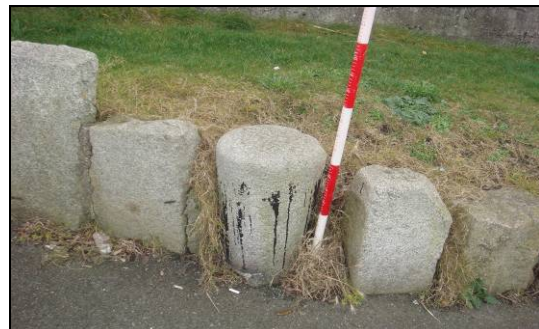
Plates 1–6: Views of the site: -The 1907 Baths Pavilion, view of the baths looking NE, a rubble wall marking an earlier 19th century property boundary, the ashlar and concrete retaining sea wall at the northern end of the baths complex, re-used roughly dressed granite masonry with a groove cut into it and a roughly dressed granite mooring post.

No features of an archaeological nature or potential were identified during the field inspection. The only visible upstanding pre-1907 feature that can be seen on the site is a granite rubble stone wall (**Plate 3**) which was a former property boundary wall running in a northeast direction, it is indicated on **Figure 9.8** in yellow. Throughout the site lies some re-used roughly dressed granite stone, including a possible mooring post (**Plate 6**), while the original use of some of these stones cannot be alluded to they do serve to enhance the area.

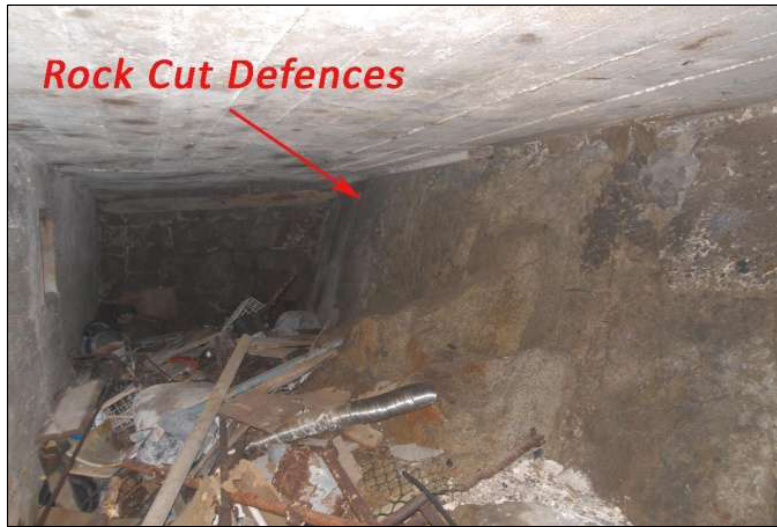
Plate 7: General view of the eastern end of the bath complex at basement level showing the 19th century granite masonry wall meeting the cut granite bedrock. This rock surface has been quarried back and is likely to have formed the lowermost part of the defences of Glasthule Battery. (After Bolton 2011)

At basement level, the granite bedrock has been cut (i.e. quarried) to form a battered near-vertical rock face (**Plate 7**). This vertical rock face is found below a poured concrete flooring structure within the bathing complex. A passage has been cut through the vertical rock face in this area to form a passageway leading to the boiler room and the rear of the complex. This rock surface has been quarried back and is likely to have formed the lowermost part of the defences of Glasthule Battery.

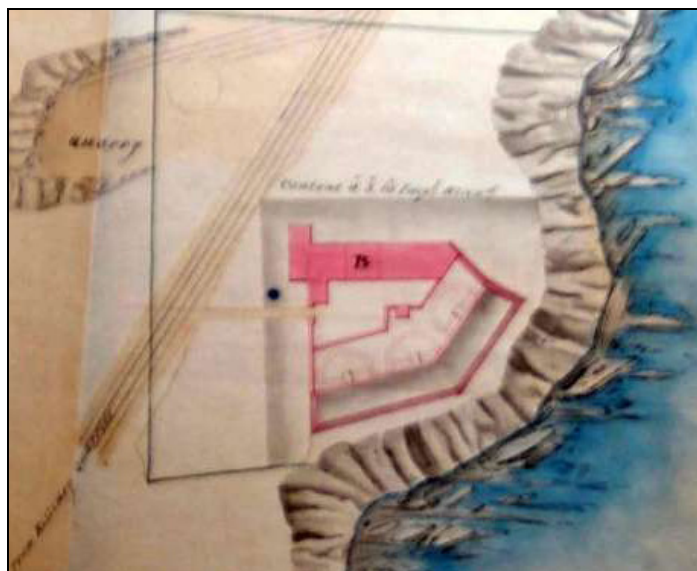
Figure 2: The 1831 Board of Ordnance Plan of "No. 12 Glasstool"

The two plots of land at Glasthule were purchased for £90 and 10 shillings from "Lords Longford, De Vesci, and Mr Daniel Sexton" in 1806; though the lands had already been legally transferred in trust to Benjamin Fisher the year before. The "three gun battery at Glasstool" was built by John Murray, who was also responsible for the batteries and towers at Dun Leary, Sandycove, and Seapoint. Glasthule battery was armed with three 24-pounder guns positioned behind an angled bastion on the rocky foreshore of Scotsman's Bay (Figure 2).

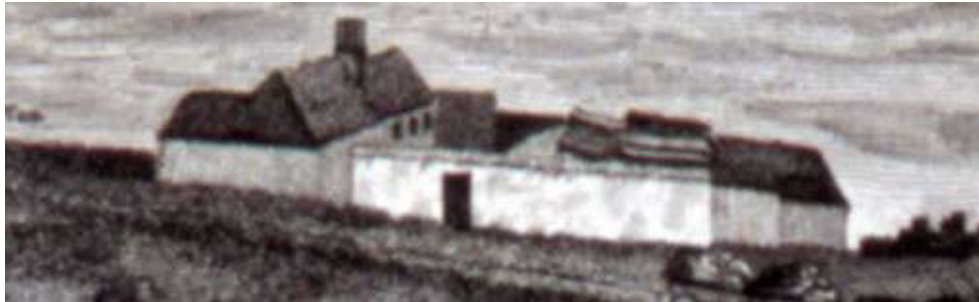
Figure 3: Detail from an engraving of Duncan's 1821 map showing Glashule Battery

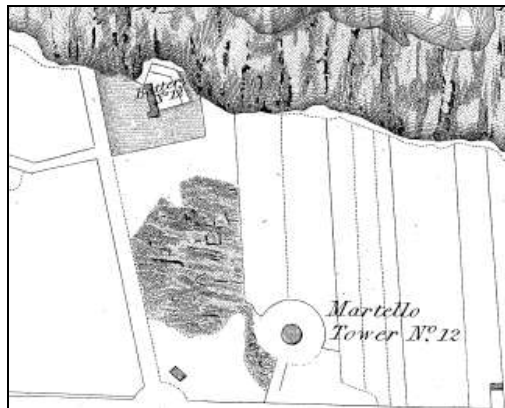
Figure 4: Detail of Rennie's 1820 map showing the battery, Martello Tower and Park Road.

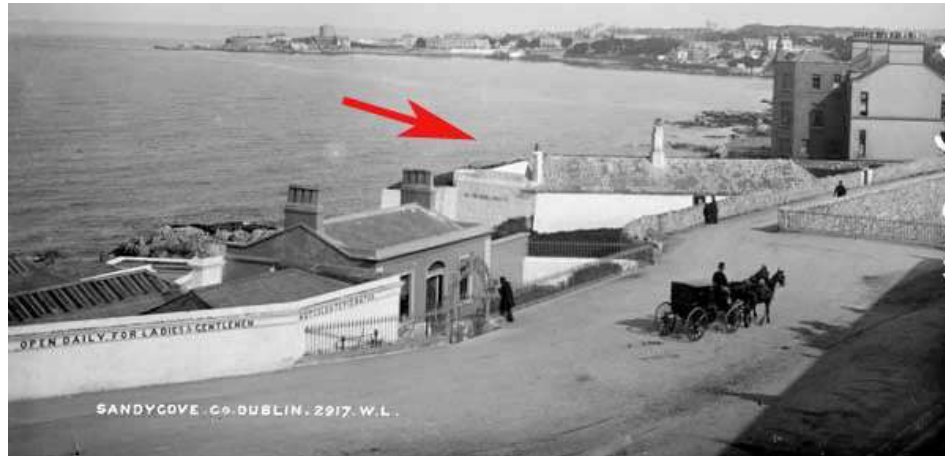
Figure 5: Historic photograph showing the whitewashed and slate-roofed guard-house and part of the battery walls (arrowed) positioned below the then street-level (after Bolton 2011).

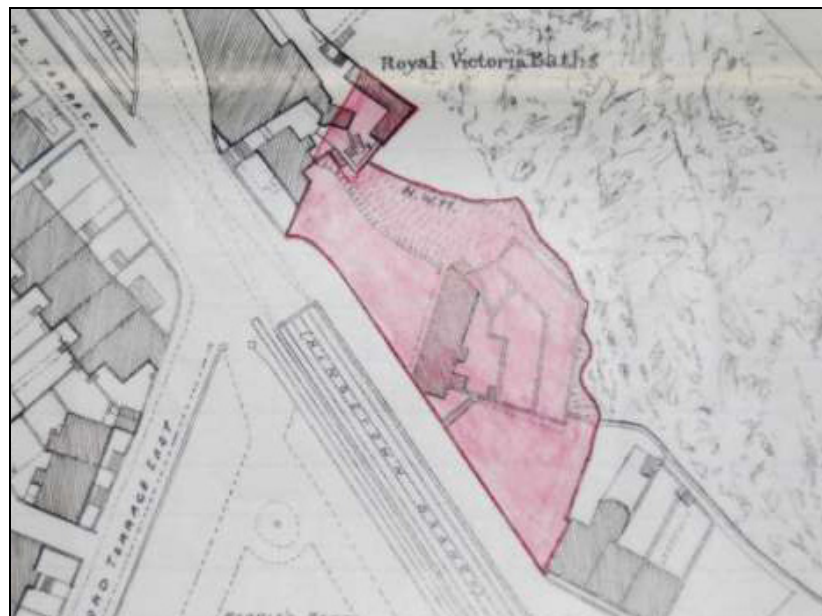
Figure 6: Copy of the 1907 deed plan map showing the battery and the extent of property purchased by Kingstown Urban District Council.

On the 14th March 1907, the Commissioners of Kingstown Harbour sold the battery to Kingstown Urban District Council “at the price of five hundred pounds ..”. The detailed plan of the site accompanying the 1907 title deed (Fig. 6) shows the battery almost unchanged from an 1831 Board of Ordnance plan (Fig. 2).

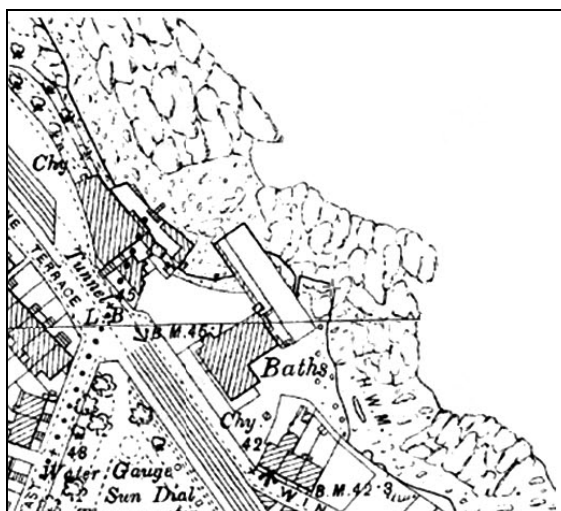
Figure 7: Revised 1908 Ordnance Survey map showing the baths complex

The battery was quickly removed to develop the site as a public baths, and cannot be traced on the 1908 Ordnance Survey 25-inch map of the site (Fig. 7). The baths were further developed and extended throughout the 20th century.

The early twentieth century development also involved the phased reclamation of the foreshore. The ordnance survey 25-inch map sheet (published in 1908 but based on an earlier survey) shows a pier in front of the battery (Fig. 7) and consequently removed the ashlar masonry of the seaward side of Glasthule Battery.

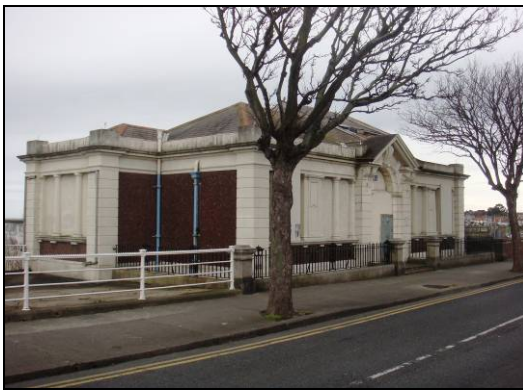
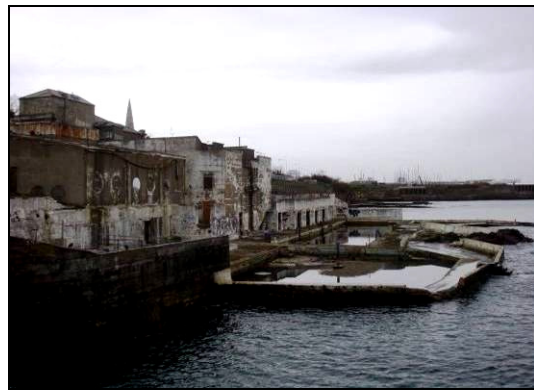
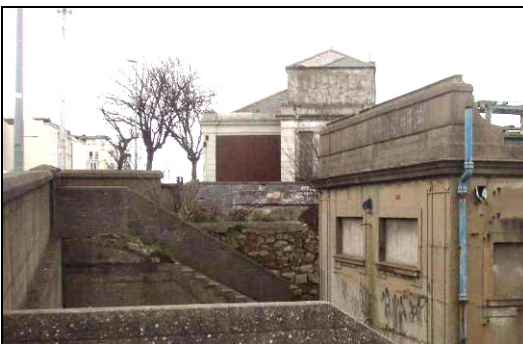
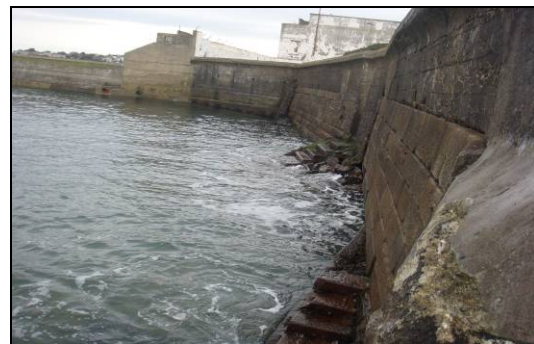
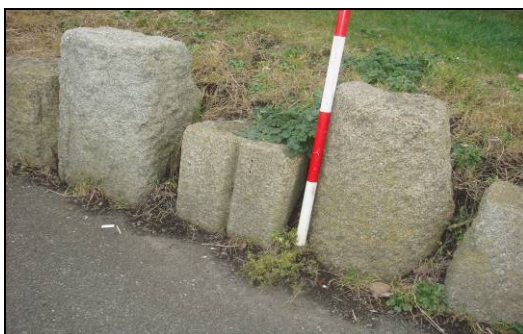
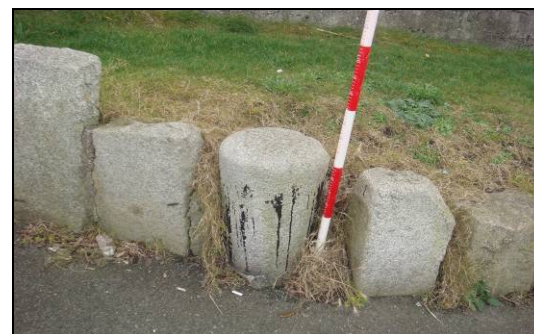
Plates 1–6: Views of the site: -The 1907 Baths Pavilion, view of the baths looking NE, a rubble wall marking an earlier 19th century property boundary, the ashlar and concrete retaining sea wall at the northern end of the baths complex, re-used roughly dressed granite masonry with a groove cut into it and a roughly dressed granite mooring post.

No features of an archaeological nature or potential were identified during the field inspection. The only visible upstanding pre-1907 feature that can be seen on the site is a granite rubble stone wall (Plate 3) which was a former property boundary wall running in a northeast direction, it is indicated on Figure 8 (below) in yellow. Throughout the site lies some re-used roughly dressed granite stone, including a possible mooring post (Plate 6), while the original use of some of these stones cannot be alluded to they do serve to enhance the area.

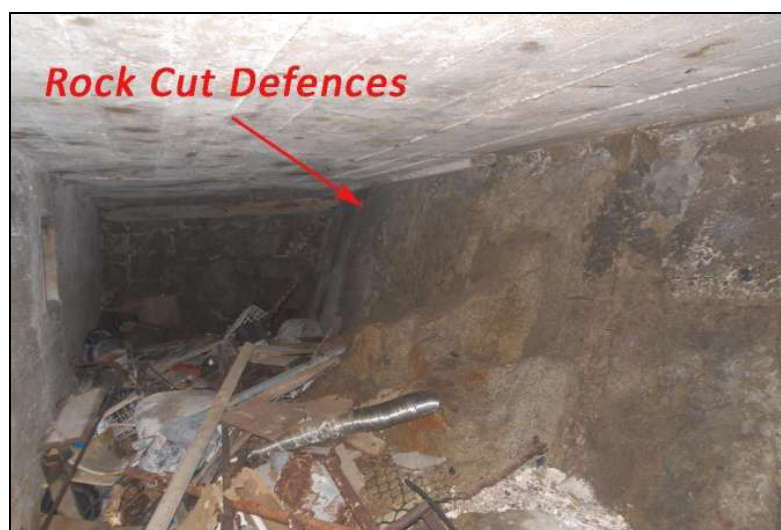
Plate 7: General view of the eastern end of the bath complex at basement level showing the 19th century granite masonry wall meeting the cut granite bedrock. This rock surface has been quarried back and is likely to have formed the lowermost part of the defences of Glashule Battery. (After Bolton 2011)

At basement level, the granite bedrock has been cut (i.e. quarried) to form a battered near-vertical rock face (Plate 7). This vertical rock face is found below a poured concrete flooring structure within the bathing complex. A passage has been cut through the vertical rock face in this area to form a passageway leading to the boiler room and the rear of the complex. This rock surface has been quarried back and is likely to have formed the lowermost part of the defences of Glashule Battery.
