# GREENLINK MARINE ENVIRONMENTAL IMPACT ASSESSMENT REPORT- IRELAND

## APPENDIX L

Welsh and Irish Landfall Final Selection Report

Greenlink Interconnector  
- connecting the power markets  
in Ireland and Great Britain

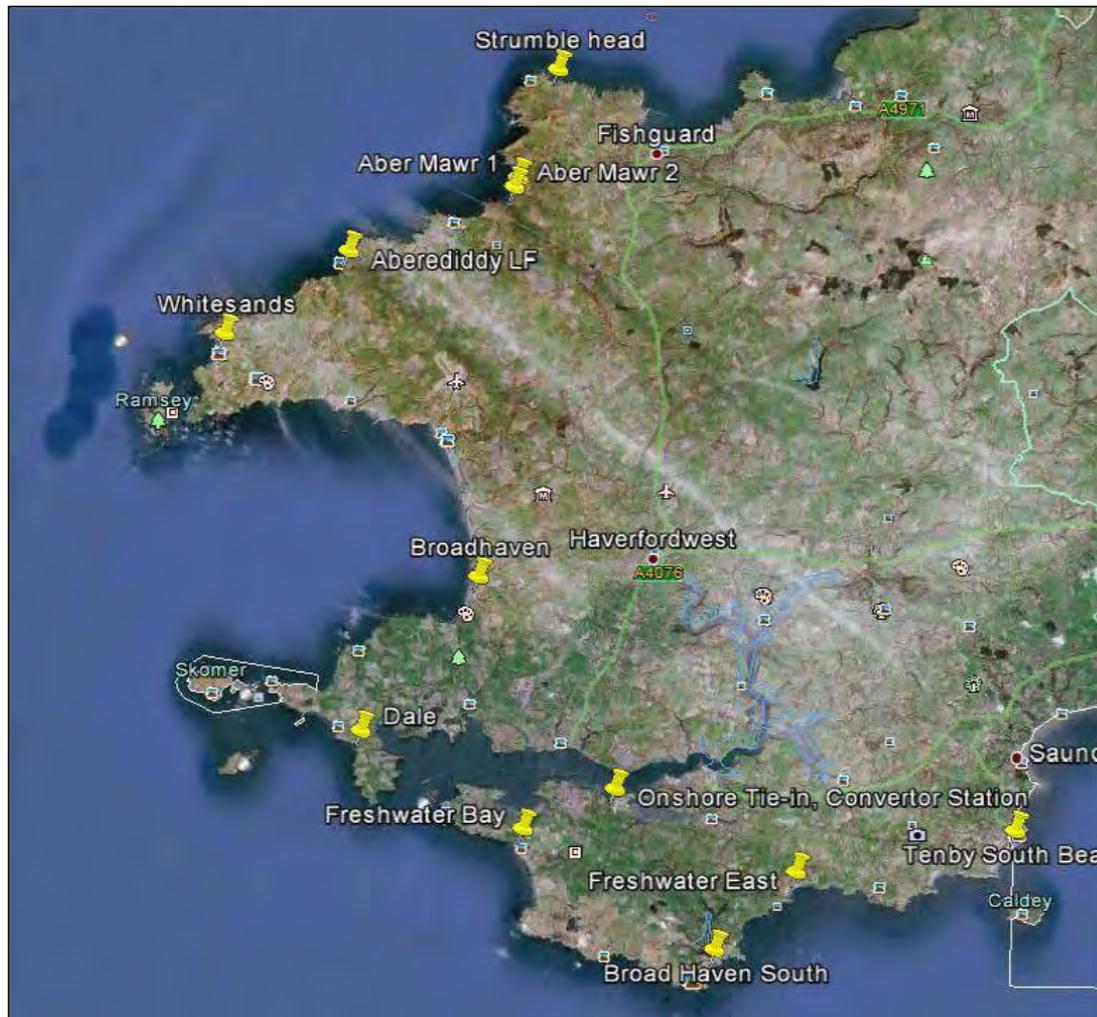
Figure 3-1 South Wales Landfall Options

LANDFALL LOCATION	AREA	LATITUDE	LONGITUDE
<b><i>Southern Side of Milford Haven</i></b>			
<b>Freshwater Bay (North End Broomhill Burrows) preferred southern option</b>	South of Milford Haven	51° 39.789'N	5° 3.956'W
Broad Haven South	South Pembroke	51° 36.466'N	4° 55.353'W
Freshwater East	South Pembroke	51° 38.715'N	4° 51.824'W
Tenby South Beach	South Pembroke	51° 40.028'N	4° 42.176'W
<b><i>Northern Side of Milford Haven</i></b>			
<b>Broad Haven [preferred option]</b>	Northwest of Milford Haven	51° 46.944'N	5° 6.210'W
Dale	Northwest of Milford Haven	51° 42.470'N	5° 11.229'W
Whitesands	North Pembroke	51° 53.742'N	5° 17.767'W
Abereiddy LF	North Pembroke	51° 56.182'N	5° 12.355'W
Aber Mawr 1	North Pembroke	51° 58.408'N	5° 4.902'W
Aber Mawr 2	North Pembroke	51° 58.161'N	5° 5.028'W
Strumble Head	North Pembroke	52° 1.523'N	5° 3.229'W

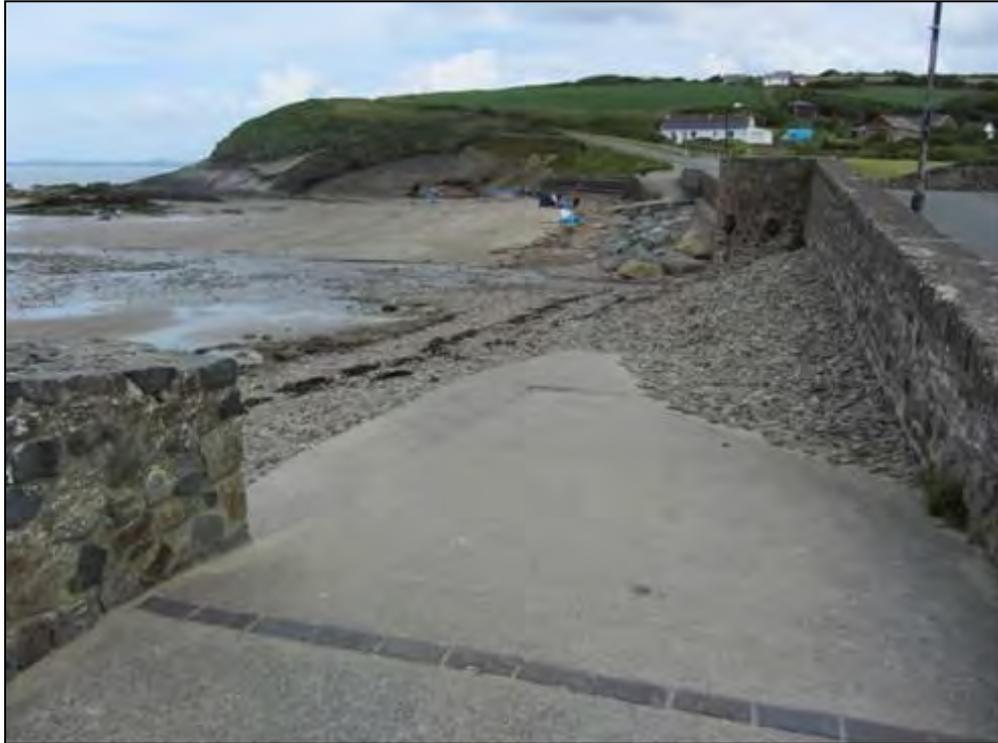
**Figure 3-2 Broad Haven**

The admiralty chart indicates the offshore geological conditions to be sand/mud/gravel. However there is some exposed bedrock at the northern edge of the beach and a small seawall and stormwater culvert in the vicinity of the proposed landfall.

While a crossing of the Haven will be technically challenging options include HDD, or tunnelling. Further studies would be needed to identify the optimal crossing methodology.

Therefore, subject to geophysical and geotechnical survey results there are no technical reasons not to situate the export cable landfall at Broad Haven.

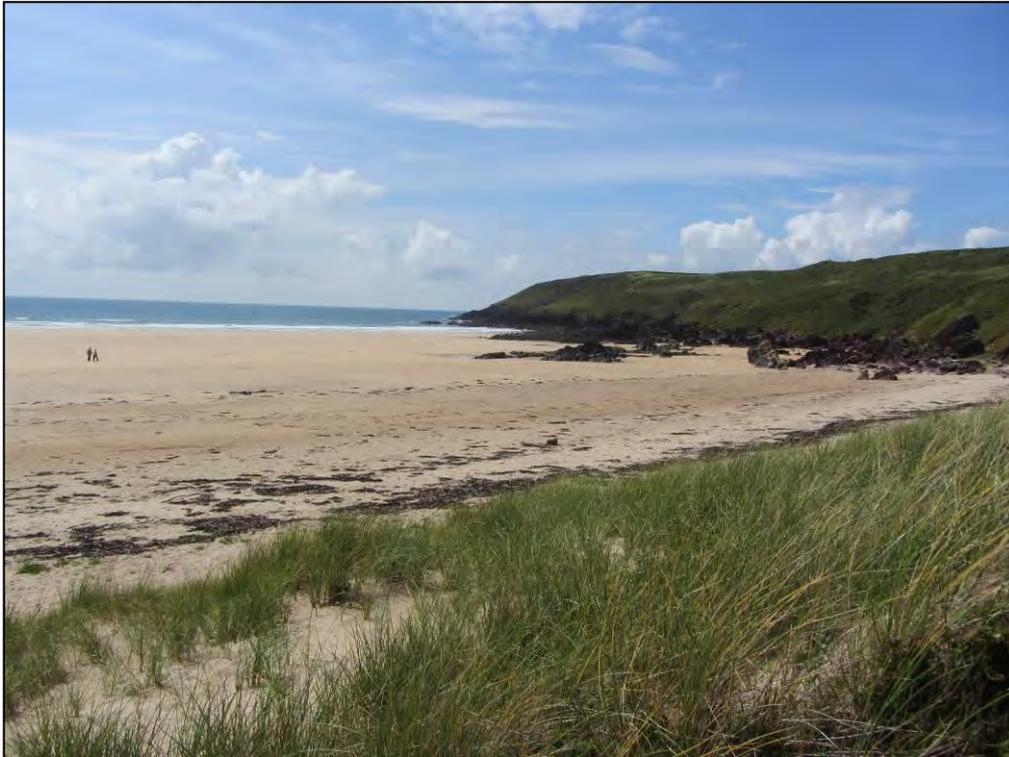
**Figure 3-3** Freshwater Bay West (North end)

The most advantageous factor of selecting this landfall is that it has the shortest onshore route to the converter station and National Grid tie-in point. In order to select this landfall a detailed unexploded ordnance survey would be required to locate any stray munitions on the seabed in the area of the proposed cable route. If this landfall option is to be further considered early consultation should be sought with the Ministry of Defence.

Due to the proximity to the firing range and harbour mouth, further studies (in addition to the usual surveys required at any landfall location) will be needed to determine the effects of ordnance, anchors and thermal insulation in order to prove the feasibility of this landfall.

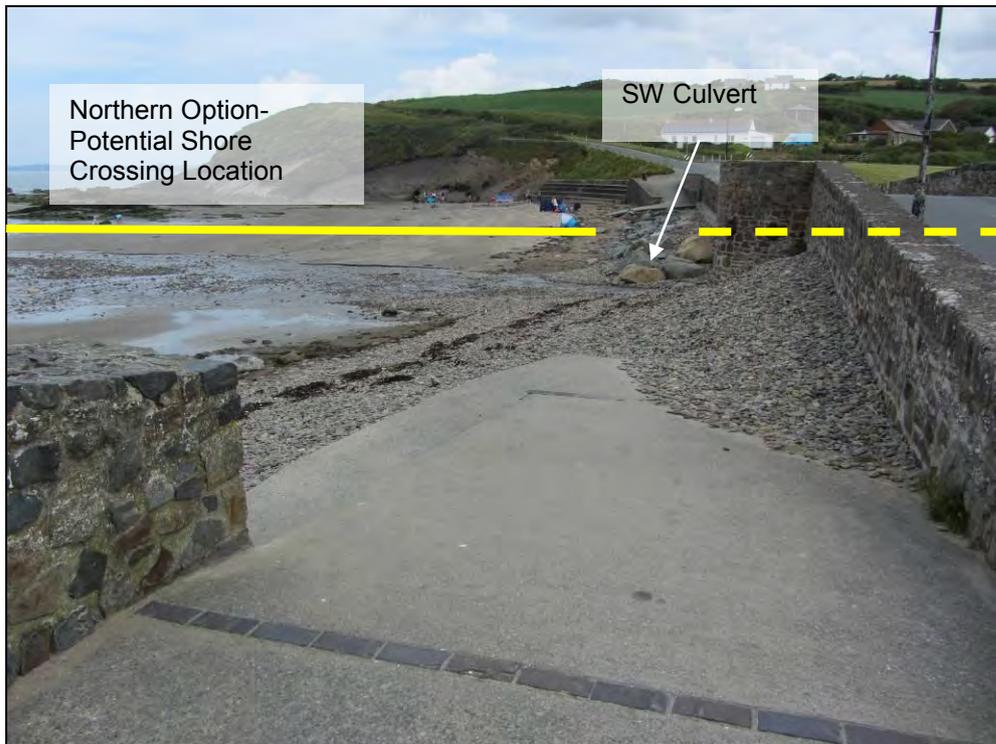
Figure 4-1 Crossing Option at Northern end of Broad Haven

- It necessitates a technically challenging but feasible crossing of Milford Haven (~3km);
- Broad Haven is a high value recreational amenity area and it is probable that the permit construction window will exclude the summer months;
- Desire to avoid laying the cable along the seafront and through the town where possible;
- Admiralty chart indicates some areas of rock in the nearshore;
- Crossing under seawall is required if routing at the northern end of Broad Haven (not a major concern);
- Stormwater culvert at the northern end of the beach may impact on northern shore crossing route options.

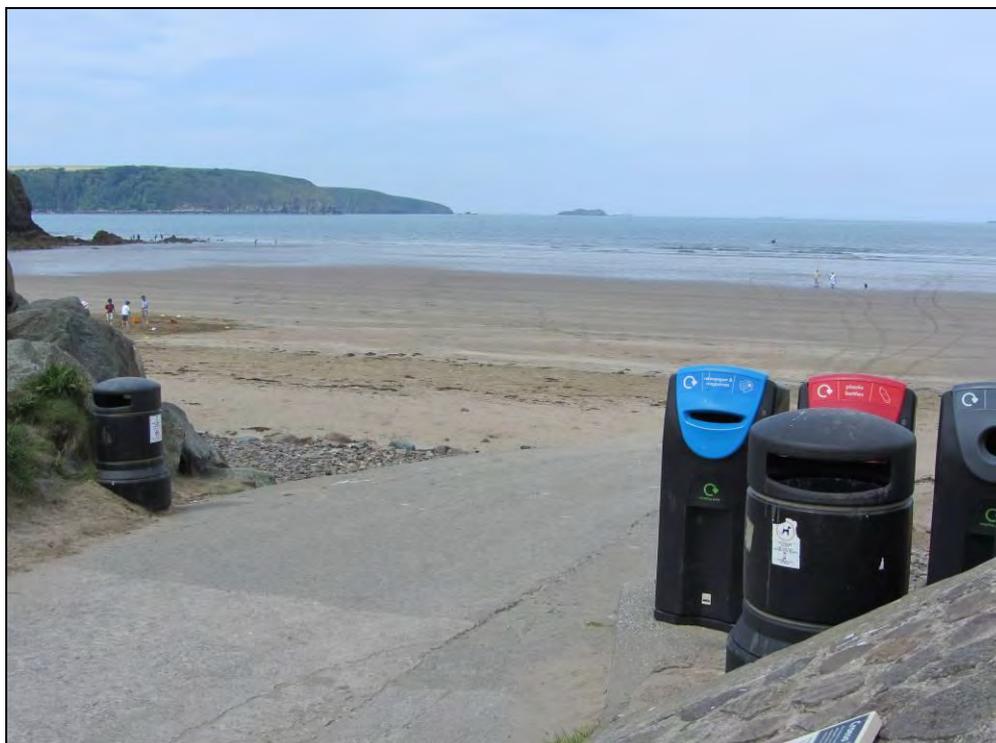
Figure 4-2 Potential crossing location at Southern end of Broad Haven

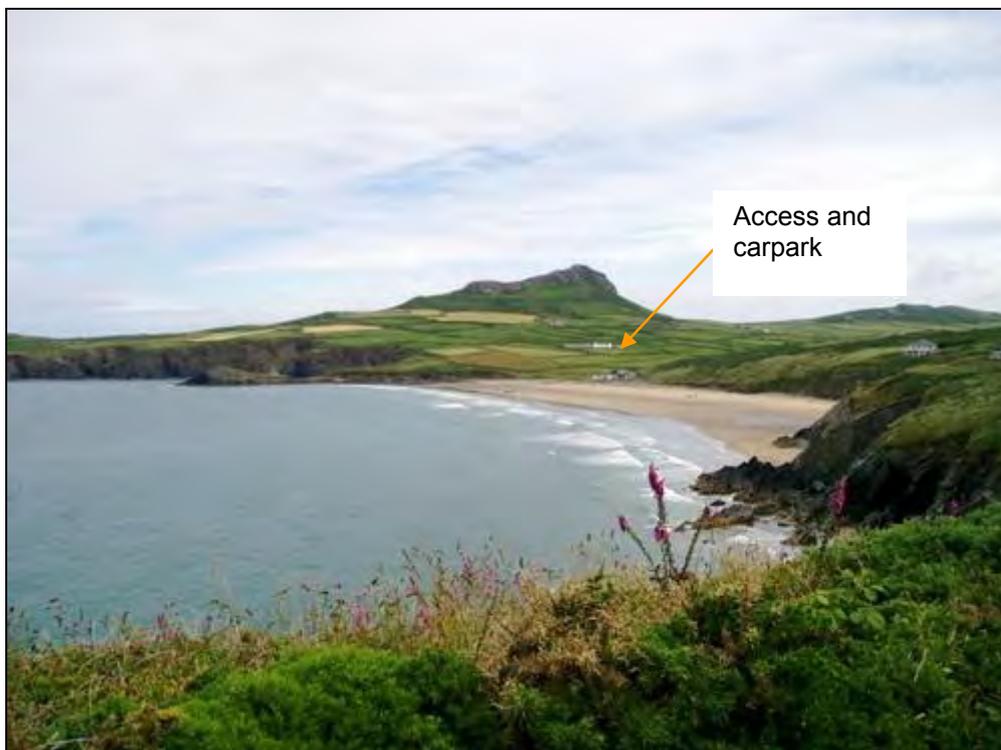
- Sandy beach with rock outcrops at northern extent, although rock noted in the nearshore on the admiralty chart;
- Exit from a beach landfall could be through to the public car-park (approximately 40m x 120m);

**Figure 4-11 Whitesands Beach, view from the South**

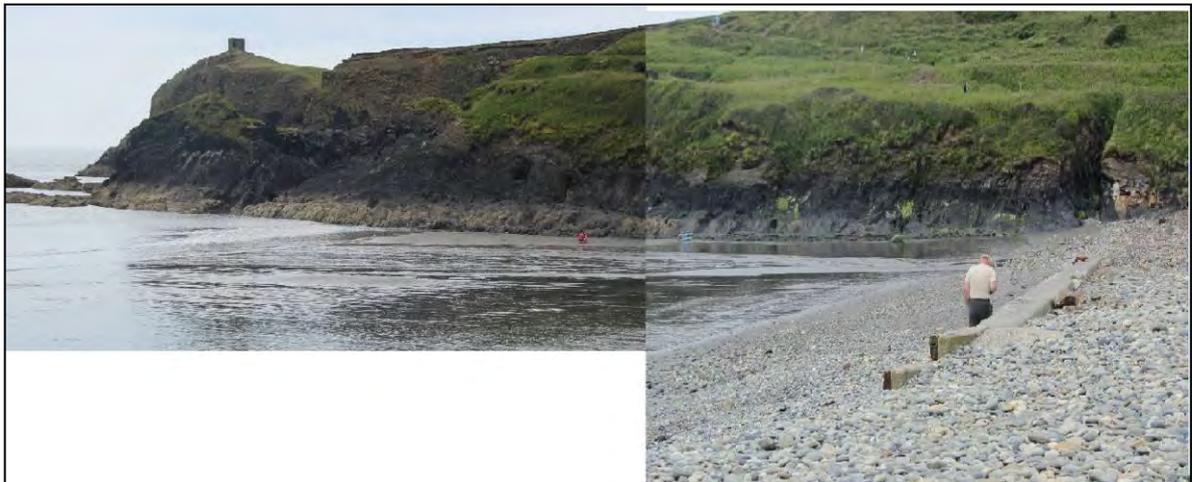
- Exposed bedrock to the west of the beach;
- To the east the foreshore comprises pebbles overlying sand;
- A small (<2m) high concrete seawall is the sea defence for the public carpark which runs along the beachfront (~30m x 120m long);
- Admiralty chart indicates shells and pebbles are present in the nearshore. The water depth increases quickly to ~25m at the end of the inlet approximately 400m offshore;
- Beach is used for access to the nearby "blue lagoon", which is a disused slate quarry which has been infilled with seawater through a breach in the outer wall. This lagoon is a popular location for tourism activities that include coasteering;
- Road access is generally suitable except for the final access to the beach which is approximately 4 to 5m wide. Much longer onshore route than Broad Haven.

**Figure 4-12** Abereiddy Beach, looking towards the North

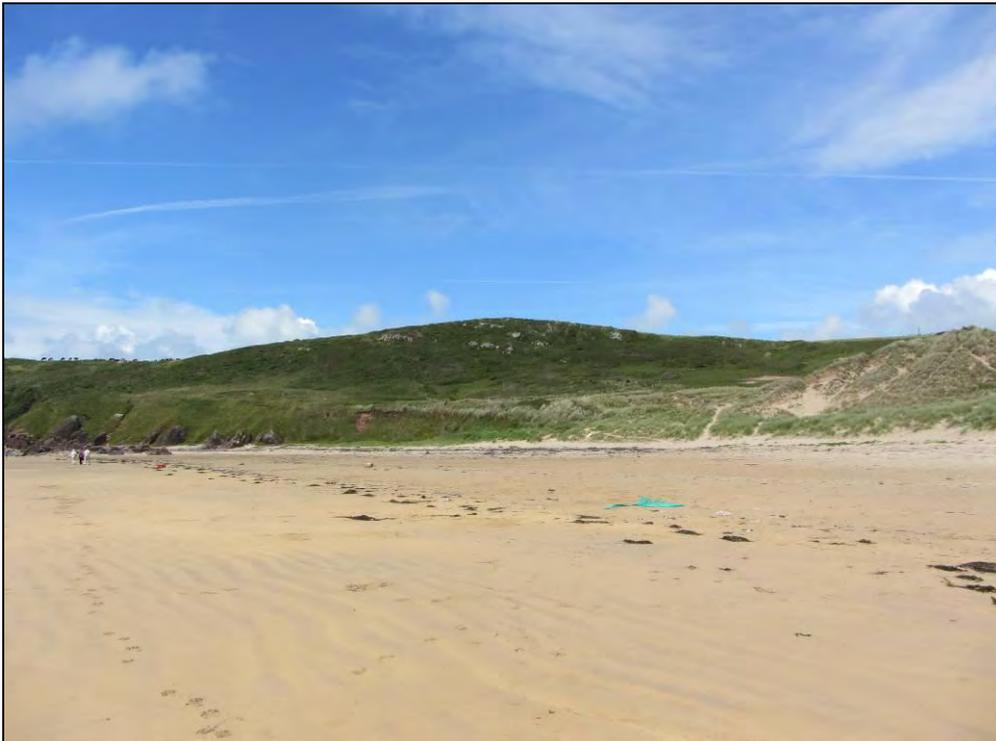
- Proximity to firing range;
- Proximity to Milford Haven harbour entrance;
- Shore crossing and working area likely to be through dunes to public carpark and subsequently be likely be subject to environmental restrictions;
- Evidence of land movement in the slope behind dunes leading up to the public access road;
- Potential for rock to be encountered in the nearshore (slate and conglomerate exposed on the beach at low tide at far Northern end of beach), areas of rock identified on admiralty chart.

**Figure 5-1** Freshwater West, Northern end of beach.

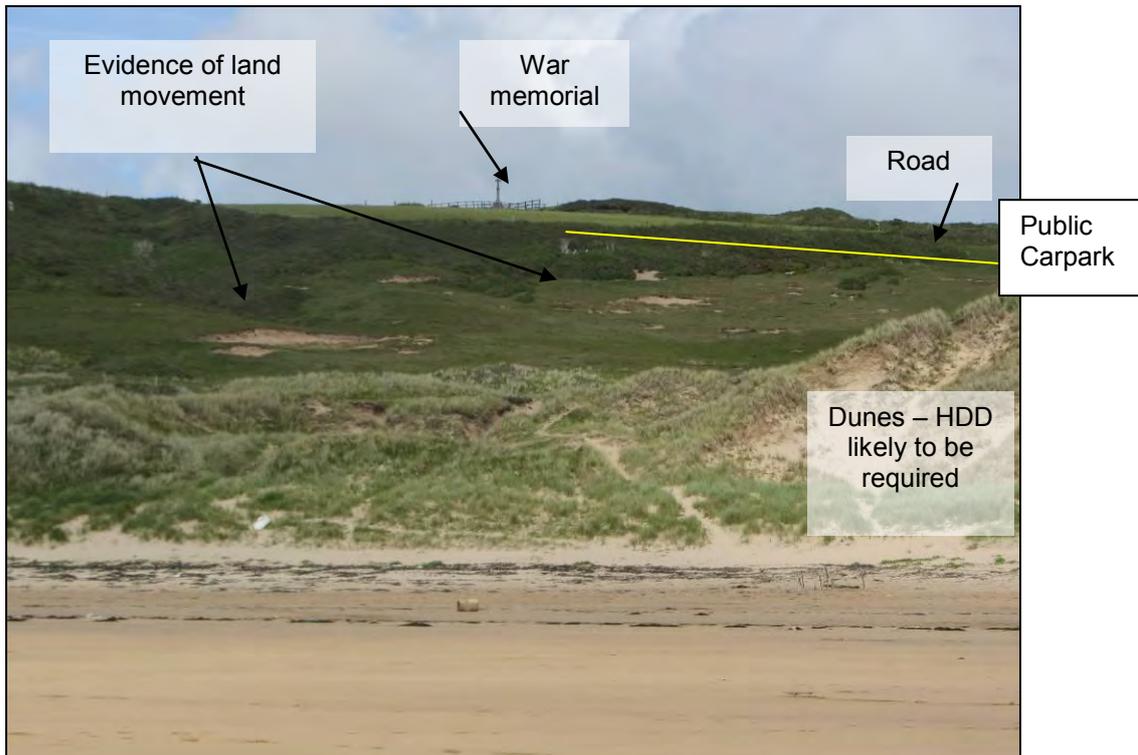
Figure 5-2 HDD exit behind dunes, to carpark

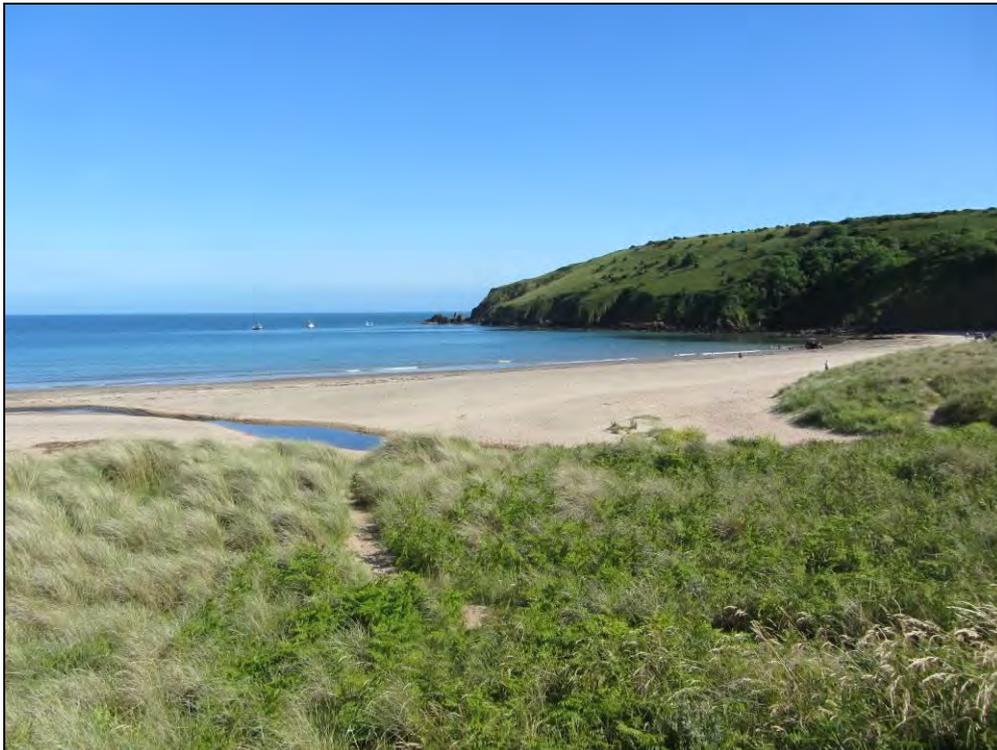
**Figure 5-6 Freshwater East, looking south-east**

- Gently sloping beach with gravel/pebbles/cobbles overlying sand;
- Admiralty chart indicates gravels and sands in the nearshore;
- The main access to the beach is from a car-park located approximately 20m to 50m from the beach at close to it's southern extent:
  - One walking path passes through small dunes (1-3m high) onto beach;
  - Another concreted footpath provides access alongside a small stream to the beach;
- Difficult onshore route to the southwest:
  - Tight narrow roads, small stream with one way narrow bridge( 4 to 5m long bridge at the beach access location) ;

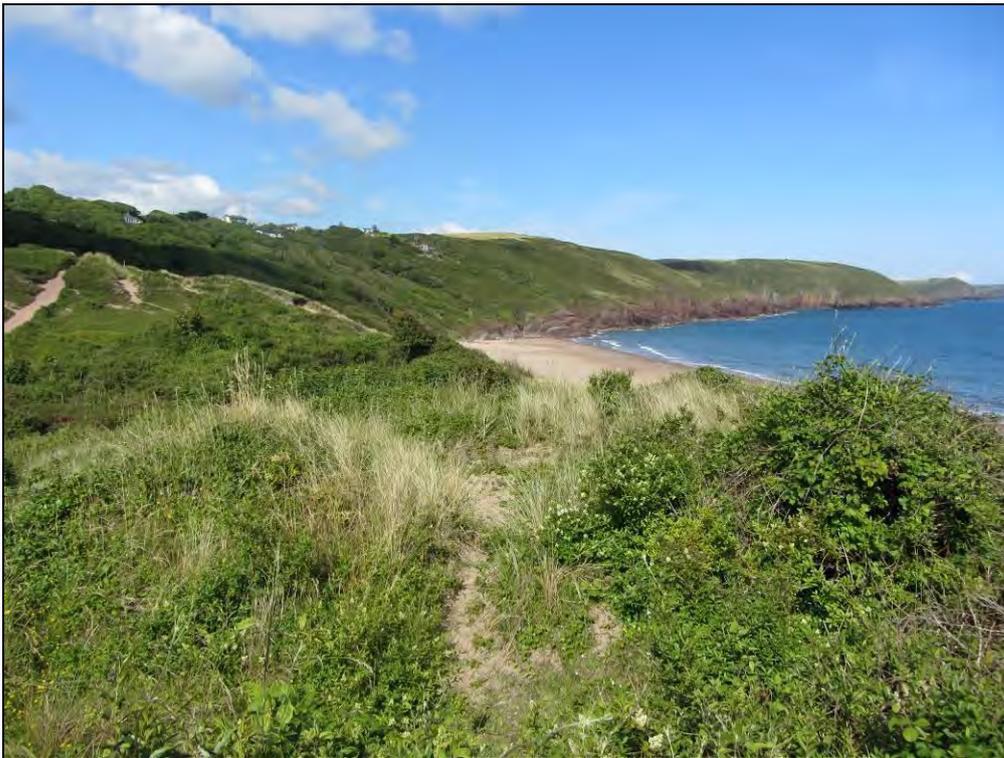
- A two lane road runs from the public access, at the southern end of the beach, towards the north. As soon as it exits the beach the road rises steeply and then run along the top of the slope approximately 300m behind the beach and estimated at over 30m high. Residential properties are located at the top of this steep bank along the length of the beach. There are also some walking access tracks down the slope to the beach and farmbike access which may be able to be improved for onshore cable construction up the slope;
- There are mooring buoys for small watercraft at the southern extent of the beach and buoys marking the boat speed zones;
- Significantly longer offshore route than Freshwater East;
- Would require UXO studies.

**Figure 5-7 View of Freshwater East looking North; note steep slope to the West**

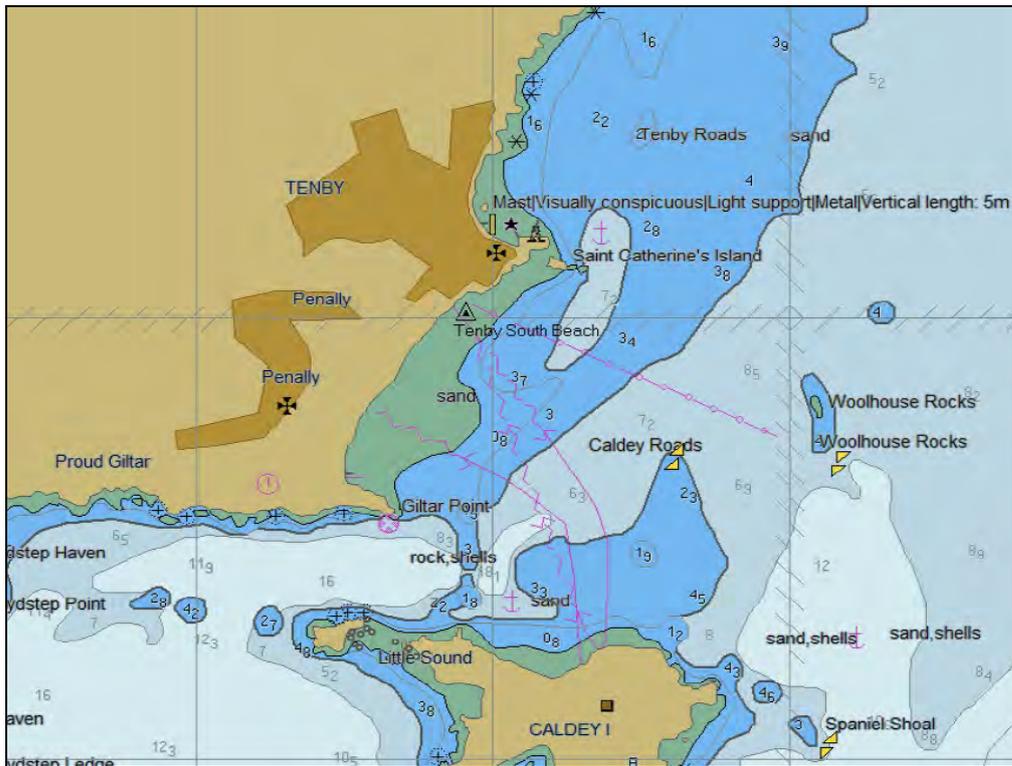
Figure 5-8 Admiralty Chart for Tenby South Beach

- Sandy beach, admiralty chart indicates sand and shells in the nearshore area;
- Golf course runs behind the majority of the beach except at the southeastern end;
- Any landfall would likely be located at the SE end of beach, near new apartment blocks in order to avoid the golf course;
- There are other cables making landfall at the SE end of beach for which proximity agreements would need to be negotiated;
- Offshore, the cable would be routed between Caldey Island and Woolhouse rocks;
- Due to proximity to the firing ranges UXO studies would be required.

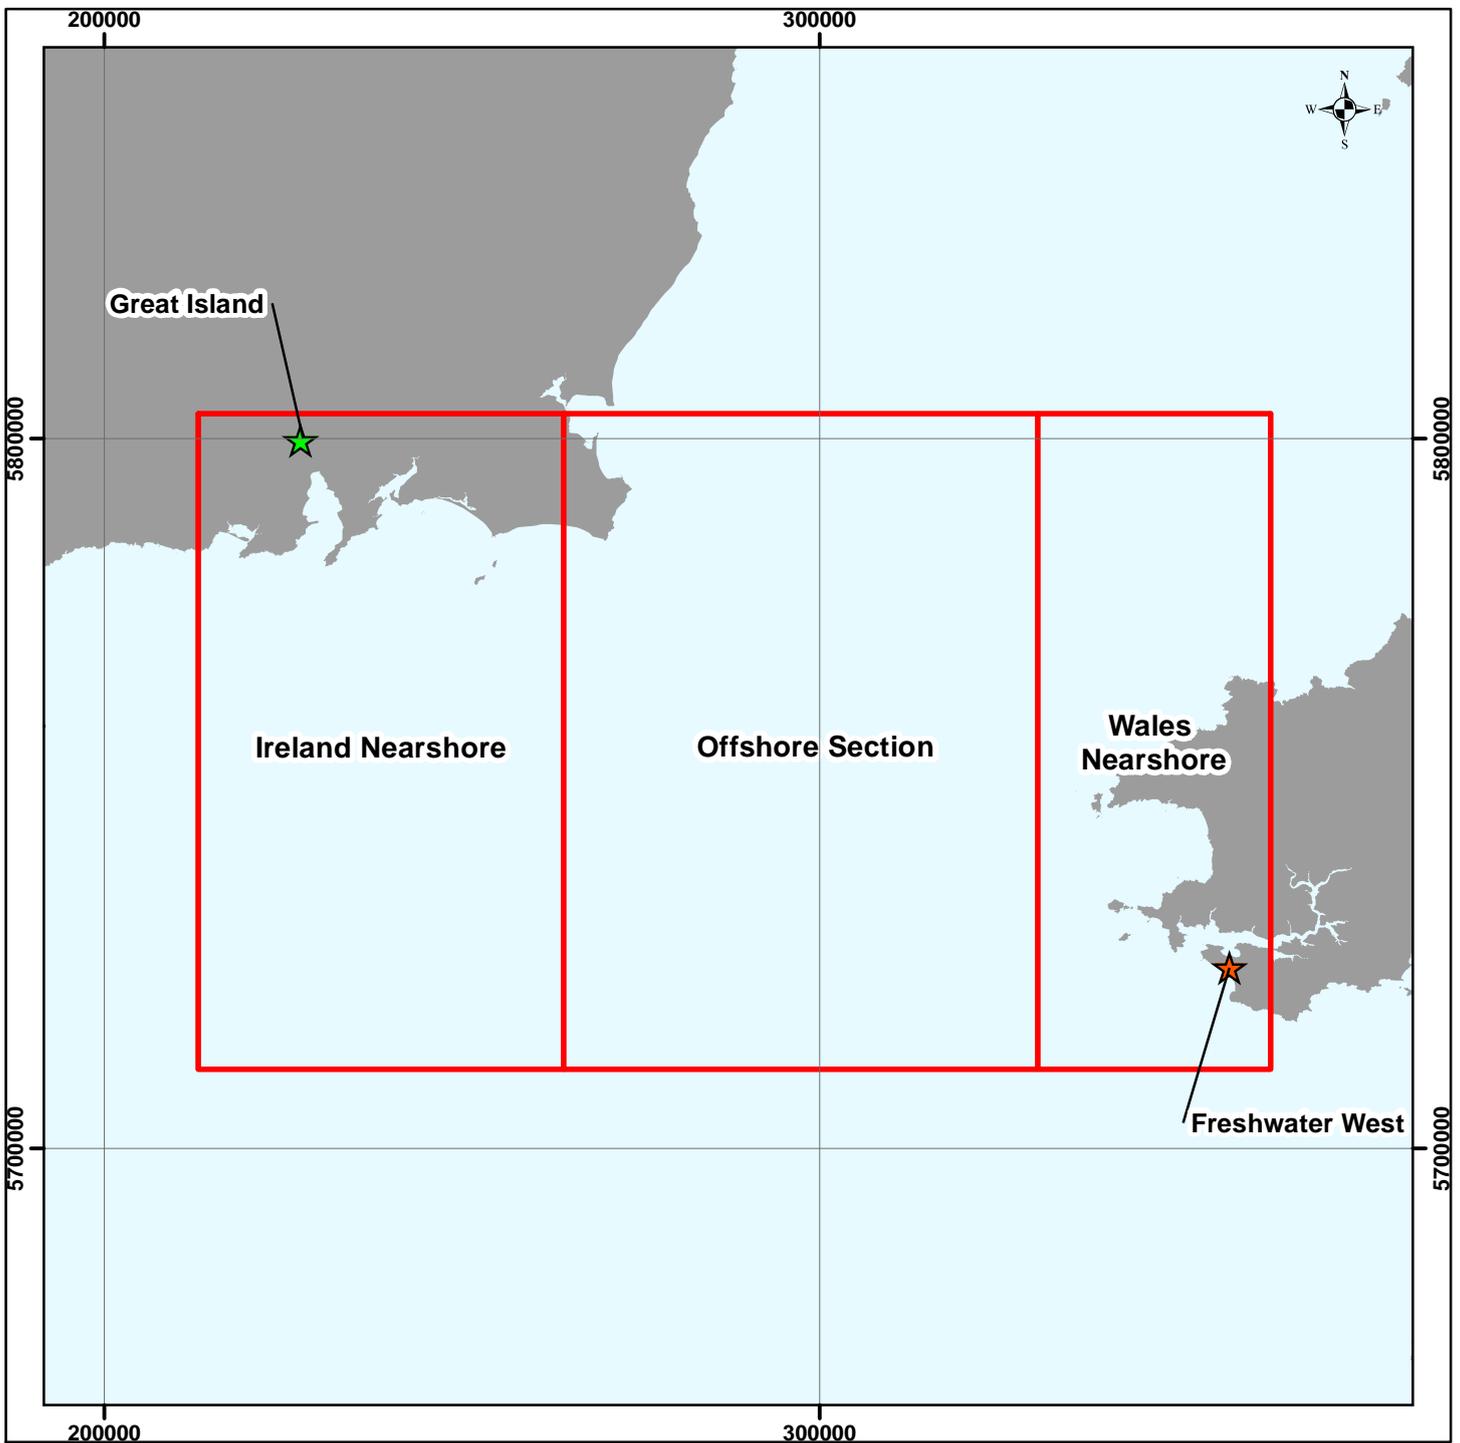
**Figure 1-1** demonstrates the study area for the landfall site selection, including the offshore and nearshore sections of the route. The landfall location for the Wales grid connection has already been identified and is marked in **Figure 1-1**.

Figure 1-1: Proposed study area for the landfall site selection including the offshore and nearshore sections of the route.

Along the Wexford coast between the eastern edge of our identified study area (refer to Figure 1-1) and Cahore Point, approximately 40km up the east coast of Ireland, the full coastline is protected by environmental designations, including Special Areas of Conservation (SAC) and Special Protected Areas (SPA). These areas of designation are as follows: Ballyteige Burrow SAC, Saltee Islands SAC, Tacumshin Lake SAC, Carnsore Point SAC, The Raven SPA, Long Bank SAC and the Blackwater Bank SAC. Due to the potential for environmental impacts and subsea conditions offshore considered not suitable for cable installation these locations were not investigated further.

Much of the coastline of southern Ireland is dominated by steep cliffs interspersed with estuarine/riverine inputs and beaches. Within the Waterford, Wexford and Great Island area (identified study area – refer to Figure 1-1), the rock formation is predominately of the Palaeozoic era ranging from Cambrian to Devonian rock types including sandstone, shale and basalt with additional igneous volcanic rock [1]. The area is well-known for its fossil heritage [2, 3, 4] and similar to the south-east Ireland coast detailed above, much of the southern coastline is also protected by environmental designations. The following environmental protection sites were identified within the study area:

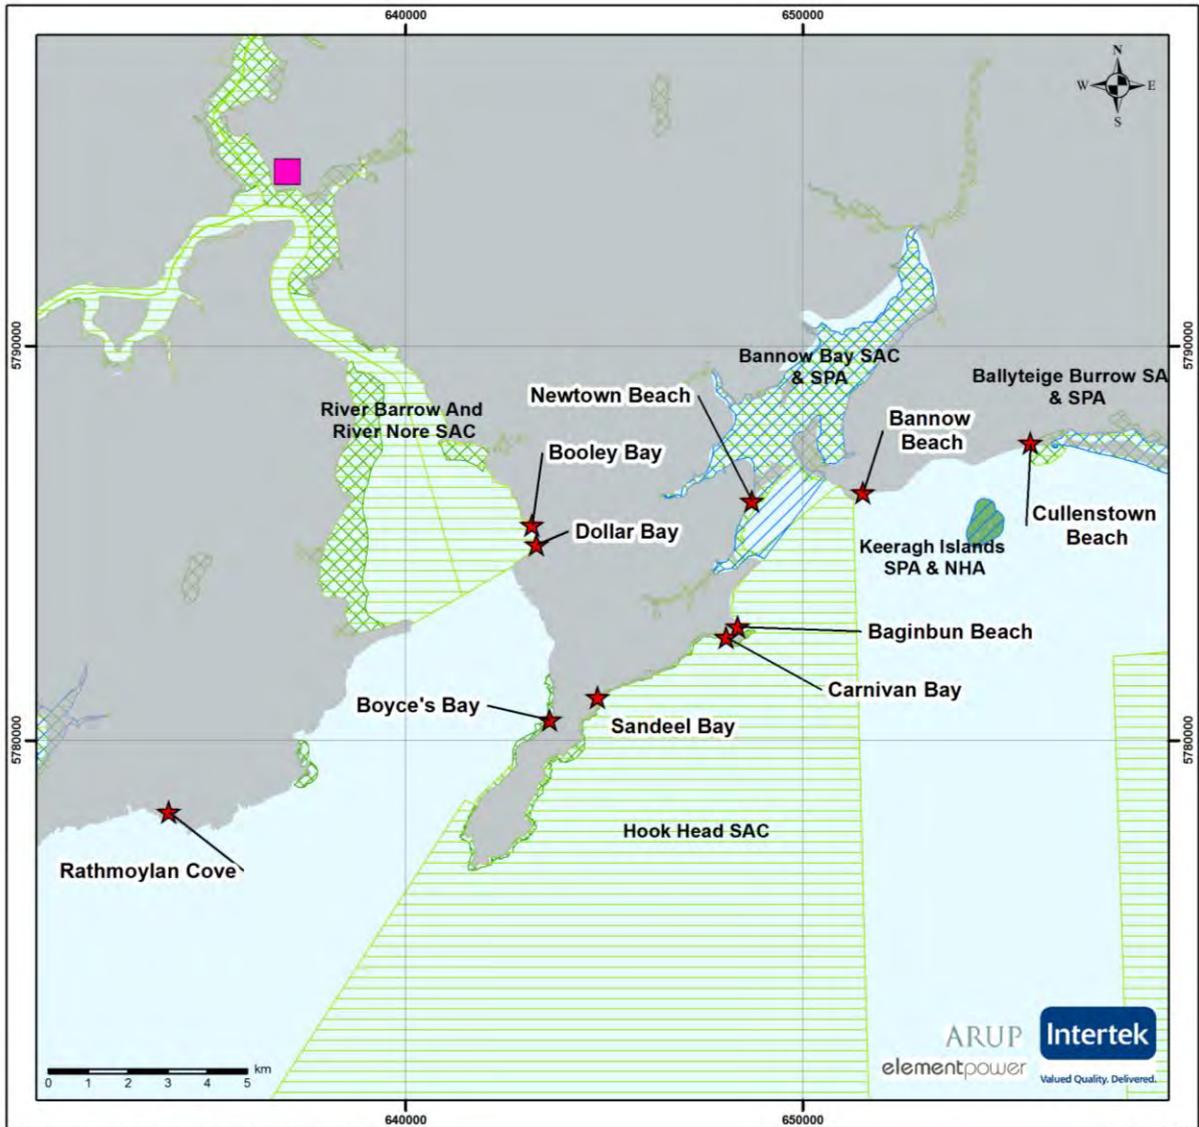
A total of 10 sites were identified prior to the site visits on 28-29 October 2015, of which 8 were assessed. The 10 sites are shown in **Figure 3-1**. Sites Rathmoylan Cove and Newtown Beach were visited on 15 October 2015 by Arup but were not visited as part of the site visits on 28-29 October 2015 as both were ranked unfavourable prior to this visit by the onshore and offshore consultant.

Figure 3-1: Ten proposed landfall sites on the Hook Peninsula within 30 km of the Great Island grid connection.

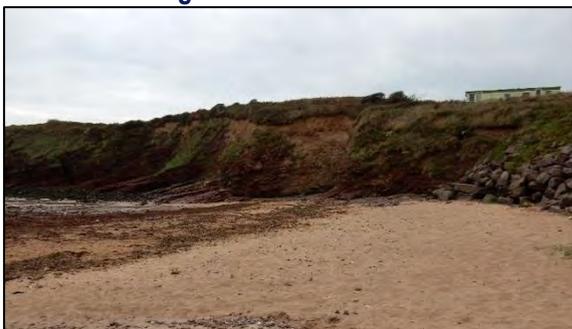
**Figure 4-1: View of eroding cliffs from the rear of the cove looking east.**

Rathmoylan Cove is an exposed beach facing due south. There are cliffs surrounding the cove on both sides approx. 15 m in height showing evidence of deep erosion, exposing red sandstone geological features including a sea cave on the eastern edge of the cove. Rock protection is installed along the rear of the beach and there is also rock outcrop along the shoreline which was covered in seaweed (see **Figure 4-1 and 4-2**).

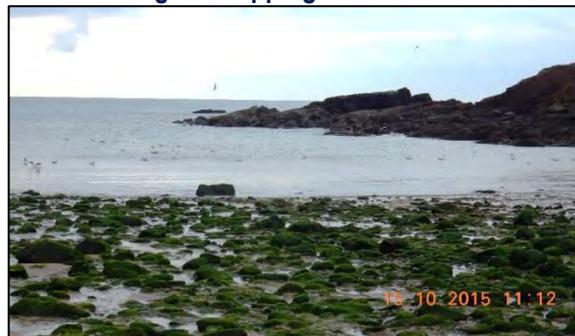
**Figure 4-2: View of the shoreline looking south east including outcropping rock and birds.**

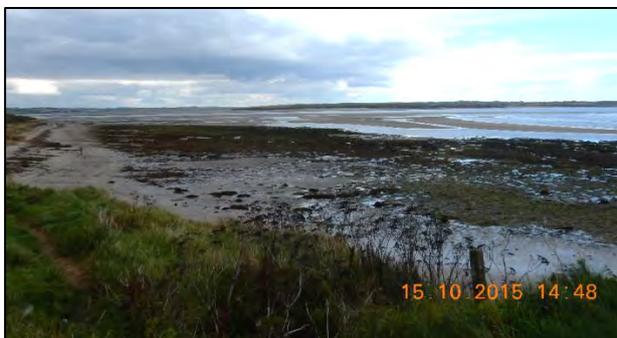
**Figure 4-3: View from the rear of the beach looking north east.**

Newtown Beach is located to the north east of the Hook Head Peninsula, on the western side of the entrance to Bannow Bay. The landfall lies within the Bannow Bay SAC and SPA and would also require the cable to cross through the Hook Head SAC offshore. Bannow Bay SAC has a number of qualifying aspects including sandflats not covered by seawater at low tide and shifting dunes (see **Figure 4-3**) which would not be suitable for cable installation due to potential ecological impacts.

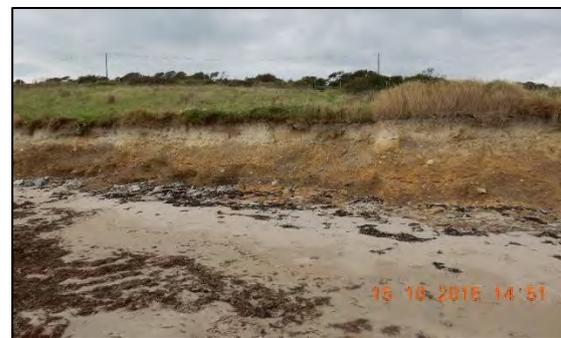
**Figure 4-4: View of the eroding vegetation at the rear of the beach.**

At the rear of the beach eroding vegetation on shallow cliffs is evident (see **Figure 4-4**). There was rock outcrop uncovered at low tide along the shoreline which was covered in seaweed. Birds were observed along the seashore including seagulls and oystercatchers.

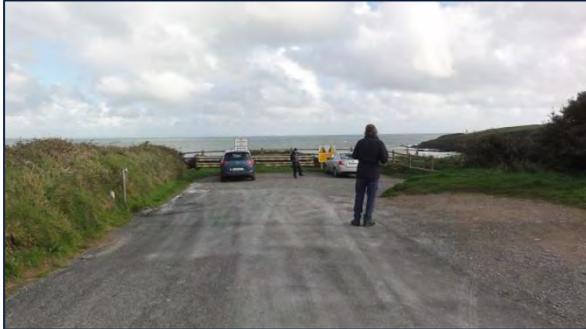
Figure 5-1: Start of access down to beach and parking spaces.

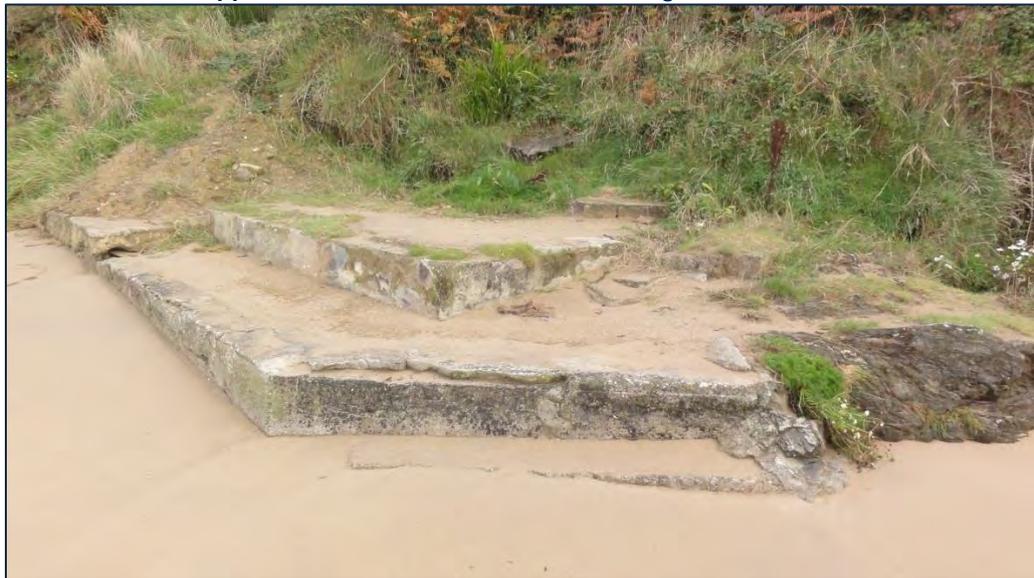
Figure 5-5: Unknown concrete stepped structures at the south end of Baginbun Beach.

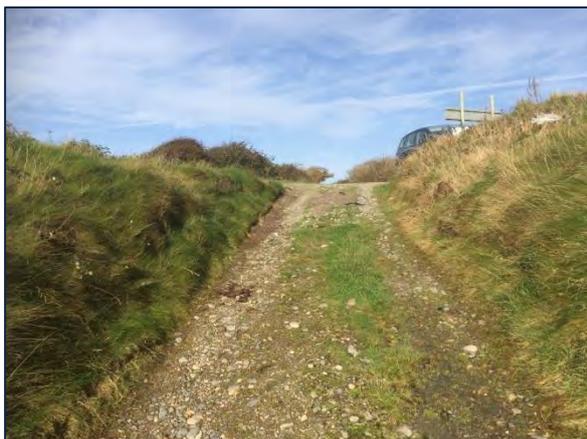
**Figure 6-3: Bannow Beach access track to the beach - largely solid and composed of stones and turf.**

At the end of the access road there is parking space for approx. 2 vehicles and two gravel access tracks verge to the right, one leading down to the beach and one leading to a private property. The access track from the access road to the beach is via a reasonably straight broken track that would minimise cable bend angles if it were to be installed up the path.

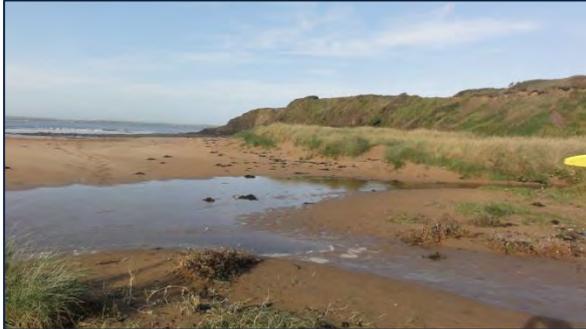
Figure 7-1: Freshwater outlet/river at Booley Bay - facing west-north-west.

The surrounding headland was dominated by vegetated cliffs to the north and south (Figures 7-3 and 7-6); both sides demonstrated low levels of coastal erosion with minor evidence of disruption by landslides. Adjacent to the access road and track was a freshwater riverine input, surrounded by unmanaged vegetation. The river water flowed directly onto the beach where the water flow was diverted along the upper reach of the beach to the southern rock outcrop where it was forced towards the sea by rocks.

Options for installation would include HDD and open-cut trenching. It is likely that the flow of fresh water onto the beach would make keeping a trench open difficult and may risk exposure of the cable during adverse weather conditions. More information is required regarding the stability of sediment on the beach through an appropriate geological assessment and survey of ground conditions.

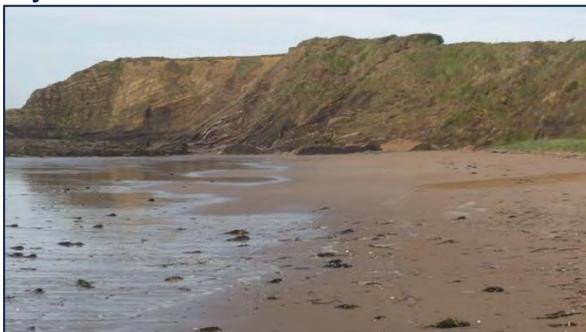
Figure 7-3: Rock headland to the north of Booley Bay. Evidence of saturated sand.

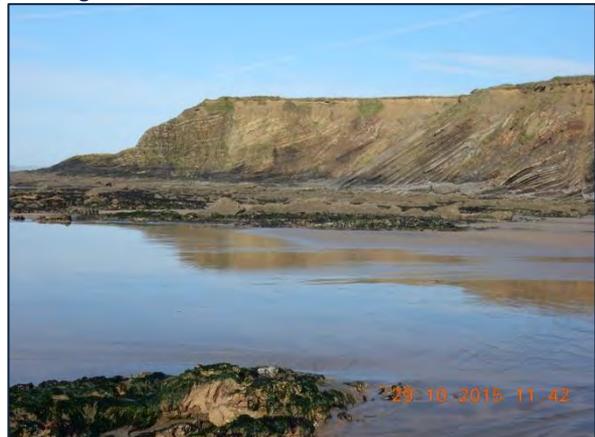
Figure 7-6: View of the rock headland and outcrop looking north-west.

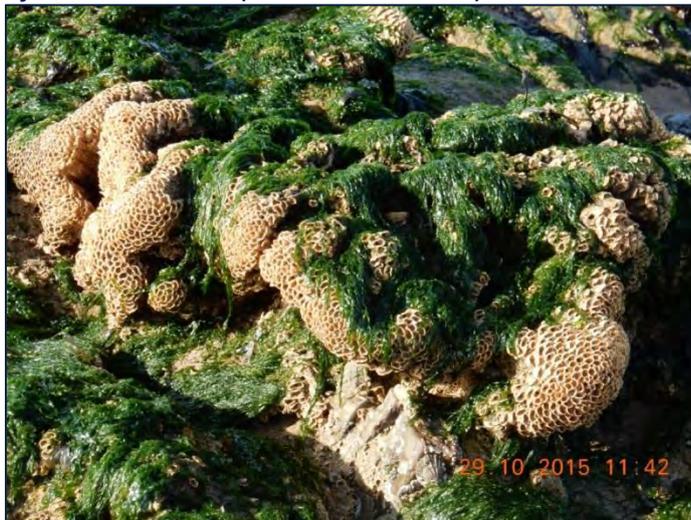
Figure 7-7: Honeycomb Worm Reef (*Sabellaria Alveolata*) on intertidal rocks at Booley Bay Landfall.

Of particular note within the Booley Bay landfall was the presence of honeycomb reef worm (*Sabellaria alveolata*) on the intertidal rocks (**Figure 7-7**). This was also present in Dollar Bay. While not listed as part of the River Barrow and Nore SAC, it is a species that is sensitive to changes in sediment regime and physical disruption (including storm damage). Most of the intertidal rock at the site was covered but the extent offshore would need additional survey.

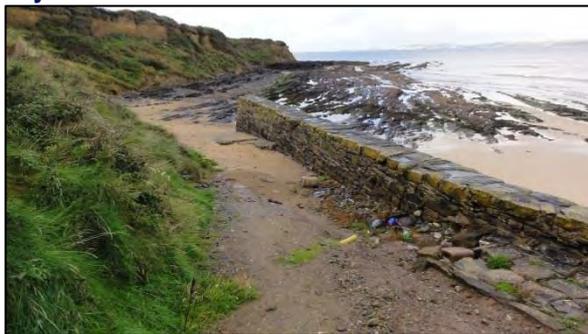
**Figure 8-1: Part of the Access Road to Boyce's Bay.**

Boyce's Bay is accessed via a 'cul-de-sac' access road off the L4045 local road, approximately 4m wide and 350m in length with hedge and/or low brick walls on either side. Three private properties and a dairy farm yard and buildings were identified off the access road.

An access track, approximately 50m in length, leads from the end of the access road down to the beach. The access track to the beach is approx. 3 m wide composed of rough terrain, and has an established sea wall of good condition at the bottom. The sea wall is approximately 2 m high and 1.2 m wide at the base. It appears to have been built on solid bed rock with a similar composition to rock outcrops observed to the north and south of the beach (**Figure 8-1**).

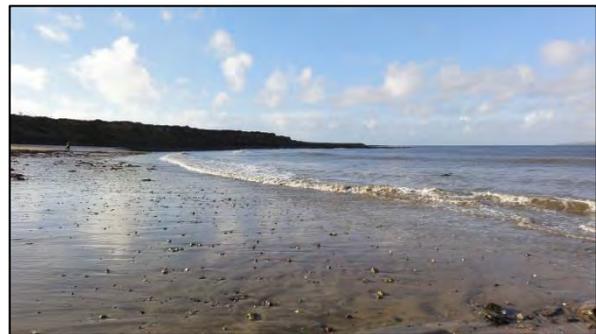
**Figure 8-2: Wave conditions during F4-5 SSE weather.**

The beach faces the south west making it an exposed site, given the prevailing south-westerly weather conditions. During the site visit, the forecast was south-southeast force 4 – 5 (13 – 24 knots) and apparent wave conditions at the site were insignificant (> 0.5 m) indicating a level of protection from the surrounding high cliffs and headland. The 5 and 10 m depth contours are 1.4 and 2.6 km, respectively. This may restrict the types of vessels that can reach the site and increase the chances of requiring anchored barges. The beach extends further north along the coastline for approximately 2 km but a rock outcrop to the north of the site prevents vehicles from passing to the additional coastline and beach.

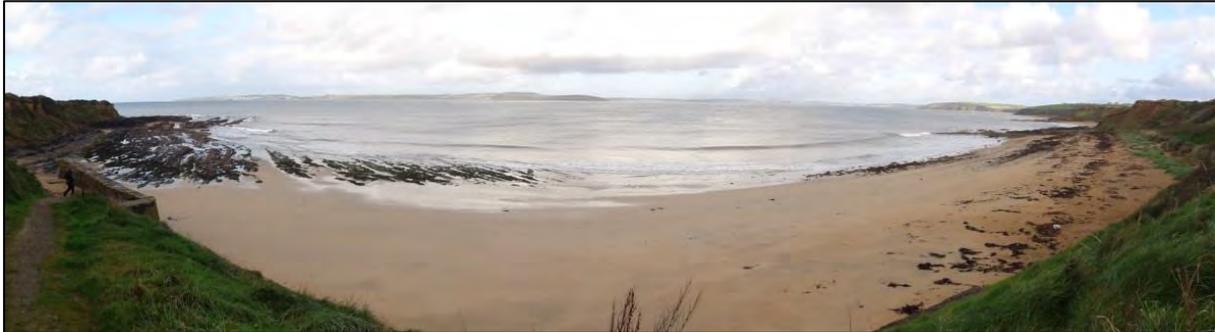
**Figure 8-5: A panoramic overview of Boyce's Bay looking west across the River Barrow and River Nore.**

The beach itself was gently sloping with evidence of a storm berm and seaweed debris on the upper reaches of the beach. The typical slope angle was 2.4° from the cliff to the water. The beach was approximately 200 m wide, with approximately 157 m of rock to the south of the beach. Fossils were observed on rock outcrops on the side of the bay (**Figure 8-6**).

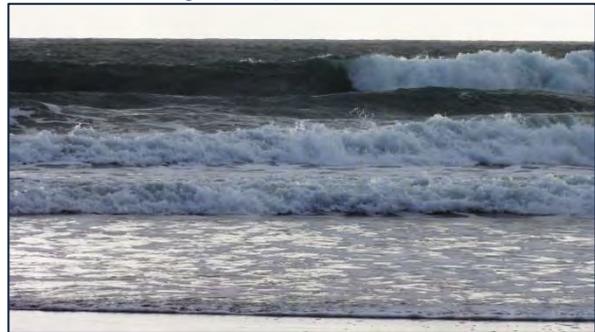
Figure 9-4: Wave conditions at the edge of the beach indicating the exposure.

The beach is large and flat. The site is very exposed to southerly wind conditions and weather conditions on the day yielded waves of approx. 1 m. The profile of the beach has a shallow gradient; wide and long with less than 2° of slope. Looking north from the water's edge, patches of stable vegetated cliff were observed in the centre with patches of exposed rock. Cliffs to the east and west demonstrate evidence of coastal erosion and more recent landslips (**Figure 9-6**).

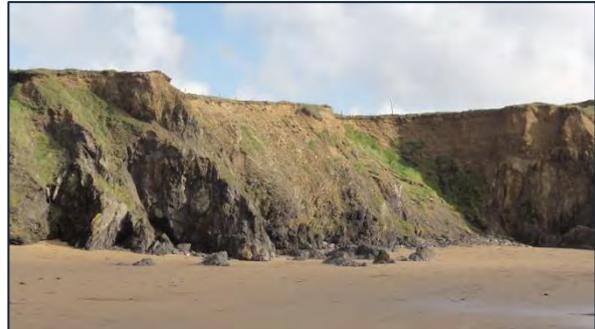
Figure 9-6: Evidence of loss of vegetation due to landslip.

The apparent instability of the cliffs and warning signs combined with the exposed beach make this site unsuitable for HDD without significant and extensive geotechnical survey to determine the ground conditions. Open cut trenching would be a possibility on the beach but the stability of the access path for installation would also need to be assessed.

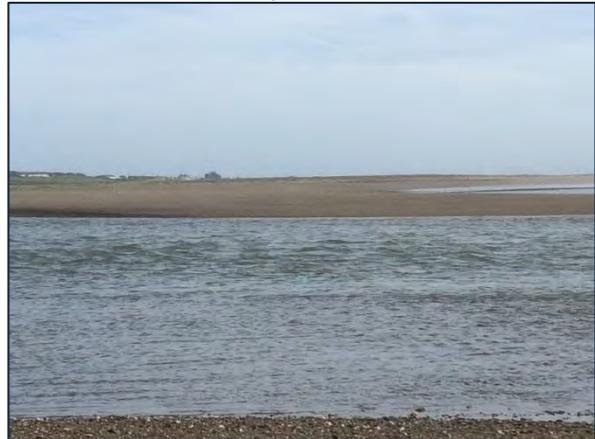
Figure 10-4: Estuarine outlet with turbulent water flowing towards the sea. Looking east from the spit towards the estuary.

The beach is the largest of all visited with enormous variation in morphology from east to west. To the east, an environmentally protected estuary outlet was observed with extreme current flows shown by the turbulent waters. A spit of sand extended outwards along the estuary outlet with evidence of rip currents and an apparent offshore sediment bar where estuarine outlet meets tides and waves. This bar would likely cause problems during installation as indicates shifting sediments.

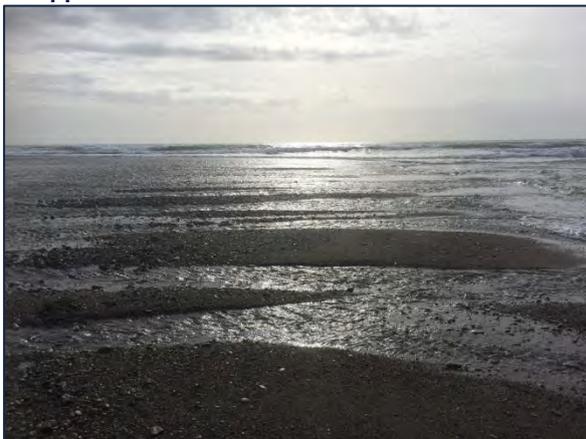
Figure 10-5: Sand patches and breaking waves on an apparent offshore sediment structure.

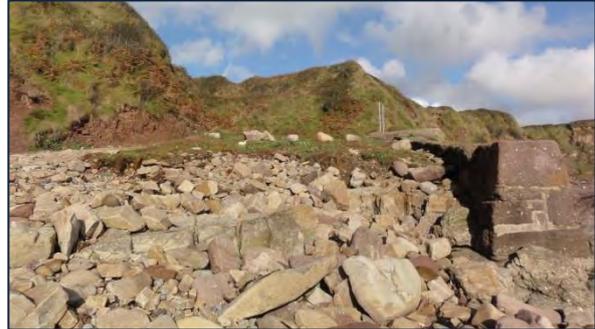
Figure 12-2: Rocky conditions at the base of the access road and evidence of sea defences.

The site would not be suitable for open-cut trenching due to the volume of rock and the seawall approaching the path. HDD may be suitable but geotechnical data assessment would be required to confirm suitability.

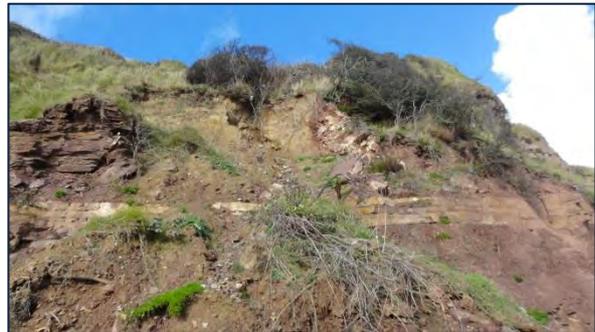
Figure 12-4: Evidence of landslip and underlying rock.

FIGURE 12-3: ROCK OUTCROP TO THE SOUTH OF THE EAST-FACING BEACH. ....	35
FIGURE 12-4: EVIDENCE OF LANDSLIP AND UNDERLYING ROCK. ....	35
