# GREENLINK MARINE ENVIRONMENTAL IMPACT ASSESSMENT REPORT- IRELAND

## APPENDIX L

Welsh and Irish Landfall Final Selection Report

Greenlink Interconnector  
- connecting the power markets  
in Ireland and Great Britain

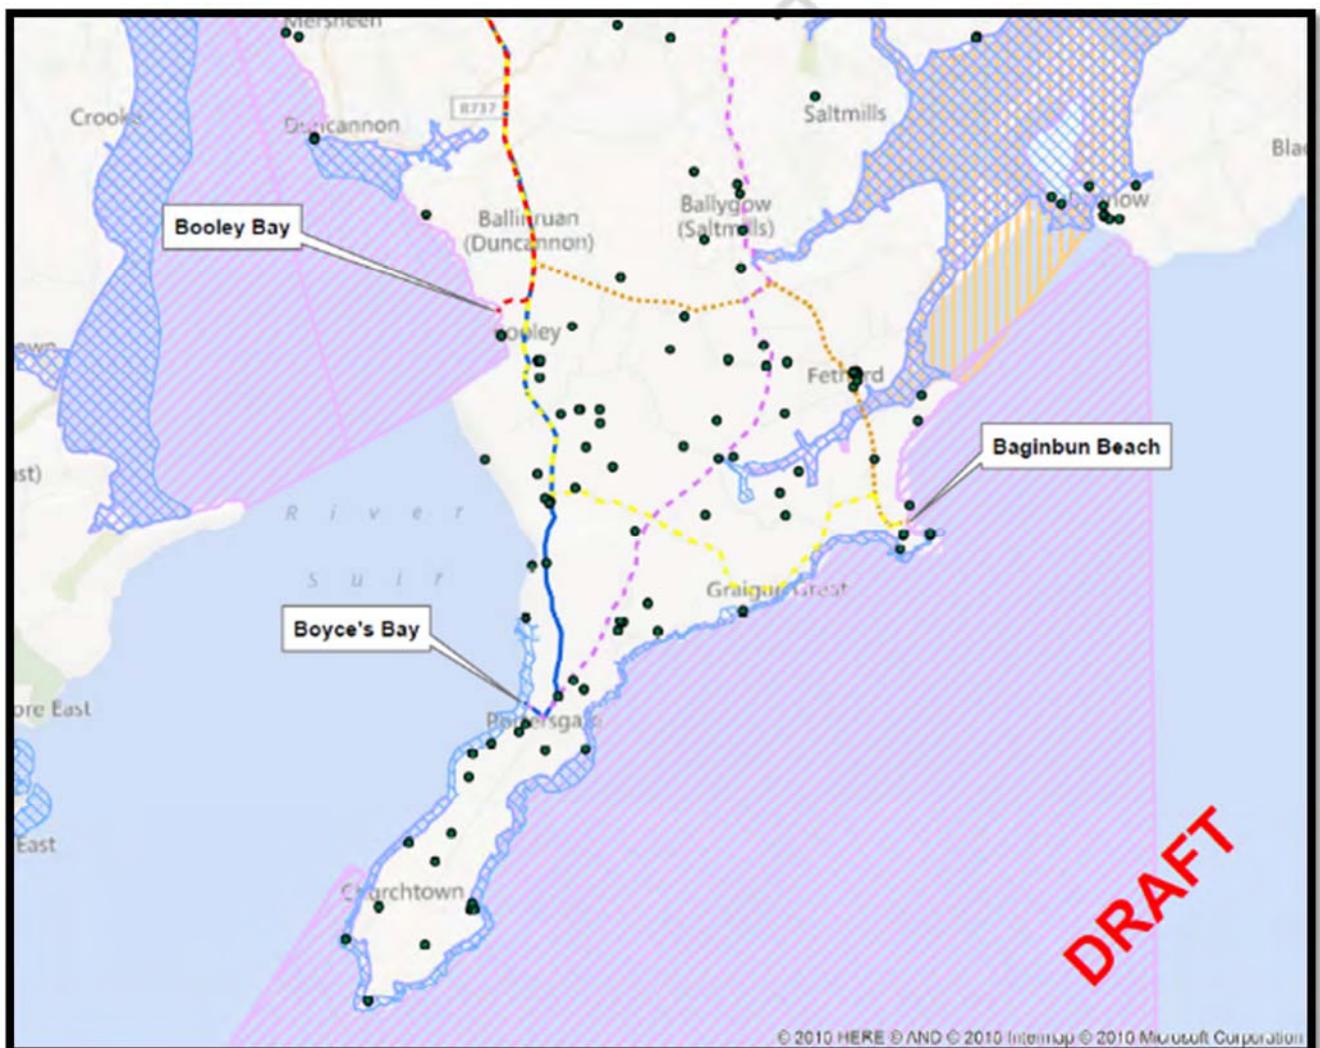
- Boyce's Bay
- Booley Bay
- Baginbun Beach

Figure 1: Landfall Sites Assessed

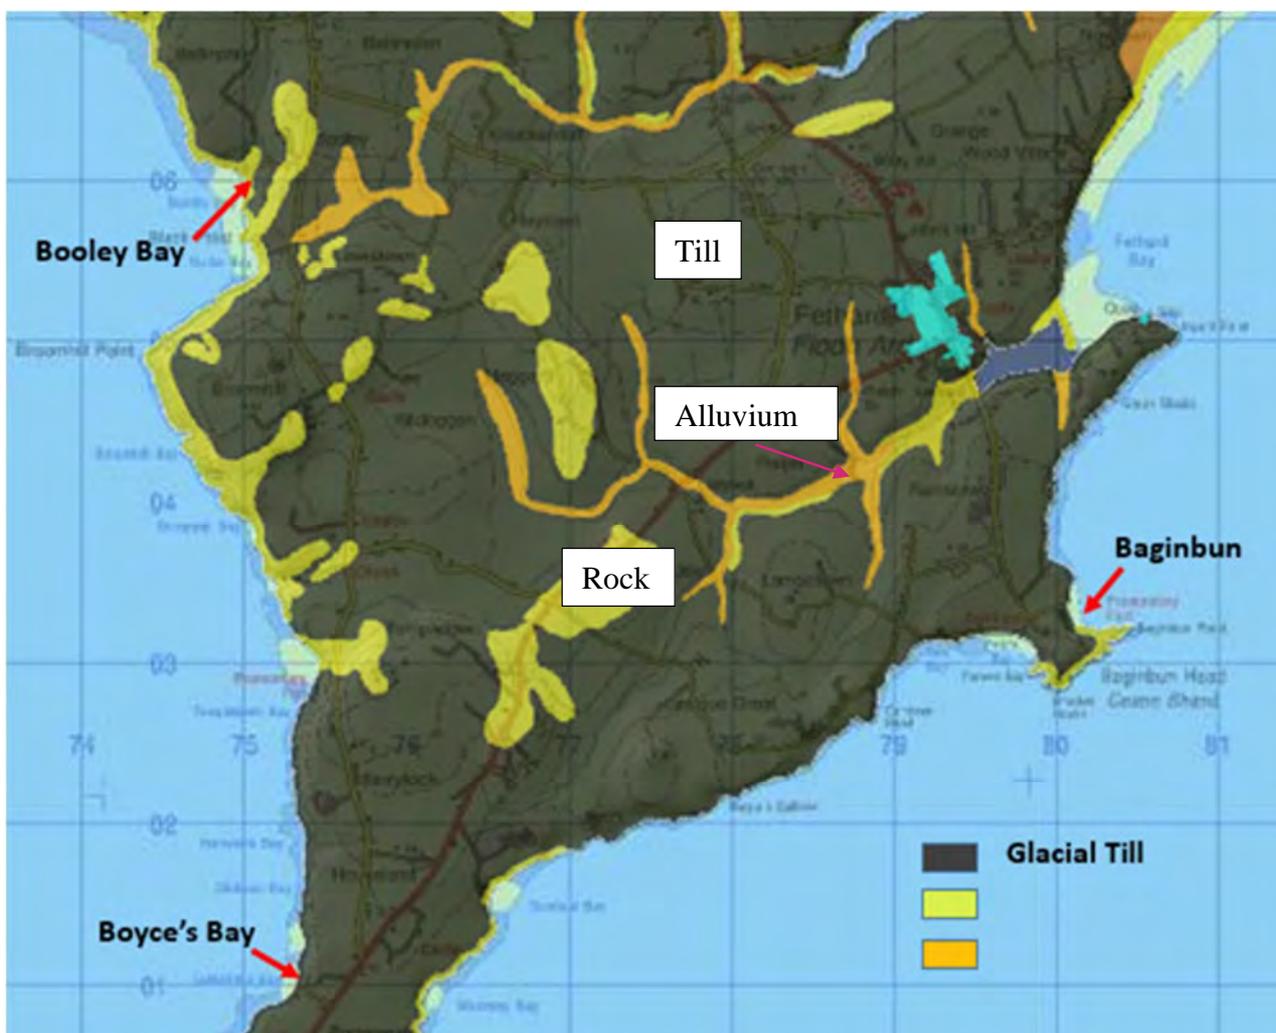
The subsoil geology of the Hook Head area is dominated by a cover of glacial till intersected with alluvial sediments associated with rivers and streams. Where till is absent or subsoil cover is very thin, rock is present close to the surface or outcropping. Beach sediments are located along coastal areas.

Figure 2: Extract from EPA subsoils mapping

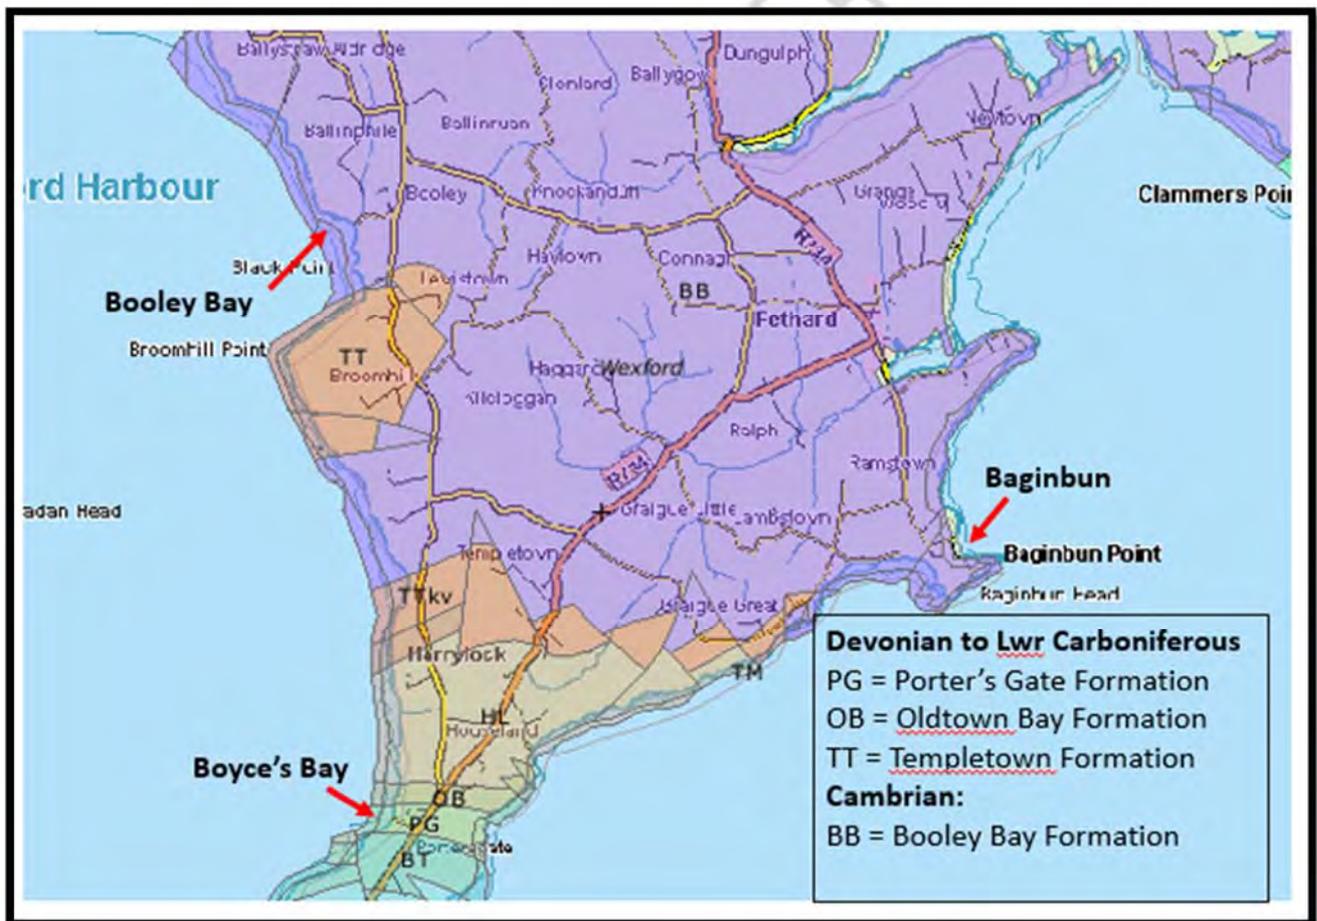
Boyce's Bay is underlain by Upper Devonian to Lower Carboniferous Old Red Sandstone, sandstone, conglomerate and siltstone. The Porter's Gate Formation is indicated as outcropping in the Boyce's Bay area and is generally described as sandstone, shale and thin limestone.

Both Booley Bay and Baginbun Beach are underlain by much older Cambrian rocks described generally as Cambrian meta-sediments in the form of greywacke, slate and quartzite. These are also described by the GSI as grey to black mudstone with siltstone.

Figure 3: Bedrock Geology (extract from the 1:100,000 scale GSI map; [www.gsi.ie](http://www.gsi.ie))

The Geological Survey of Ireland's (GSI) online mapping database was consulted to determine the regional geology at each location. Figure 2 indicates the underlying regional bedrock geology of the three sites visited.

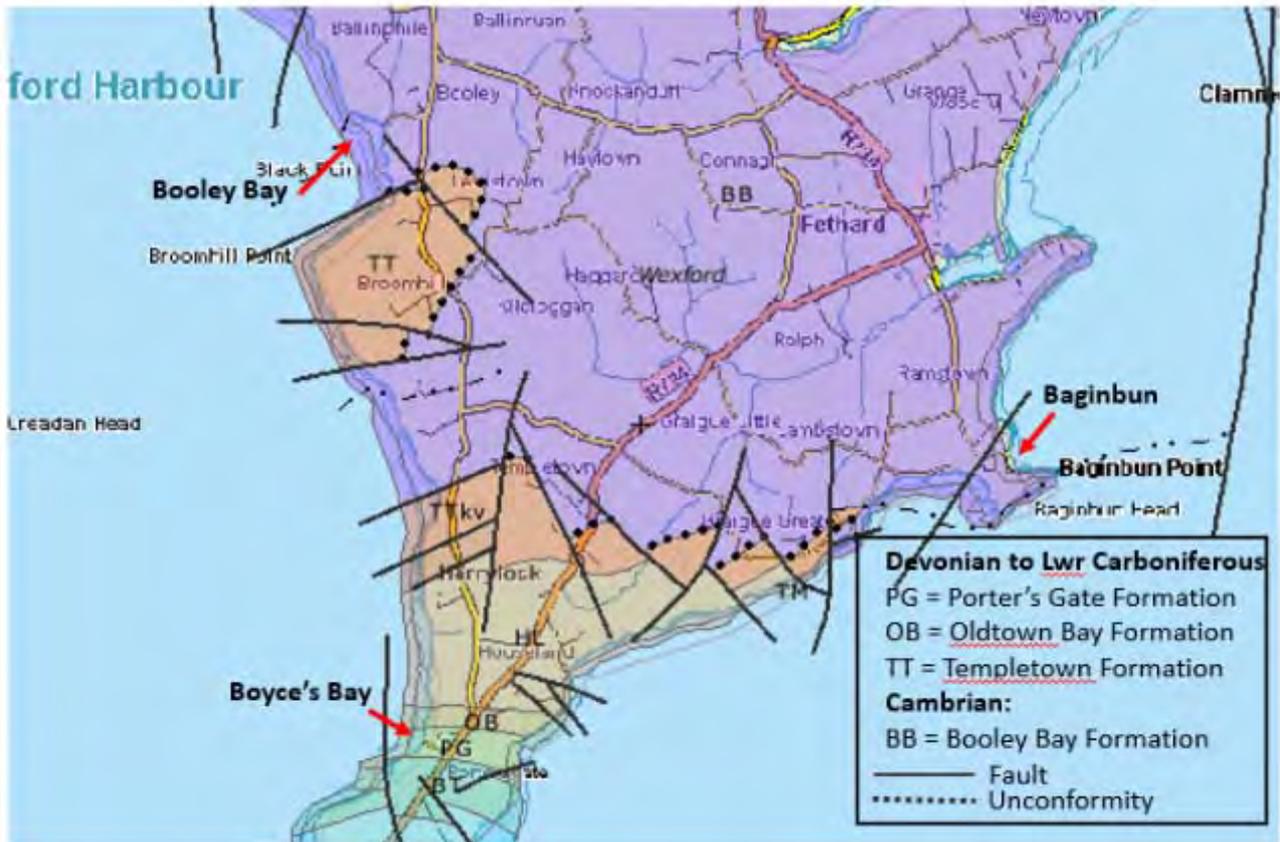
Figure 4: Structural Geology (extract from the 1:100,000 scale GSI map; [www.gsi.ie](http://www.gsi.ie) )

The regional structural geology of the area and at each landfall location is indicated on Figure 4.

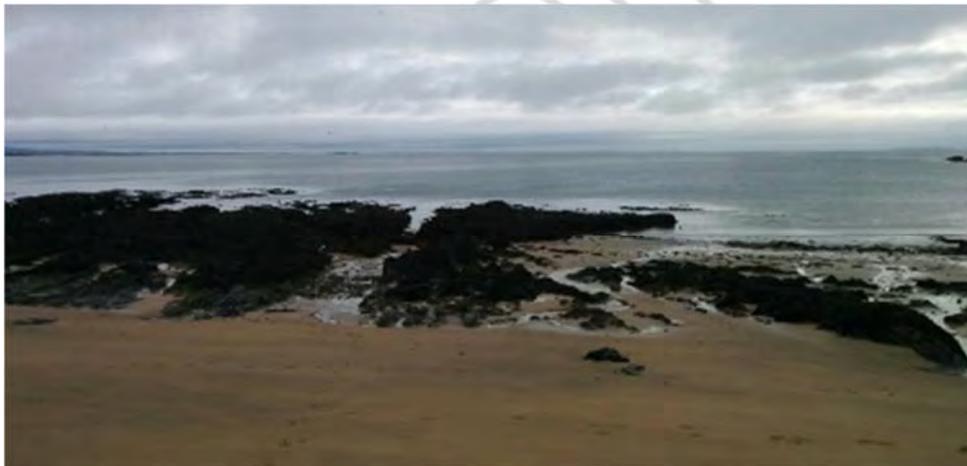
The northern side of the beach is bounded to the west by coastal cliffs with bedrock outcropping in places along the beach but more frequently towards the shoreline as shown in Photo 1.

**Photo 1: Outcropping rock**

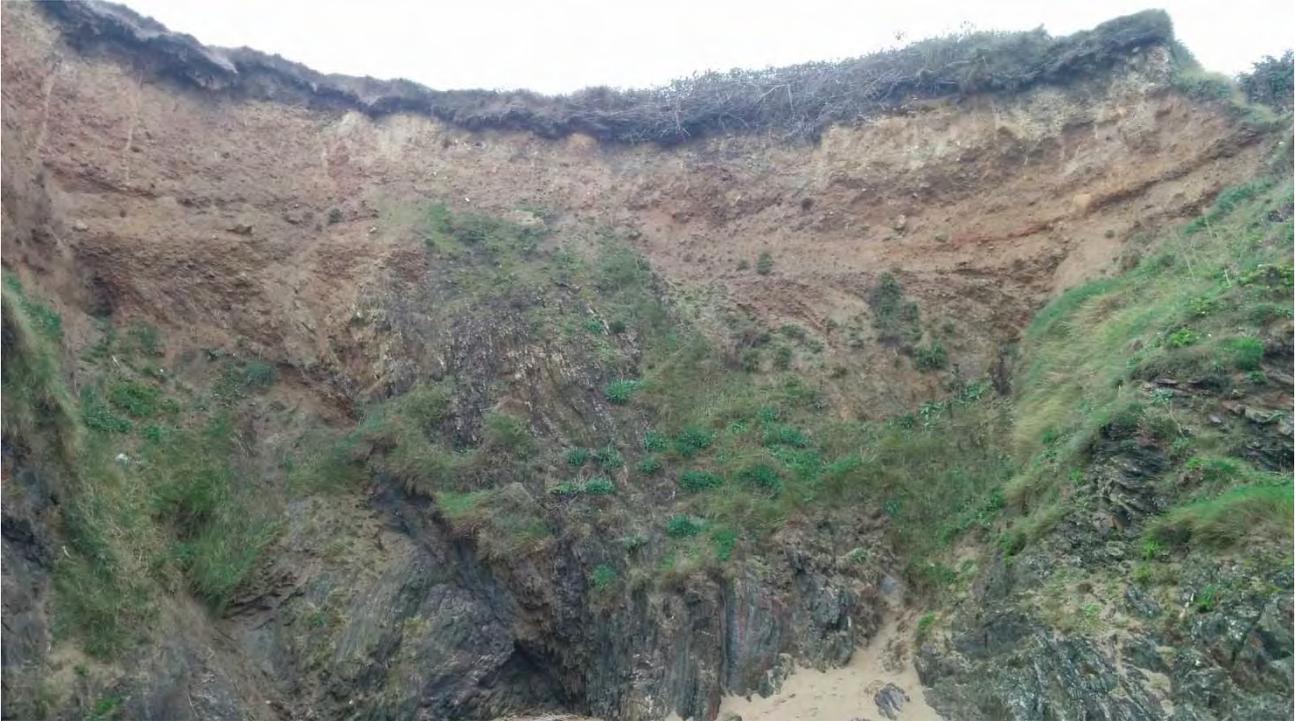
The cliffs are comprised of outcropping rock with a cover of 1 to 2.0m of overburden. While the cliffs are vegetated with grass and scrub in places, there is an abundance of unvegetated subsoil (potentially glacial till) towards the top of the slope as indicated in Photo 2.

**Photo 2: Subsoil overlying bedrock**

The slope morphology changes along the cliff with the greatest variability in the bedrock. Towards the crest of the slope the overburden is either standing at a steep to sub-vertical angle or is densely vegetated. Minor visual indicators of slope movement and shallow slumping of the subsoil material were observed along the slope as indicated in Photo 2 and Photo 3 below.

The bedrock is highly variable along this section of beach ranging from the interlayered meta-sediments indicated in Photos 2 and 3 to more massive greywackes at the northern end of the beach as show on Photo 4.

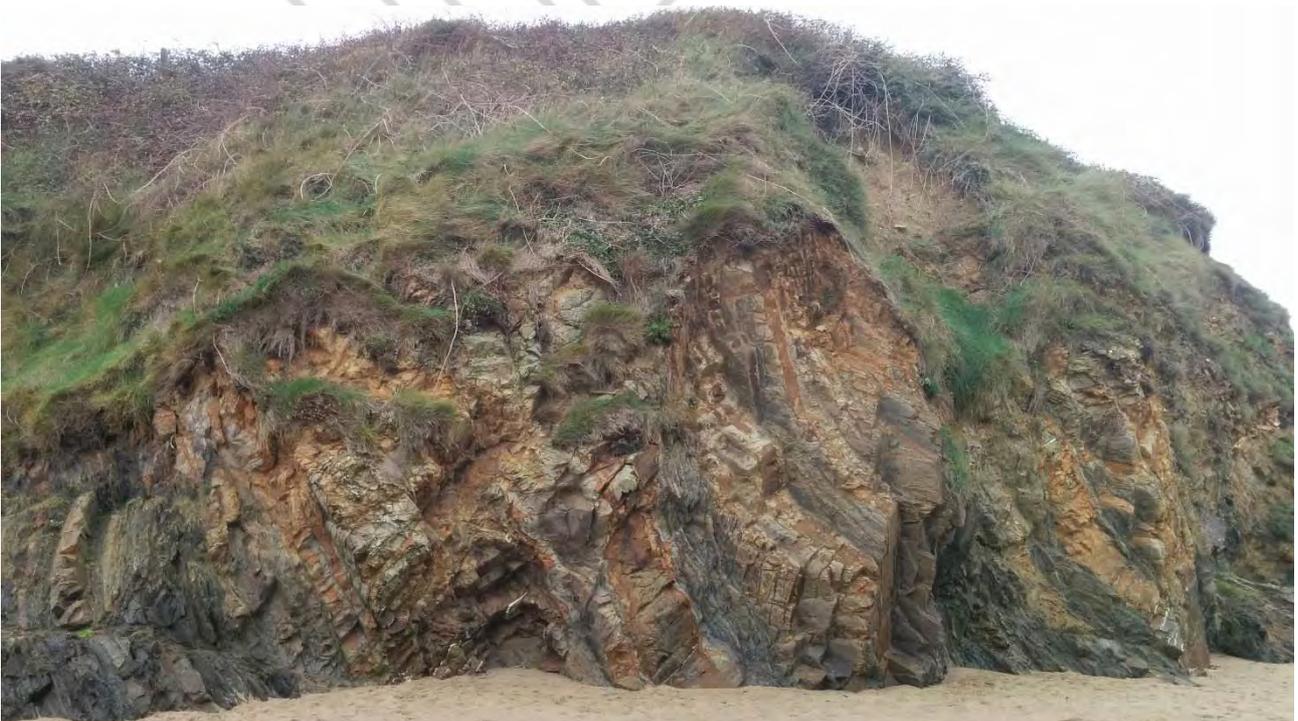
**Photo 3: Subsoil overlying bedrock**

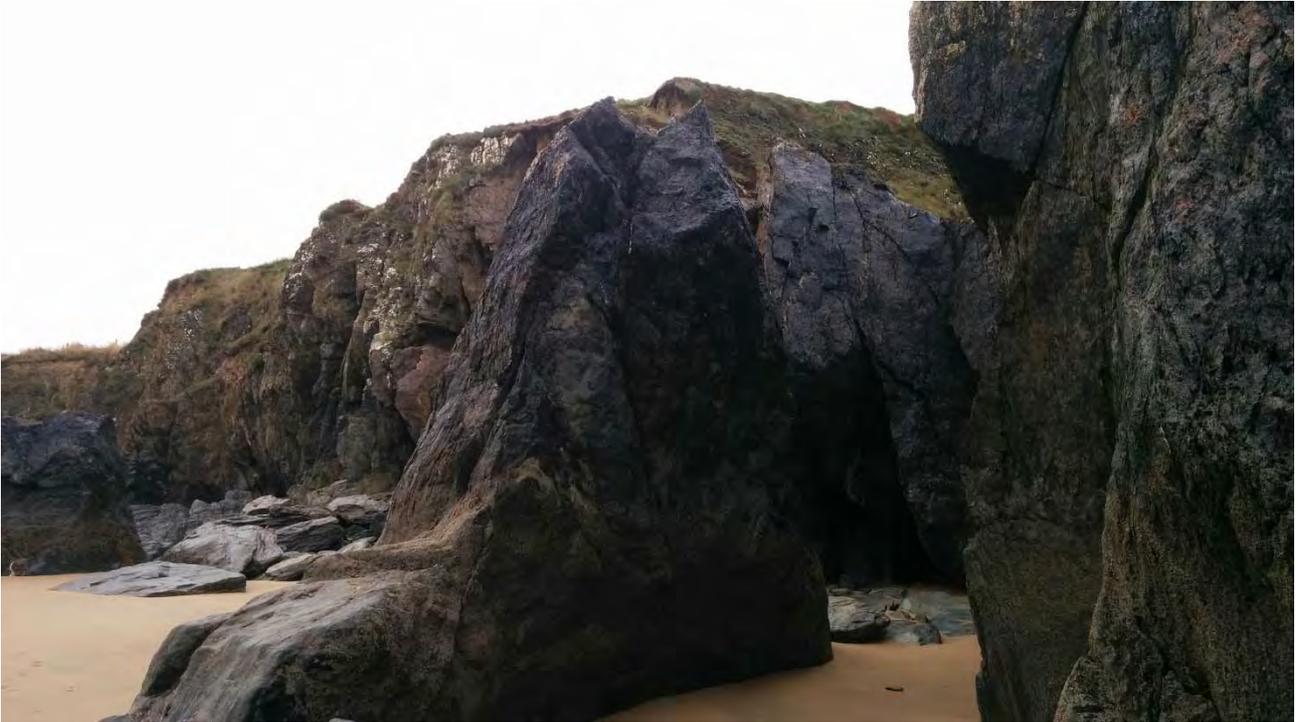
**Photo 4: North side of the Beach.**

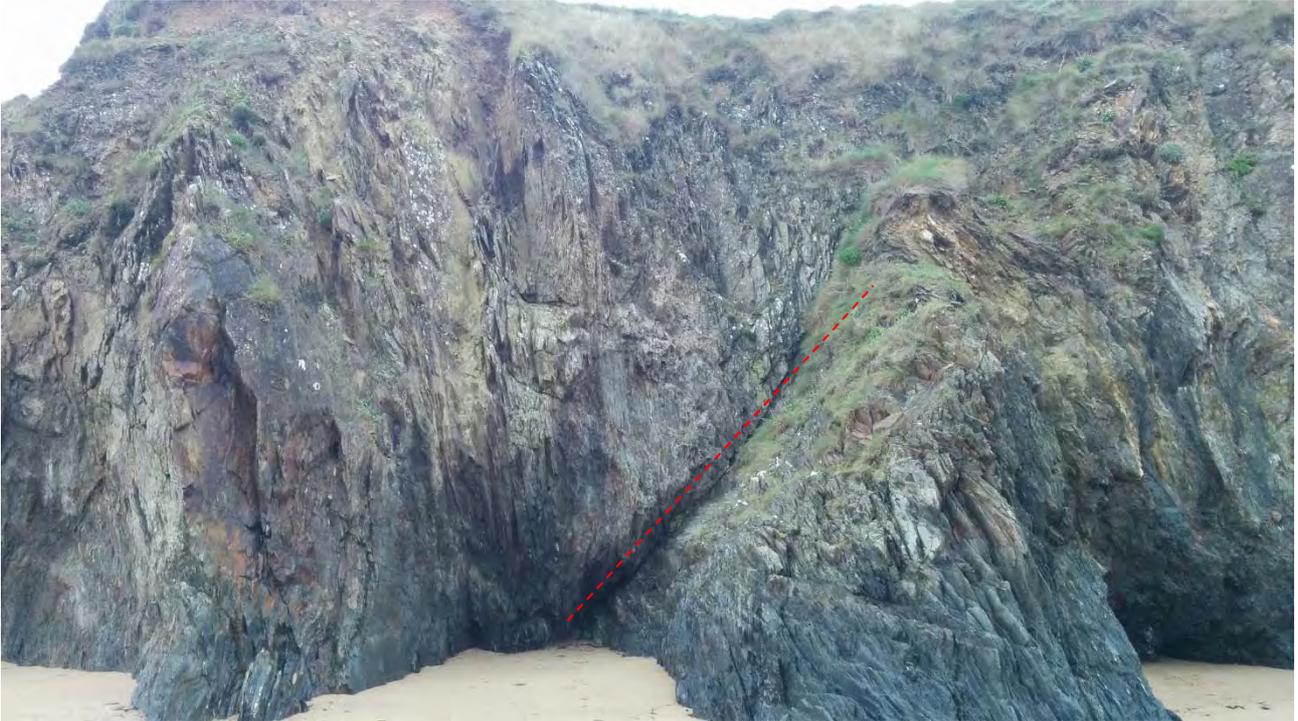
The structural geology at this location is highly complex manifested by the presence of regular minor folding and faulting visible along the rock faces (see Photo 5 for example). Bedding where present is sub-vertical to vertical.

**Photo 5: Faulting visible on rockface (faultline shown in red)**

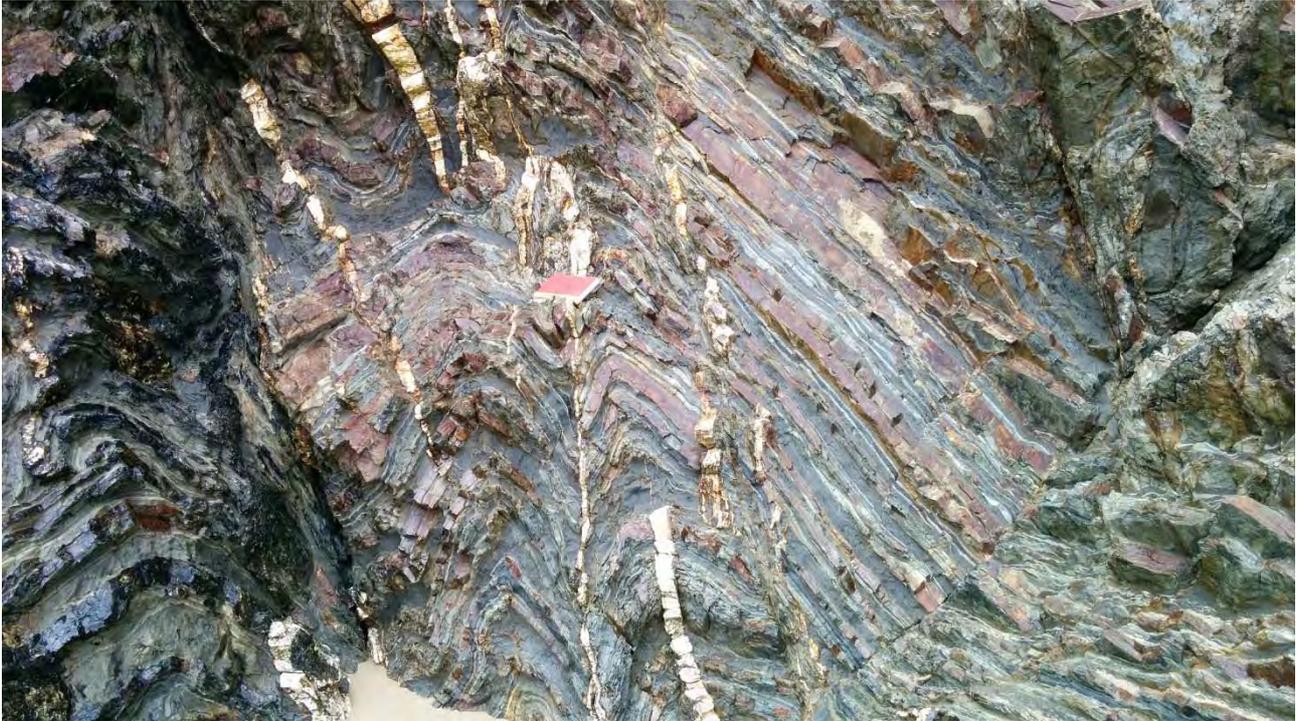
The southern side of the beach has a number of geological features which are likely to require protection. Photo 6 is an example of chevron folding in the metasediments.

**Photo 6: Chevron folding in interlayered meta-sediments.**

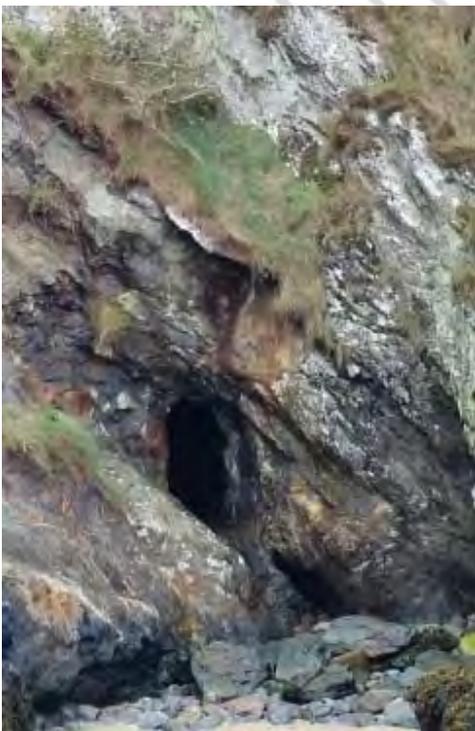
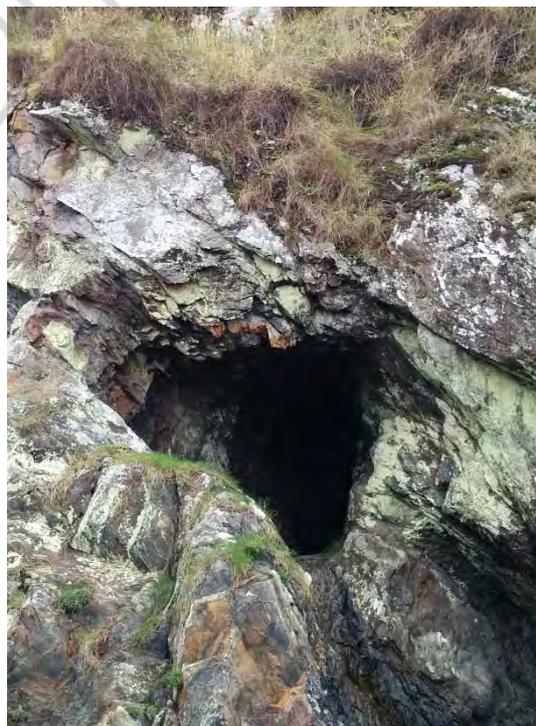
A number of caves are also present at a number of locations along the cliff face in this location (see Photo 7).

**Photo 7: Caves**

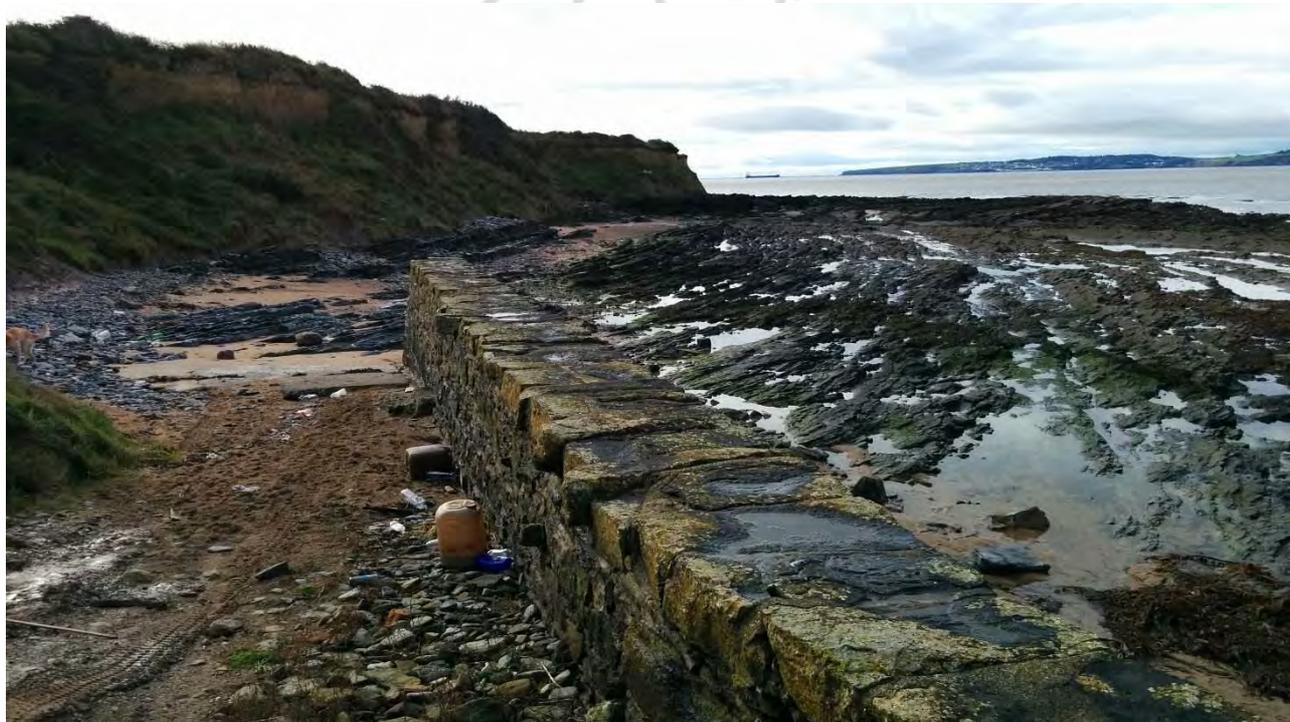
Limestone visibly outcrops along the southern end of the beach both at the base of the surrounding cliffs in this location and along the beach.

**Photo 8: Access to Boyce's Bay with outcropping limestone**

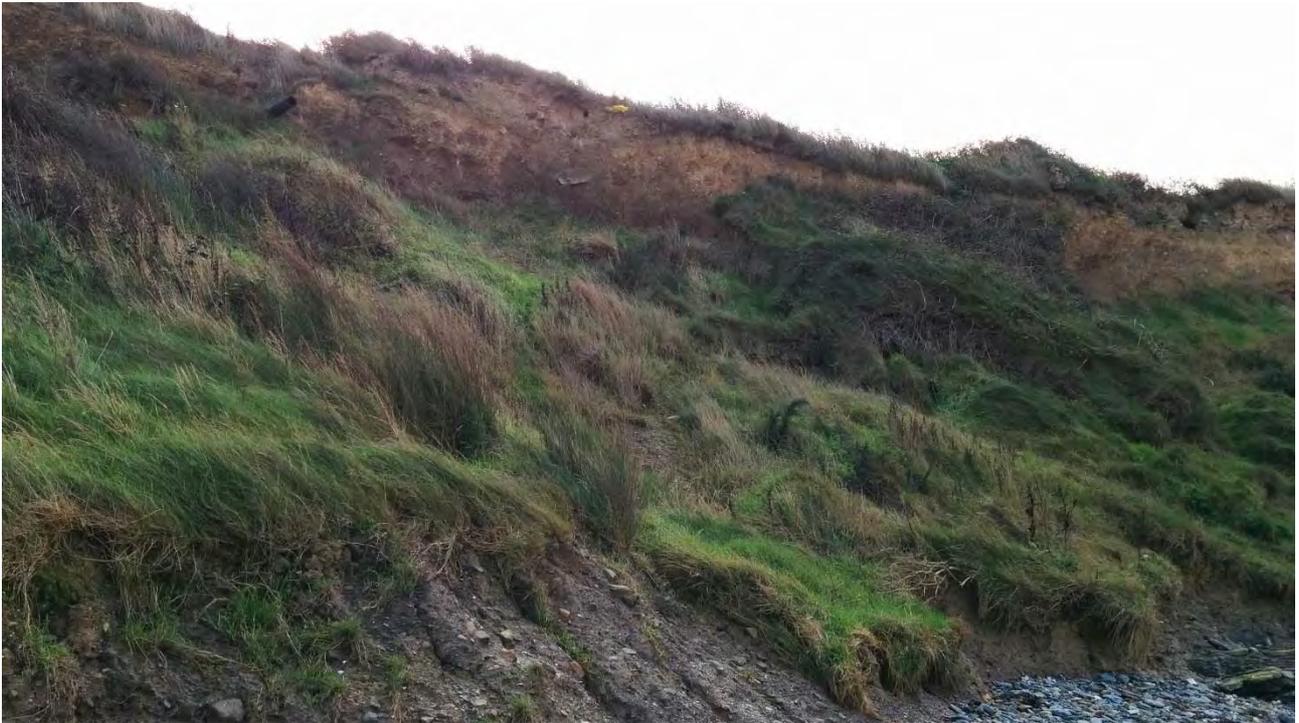
The surrounding cliffs at this location are comprised predominantly of subsoil of potentially glacial till. They are densely vegetated with grasses and scrub but there are many indicators of instability and slope movement as shown in Photo 9.

**Photo 9: Soil slopes along Southern side of Boyce's Bay**

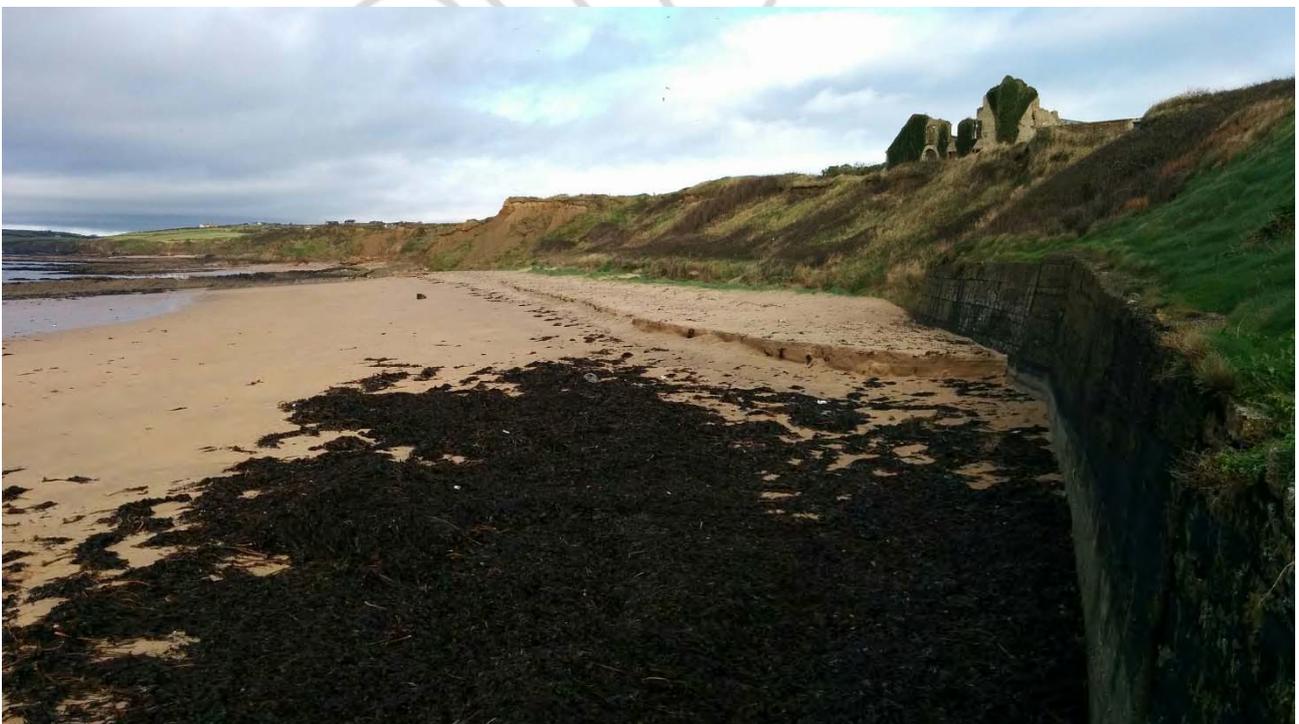
Moving in a northerly direction along the beach, the outcropping rock becomes less frequent and the beach is bounded predominantly by soil slopes.

**Photo 10: Looking North along Boyce's bay.**

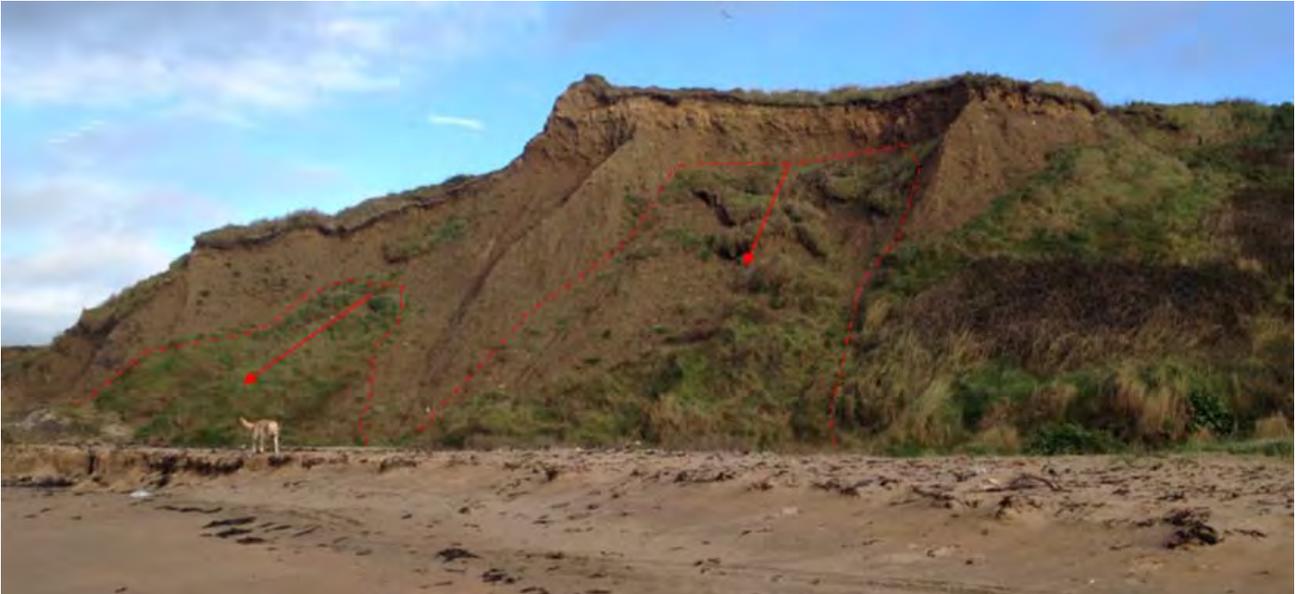
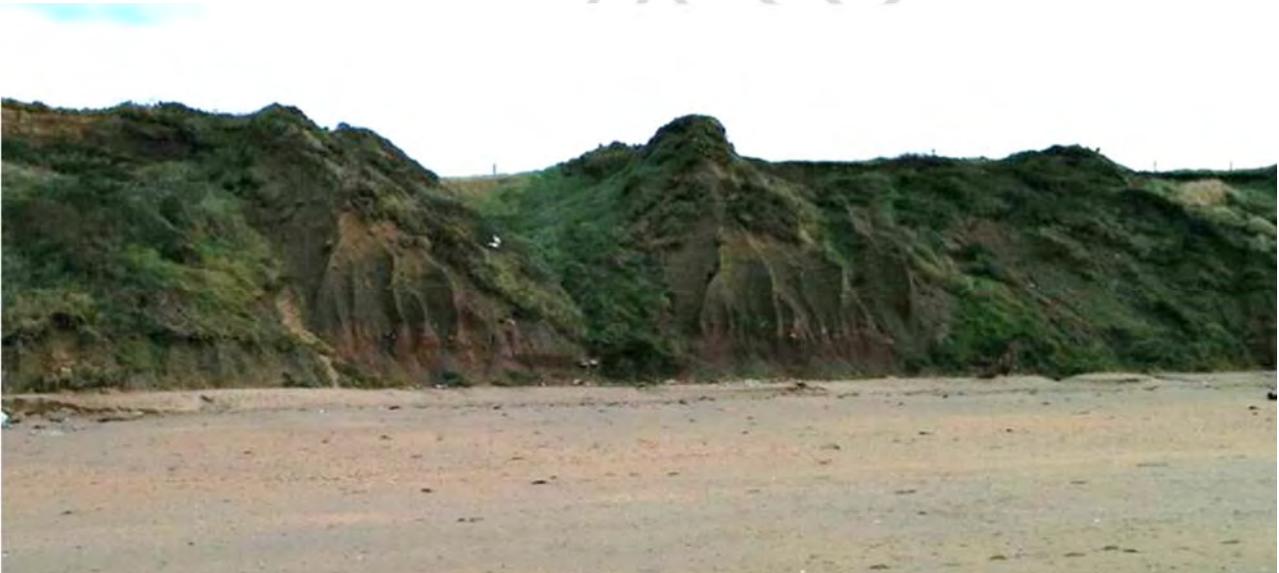
There is an abundance of slope failures visible along the slope. These failures appear to be progressive and predominantly shallow and are likely to have formed due to continual cliff recession due to over-steepening of the slope by erosion of the toe of the slope (Photo 11).

**Photo 11: Slope failure along soil slopes.**

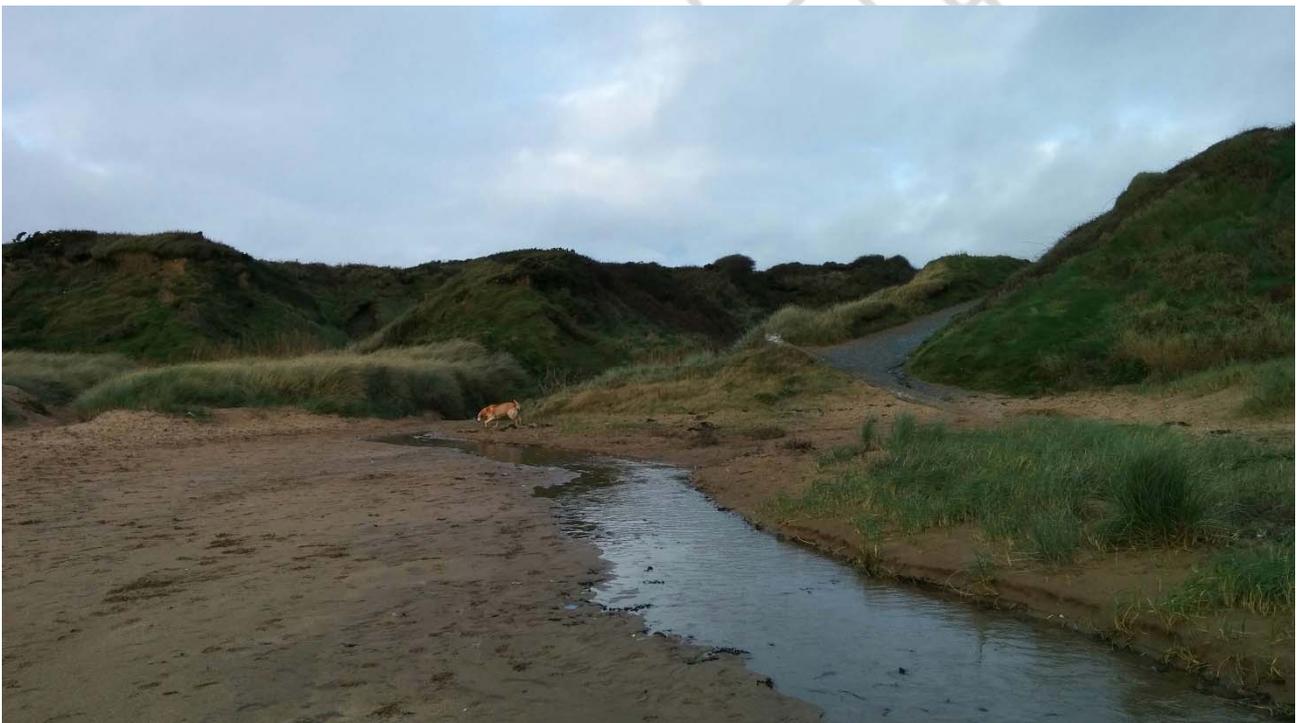
The access to Booley Bay runs parallel to a freshwater river. On both sides of the river the area is dominated by vegetated headlands to the north and south (Photo 12).

**Photo 12: Freshwater stream**

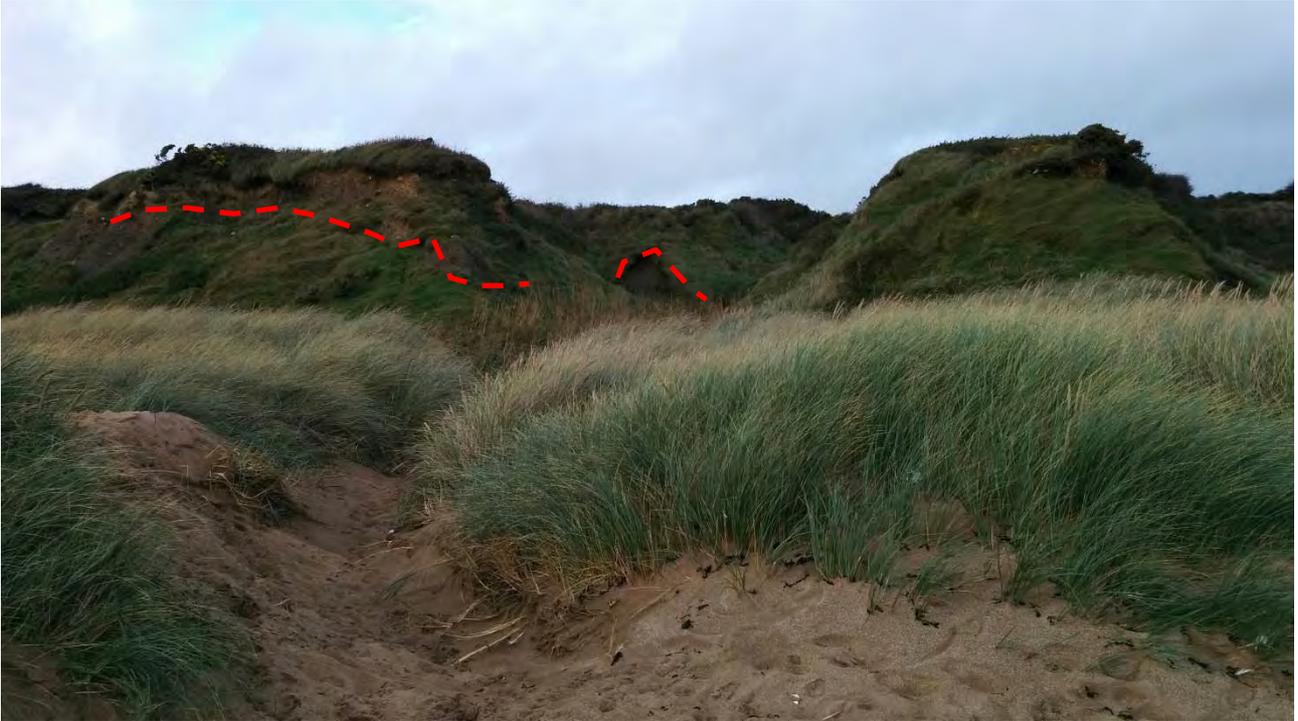
Directly north of the river, the area is dominated by a small dune system which is densely vegetated. Minor instabilities, soil creep and shallow slides were observed on the cliff faces as indicated on Photo 13.

**Photo 13: Minor instabilities**

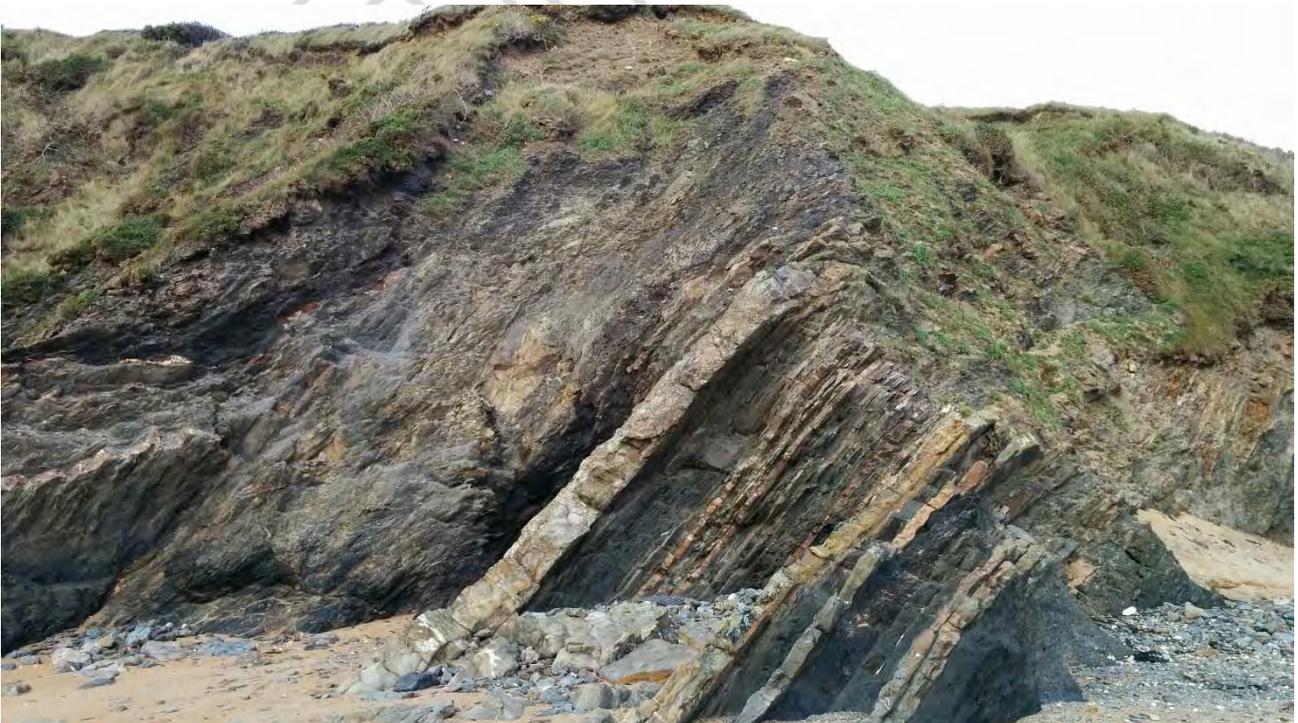
The dune system transitions into an area of outcropping rock and cliffs. Rockhead is irregular and a thin soil cover is generally present except in areas where depression in the rockhead have been infilled with subsoil material (Photo 14).

**Photo 14: Rock outcrops showing variability of rock present**

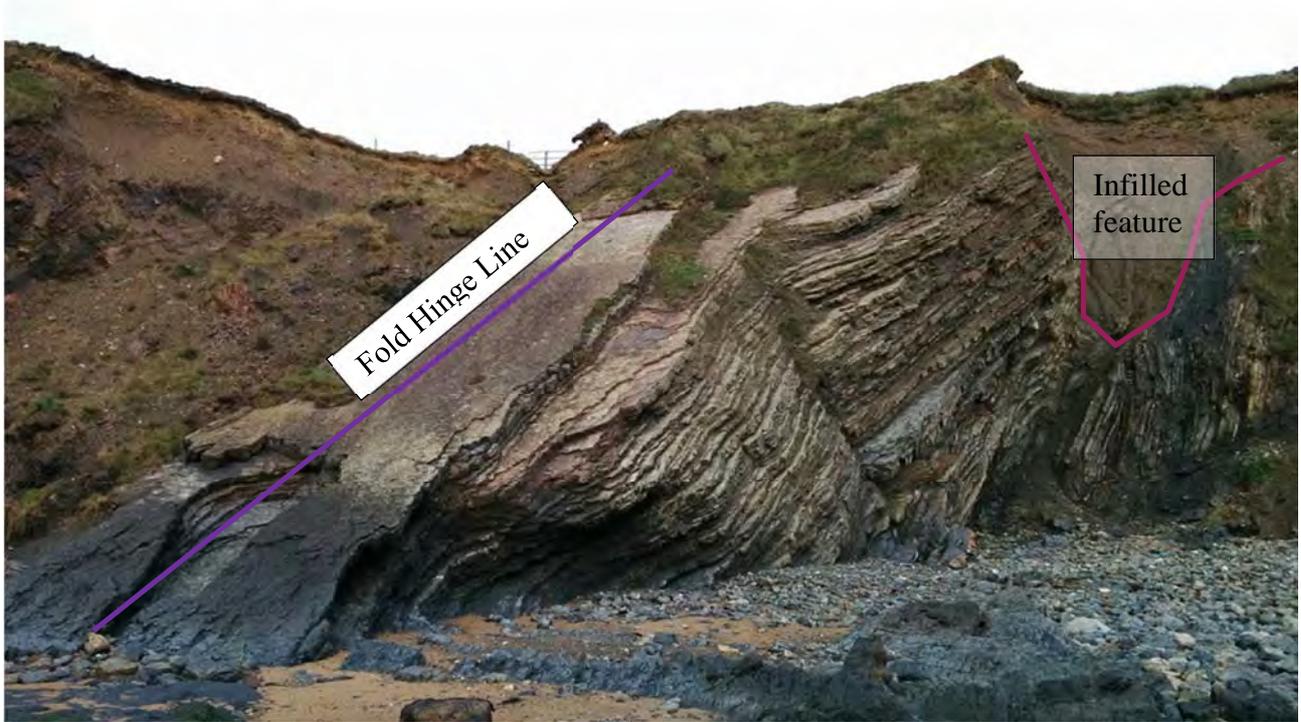
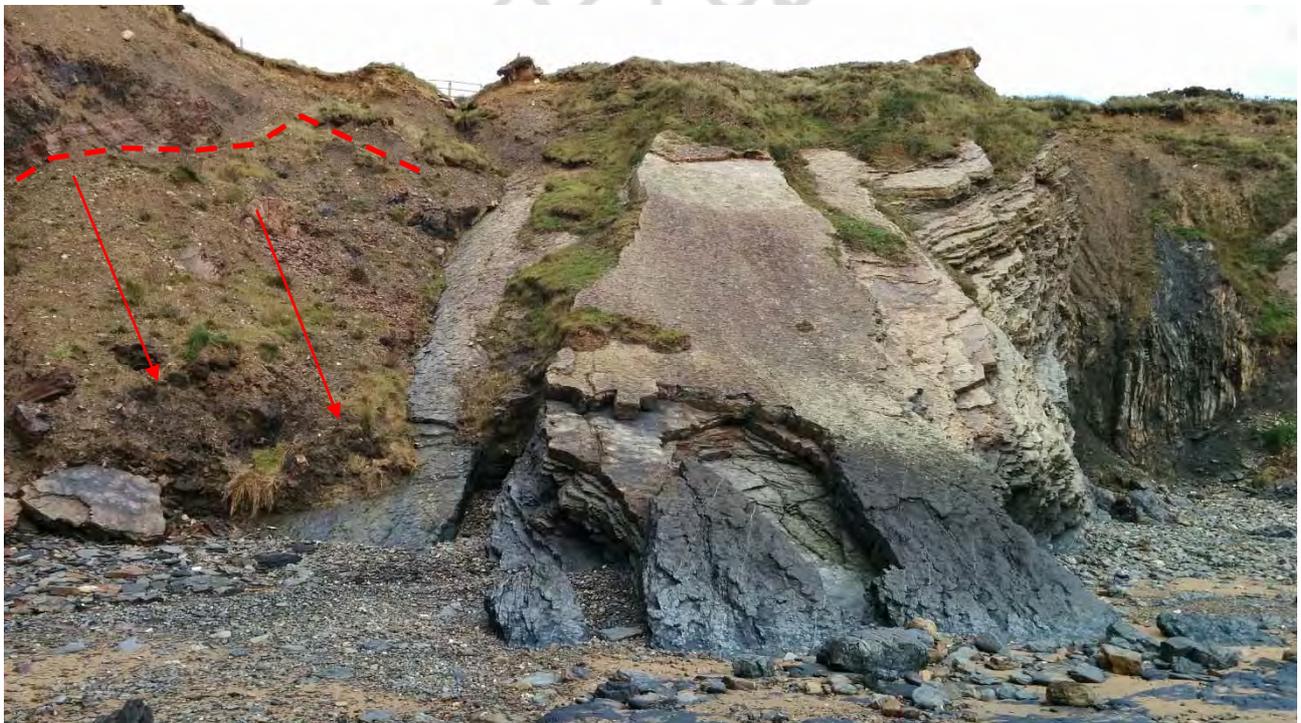
The geology is complex with interlayered meta-sediments and many structural features evident. (Photo 15)

**Photo 15: Outcropping fold and adjacent areas of infill and instability**

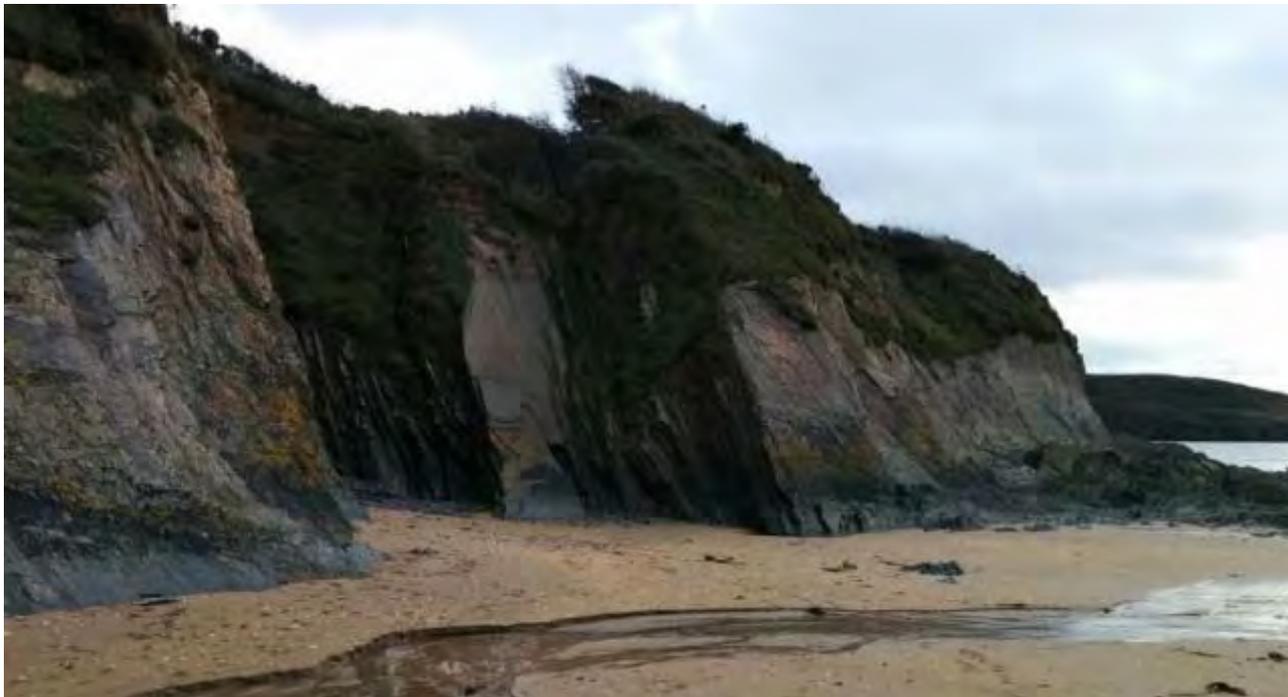
The southern side of Booley Bay is dominated by steeply dipping slate dominated meta-sediment with a thin soil cover vegetated with grass towards the top of the slope as shown on Photo 16:

**Photo 16: Southern side of Booley Bay**

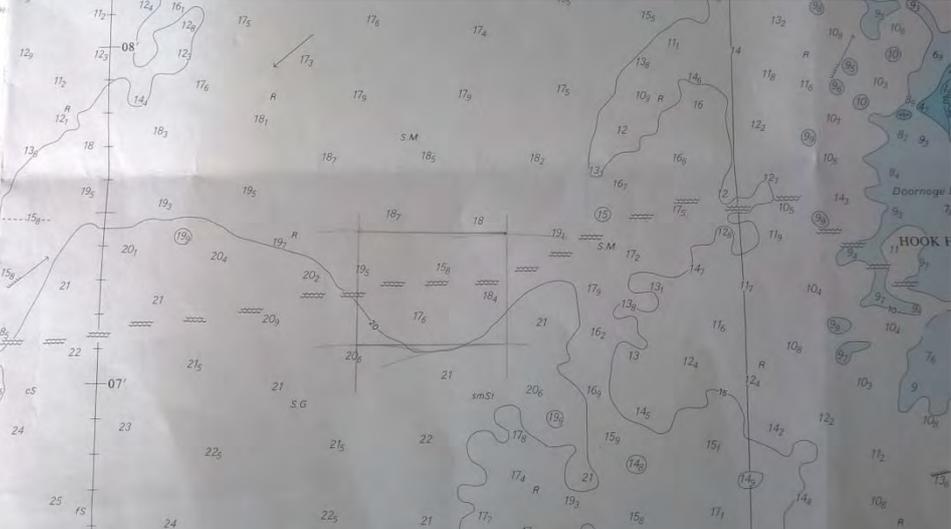
<p>Anthony Bates Partnership (Colm Sheehan) is dredging consultants. <a href="http://www.anthonybates.co.uk/">http://www.anthonybates.co.uk/</a></p> <p>Dredged spoil is deposited at estuary mouth in boxed zone indicated below. Dredging licence is available on their website (<a href="http://www.environ.ie/planning/foreshore/applications/port-waterford-company">http://www.environ.ie/planning/foreshore/applications/port-waterford-company</a>). Foreshore Licence reference: FS005701</p>
