# Appropriate Assessment Screening Report & Natura Impact Statement to inform Appropriate Assessment

Proposed removal of three existing pipe culvert bridges  
and the construction of three new culvert bridges, at  
Bushypark, Co Galway

For OPW

July 2022

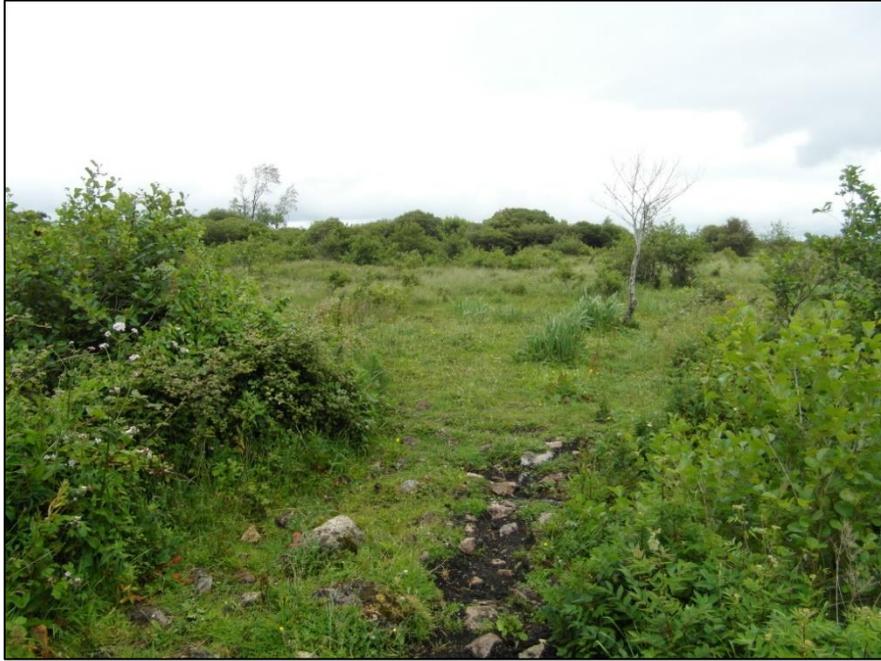
**Photograph 1: Site at Bushypark, Co Galway,  
showing location of proposed project at UB2, F776– Chainage 350**

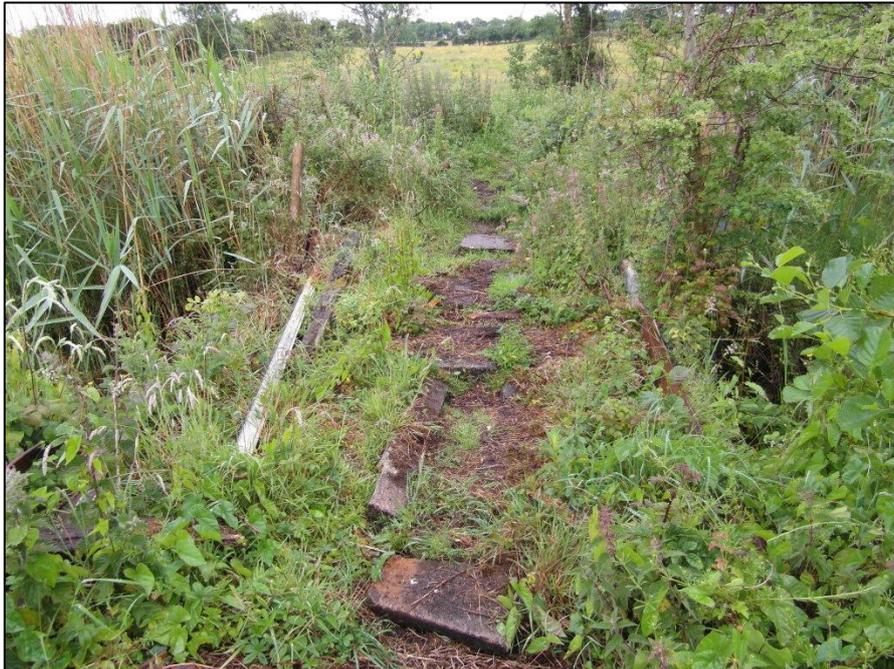
**Photograph 2: Site at Bushypark, Co Galway,  
showing location of proposed project at UB3, F776– Chainage 410**

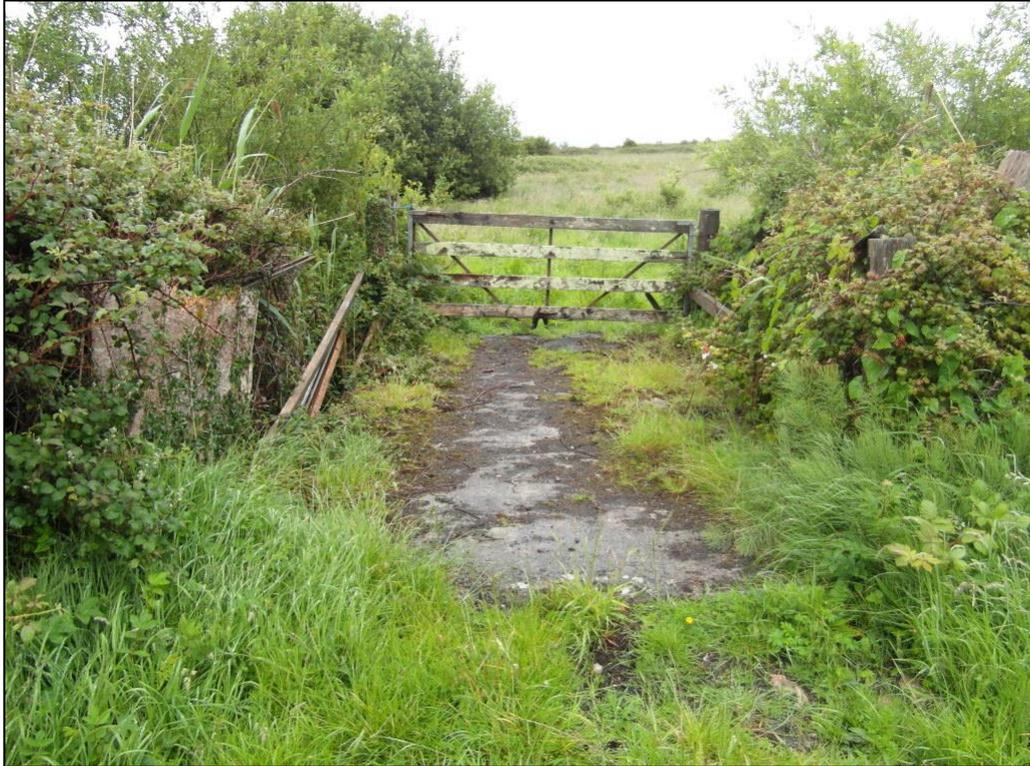
**Photograph 3: Site at Bushypark, Co Galway,  
showing location of proposed project at UB4, F776– Chainage 510**

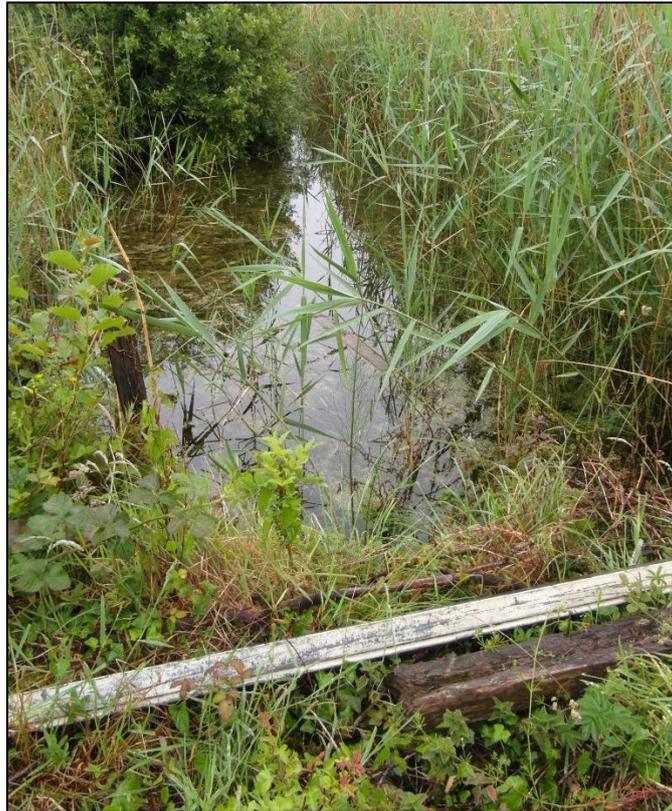
**Photograph 5: View of drain at proposed new bridge at UB3, F776– Chainage 410**

looks slightly drier, compared to the fields north of bridges UB3 and UB4, with more grass present but also turning to scrub. The field to the south is grass pasture with large bramble patches. The bridge here is stone and soil top with grass, no side rails and in a fairly poor state. The channel sides are vegetated with bramble, small alder trees and willow while the channel centre is more open than at the other two bridge areas. From the bridge the channel runs north-west for 125 m before turning north and entering the Corrib River 160 m to the north. The whole channel is fairly deep with a high water level and with no visible flow.

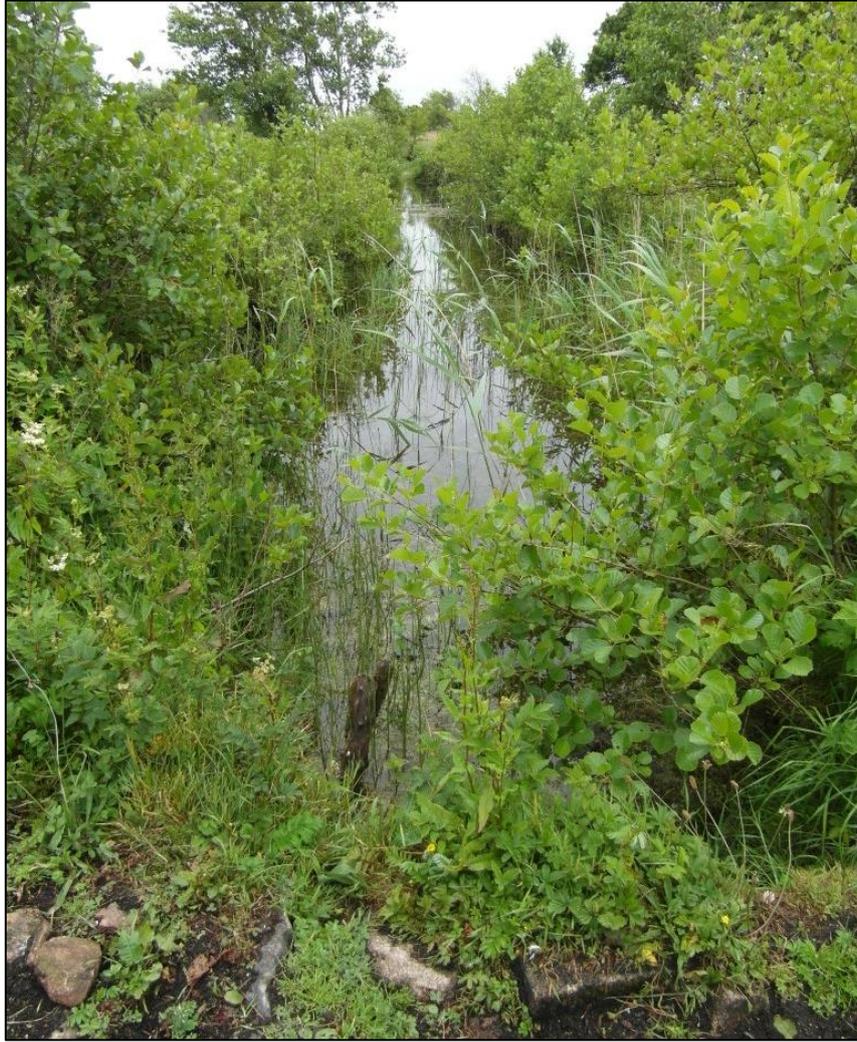
**Photograph 6: View of drain at proposed new bridge UB2, F776– Chainage 350**

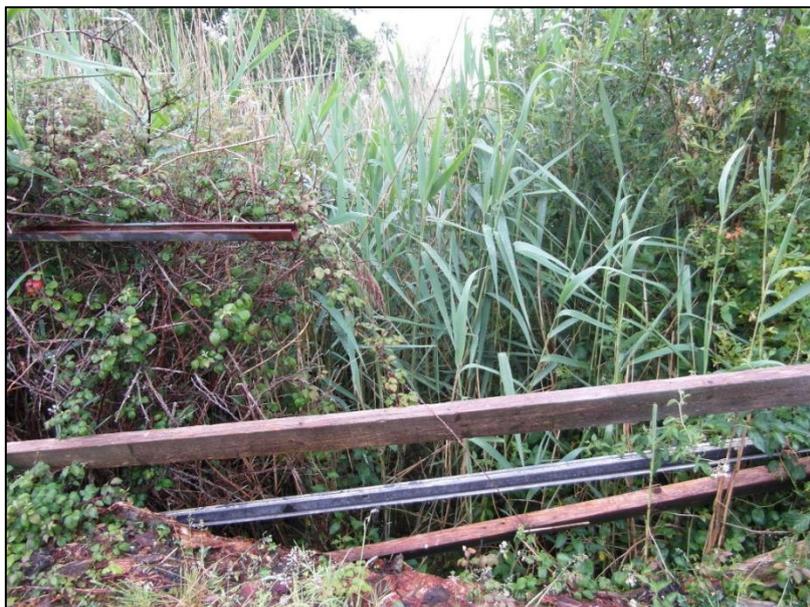
**Photograph 8: View of drain showing well vegetated nature of the channel**

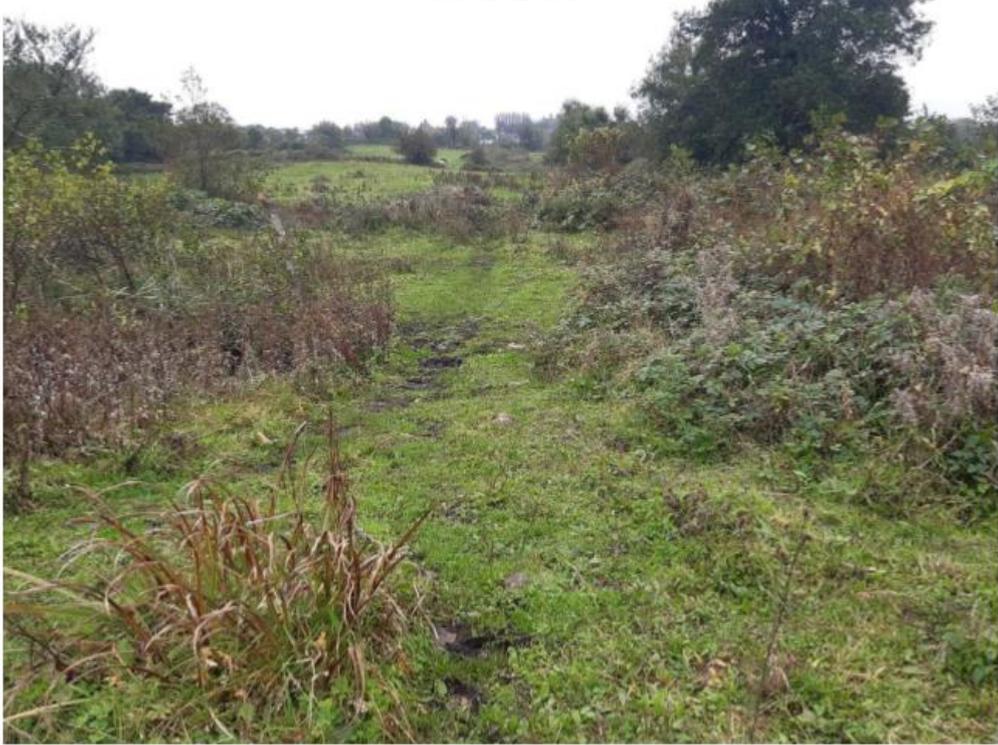
Existing Structure

Collapsed Timber deck

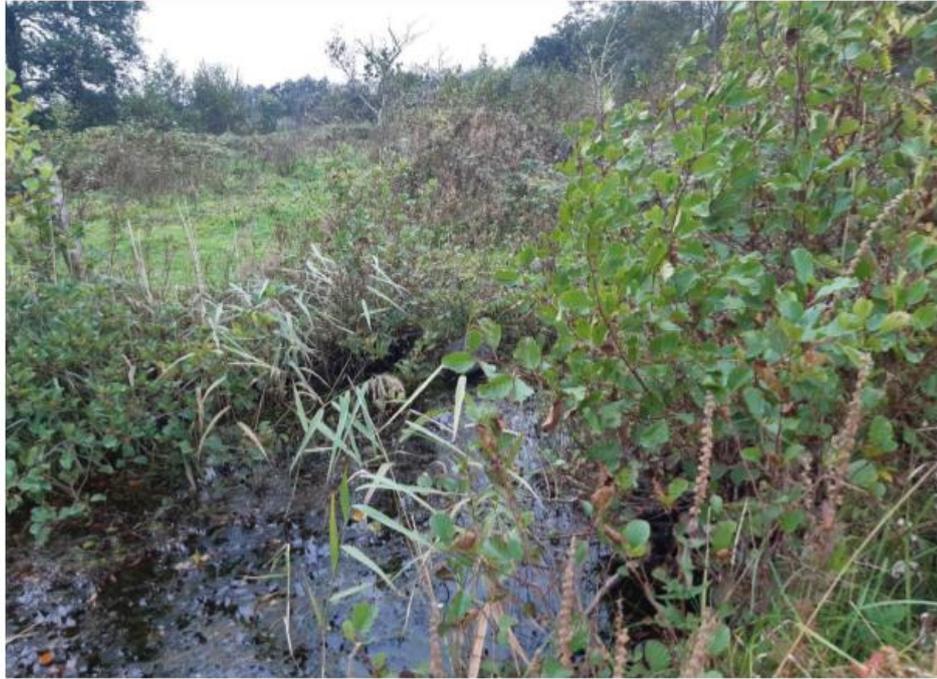
View looking Upstream

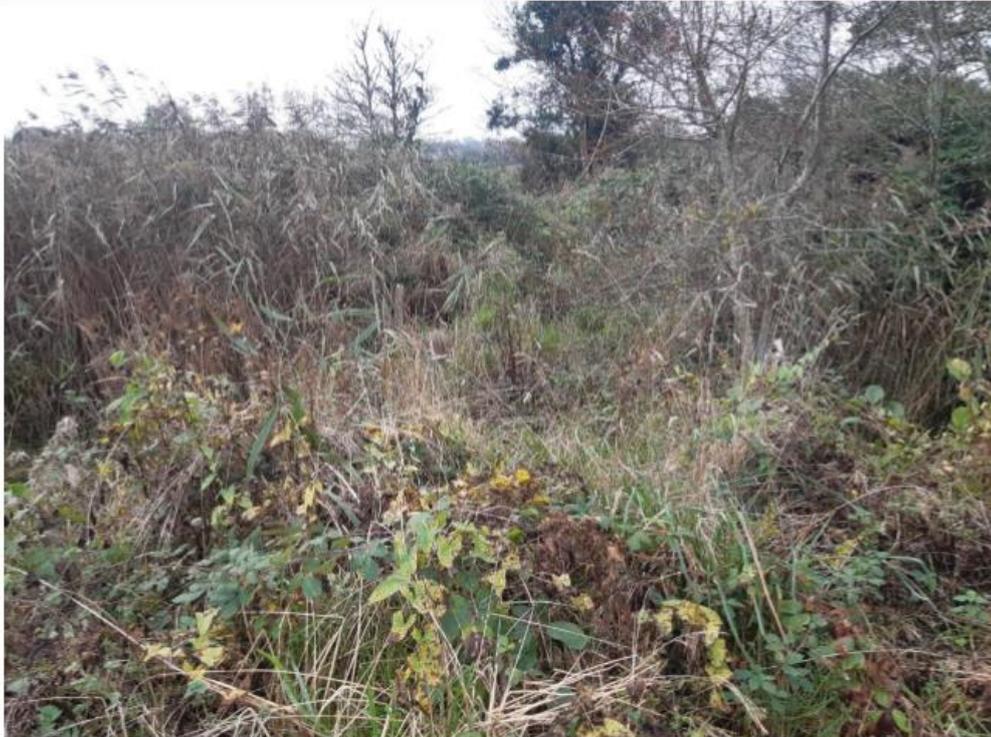
View looking Upstream

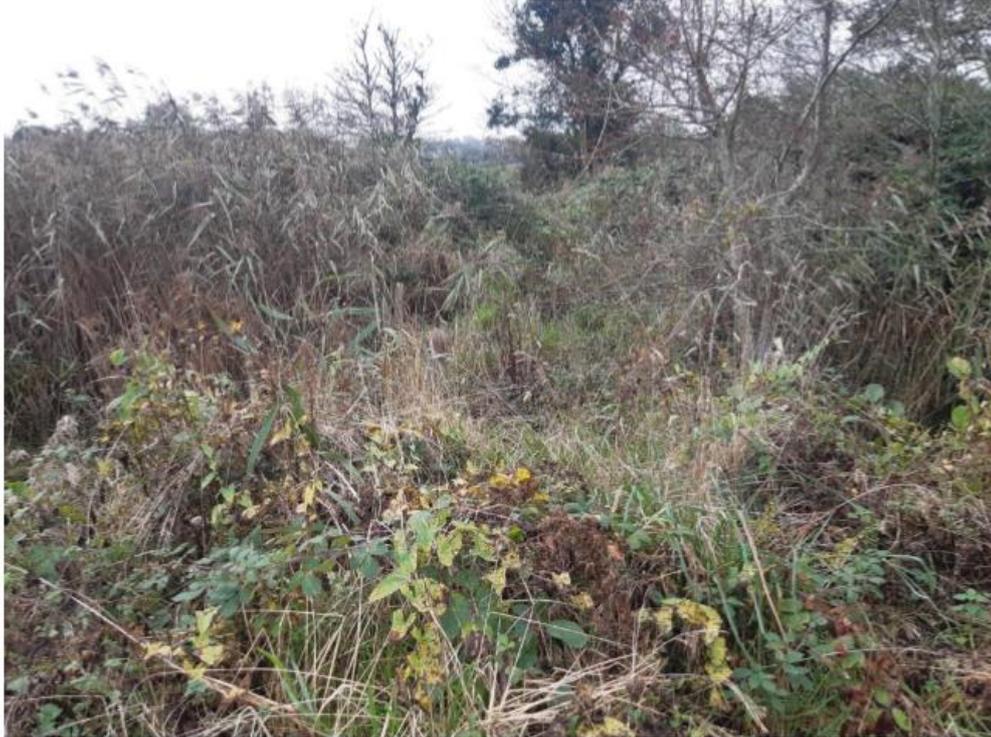
View looking Upstream Site is overground and structure is difficult to locate
